Inspection Photos
Location Name: Champlin 248 Amoco A#3
Location ID:320030

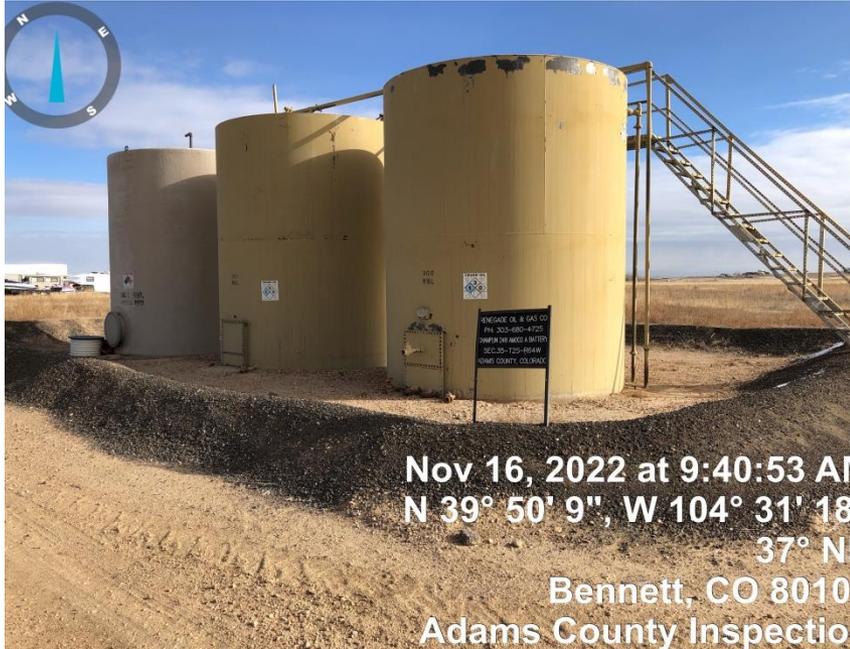
Photo#1 Production Tanks & Produced Water Tank

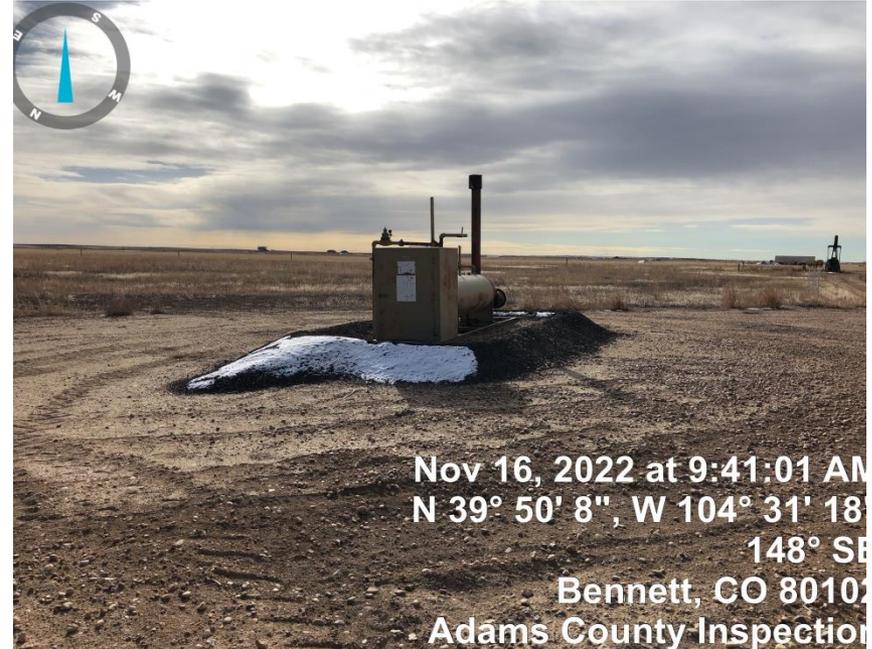
Photo#2 Separator

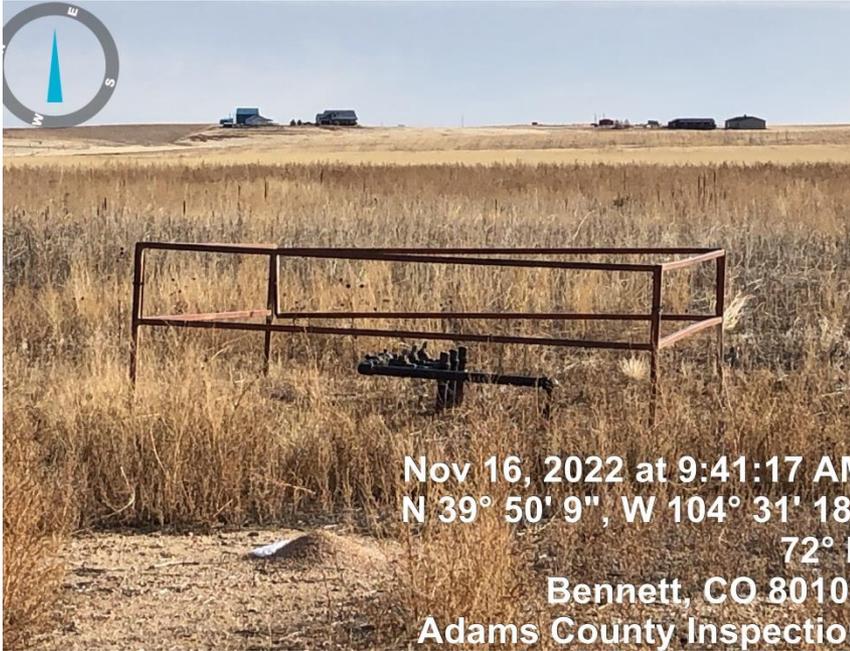
Photo#3 Flowline Header

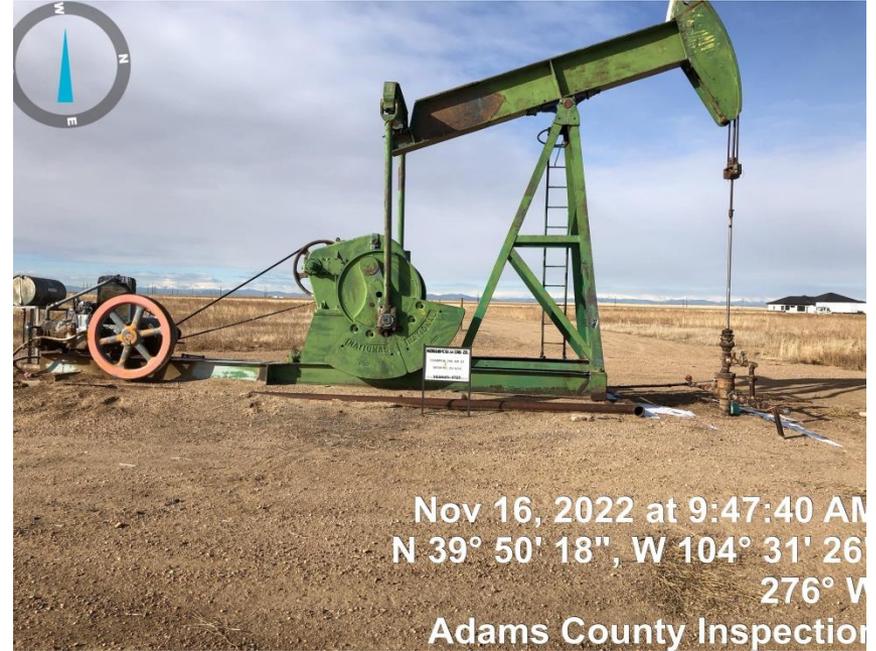
Photo#4 Pumpjack/Wellhead
