Inspection Photos

Location Name: CAERUS PICEANCE LLC KRK LTD-67S92W /7NWSE

Location ID: 334835

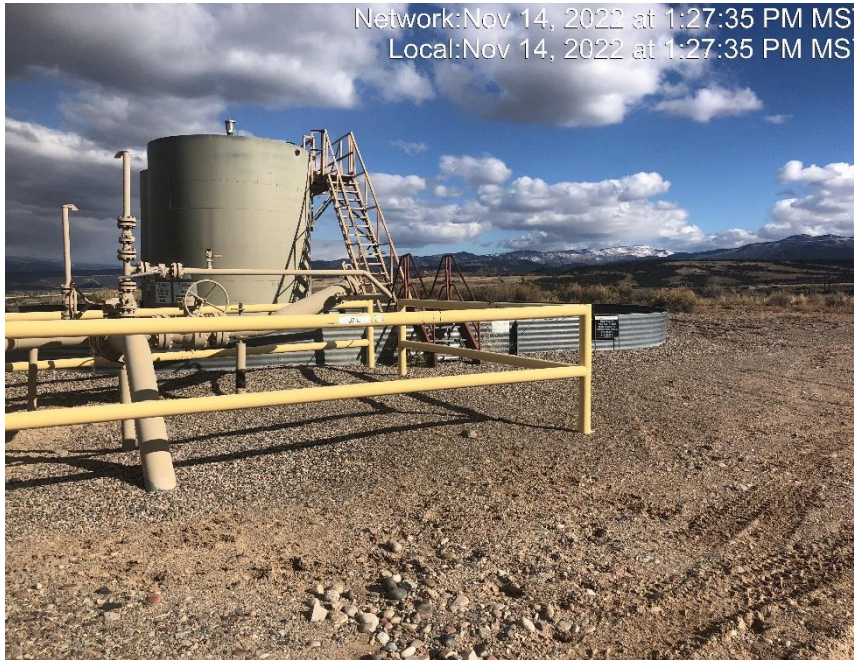
Photo #8377 From entrance to location.

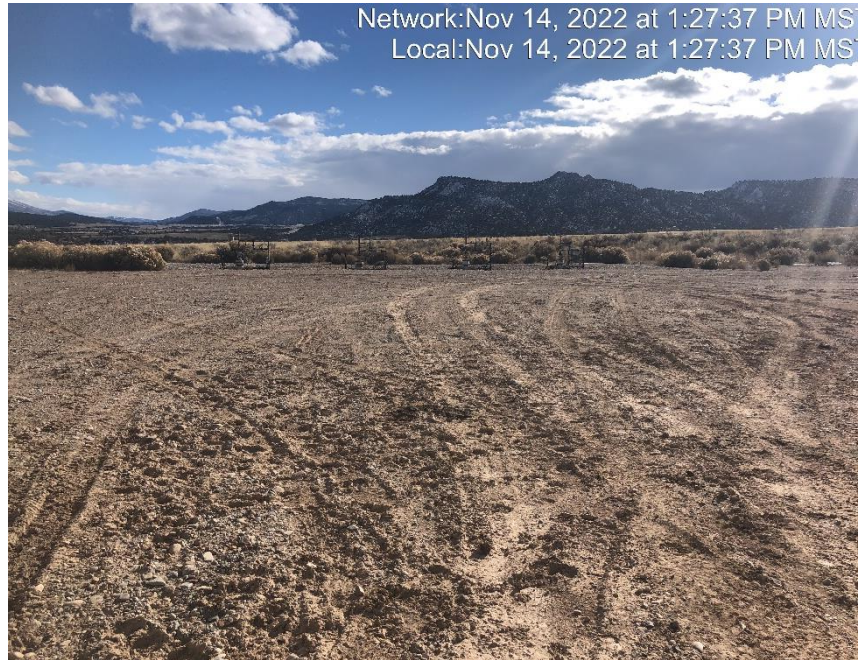
Photo #8378 From entrance to location

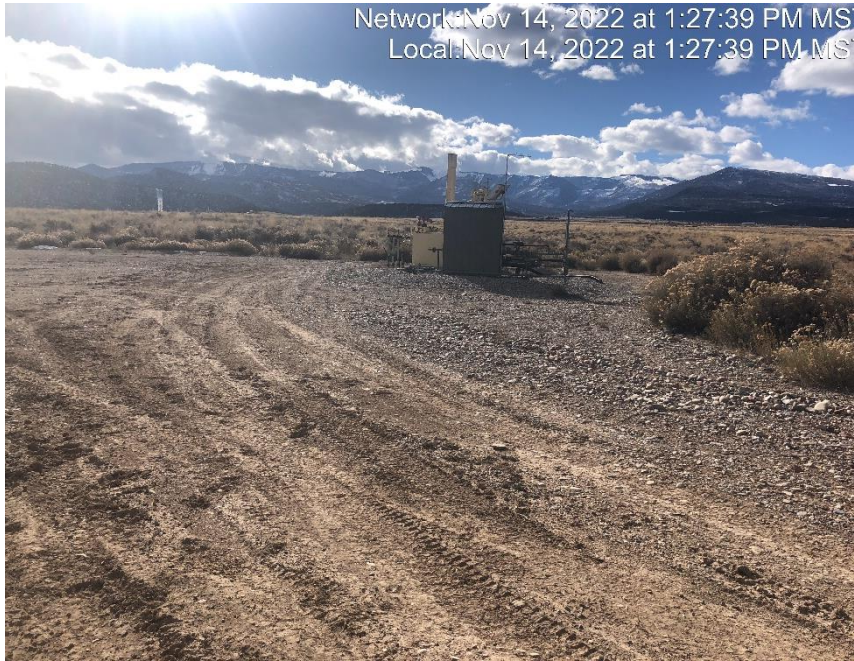
Photo #8379 From entrance to location.

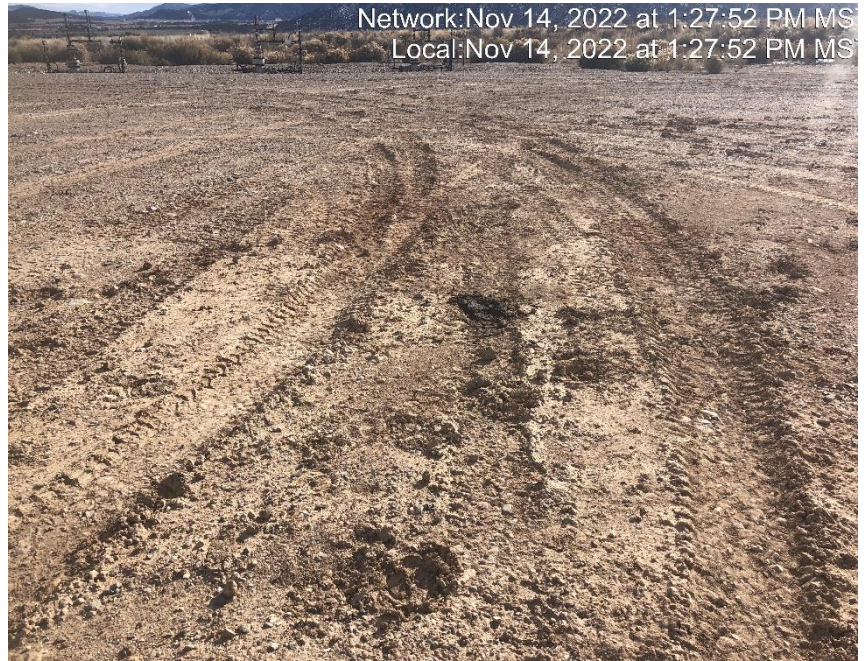
Photo #8380 Location lacks stabilization.

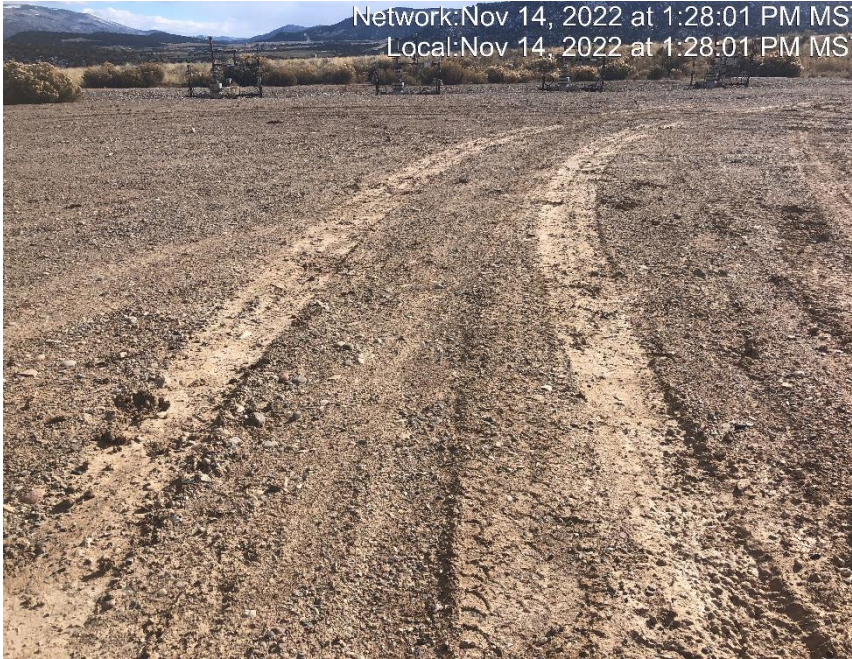
Photo #8381 Location lacks stabilization.

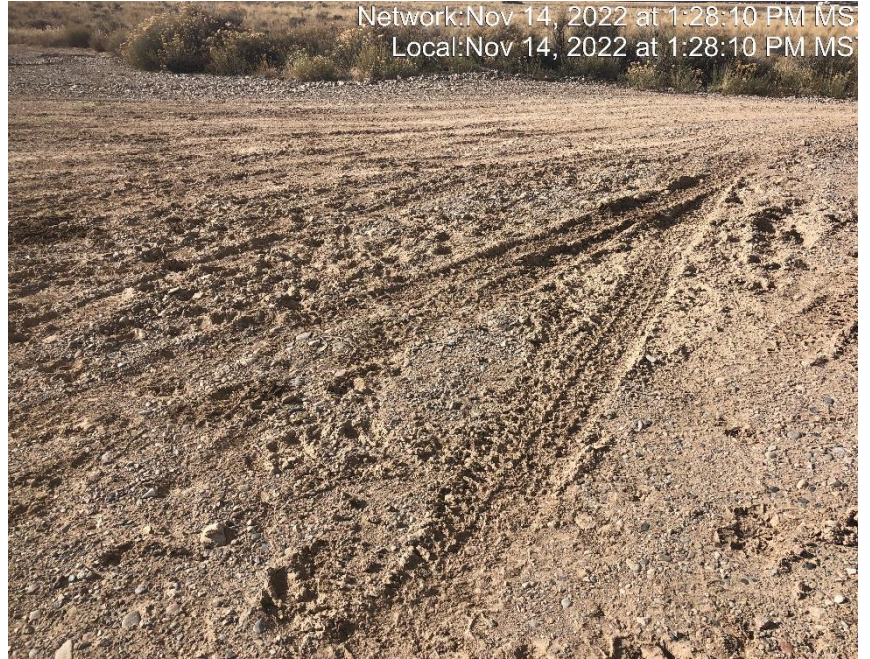
Photo #8382 Location lacks stabilization.

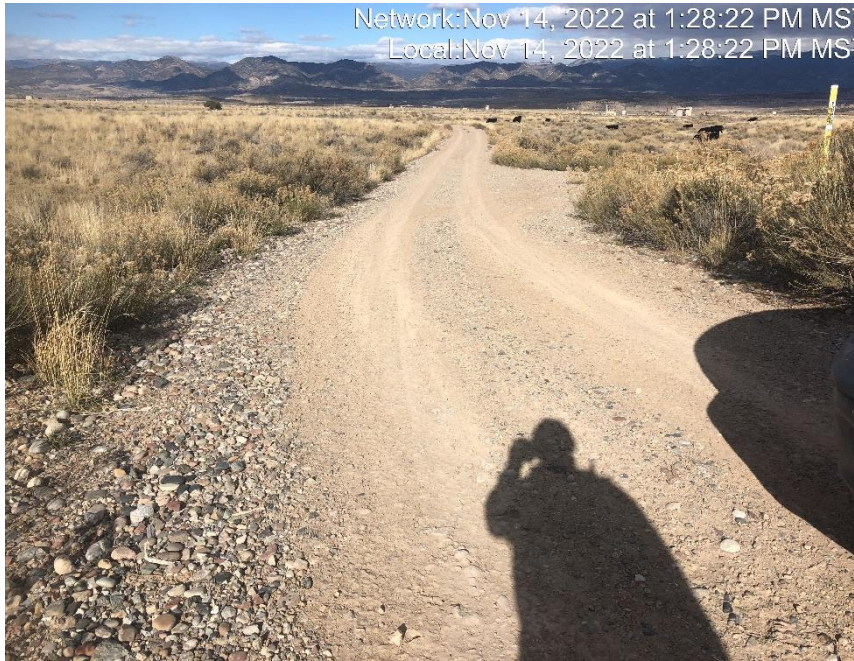
Photo #8383 Insufficient tracking BMP at entrance to location.
