Inspection Photos

Location Name: CAERUS PICEANCE LLC KRK-67S92W /7NENE

Location ID: 323941

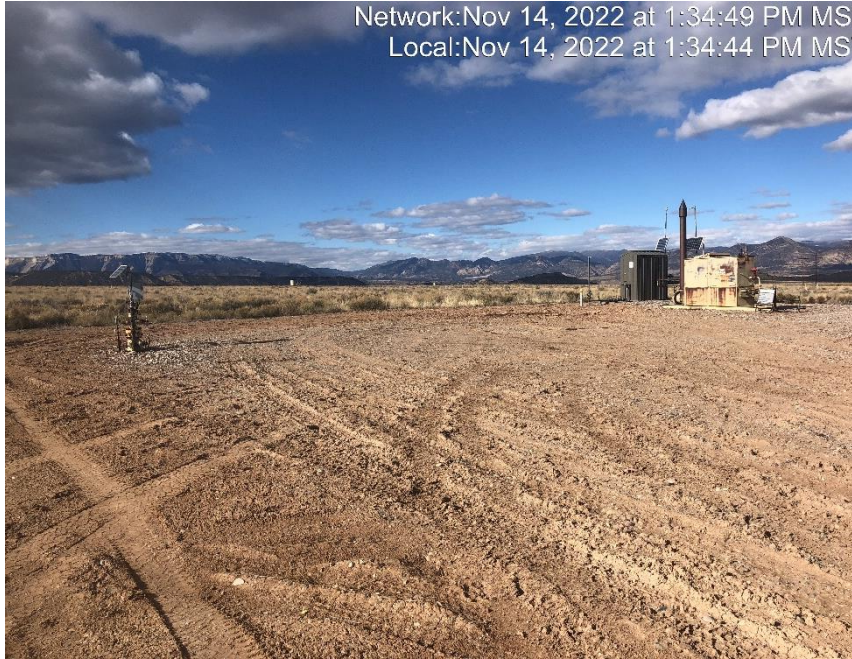
Photo #8388 From entrance to location.

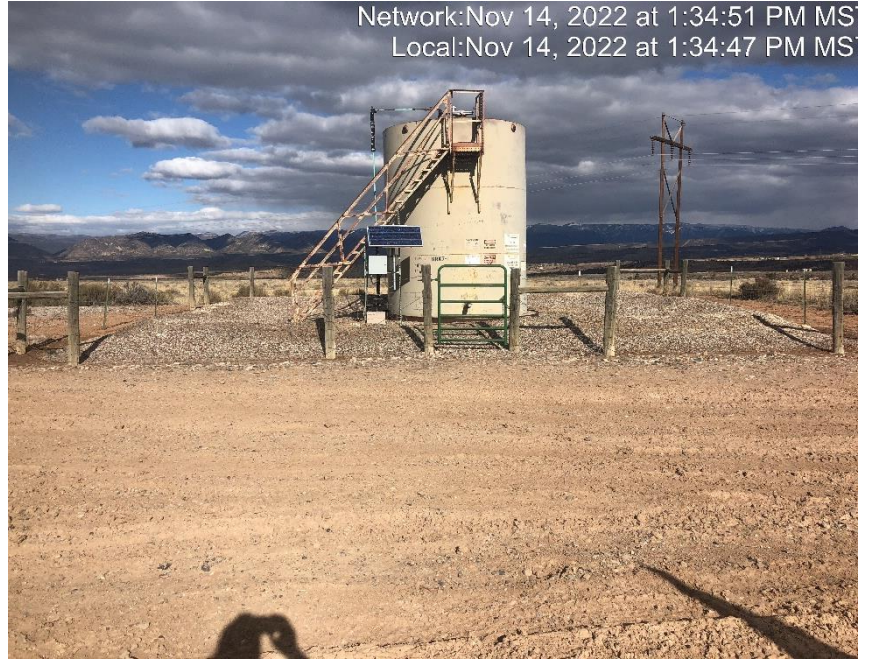
Photo #8389 From entrance to location

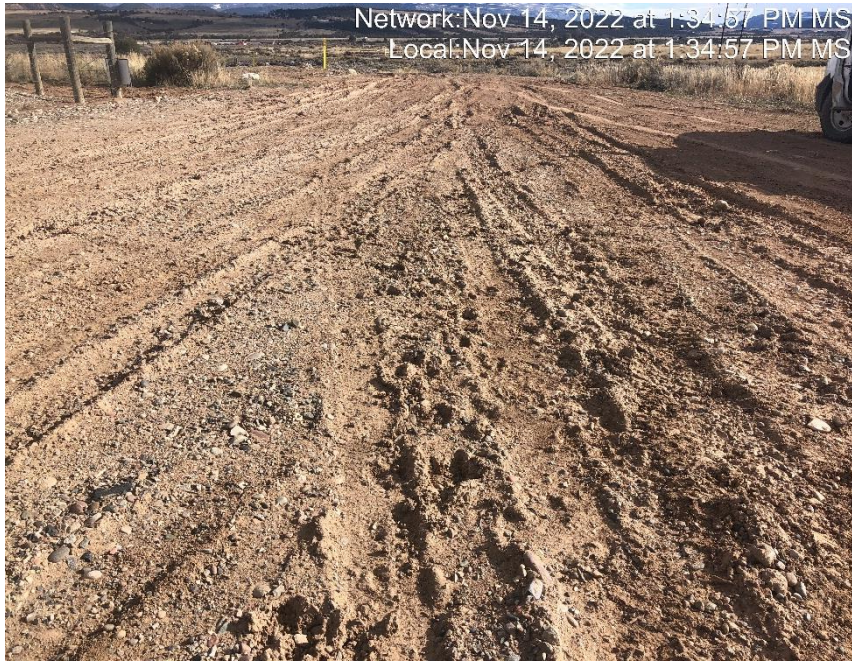
Photo #8391 Location lacks stabilization.

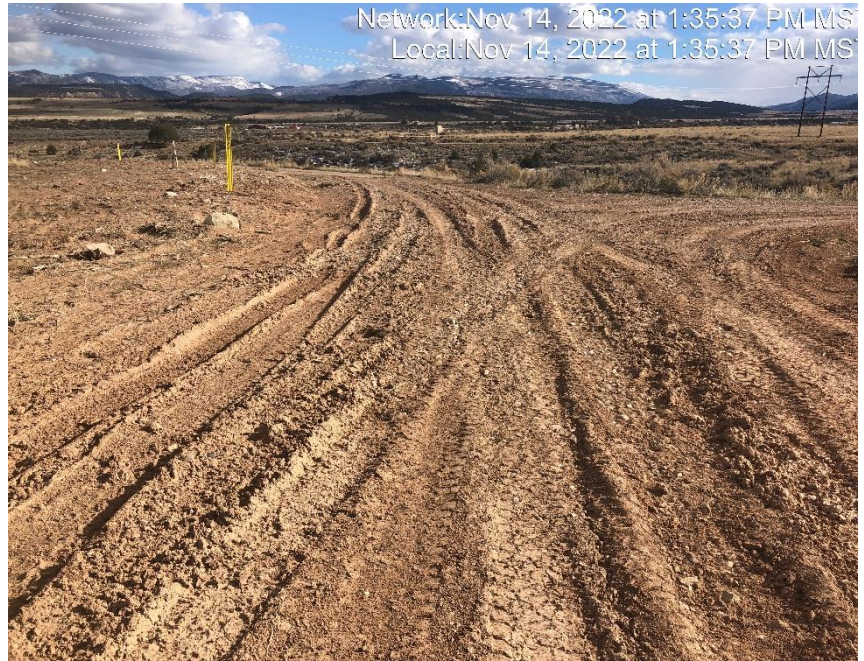
Photo #8393 Insufficient tracking control at entrance to location.
