# Inspection Photos

Loc: 333537

Operator: SIMCOE LLC / LOGOS OPERATING LLC

Inspection Date: 11/16/2022

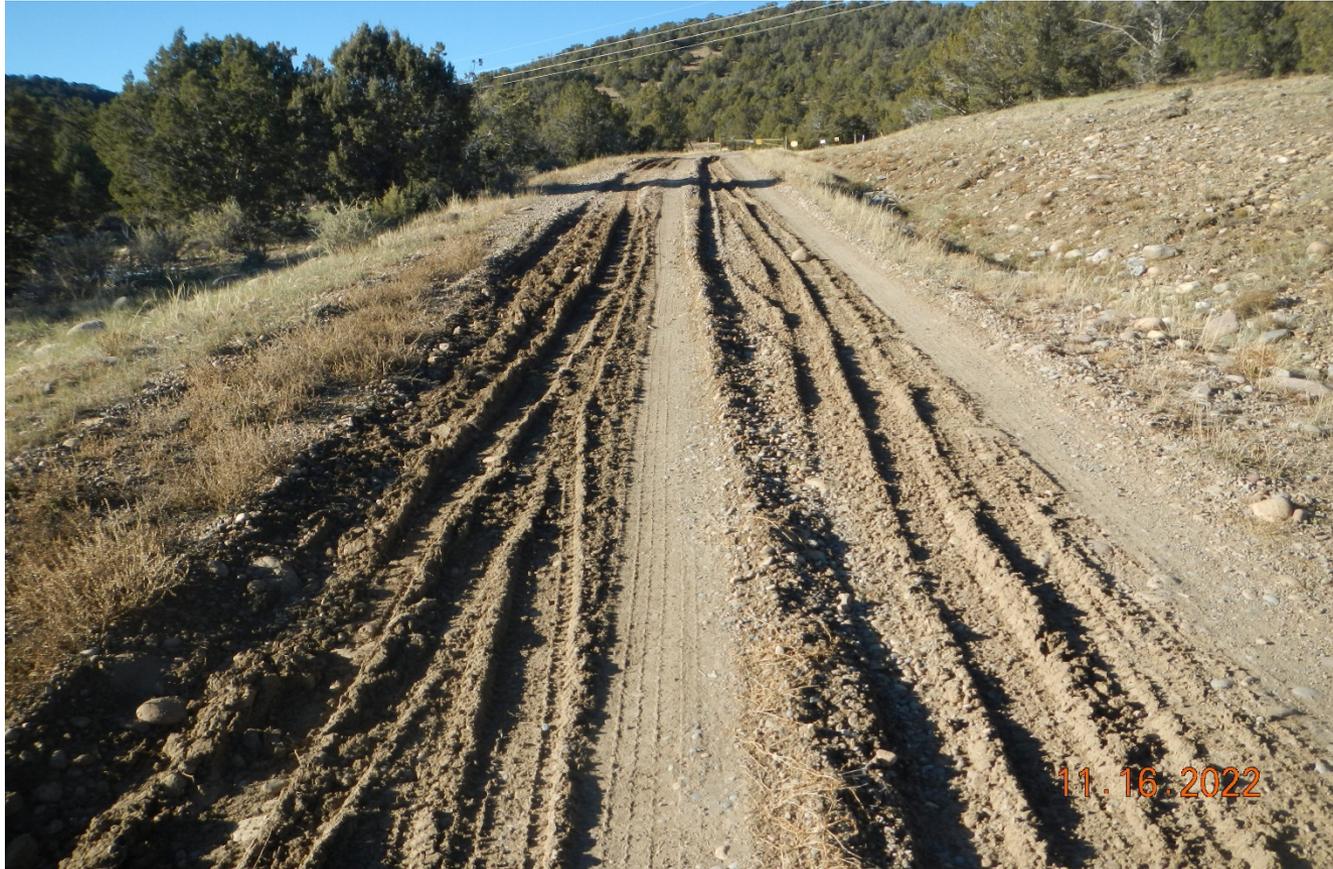
**Photo 1.** Facing northwest along the access road. There is vehicle rutting and erosion along the road that needs to be repaired.

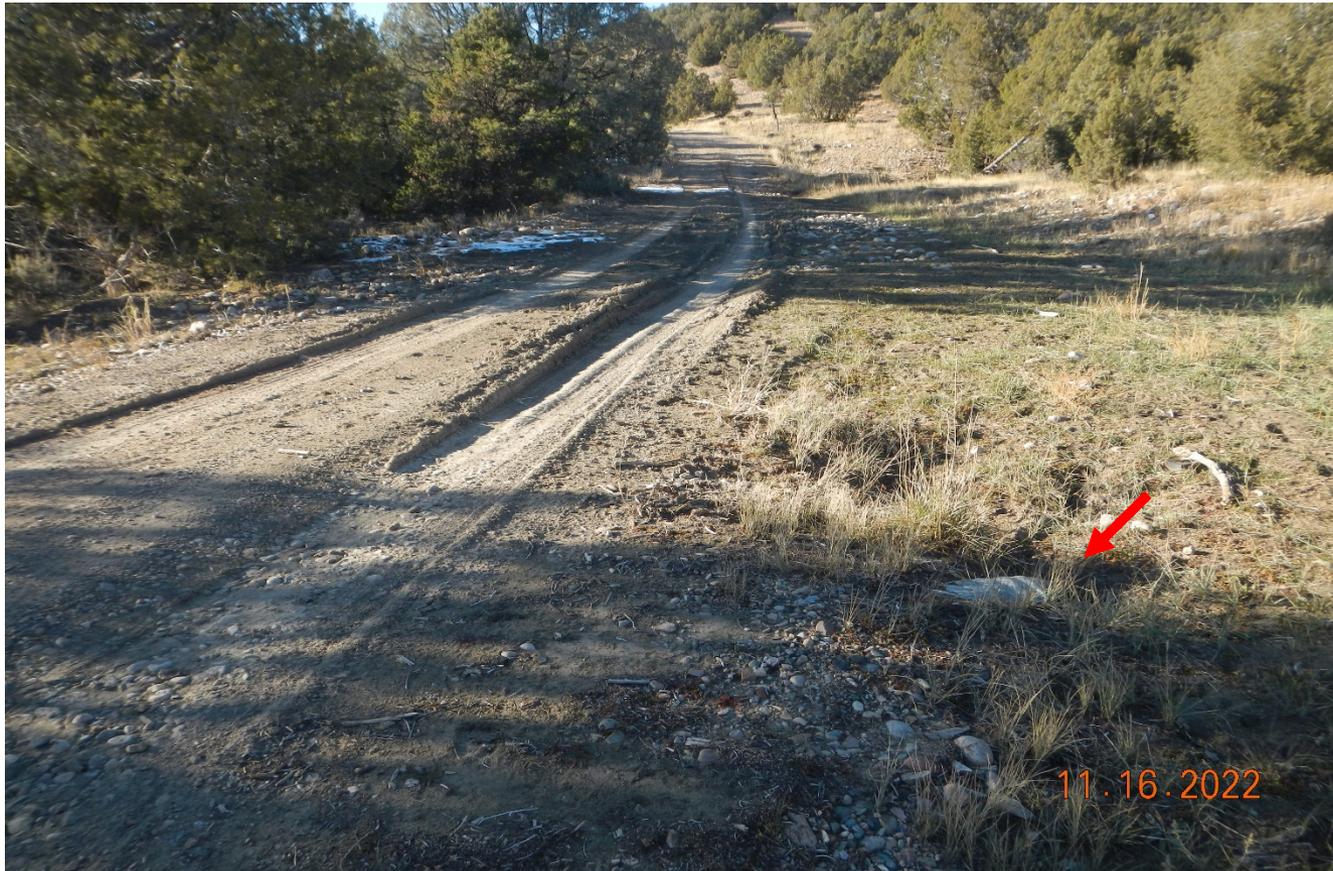
**Photo 2.** Stormwater is not being directed toward the culvert at red arrow which is causing erosion of the road. Lat/Long:37.13286,-107.82855

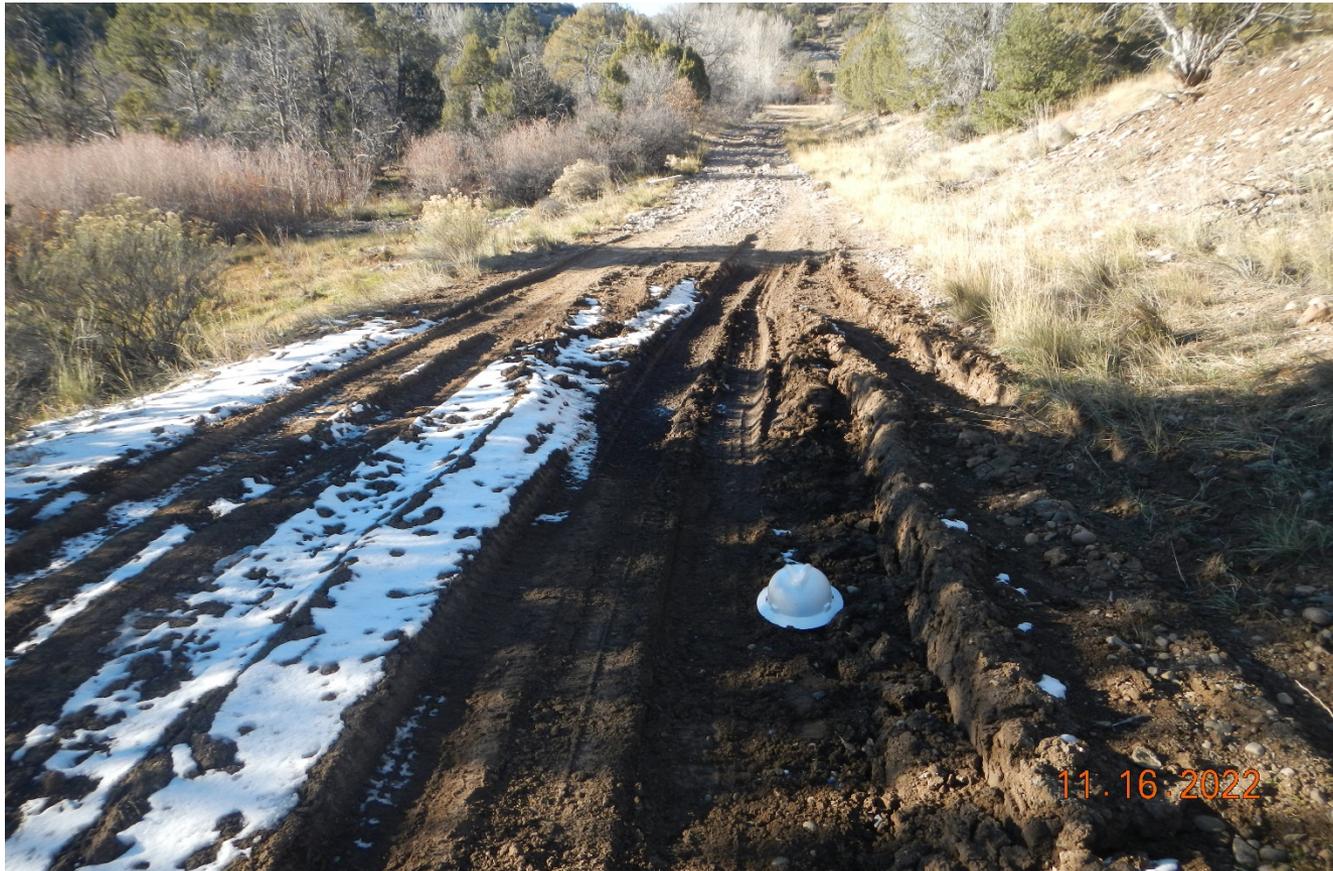
**Photo 3.** Facing northwest along the access road. There is vehicle rutting and erosion along the road that needs to be repaired. Stormwater further up the drainage is being directed down the road to this area.

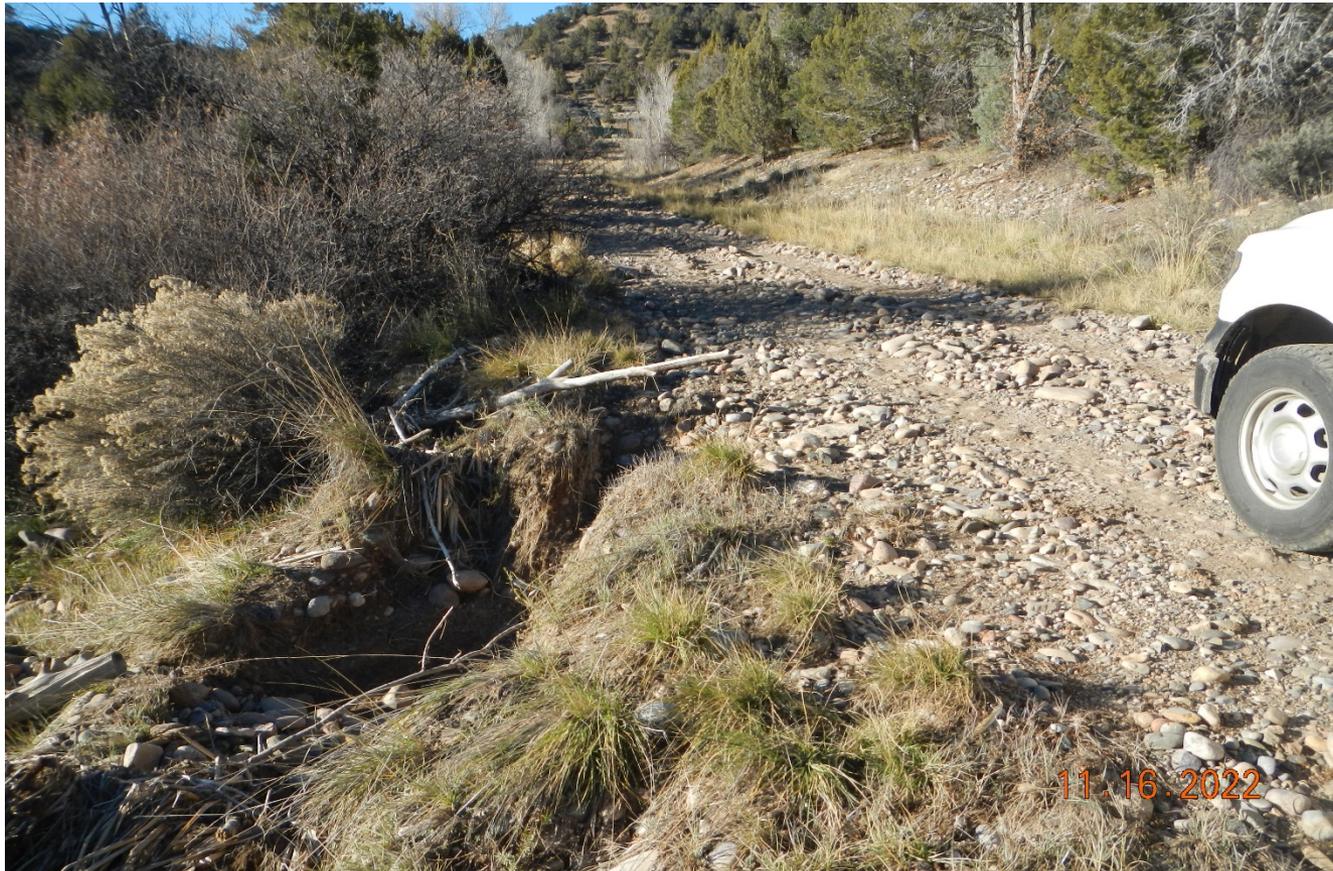
**Photo 4.** Facing northwest along the access road. There is vehicle rutting and erosion along the road that needs to be repaired. Stormwater further up the drainage is being directed down the road to this area.

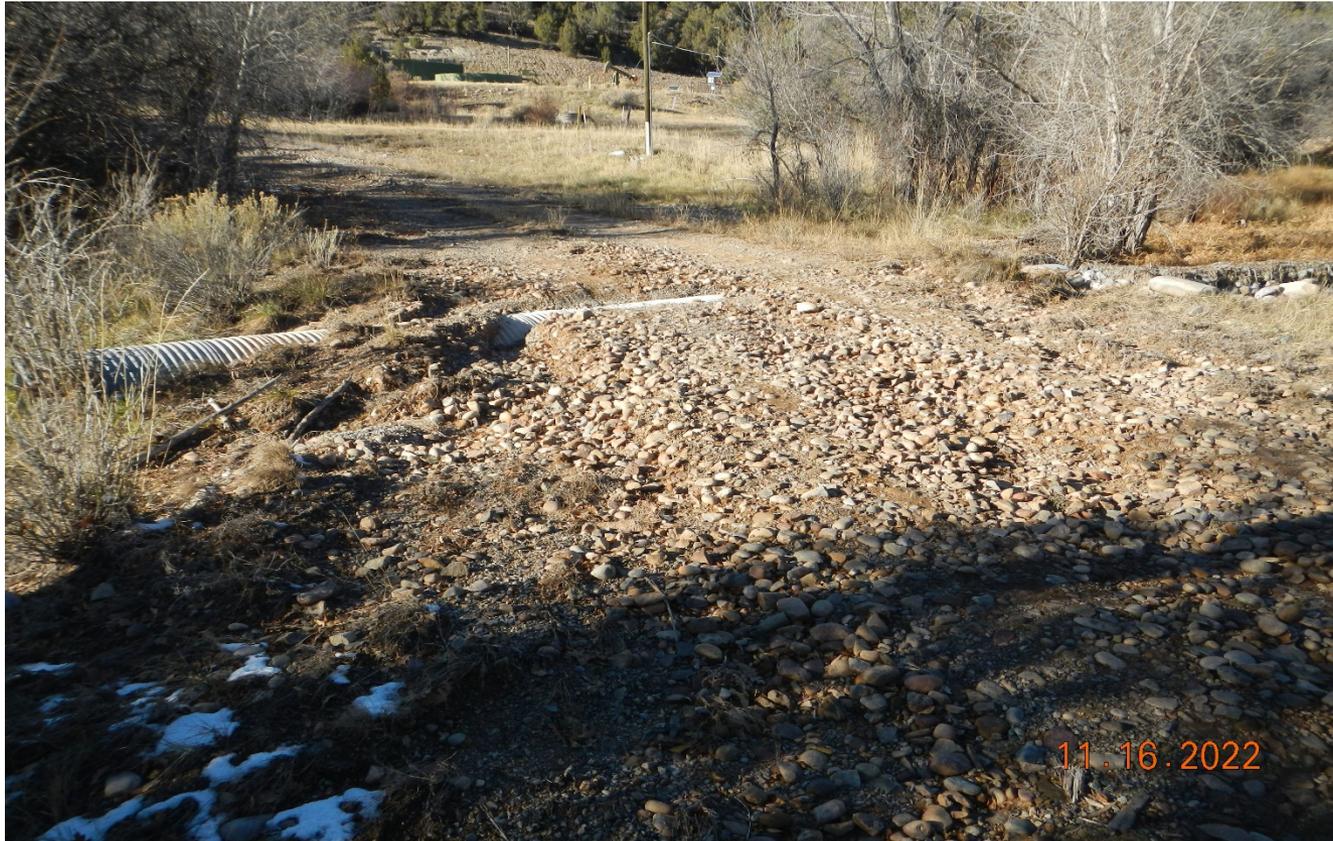
**Photo 5.** Stormwater from the drainage at right side of photo is being directed down the road and has washed out this culvert due to insufficient size of culvert. A larger or multiple culverts are need to allow proper drainage away from the road. Lat/Long:37.13507,-107.83293.

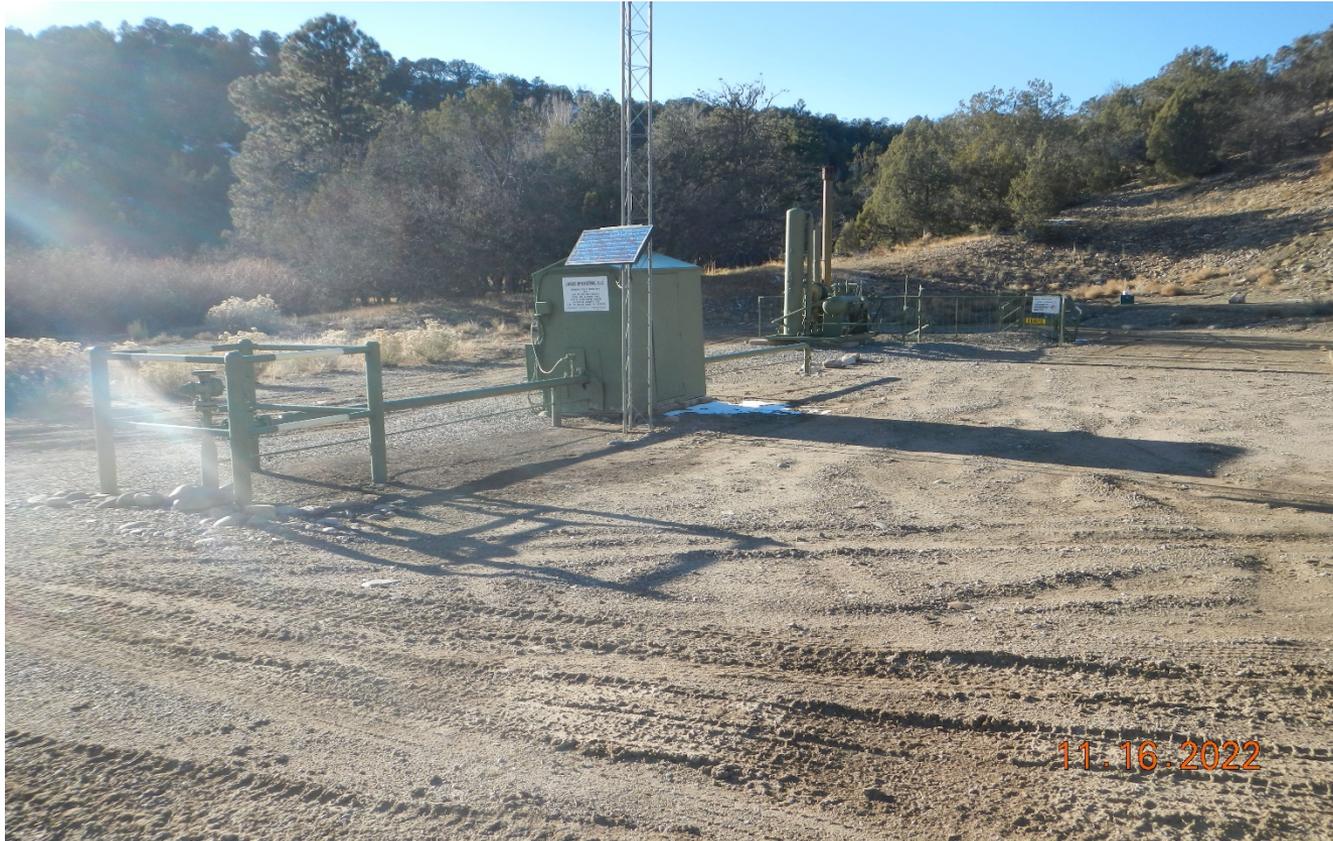
**Photo 6.** Facing toward the Logos production equipment.

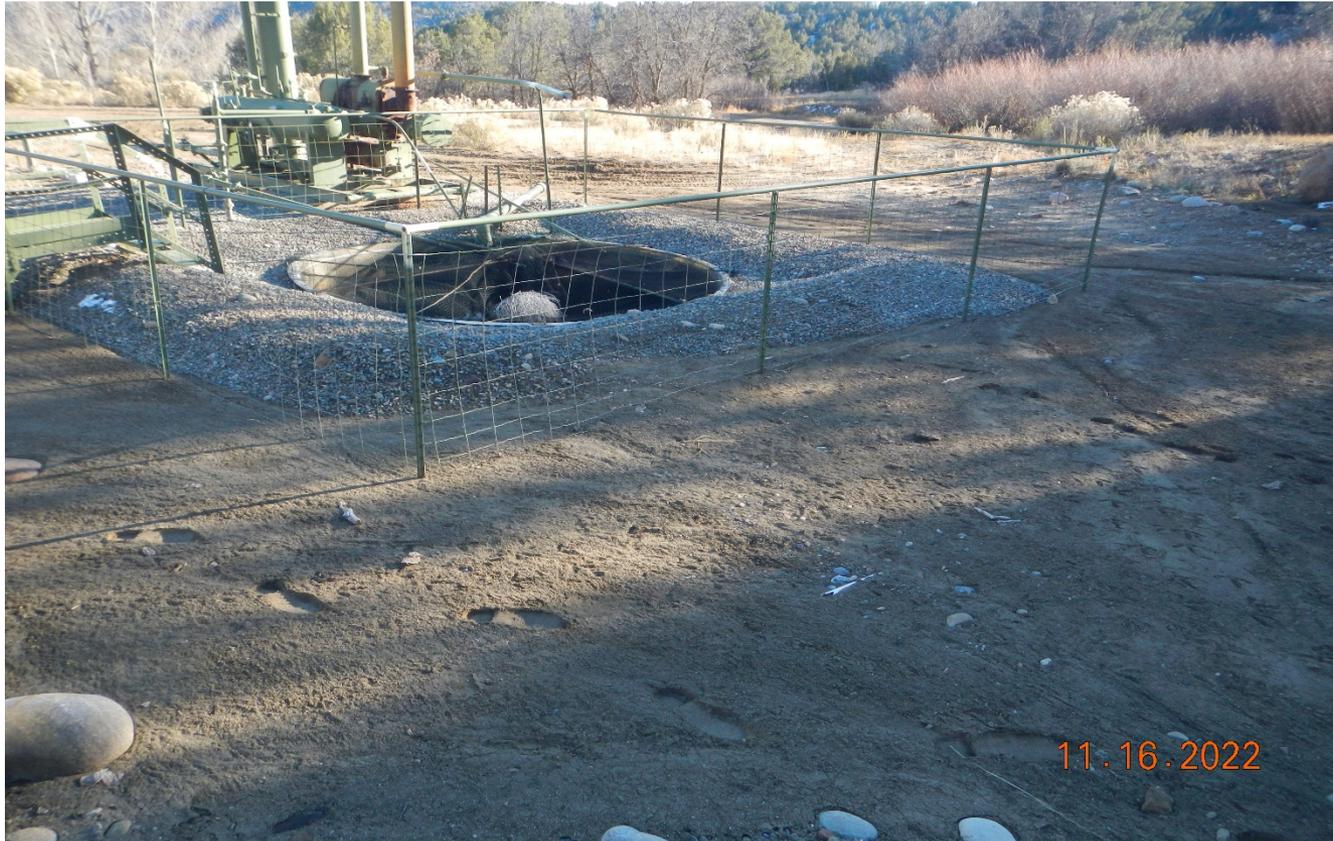
**Photo 7.** Facing toward the open top tank. Sediment has accumulated at the berm of the tank and stormwater is being directed into the tank. Stormwater needs to be diverted away from the open top tank and berm repaired.

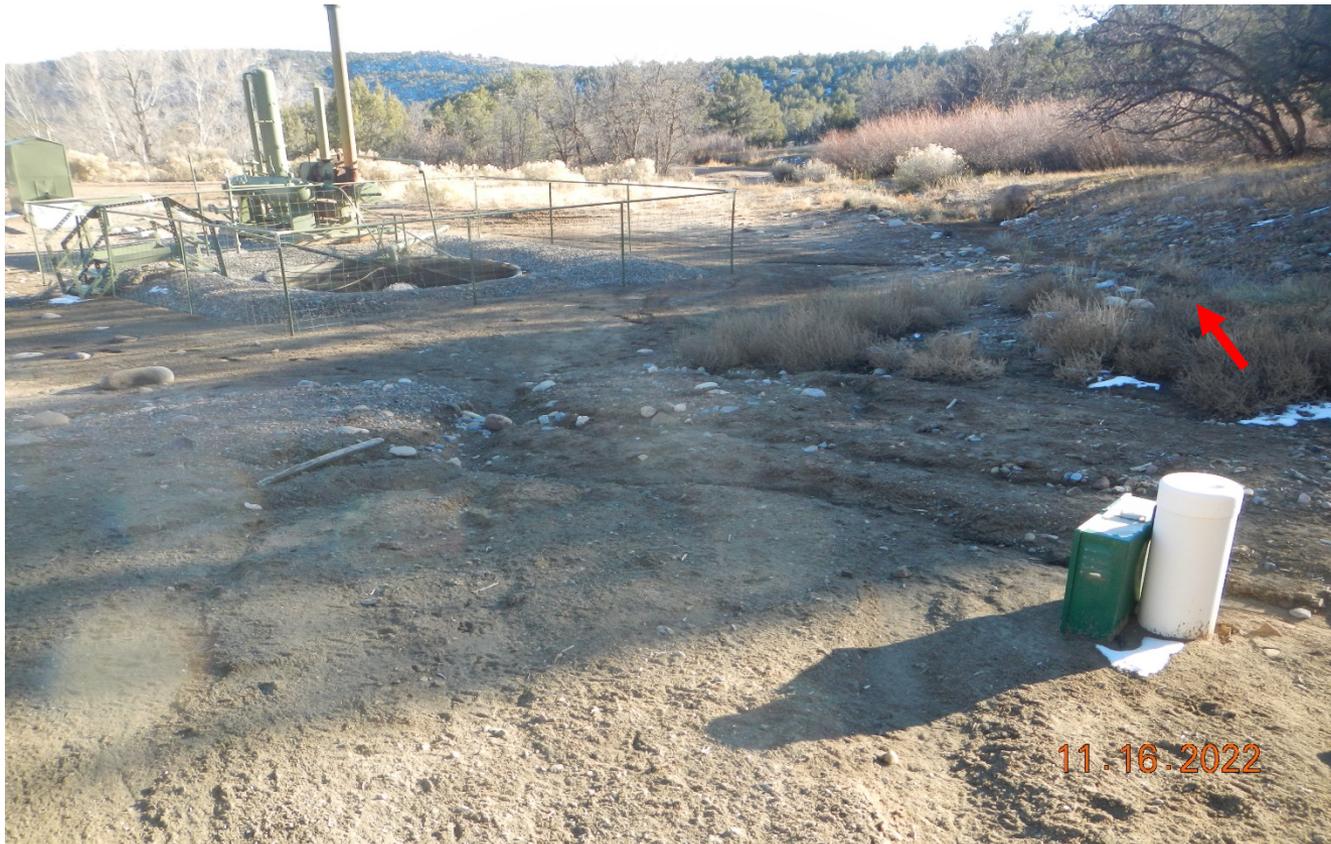
**Photo 8.** Northwest side of the location facing southwest. The diversion ditch at red arrow has filled in with sediment causing stormwater and sediment to flow toward the open top tank.

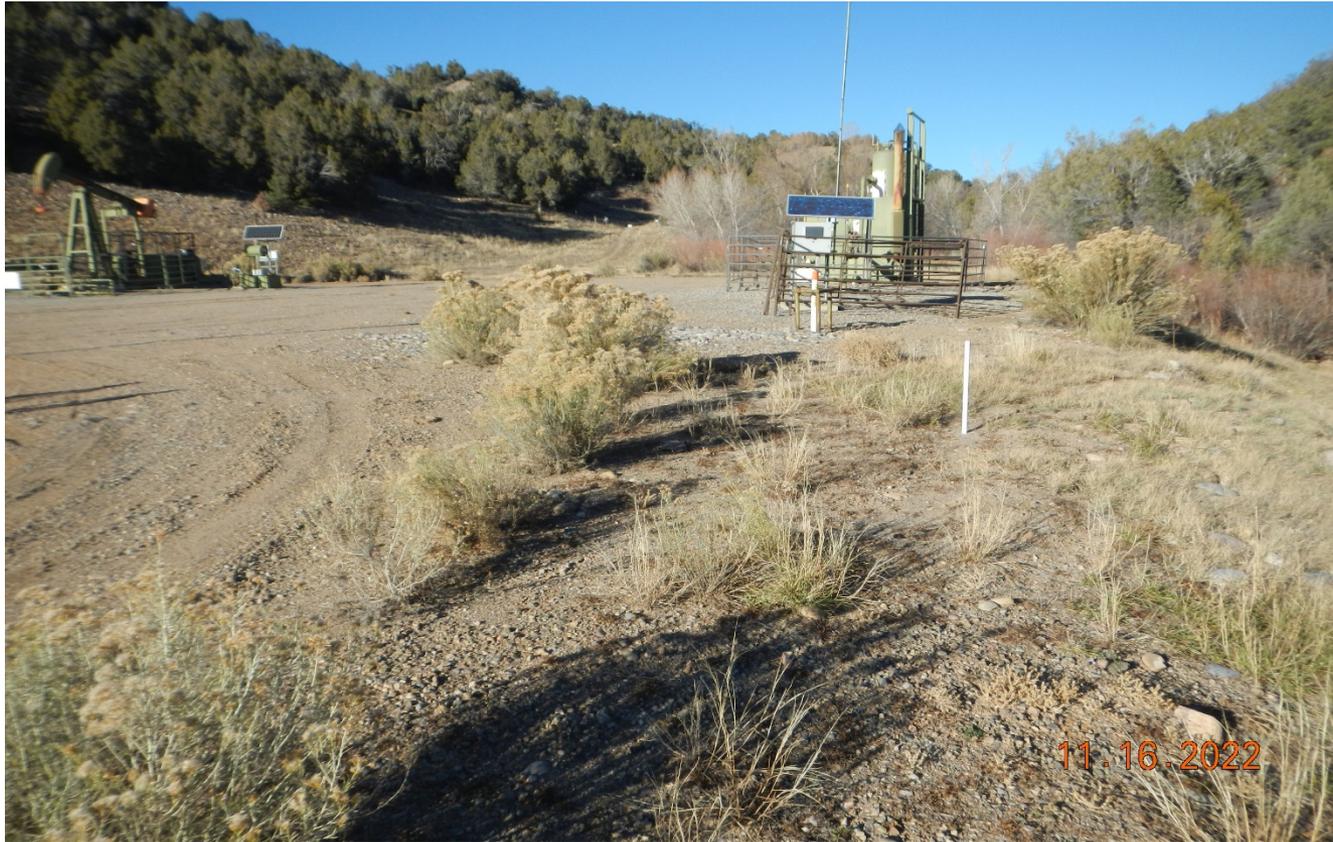
**Photo 9.** South side of the location facing east.

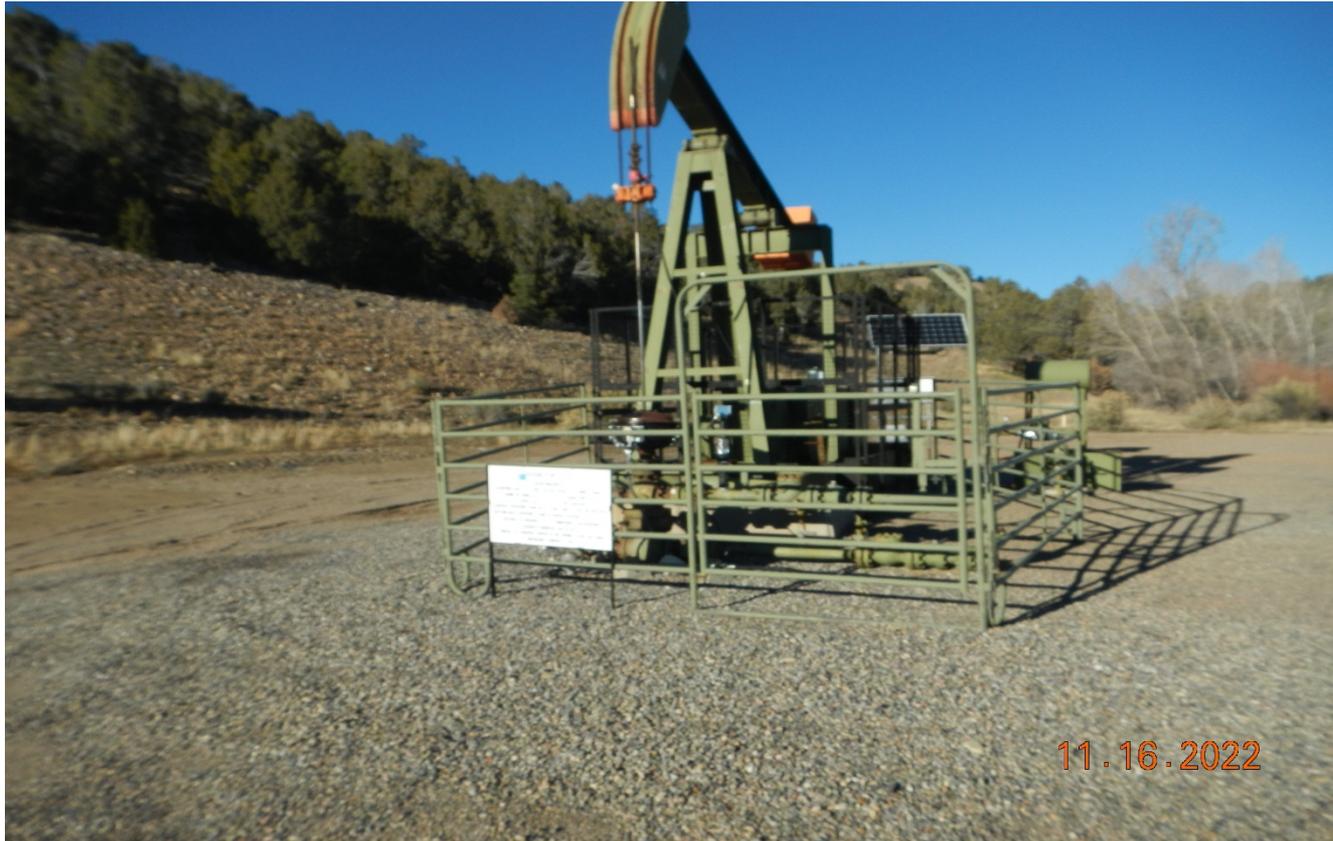
**Photo 10.** Facing toward the wellsite. Simco sign is posted at the wellhead.
