Inspection Photos

Loc: 325172

Operator: LOGOS OPERATING LLC

Inspection Date: 11/16/2022

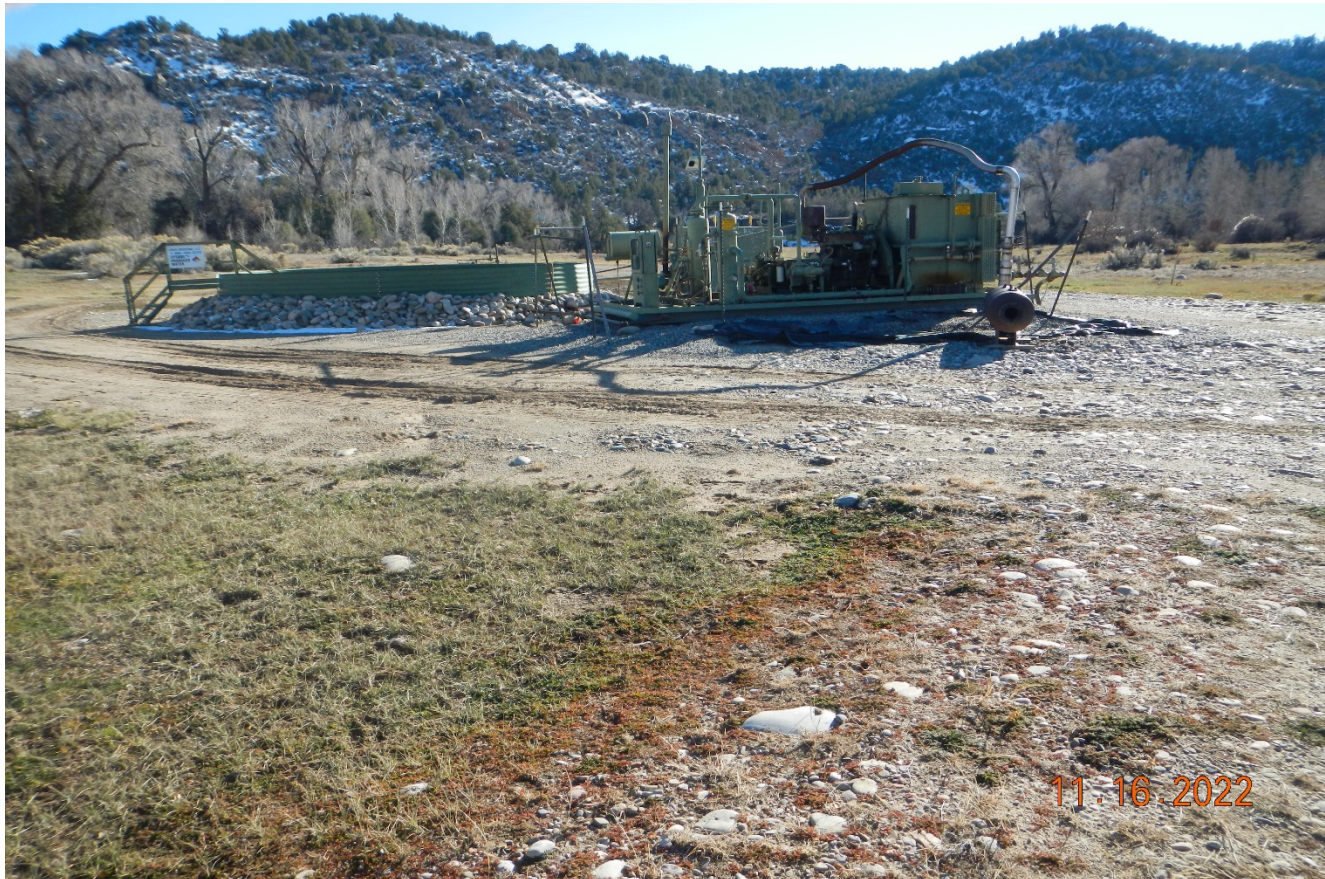
Photo 1. Facing southeast toward the location and production equipment. The wellsite is located within an oxbow of the Florida River that is prone to flooding.

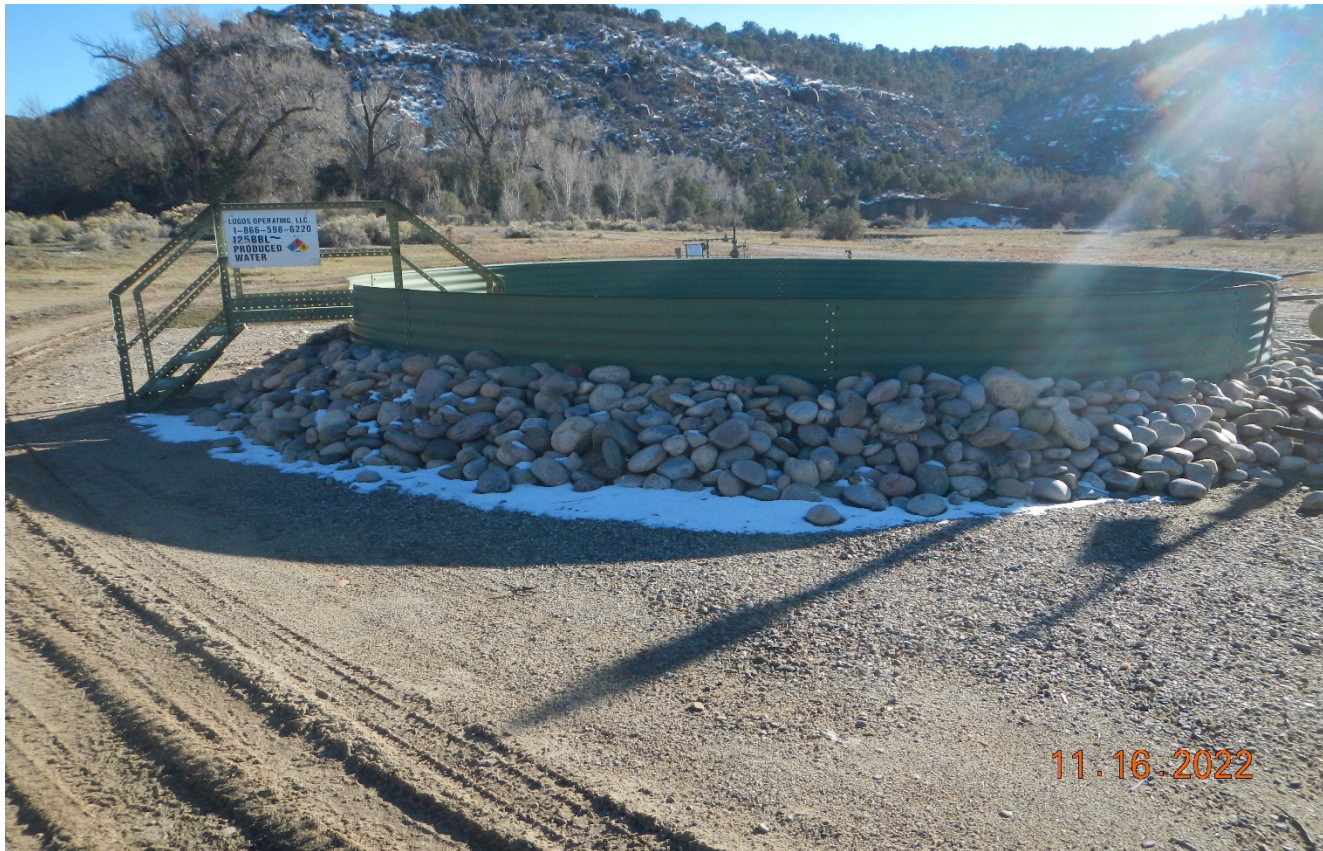
Photo 2. Facing toward the open top tank. There has been round rock placed around the containment. The round rock is pervious and will not prevent flood water from entering underneath the steel containment. Round rock will also be easily displaced as they do not lock in place as well as angular rock. Another solution needs to be implemented.

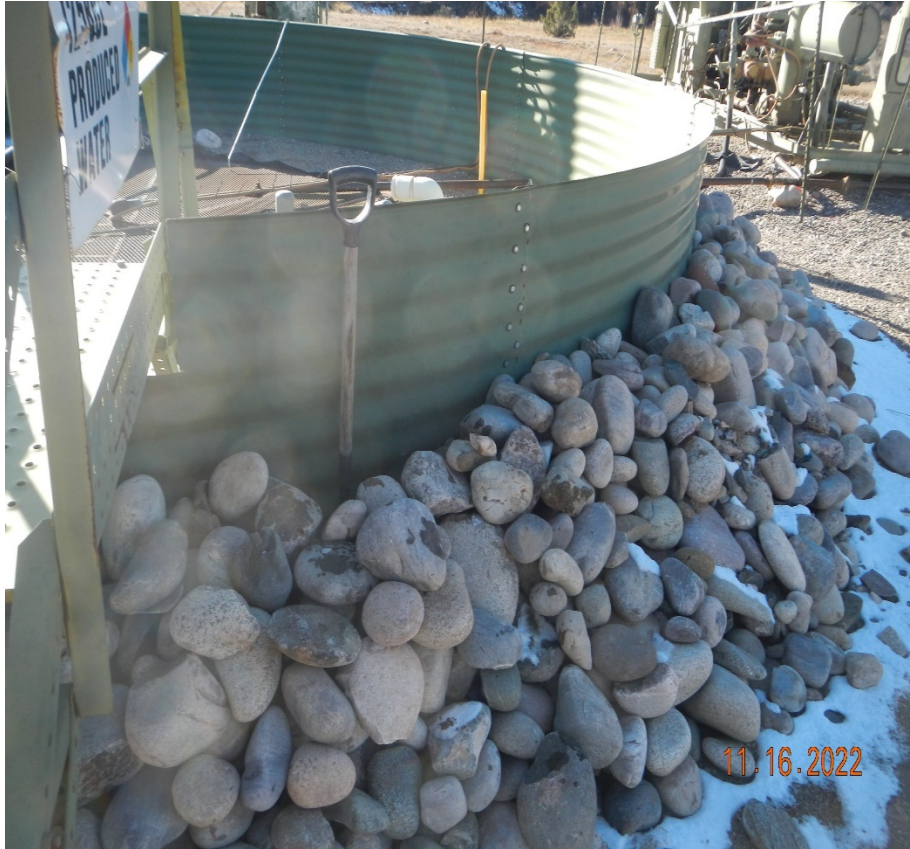
Photo 3. The steel containment is no constructed per the Operator's SWMP. A 3.5 ft. shovel was placed at the containment for scale.

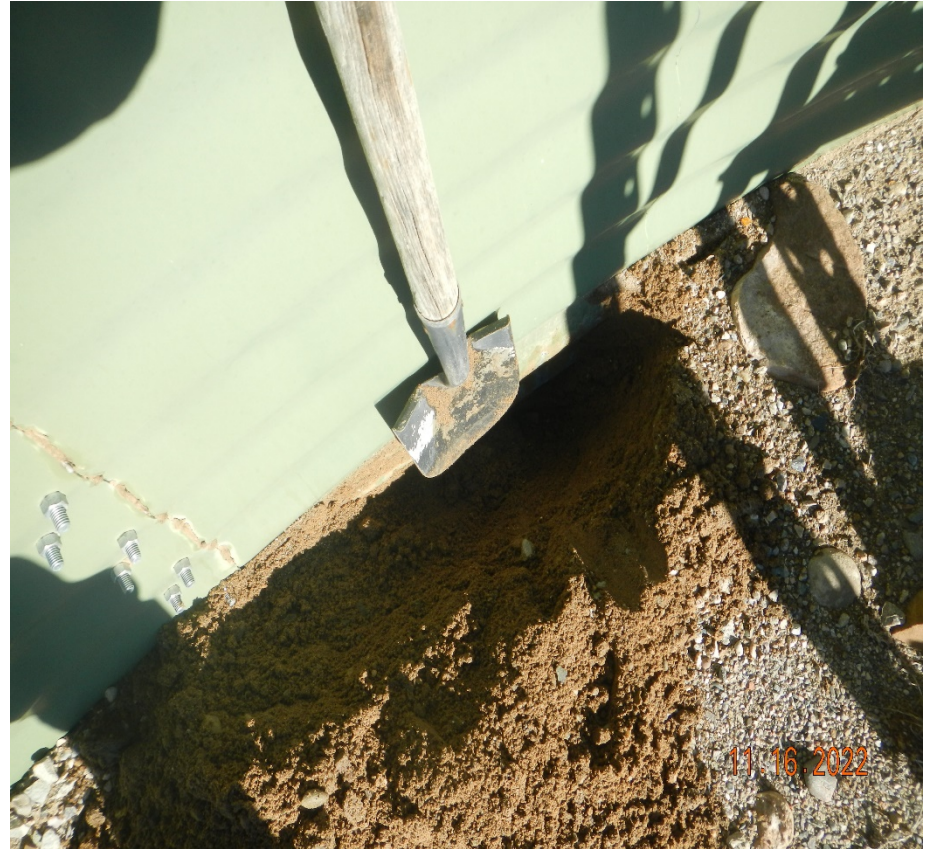
Photo 4. The steel containment is only about 4 inches below grade. The steel containment is not constructed per the Operator's SWMP.

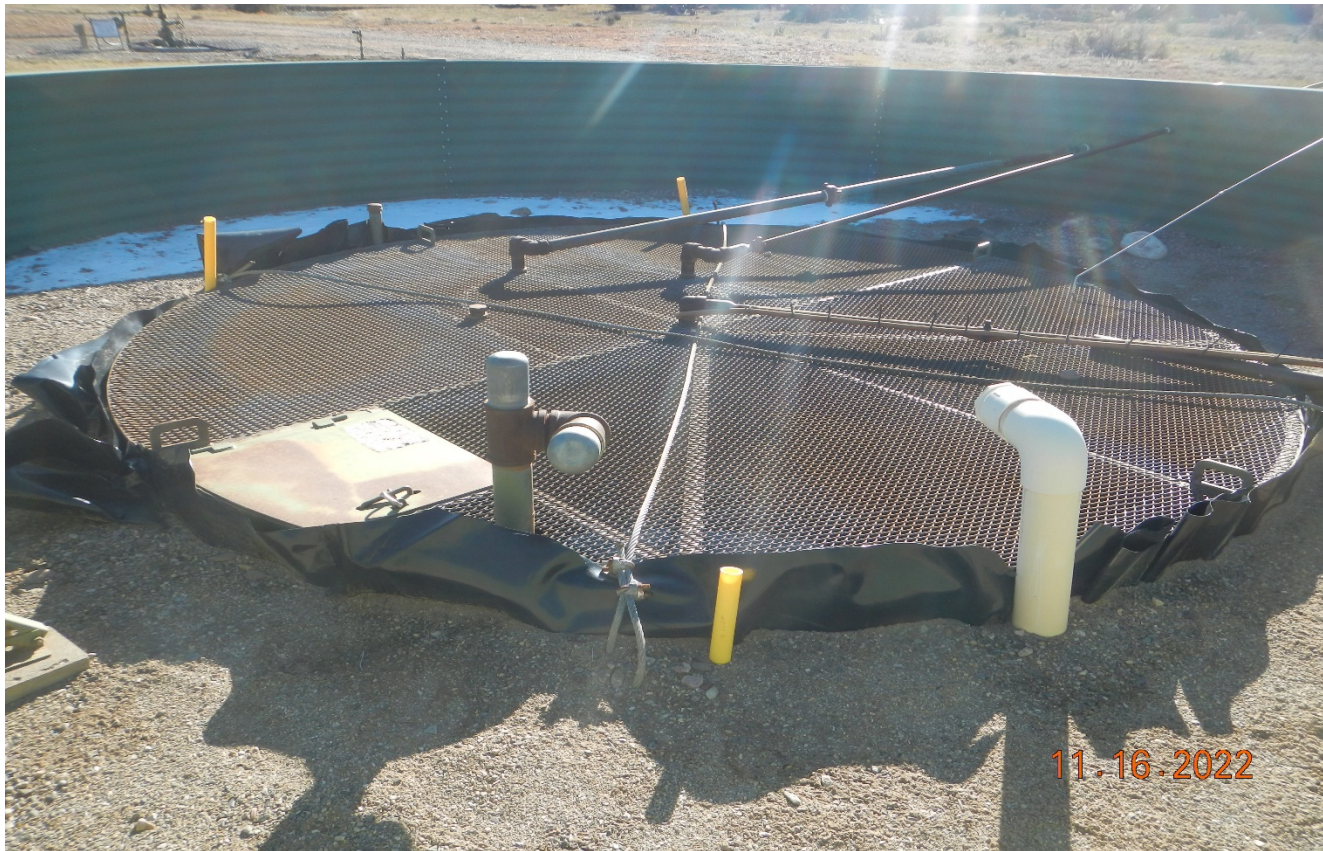
Photo 5. Facing toward the open top tank.

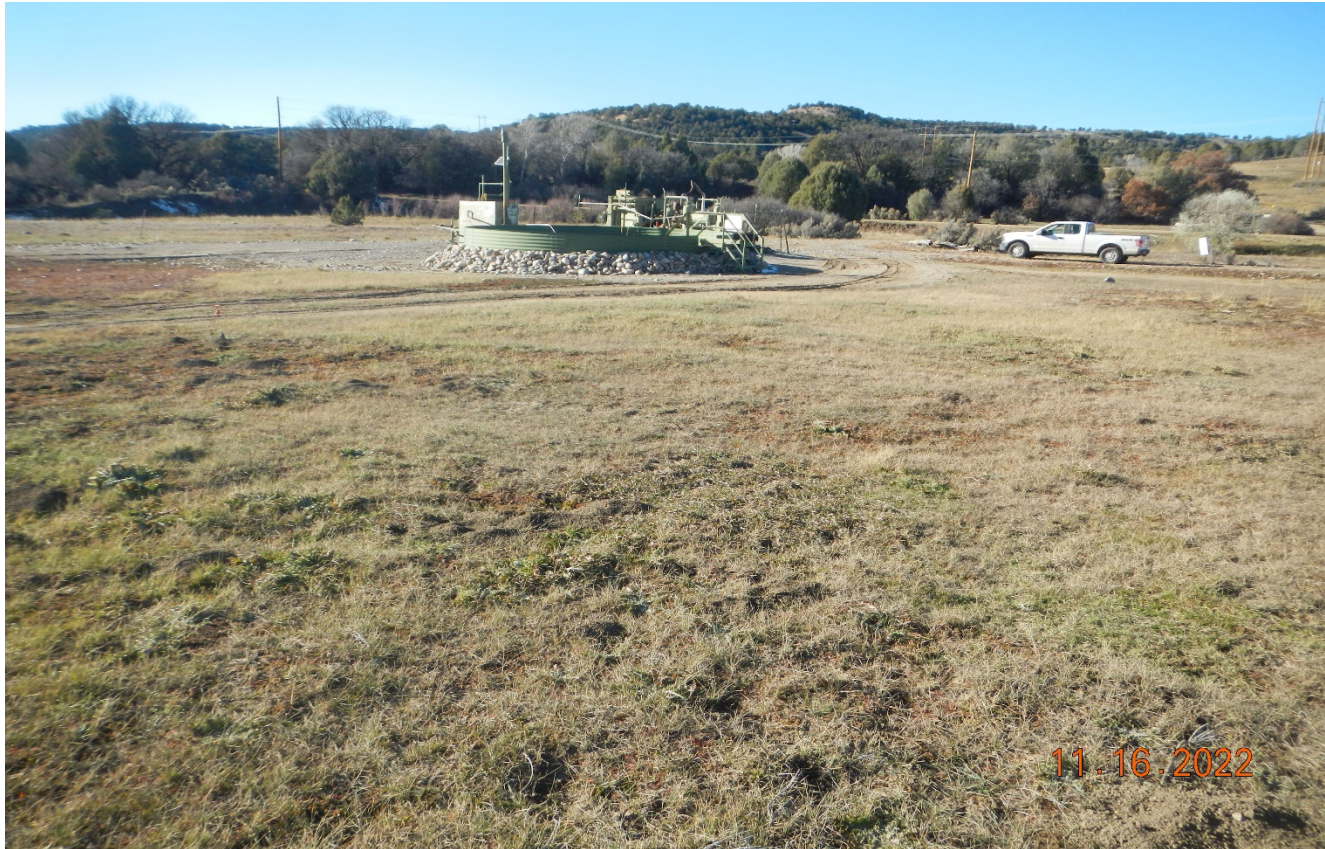
Photo 6. Facing northwest toward the location.

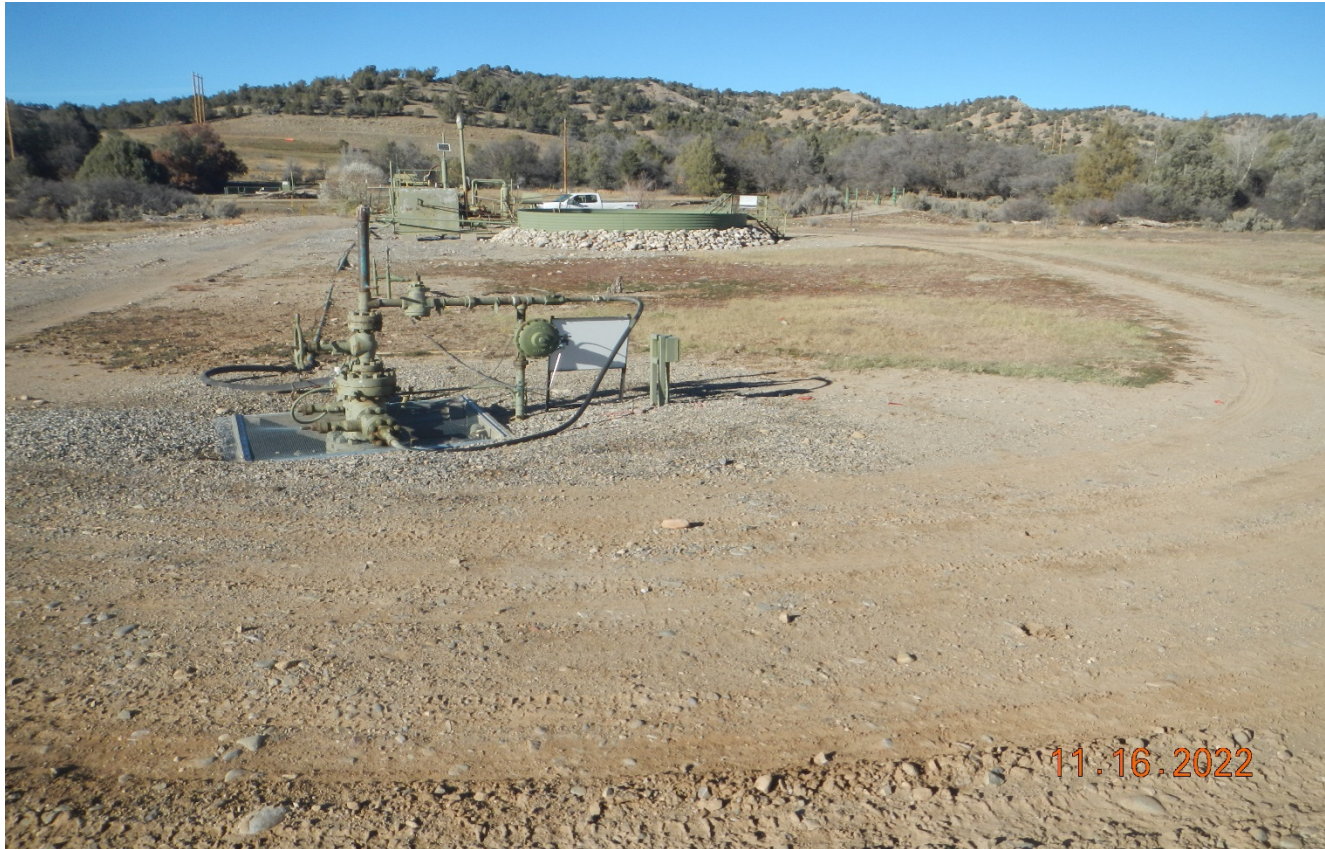
Photo 7. Facing north toward the location. The wellhead cellar was covered to prevent entry.

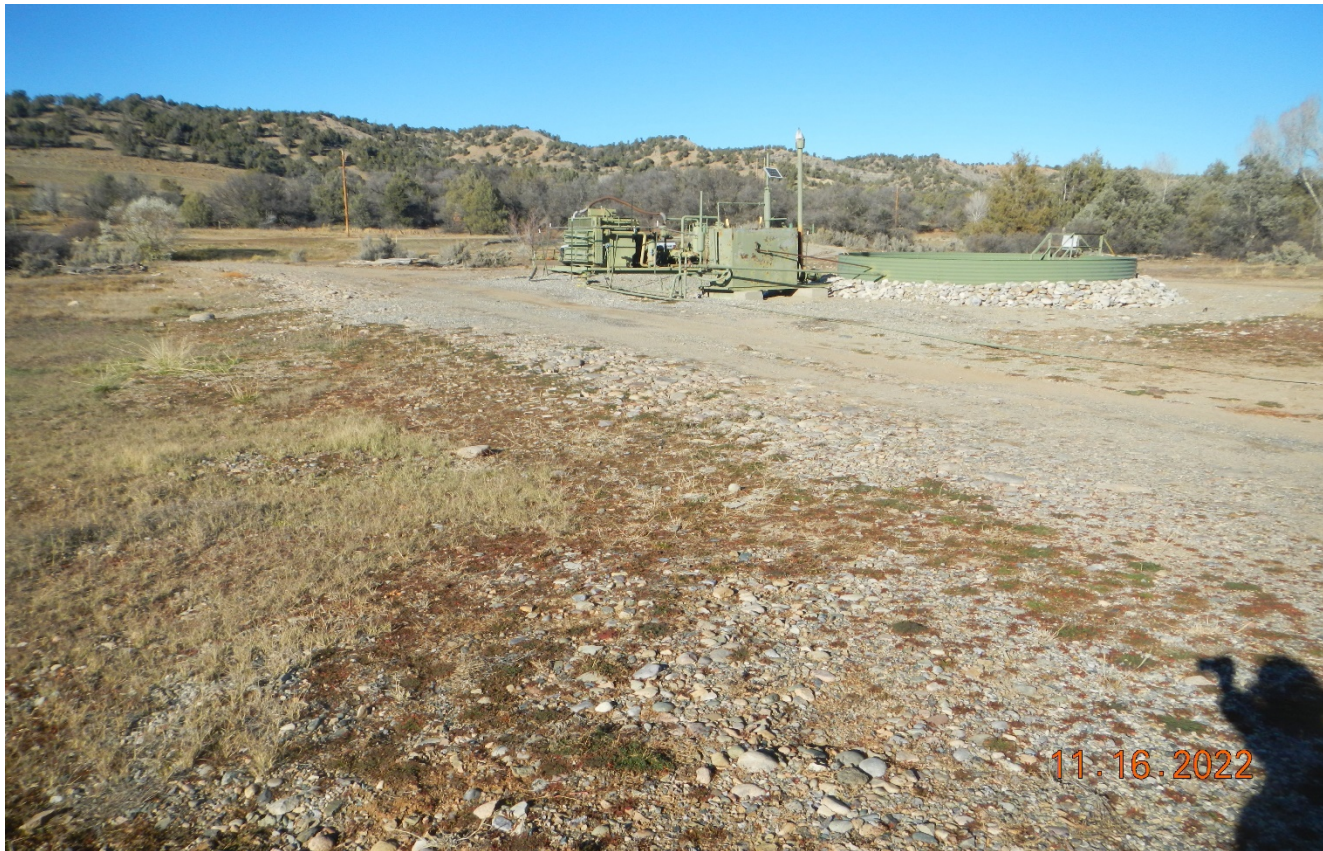
Photo 8. Facing northeast toward the location.

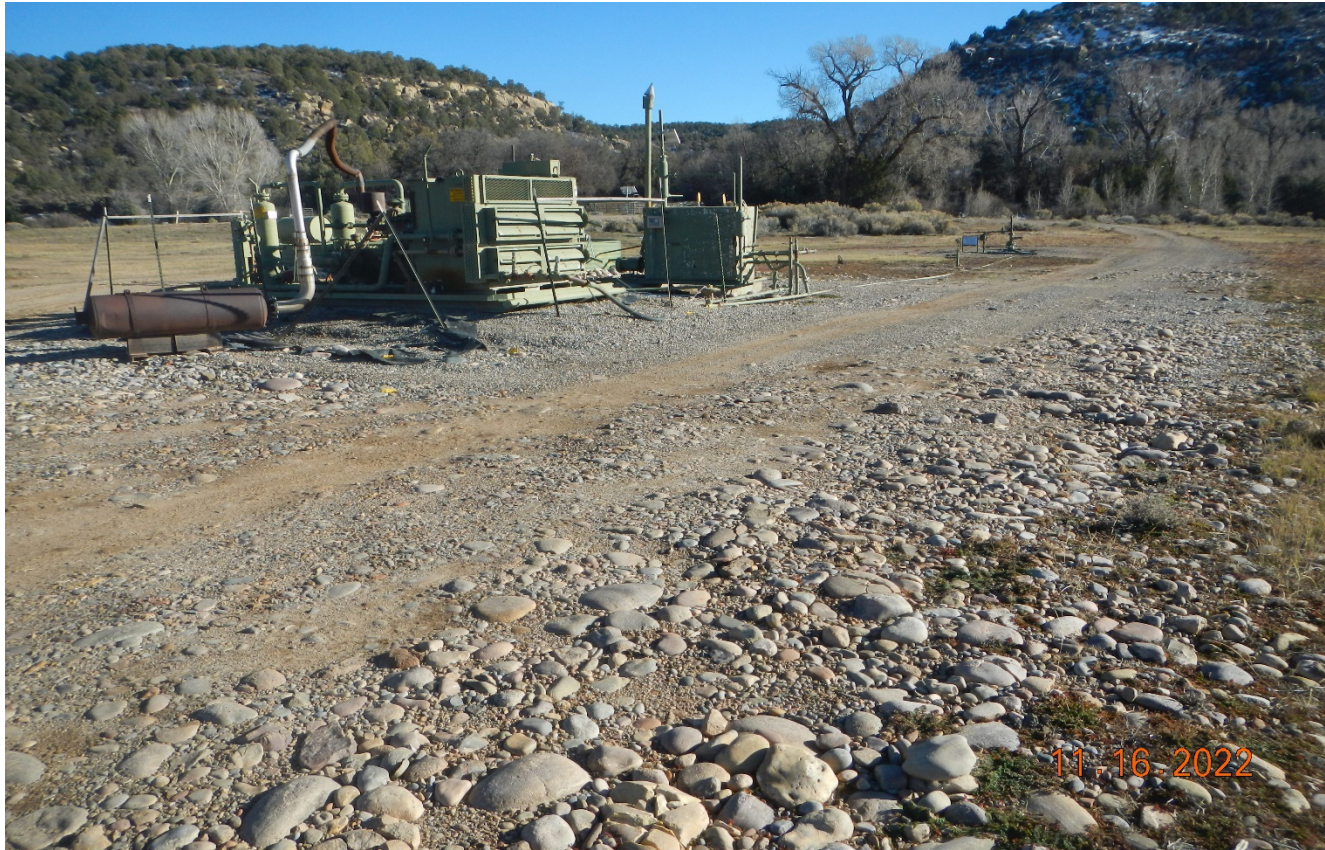
Photo 9. Facing southeast toward the location. The area of the road shows signs of scouring where flood flows across the road from left to right towards the Florida River.
