Colorado Oil and Gas Conservation Commission

# TEP Fed. RG 11-13-298, #482958 Annotation Report

# TEP Fed. RG 11-13-298, #482958 Issue Report

11/21/2022

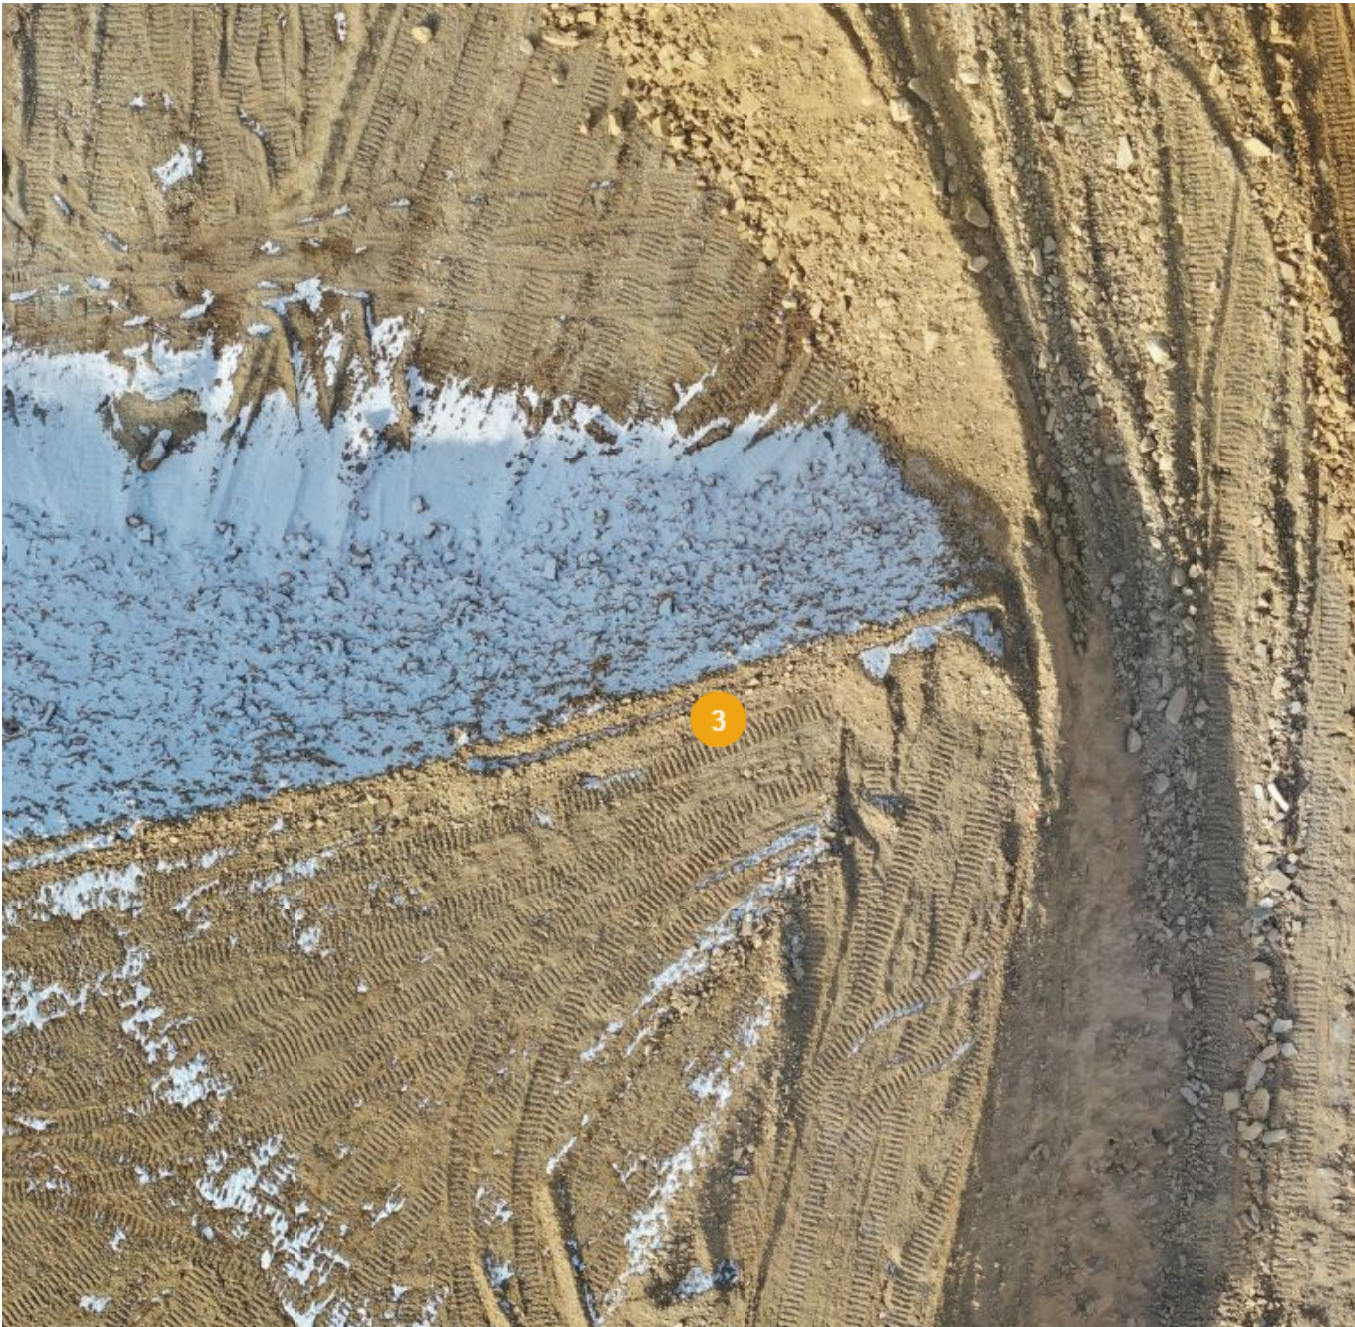
3 - Incomplete Work

Summary:	Figures within SWMP #403047575 identifies a stormwater discharge point, to allow stormwater discharge from the working pad area of the Location to the storwmater diversion ditch; no outlet has been constructed on the northern end of the Location to allow for discharge per the SWMP.		
Created:	Nov 28, 2022, 12:42pm by Aaron Trujillo		
Cost of Repair:	—		
Coordinates:	39.88306, -108.34632		
Elevation:	6638.68 ft

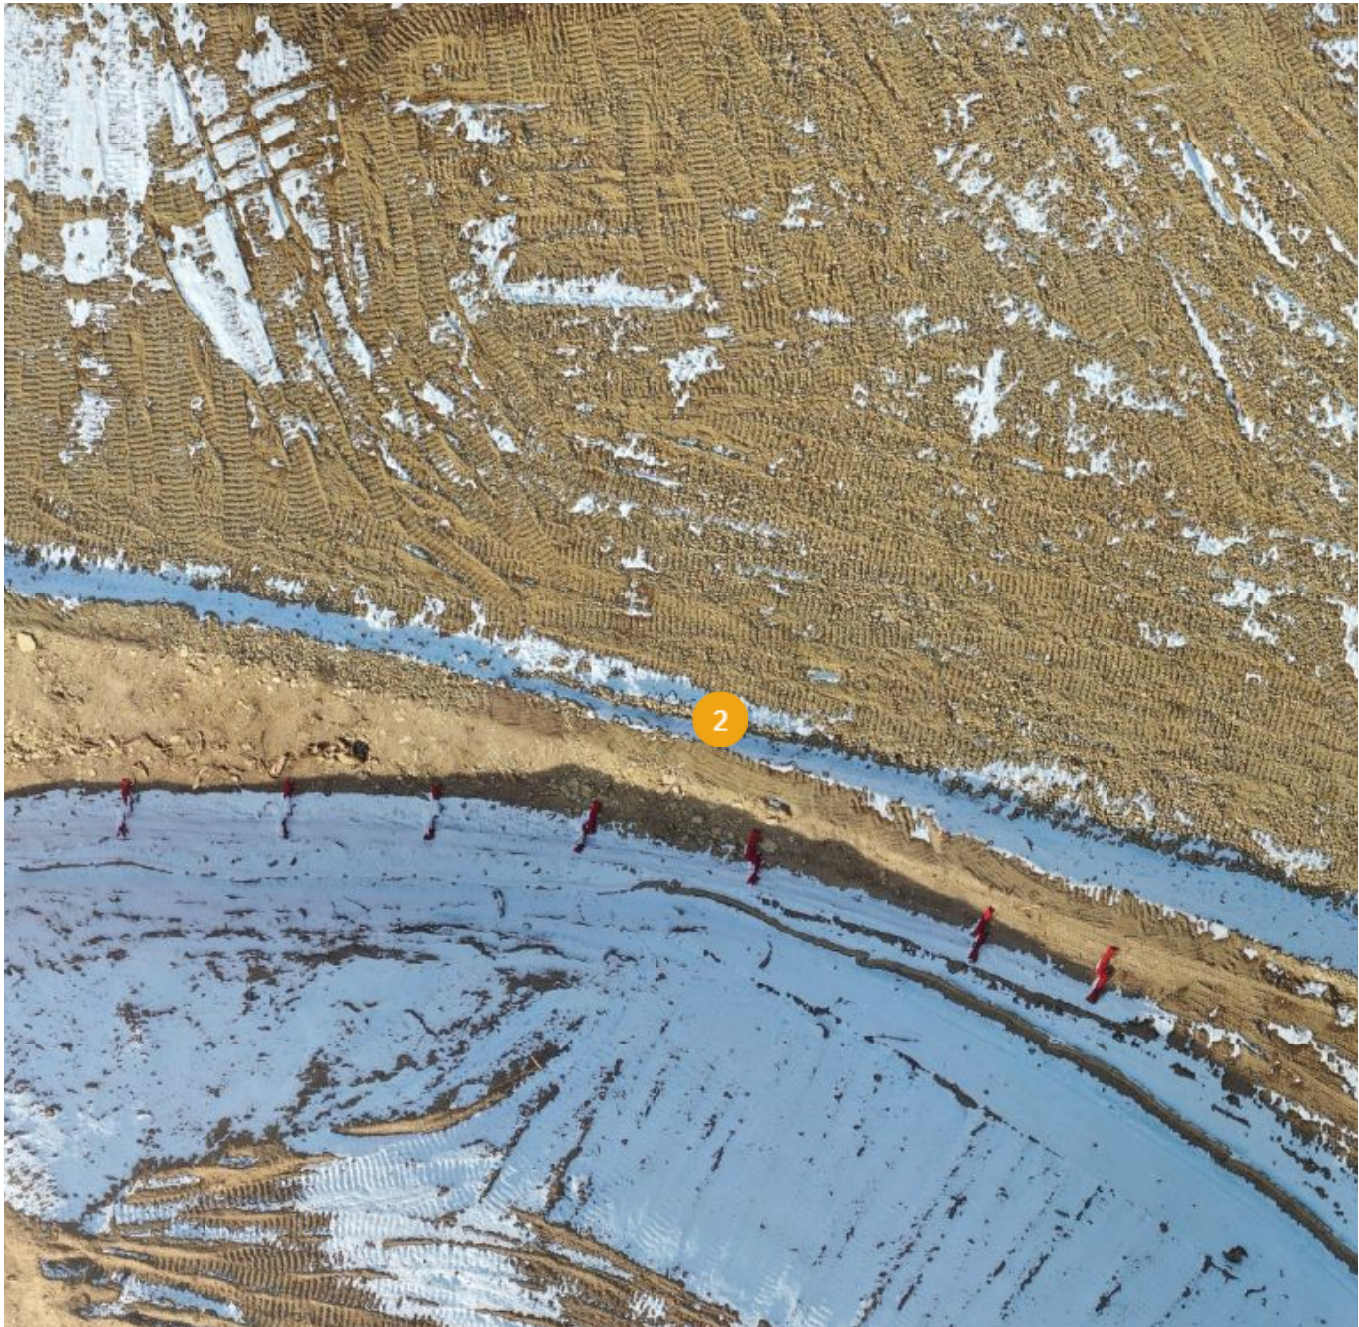
2 - Incomplete Work

Summary: **Figures within SWMP #403047575 identifies a stormwater discharge point, to allow stormwater discharge from the working pad area of the Location to the stormwater diversion ditch; no outlet has been constructed on the south end of the Location to allow for discharge per the SWMP.**

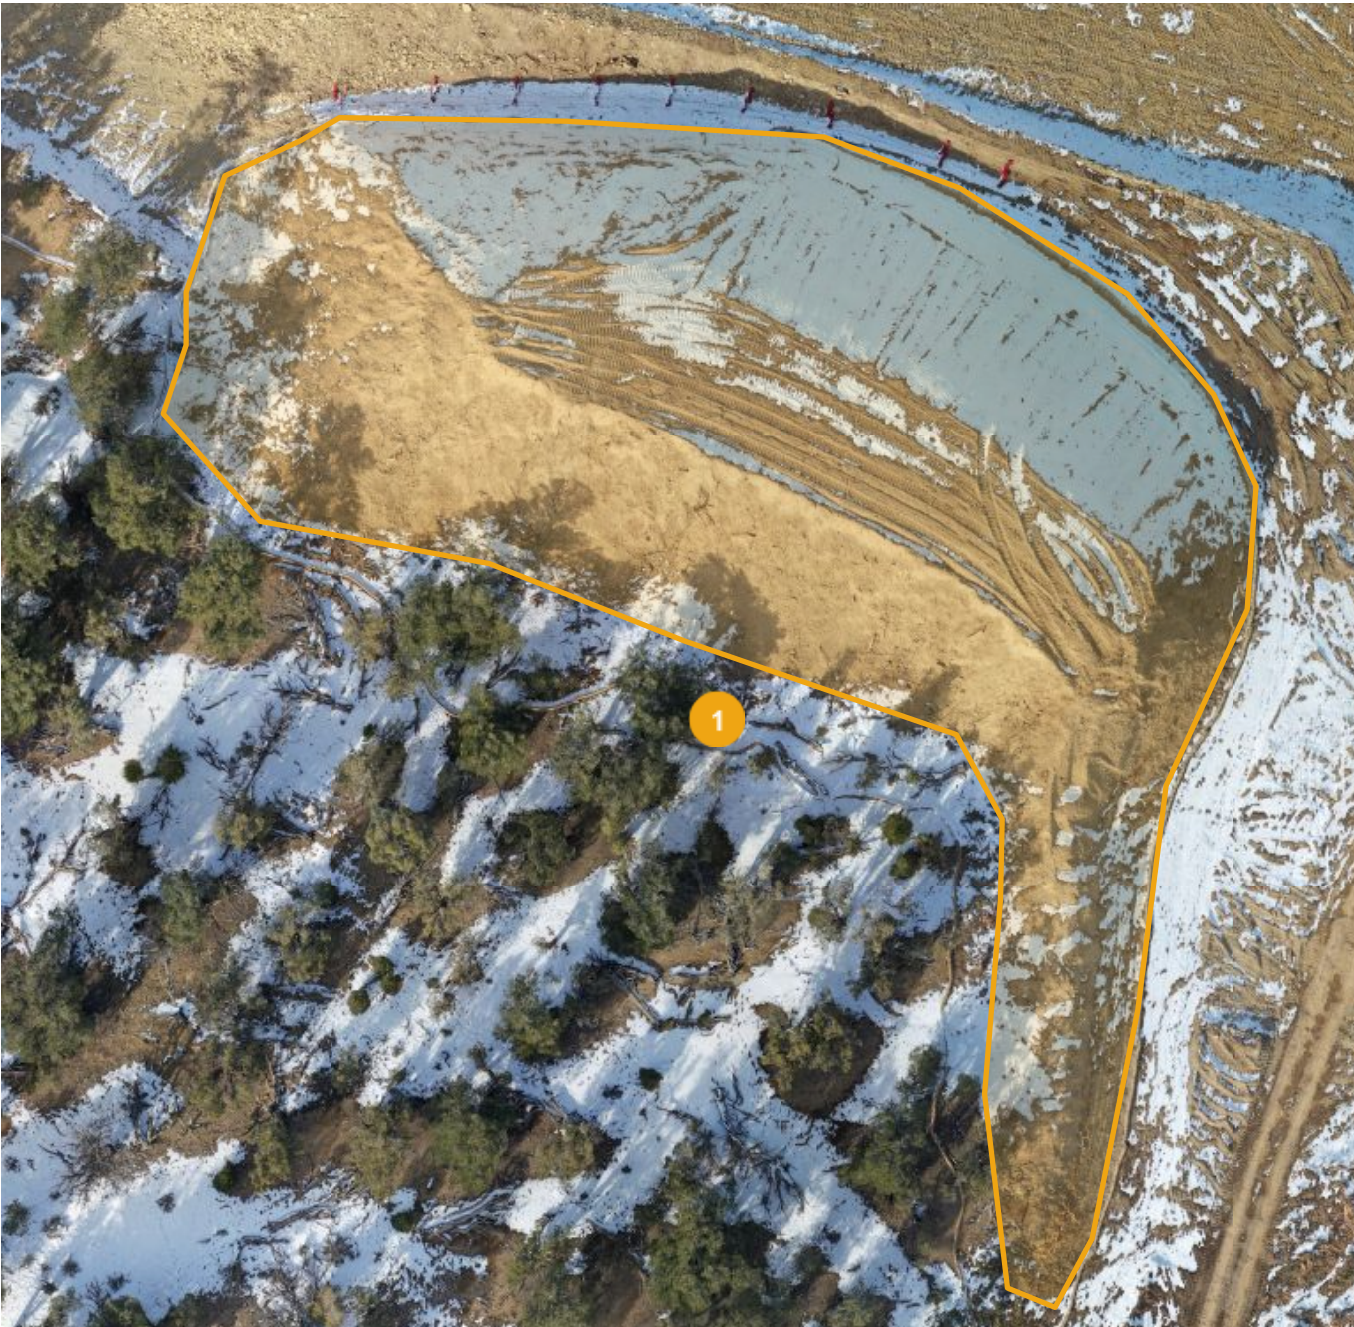
1 - Observation

Summary:	BMPs to stabilize and protect topsoil stockpile are missing or insufficient.
Created:	Nov 22, 2022, 3:01pm by Aaron Trujillo
Cost of Repair:	—
Coordinates:	39.88152, -108.34683
Area:	0.59 acres
Surface Area:	0.70 acres

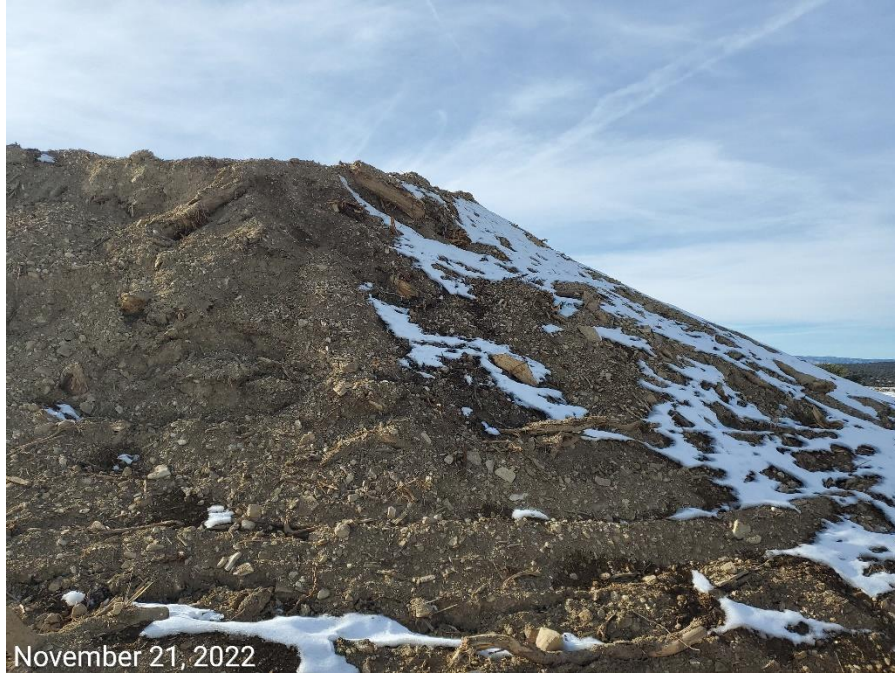
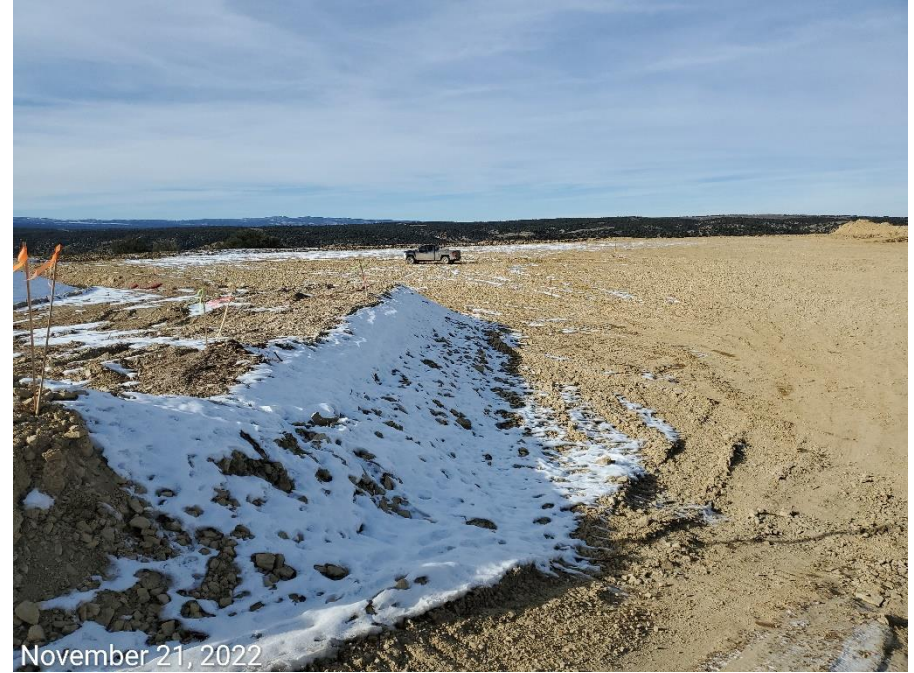
**Photo 1:** Photos 1-2 taken from the south end of the Location. Photos provide an overview of the location from west, northwest, northeast to east.

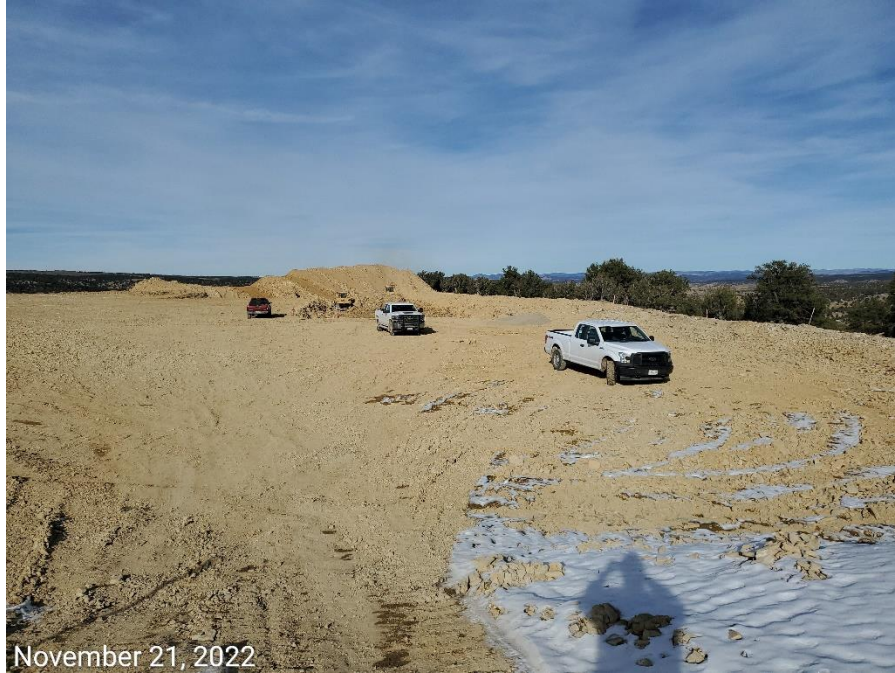
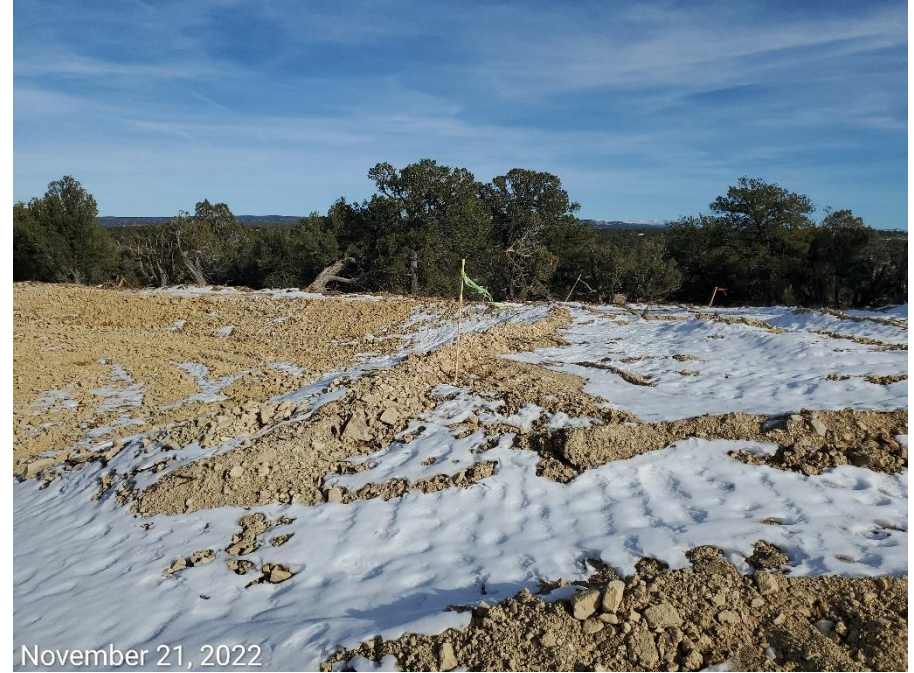
**Photo 2:** See comment under photo 1.

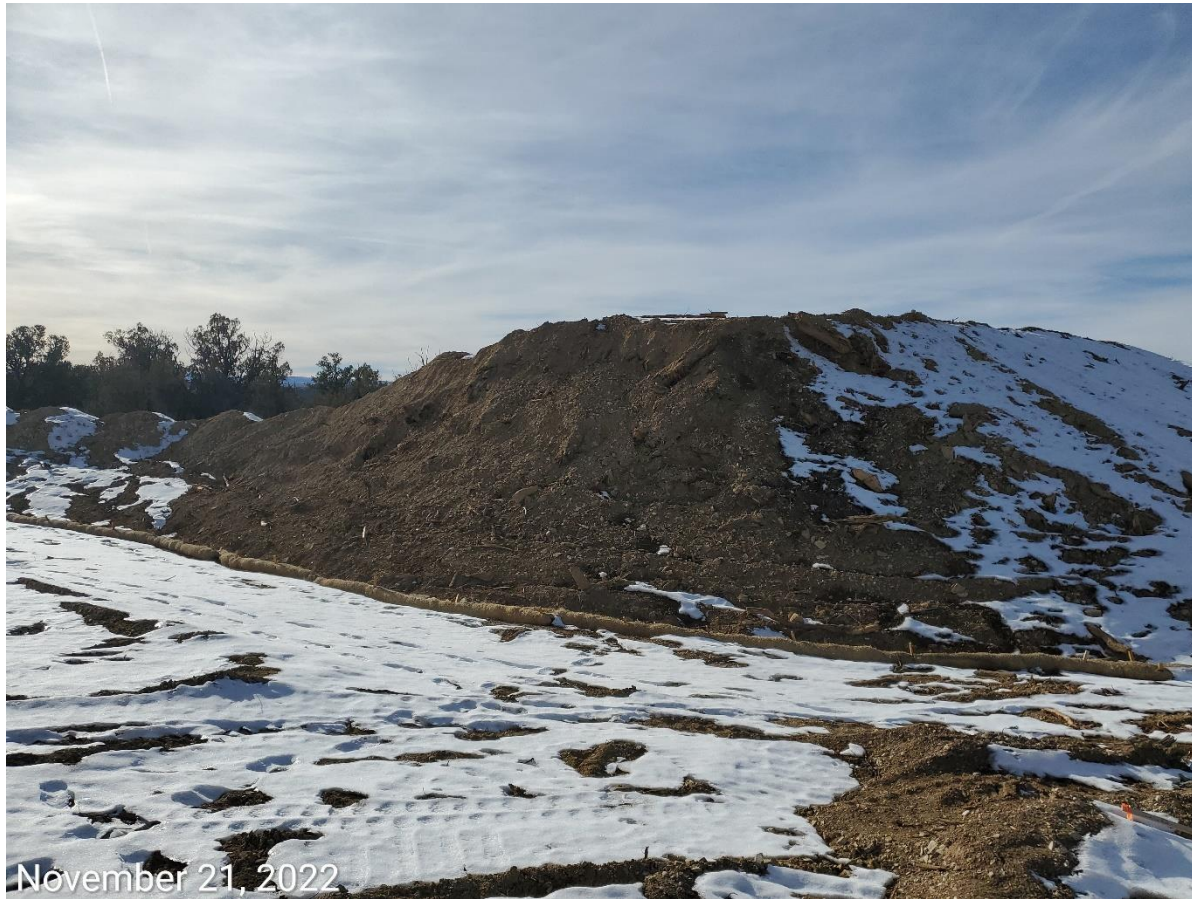
**Photo 3:** Photos 3-5 taken from the southwest end of the Location. Photo shows topsoil stockpiles. Stockpile missing required signage. Photos also show BMPs to stabilize, and protect the topsoil stockpile from wind or water erosion are missing or insufficient. Stockpile constructed larger than advisable, and with steep slopes.

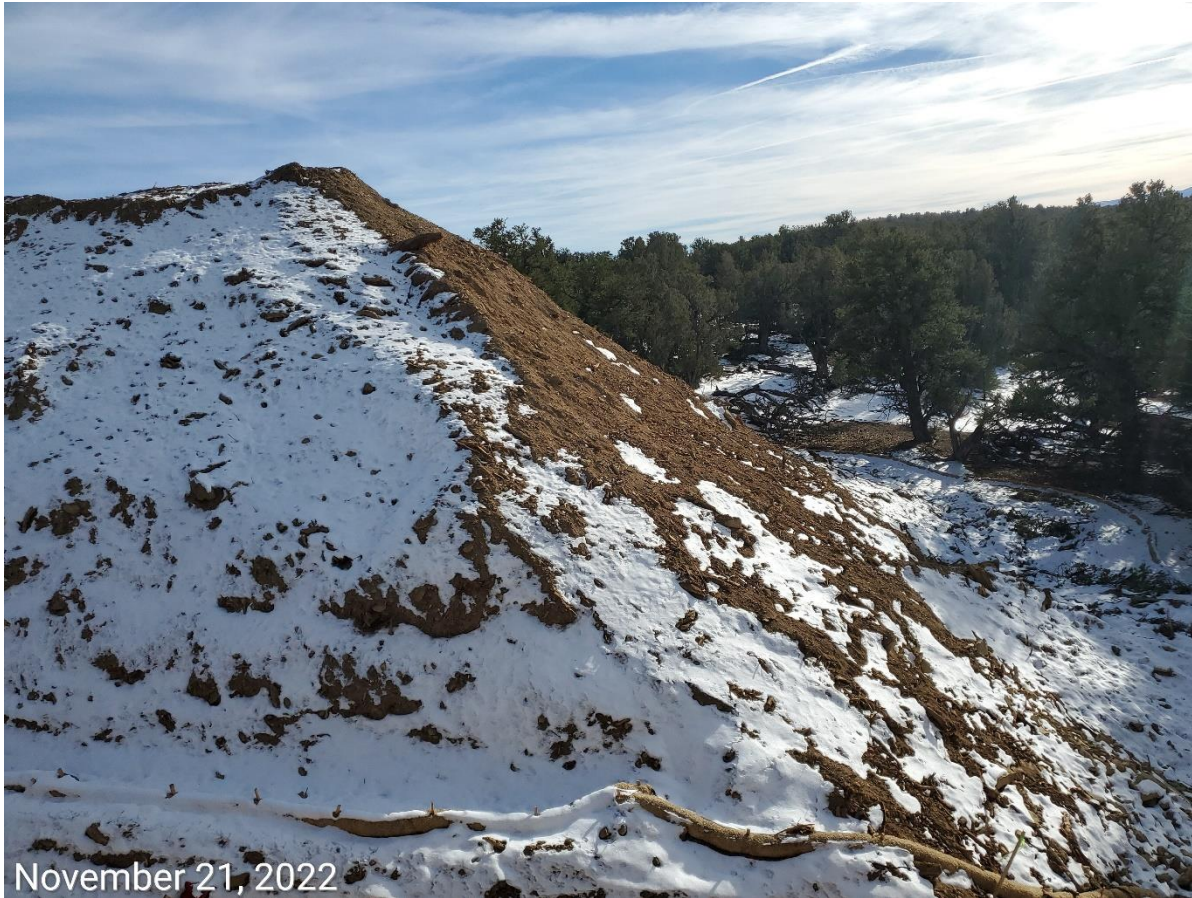
**Photo 4:** See comments under photo 3.

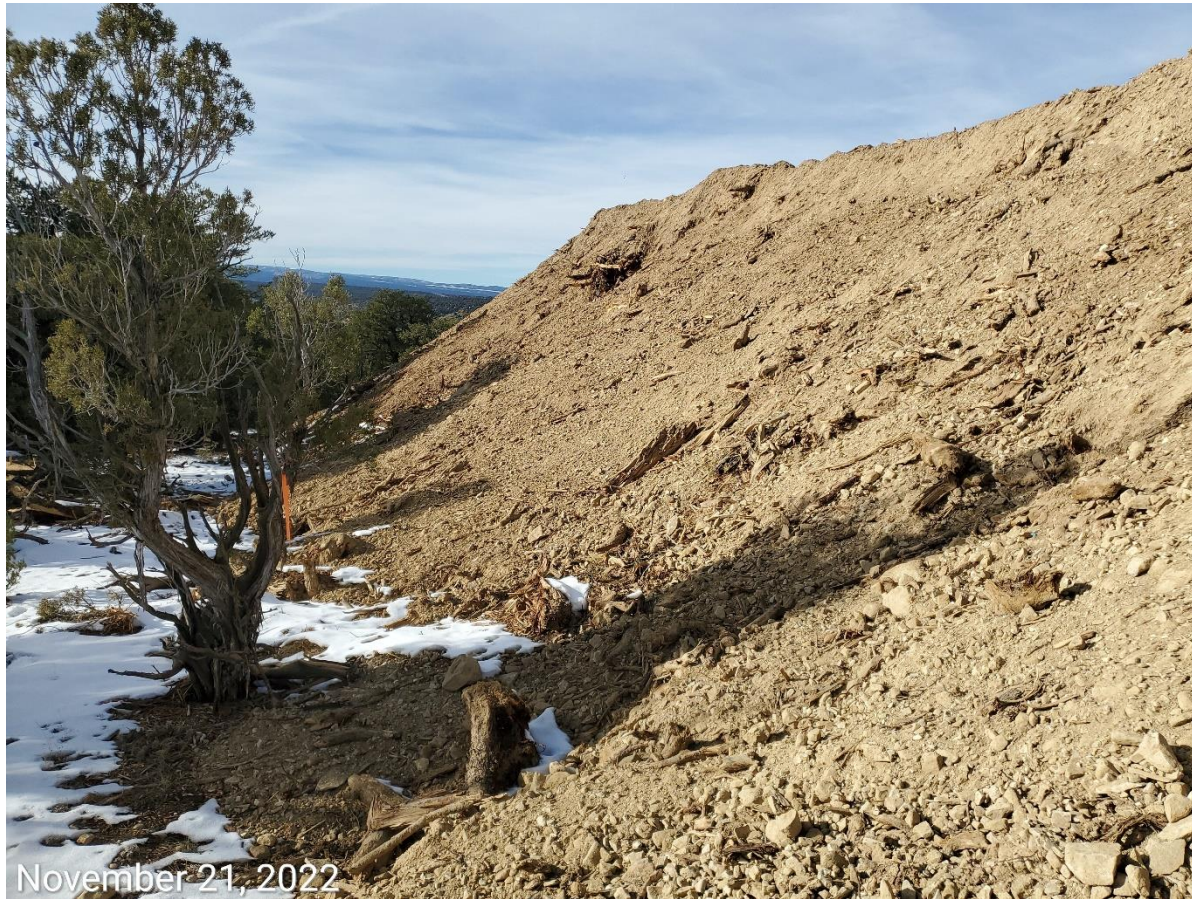
**Photo 5:** See comments under photo 3.

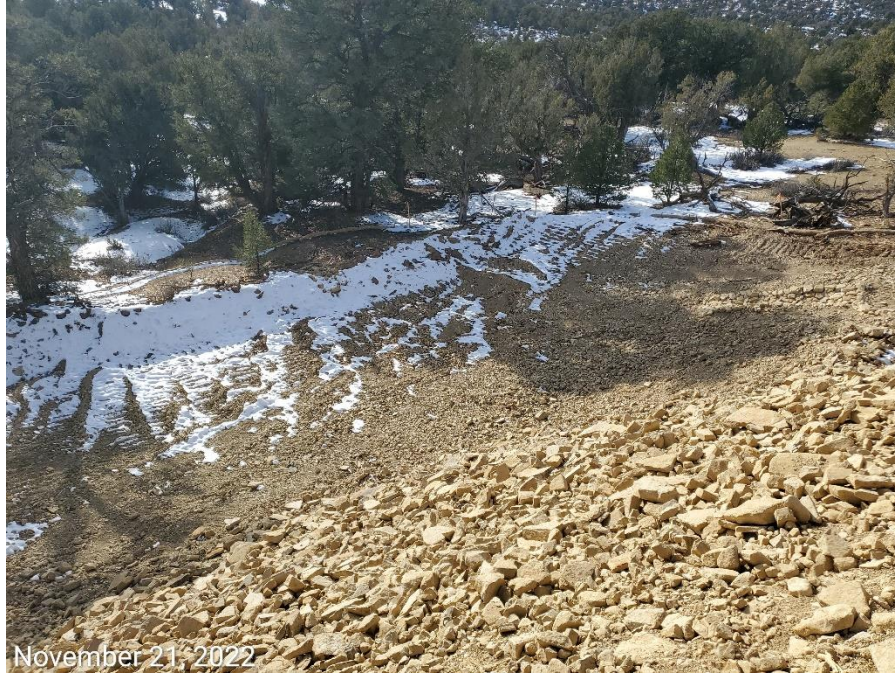
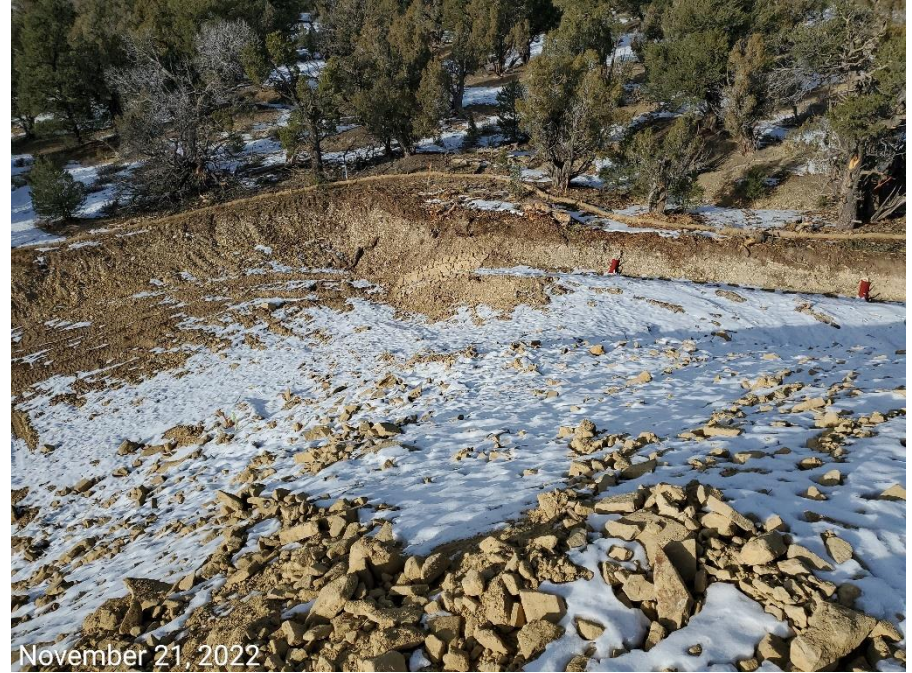
**Photo 6:** Photos provide example of 2 out of 3 sediment traps constructed on the Location. BMPs appear to have been constructed per good engineering requirements, and in proper functioning condition at time of inspection.

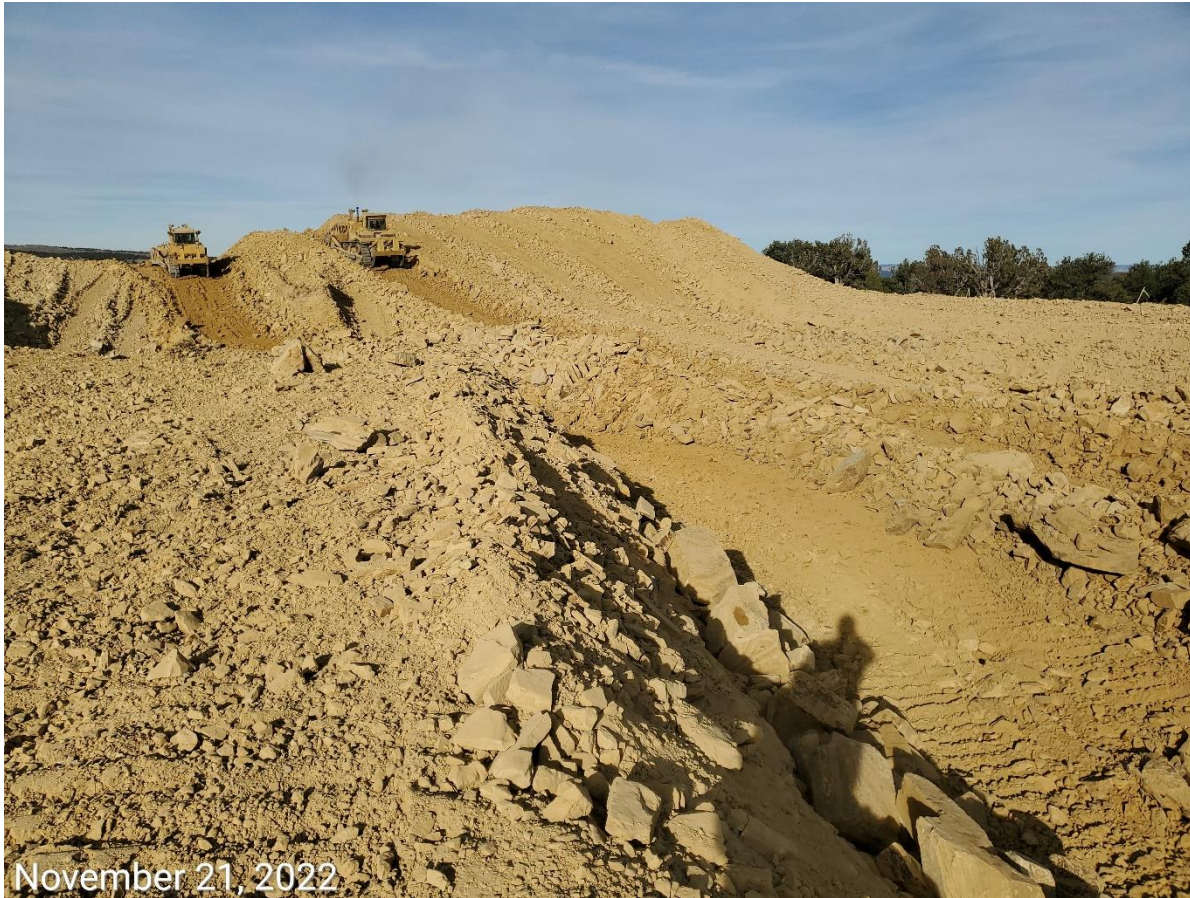
**Photo 7:** Photo shows construction of the cuttings trench “in process”.

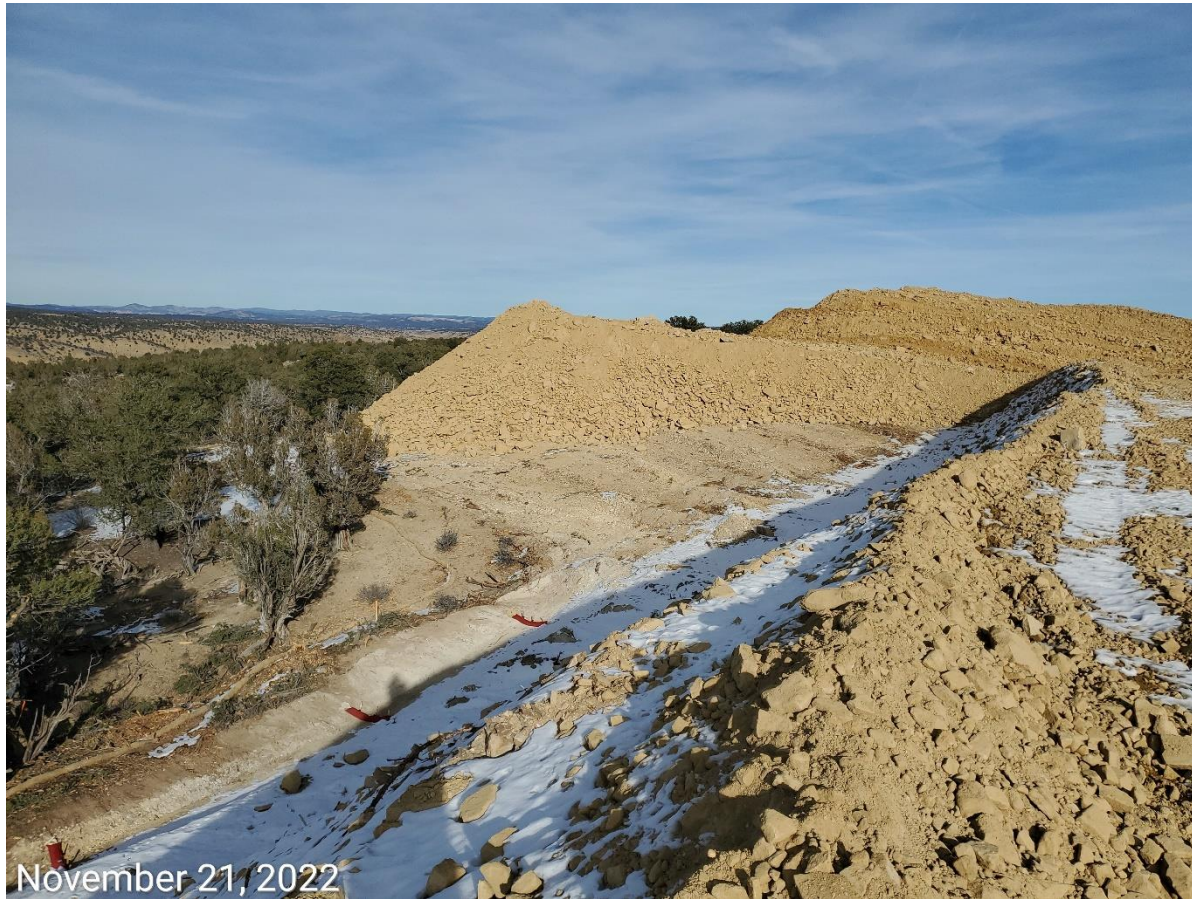
**Photo 8:** Photo taken from the north end of the Location, facing northeast. Photo shows the “Trench Backfill” location per construction figures. Trench construction in process at time of inspection. Currently, erosion logs at the toe of the slopes are the only stormwater BMP in place to manage runoff.

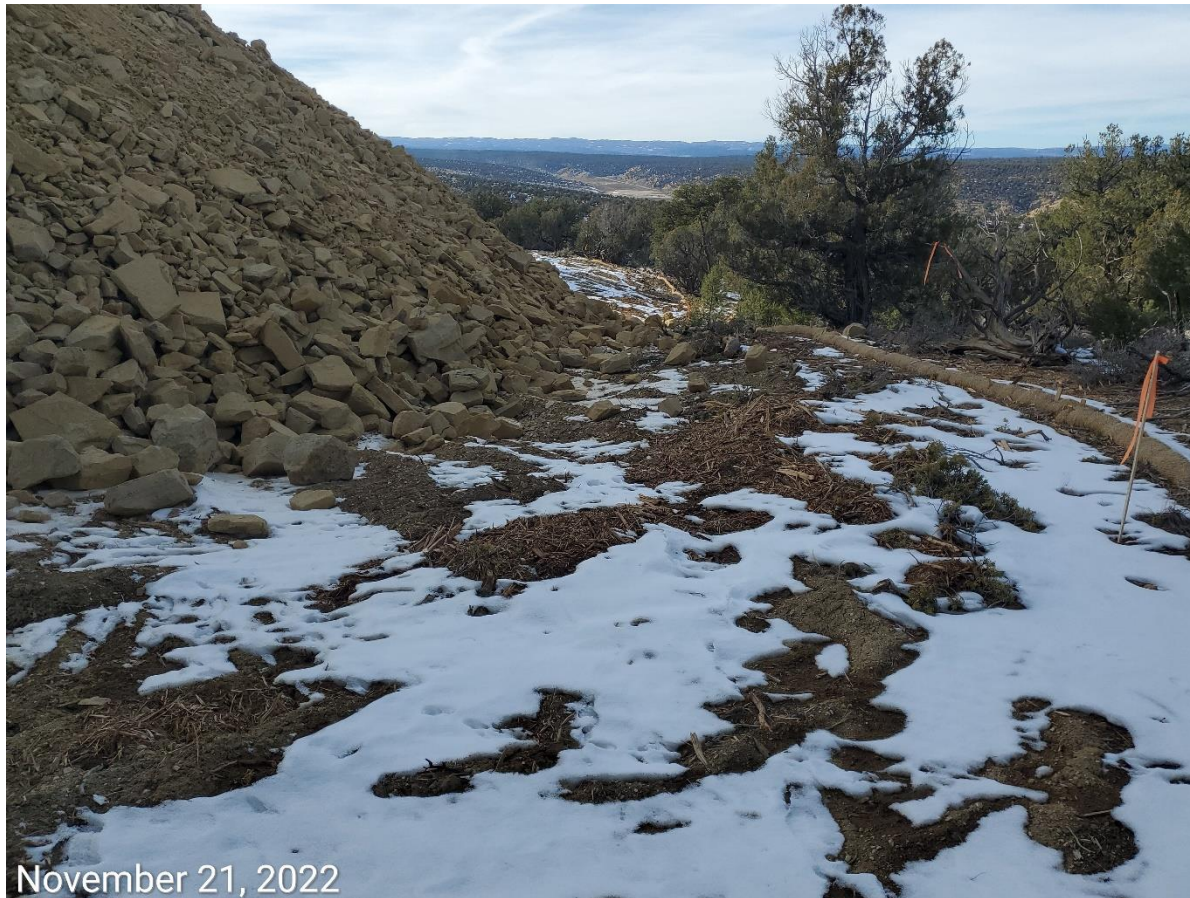
**Photo 9:** Continued from photo 8. Photo shows erosion logs at the toe of the slopes are the only stormwater BMP in place to manage runoff.

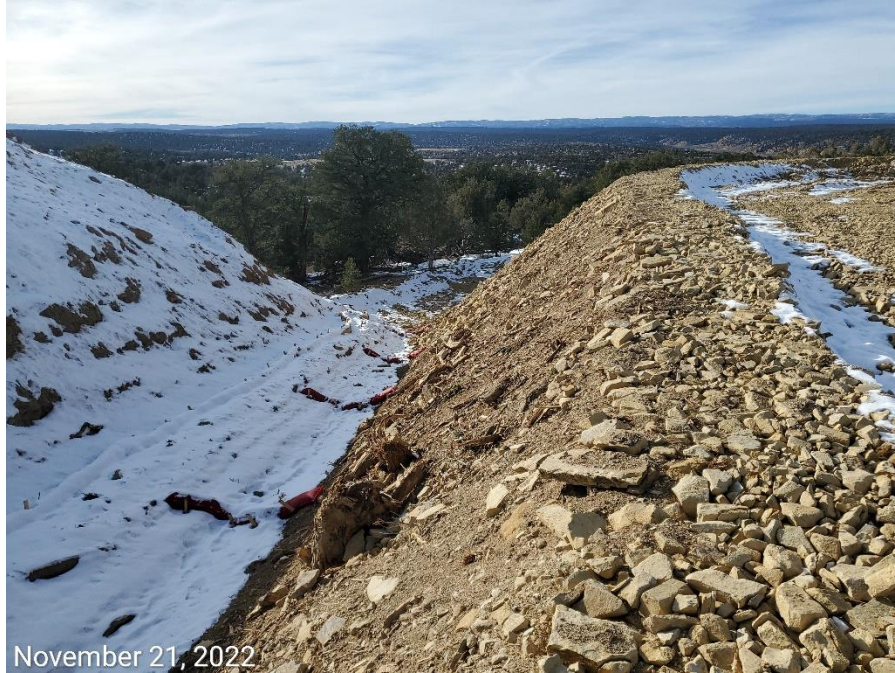
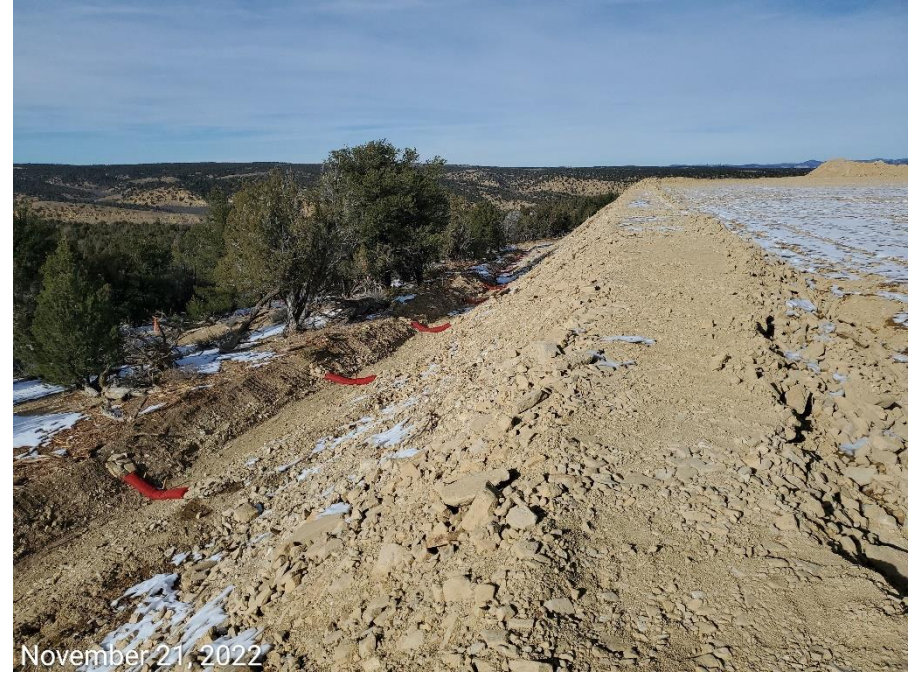
**Photo 10:** Photos example showing fill slopes of the Location. SWMP states hydro-mulch will be applied at the cut and fill slopes of the Location. Photo shows BMP has not yet been installed. Due to the combination of rocky and fine material composing the slopes, as well as the steep grade, hydro-mulch may be inadequate per the sites conditions.
