# Site Inspection Report

**Site: UPRR 42 D2 TANK**  
11/23/2022

## SITE INSPECTION REPORT

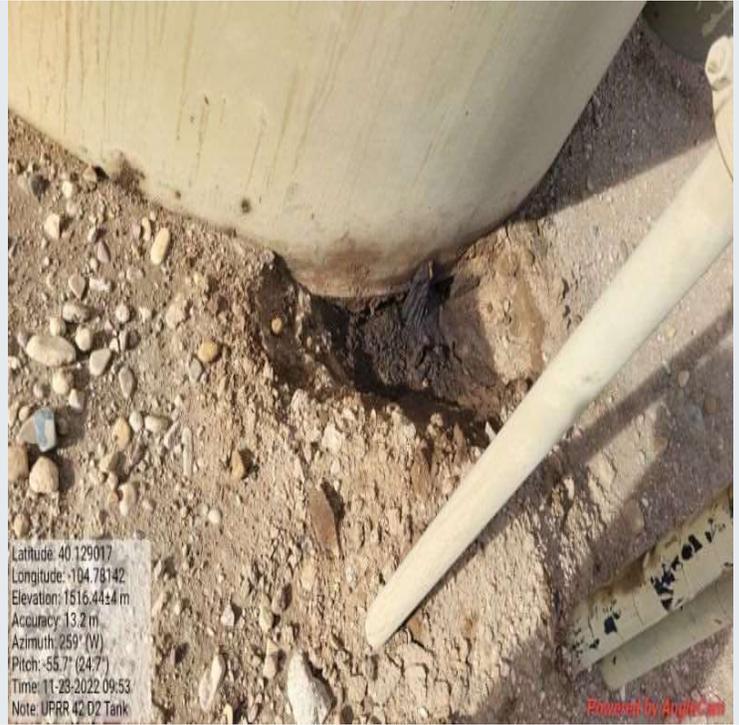
**Question:** Soil impacts remain in situ?  
**Response:** Yes  
**Notes:**

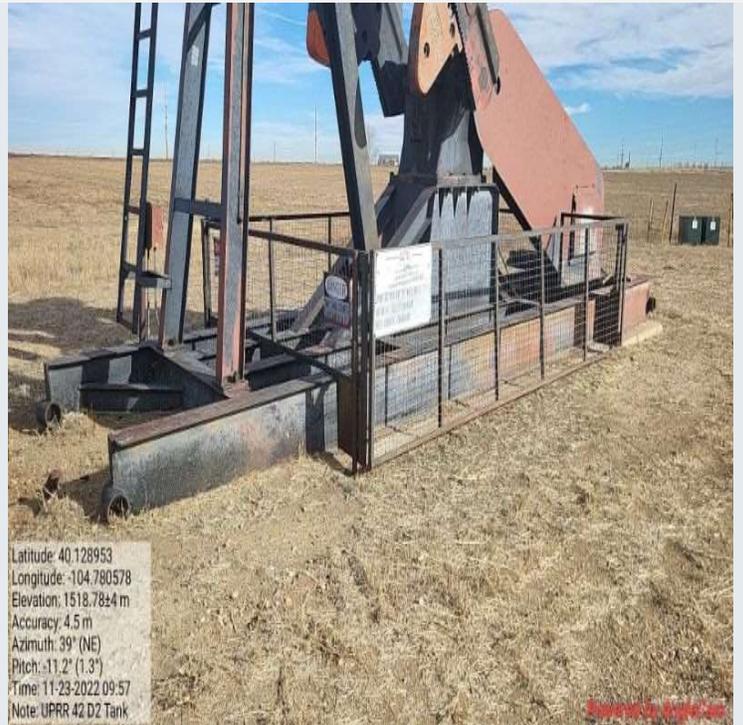
**Question:** Emergency signage in compliance with 605.g.?  
**Note:** Location of signage - Location entrance, Tank Battery, Wellhead(s).  
**Response:** Yes  
**Notes:** Well head and tank battery.

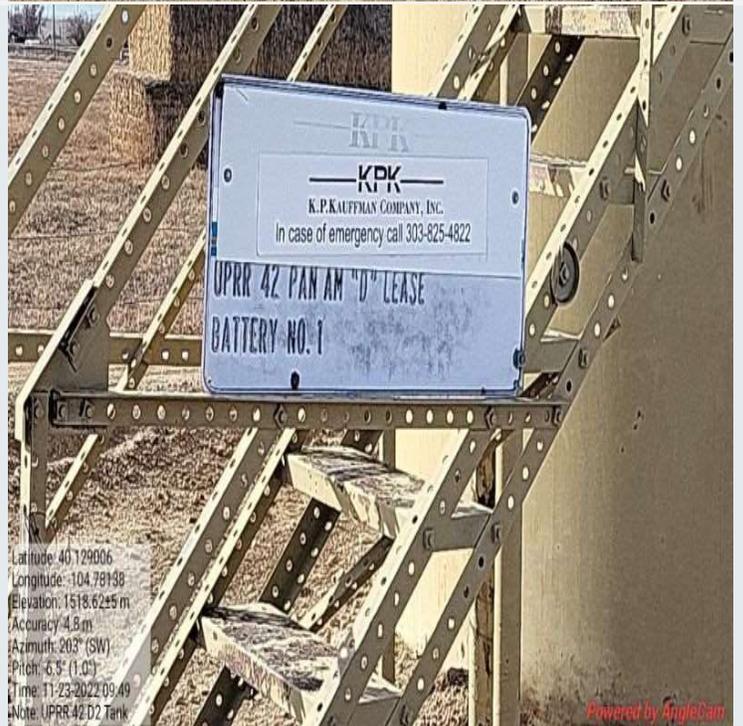
**Question:** Emergency signage in compliance with 605.g.?  
**Note:** Location of signage - Location entrance, Tank Battery, Wellhead(s).  
**Response:** Yes  
**Notes:** Well head and tank battery.

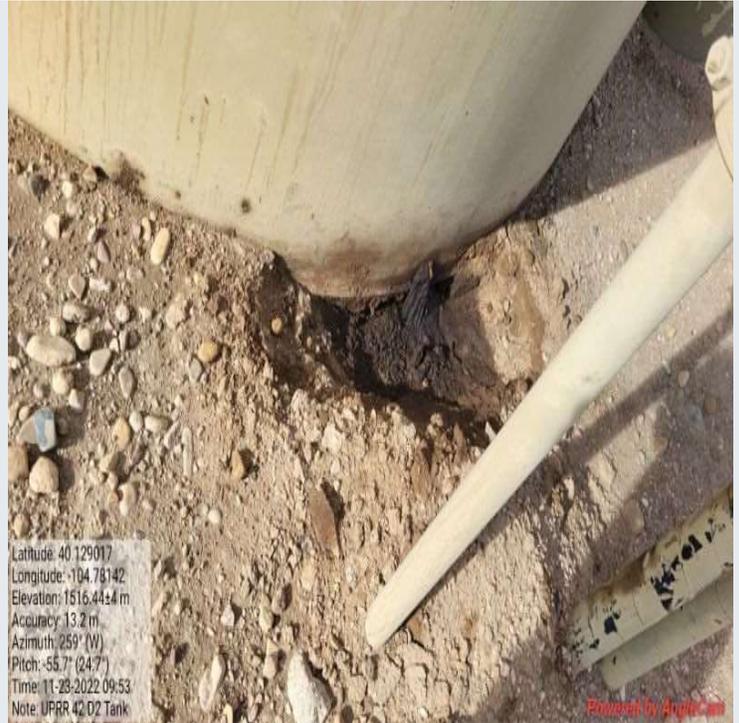
**Question:** Ground surface appears clean (no evidence of new equipment leaks, oil leaks, spills, or releases)?

**Response:** No

**Notes:** Around bottom of tank and to the side staining are present.

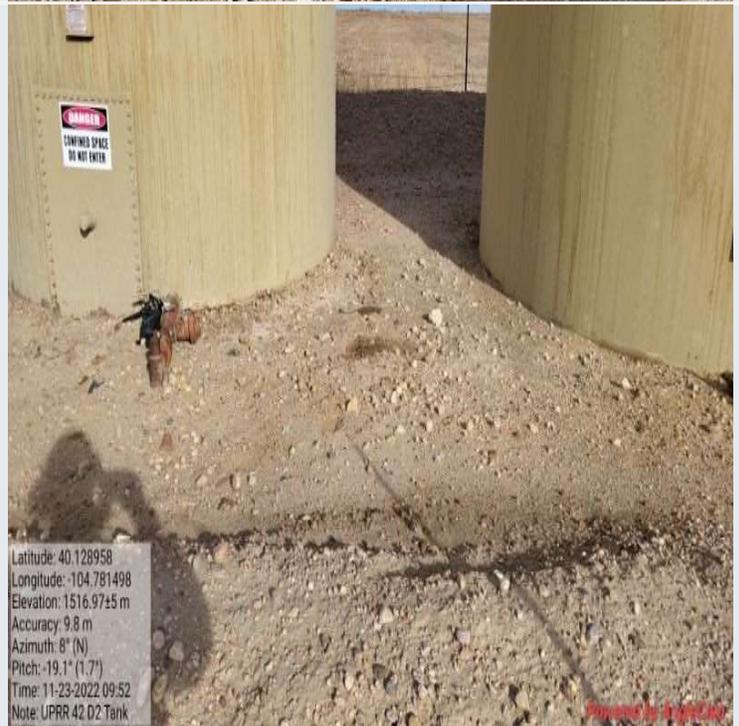
**Question:** Ground surface appears clean (no evidence of new equipment leaks, oil leaks, spills, or releases)?

**Response:** No

**Notes:** Around bottom of tank and to the side staining are present.

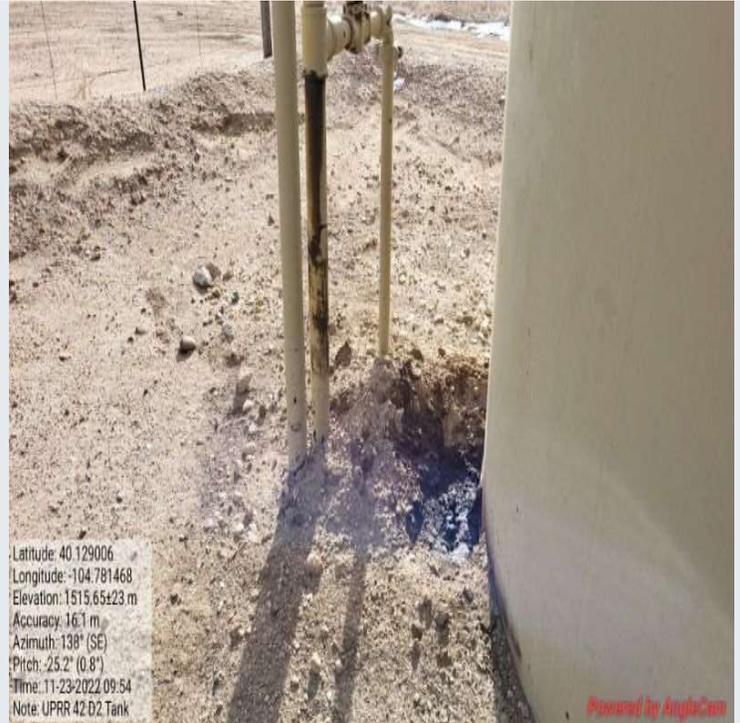
**Question:** Ground surface appears clean (no evidence of new equipment leaks, oil leaks, spills, or releases)?

**Response:** No

**Notes:** Around bottom of tank and to the side staining are present.

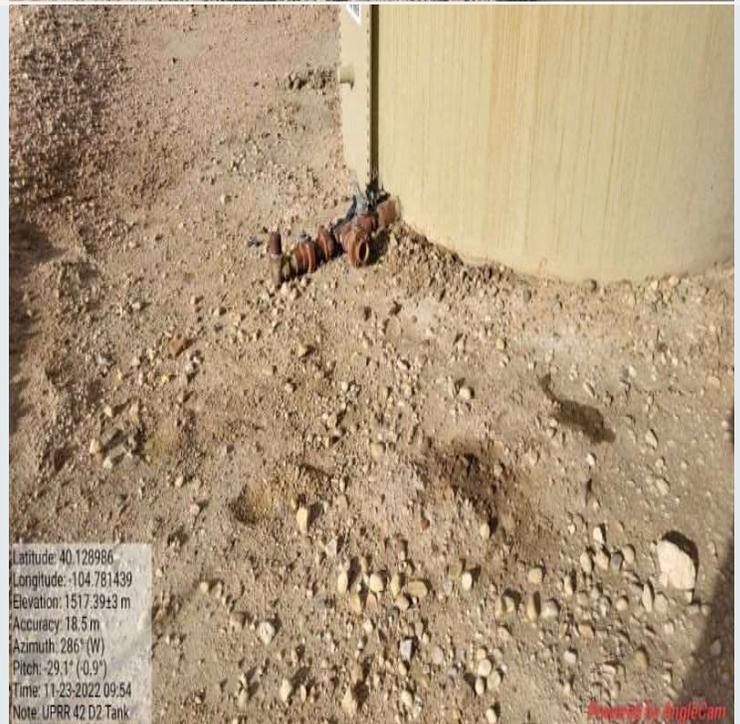
**Question:** Ground surface appears clean (no evidence of new equipment leaks, oil leaks, spills, or releases)?

**Response:** No

**Notes:** Around bottom of tank and to the side staining are present.

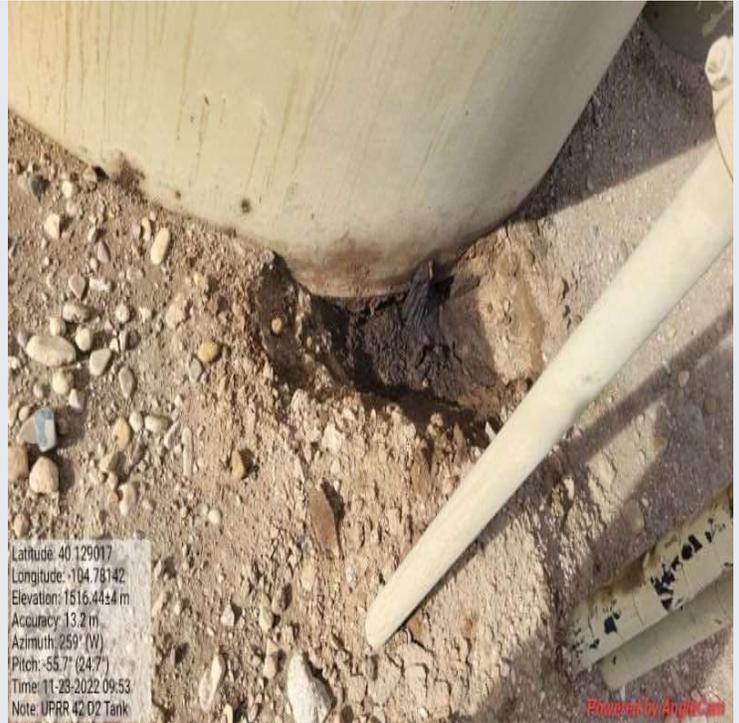
**Question:** Ground surface appears clean (no evidence of new equipment leaks, oil leaks, spills, or releases)?  
**Response:** No  
**Notes:** Around bottom of tank and to the side staining are present.

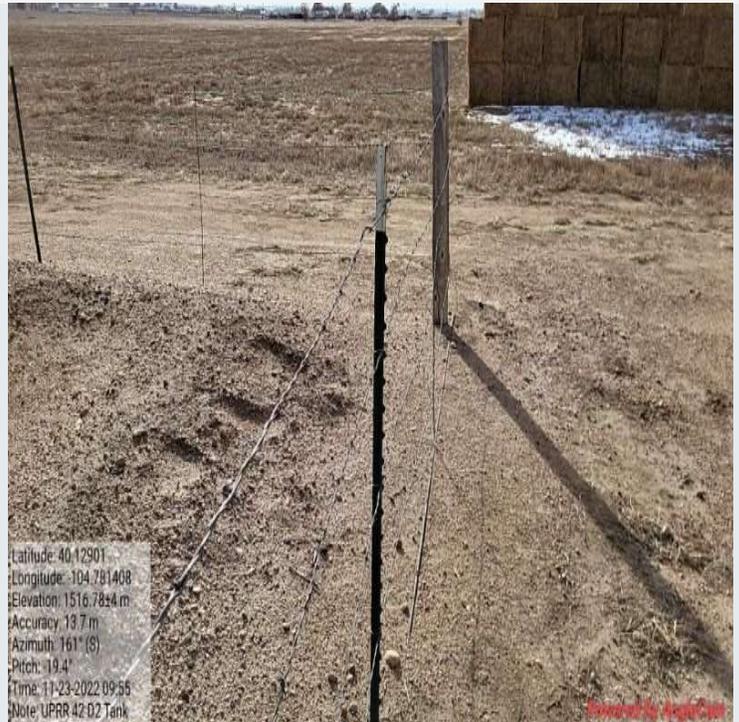
**Question:** Is fencing adequate/appropriate for site and well(s) and maintained?  
**Response:** Yes  
**Notes:** Around tanks and separator.

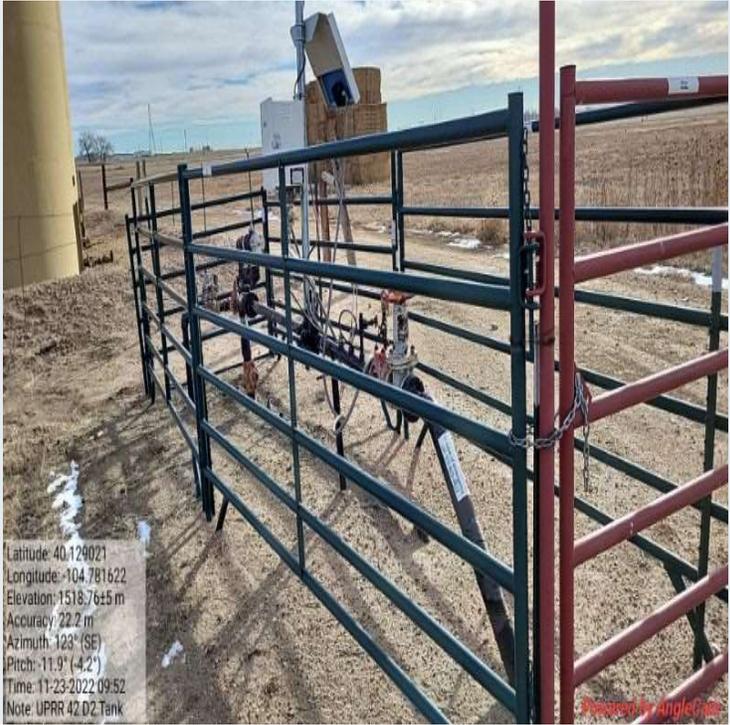
Photo
<p><b>Question:</b> Is fencing adequate/appropriate for site and well(s) and maintained?  <b>Response:</b> Yes  <b>Notes:</b> Around tanks and separator.</p>

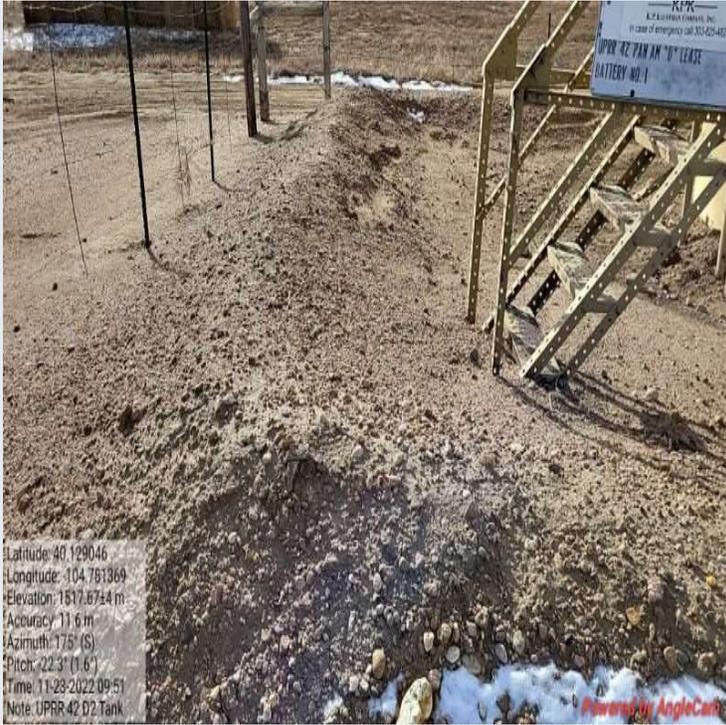
Photo
<p><b>Question:</b> Is earthen berm secondary containment present and in good condition (compacted, complete, no evidence of erosion, animal burrowing, etc.)?  <b>Response:</b> Yes  <b>Notes:</b> Around tanks and separator.</p>

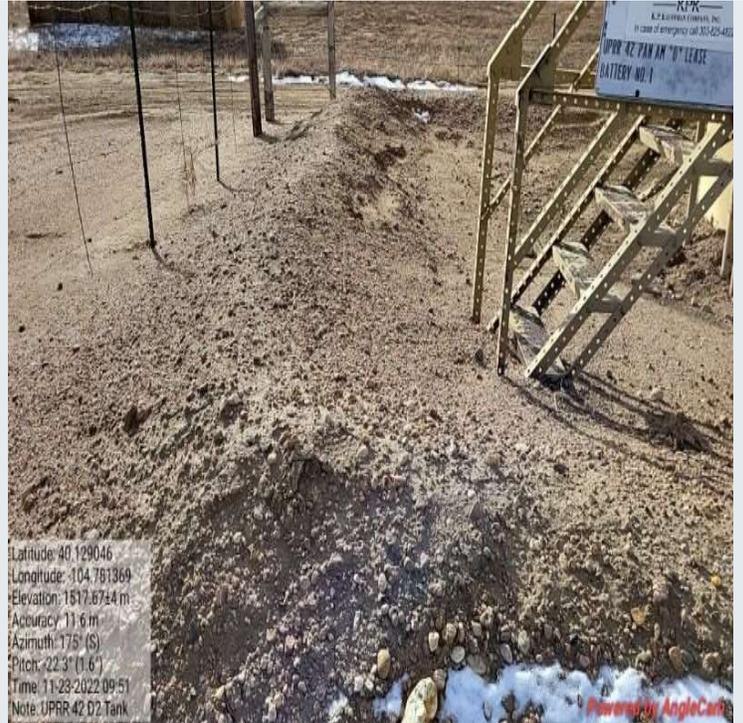
**Question:** All stormwater erosion control measures and BMPs are present and in good/working condition?

**Response:** Yes

**Notes:** Earthen berm.

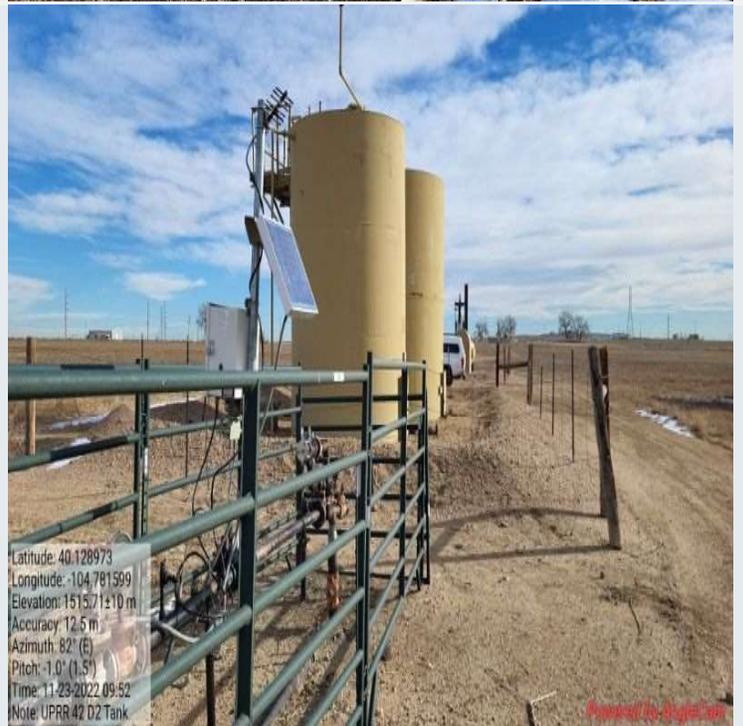
**Question:** Site free of unused equipment, weeds, debris/trash?

**Response:** Yes

**Notes:** No trash or weeds.
