Inspection Photos
Location Name: Gunderson 20-03
Spill/Release Point ID: 483326

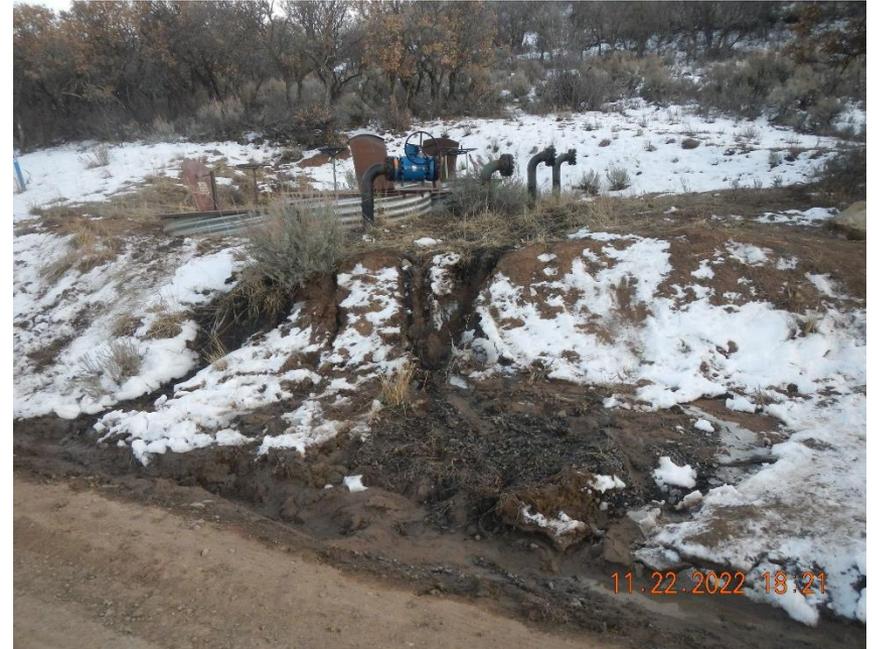
Valve can where Spill/Release Point ID #483326 originated from.

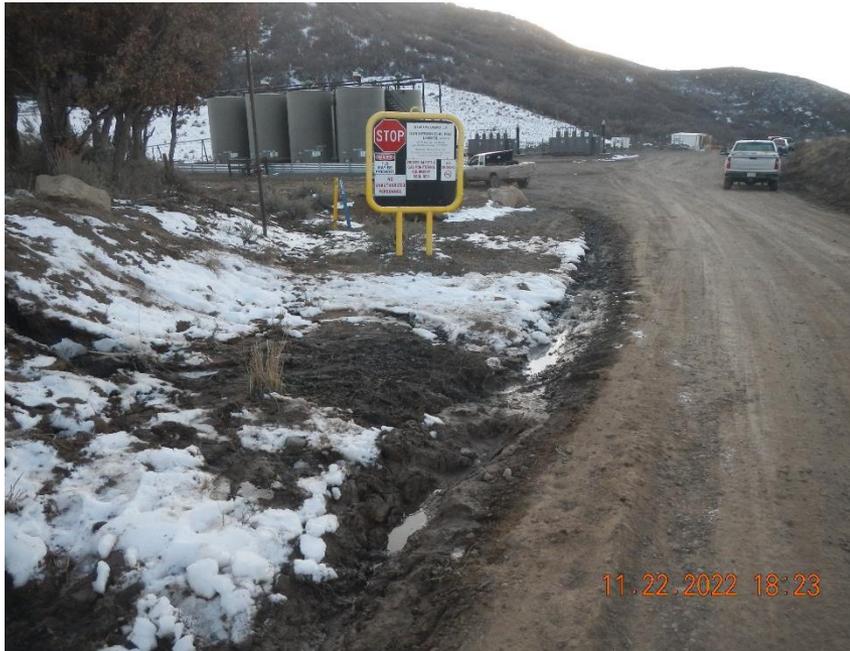
Flow path along access road.

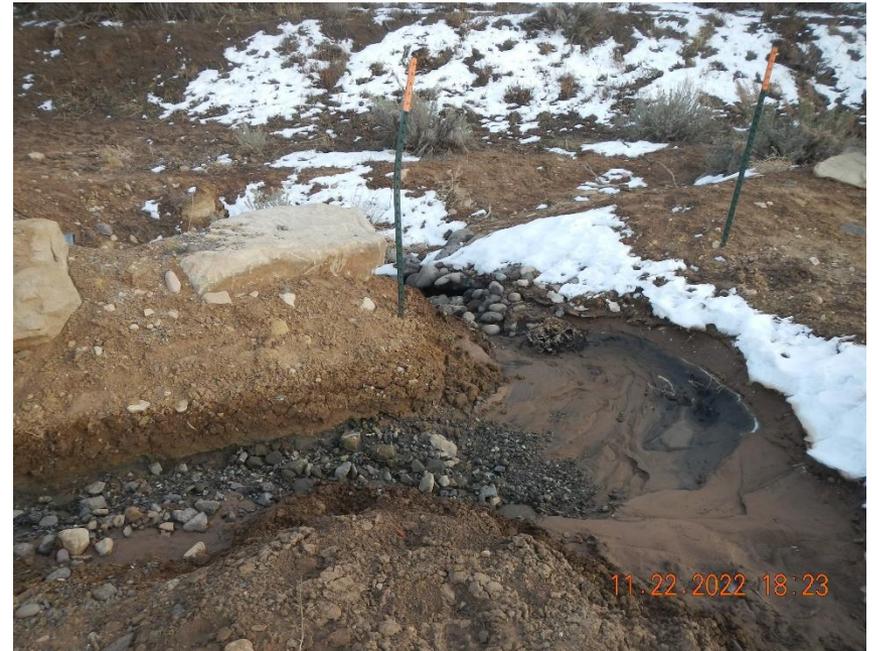
Flow path into location storm water feature in the northeast corner of the location.

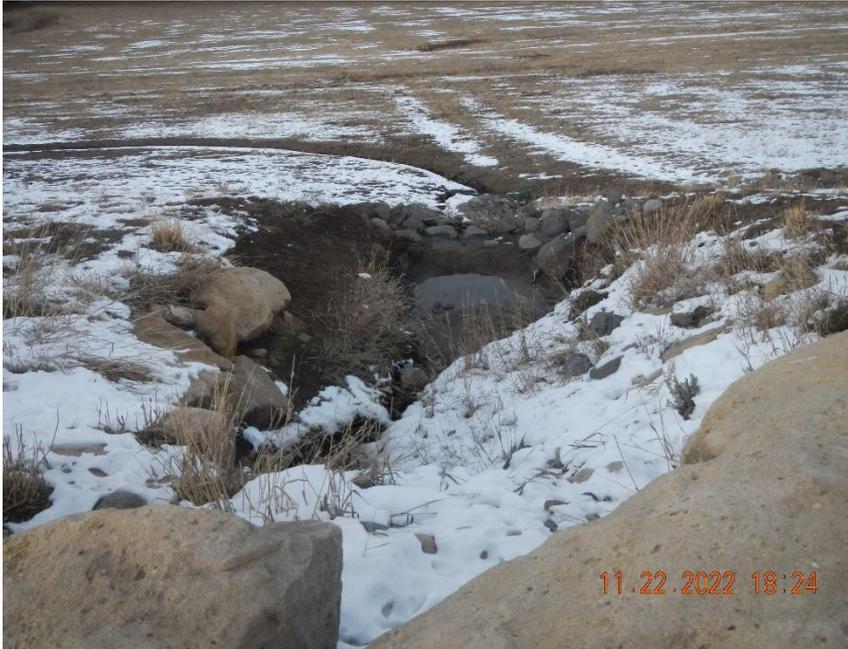
Flow path through culvert under access road into sediment traps.

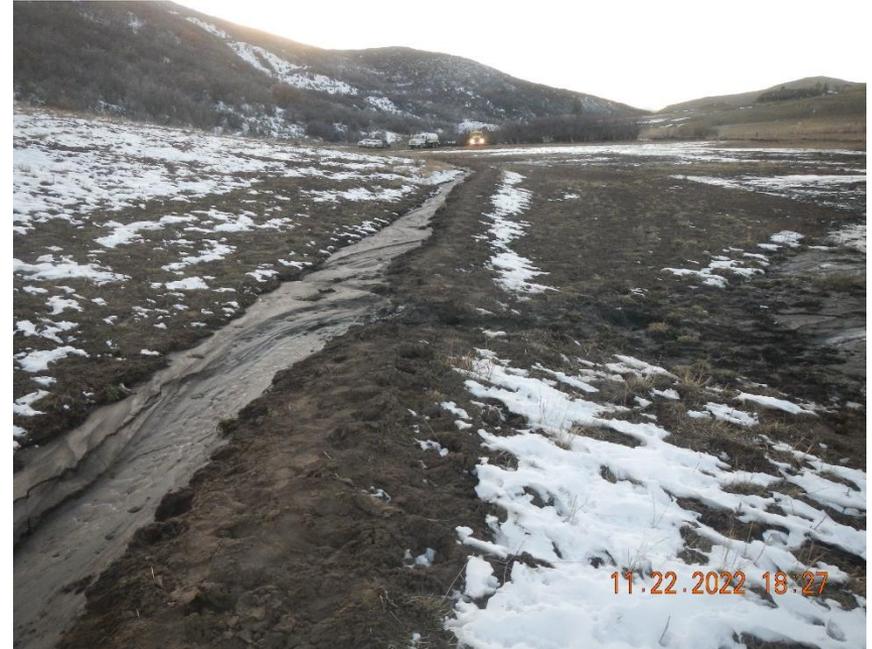
Area where released fluids breached the bank of a storm water diversion ditch.

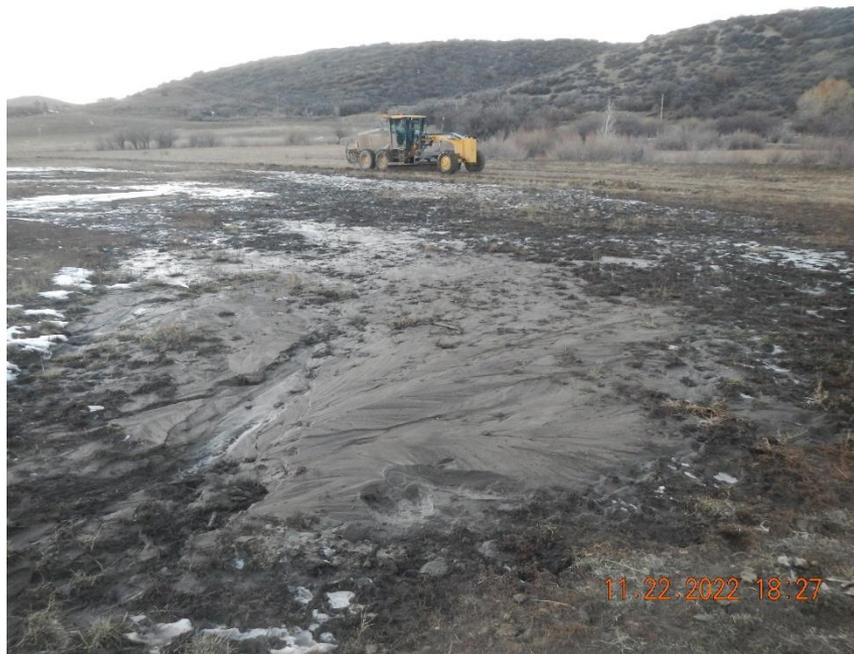
Flow path into field from breach in storm water ditch.

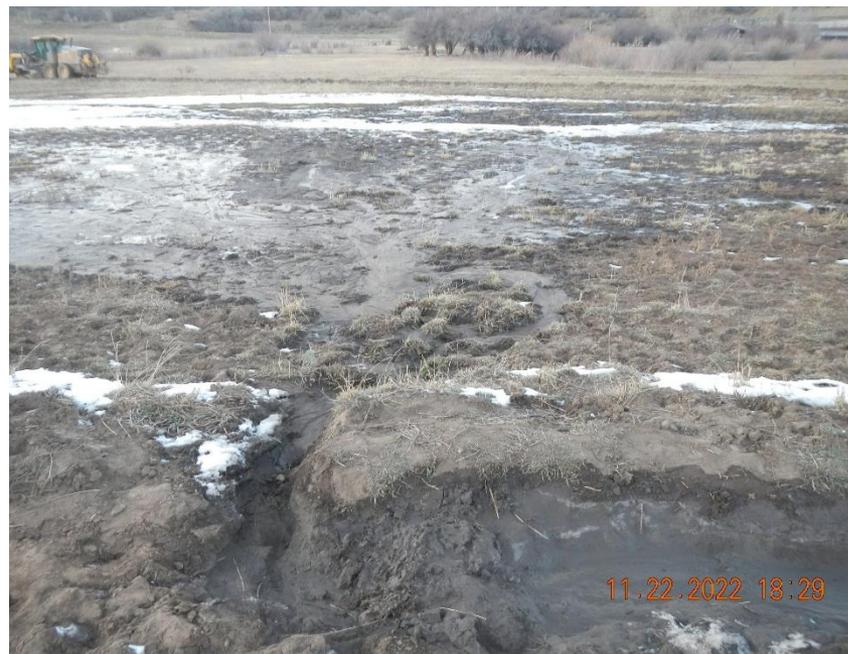
Second area where storm water ditch was breached.

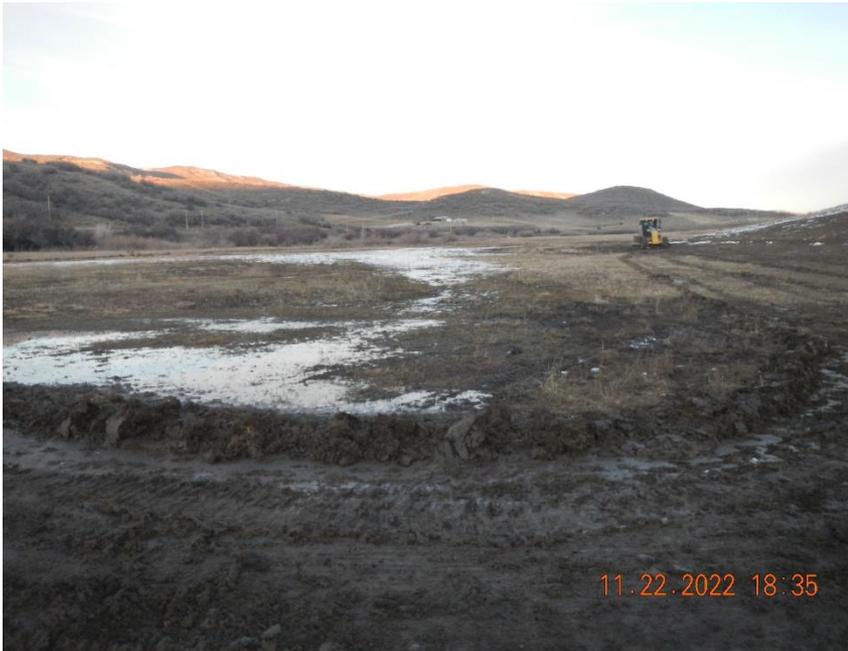
Affected field with grader creating a containment berm.

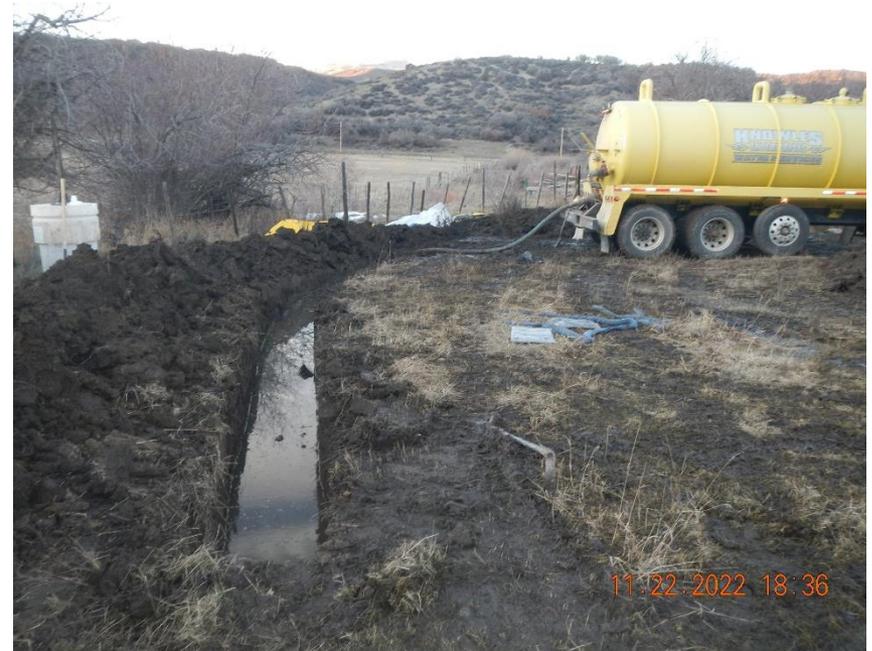
Initial response containment berm and collection area for released fluids.

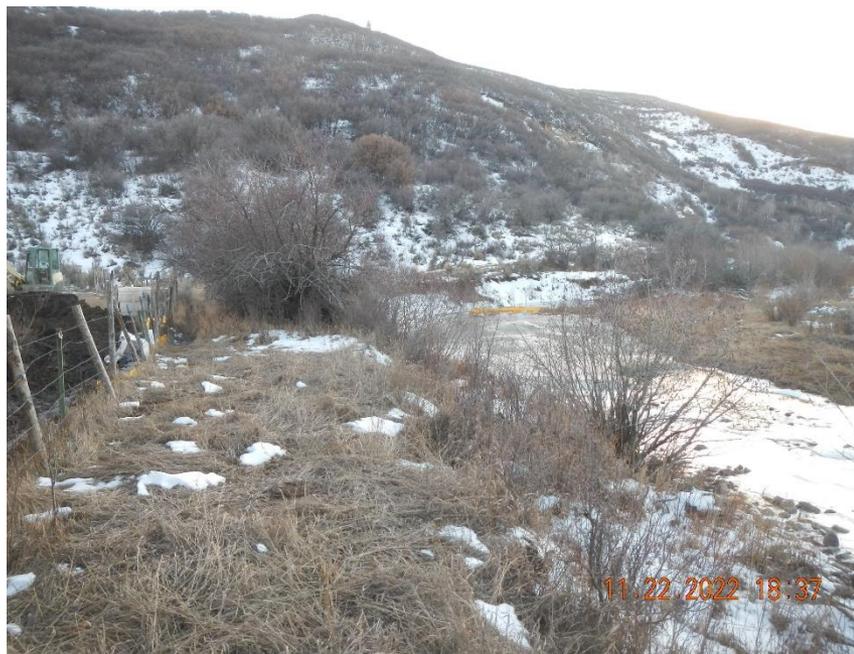
Buzzard Creek adjacent to affected field. Boom across the creek can be seen in the center of this photo.

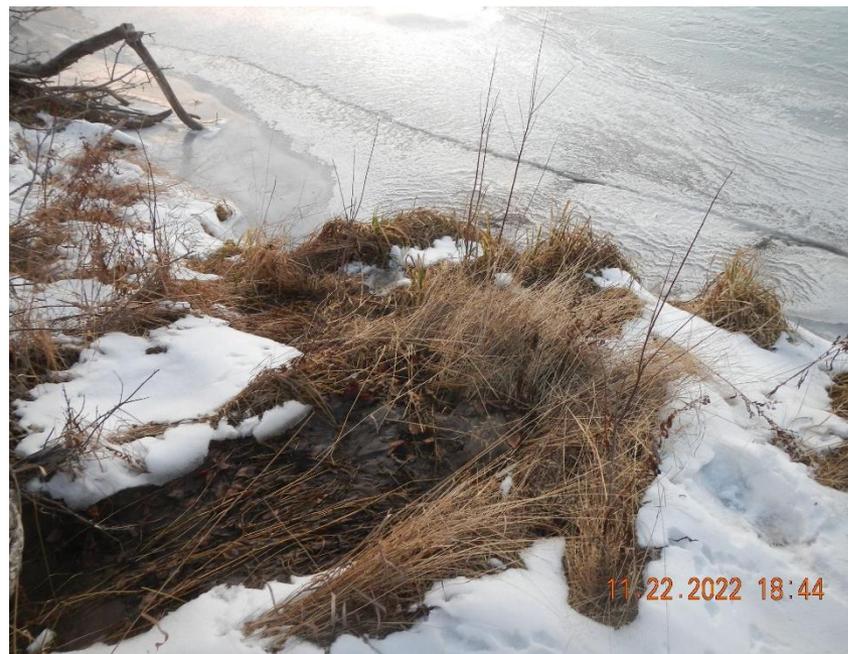
Area where released fluids entered Buzzard Creek.

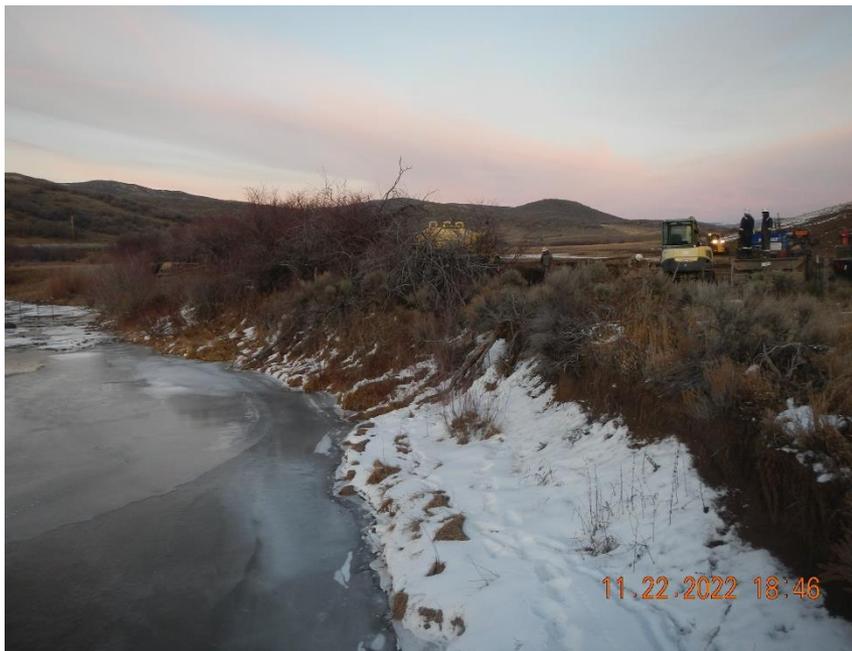
View of Buzzard Creek downstream of affected field.

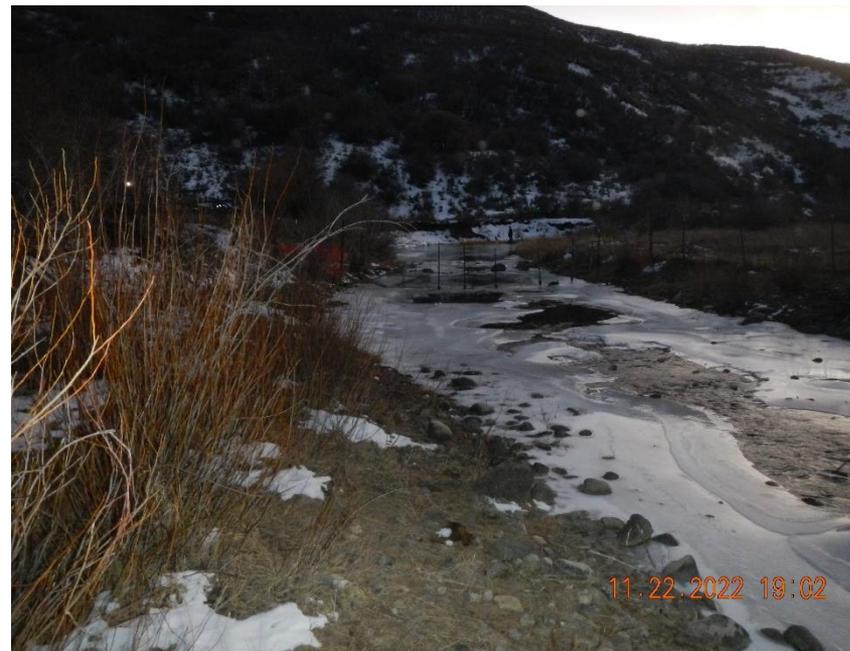
Second area where released fluids entered Buzzard Creek.
