Inspection Photos

API: 071-08419

Operator: OGRIS OPERATING LLC

Inspection Date: 11/30/2022

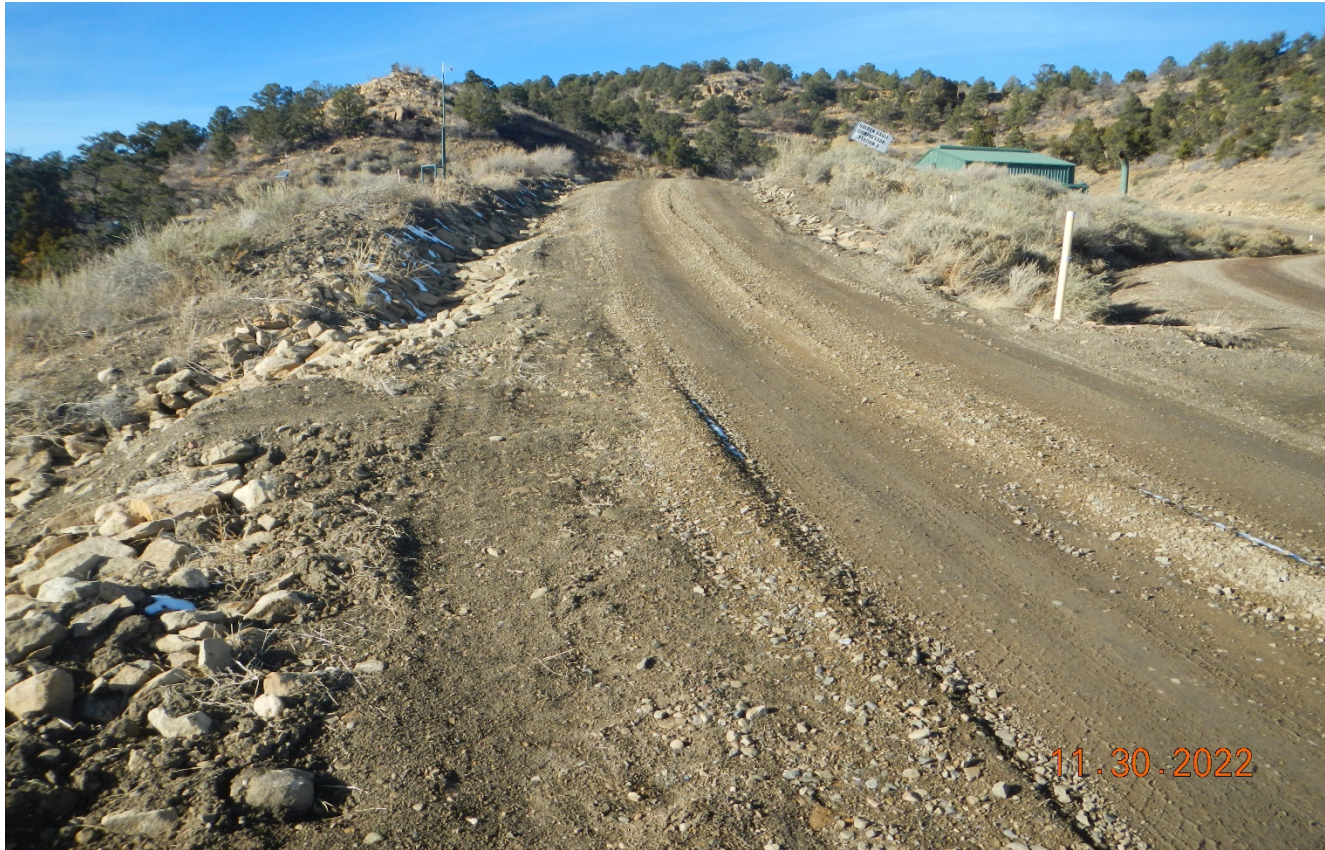
Photo 1. Facing northwest toward the access road. The erosion on the road has been repaired and diversion has been installed off the road side with rip/rap.

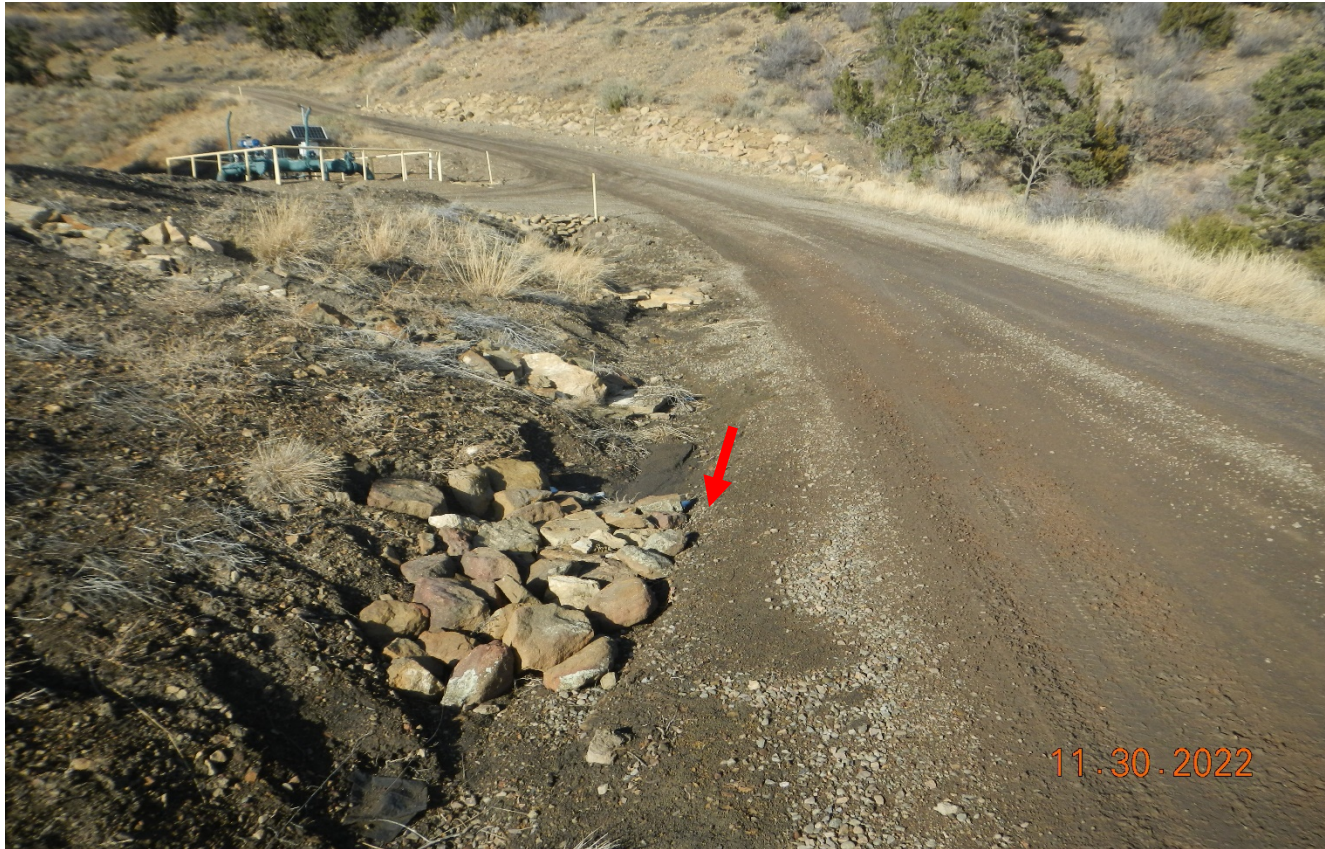
Photo 2. There has been rock check dams installed along the road side where erosion was occurring. There is concerns with the check dam installation Stormwater can erode around the check dams. Installation should be from bank to bank, keyed in, with low point in the middle.

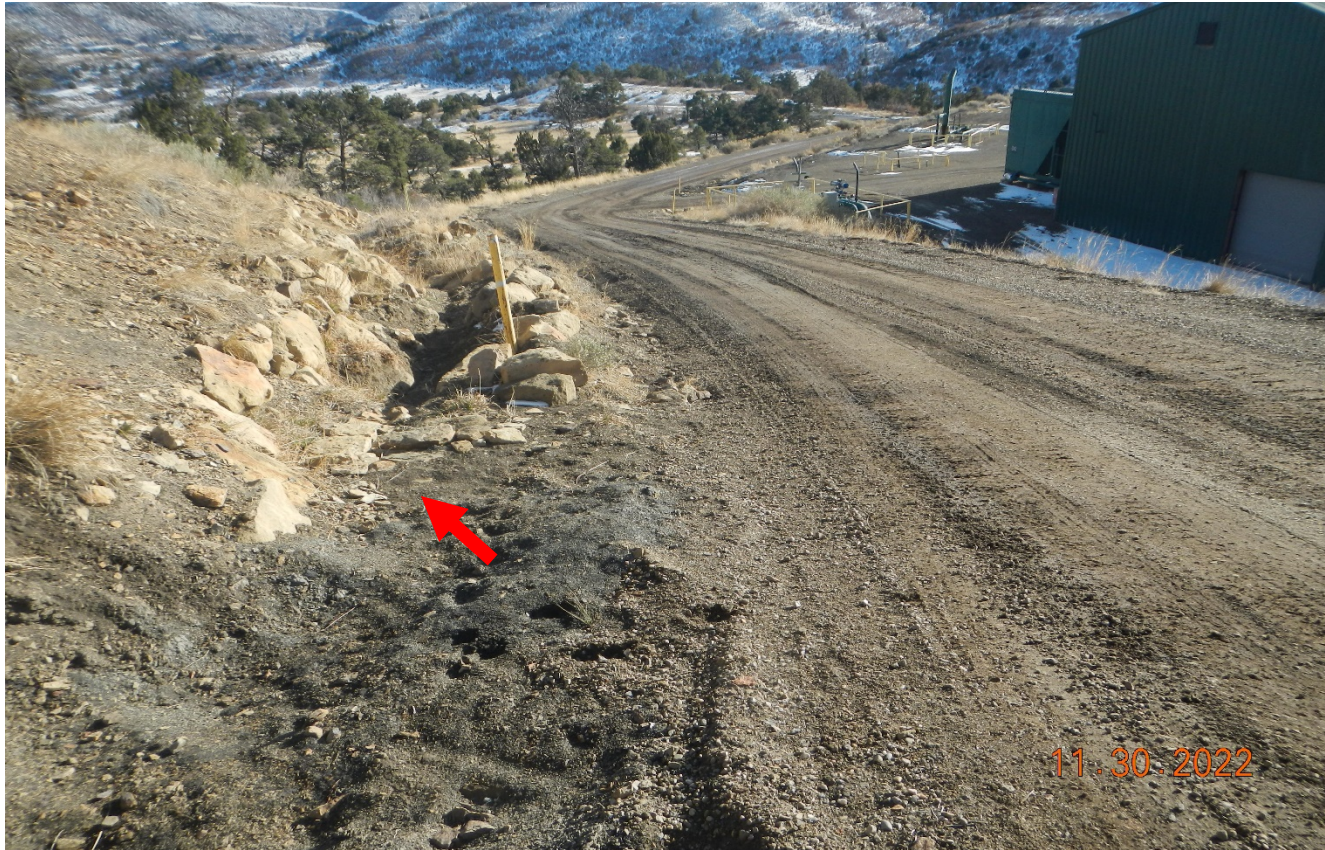
Photo 3. This area along the road may need to be dug out more to ensure stormwater flows into the diversion shown at red arrow.

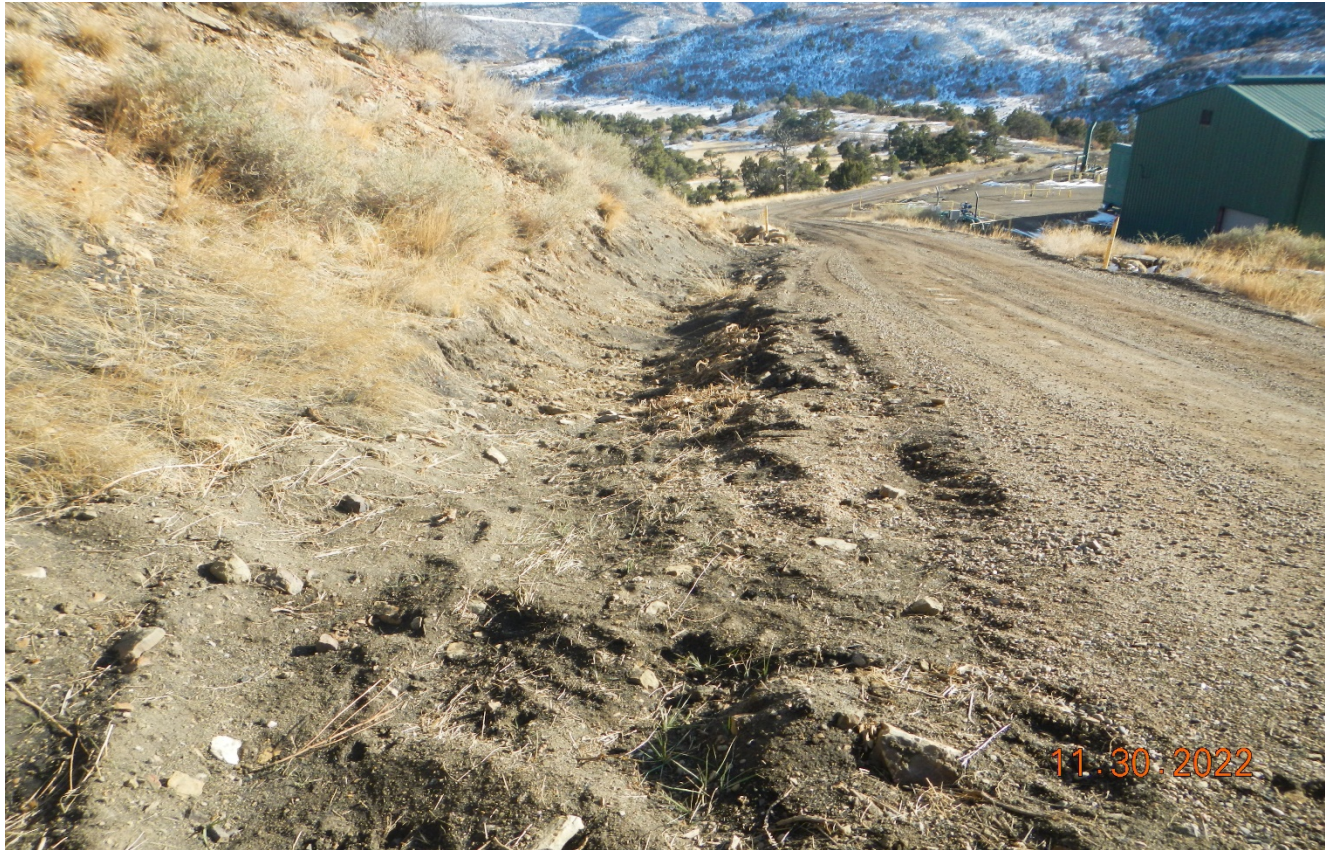
Photo 4. Further up the road. The loose soils on the roadside should be seeded for stabilization.

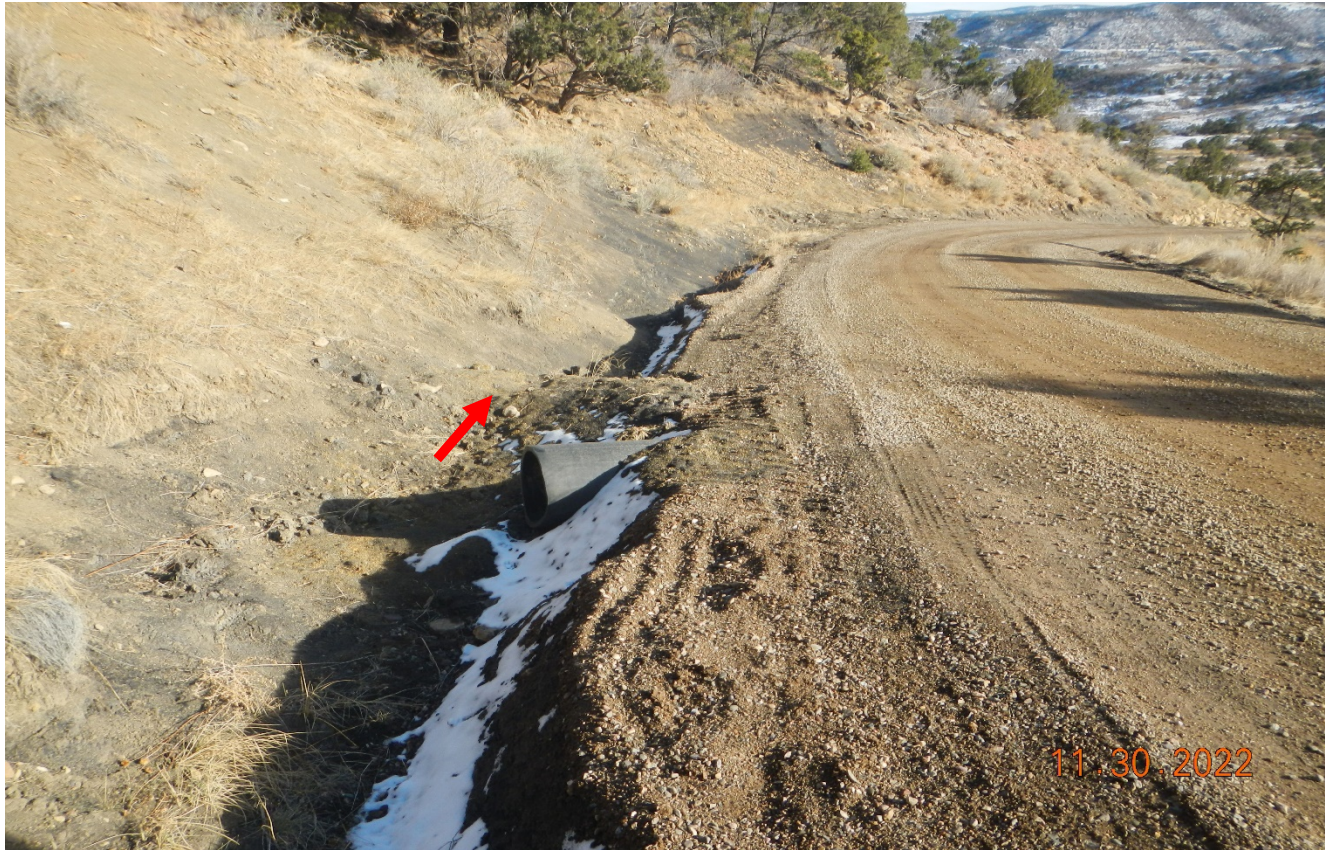
Photo 5. Further up the road a culvert was installed which will help with concentrated flows along this area. There is concerns that stormwater will overtop the embankment at red arrow which should be built up better and compacted.

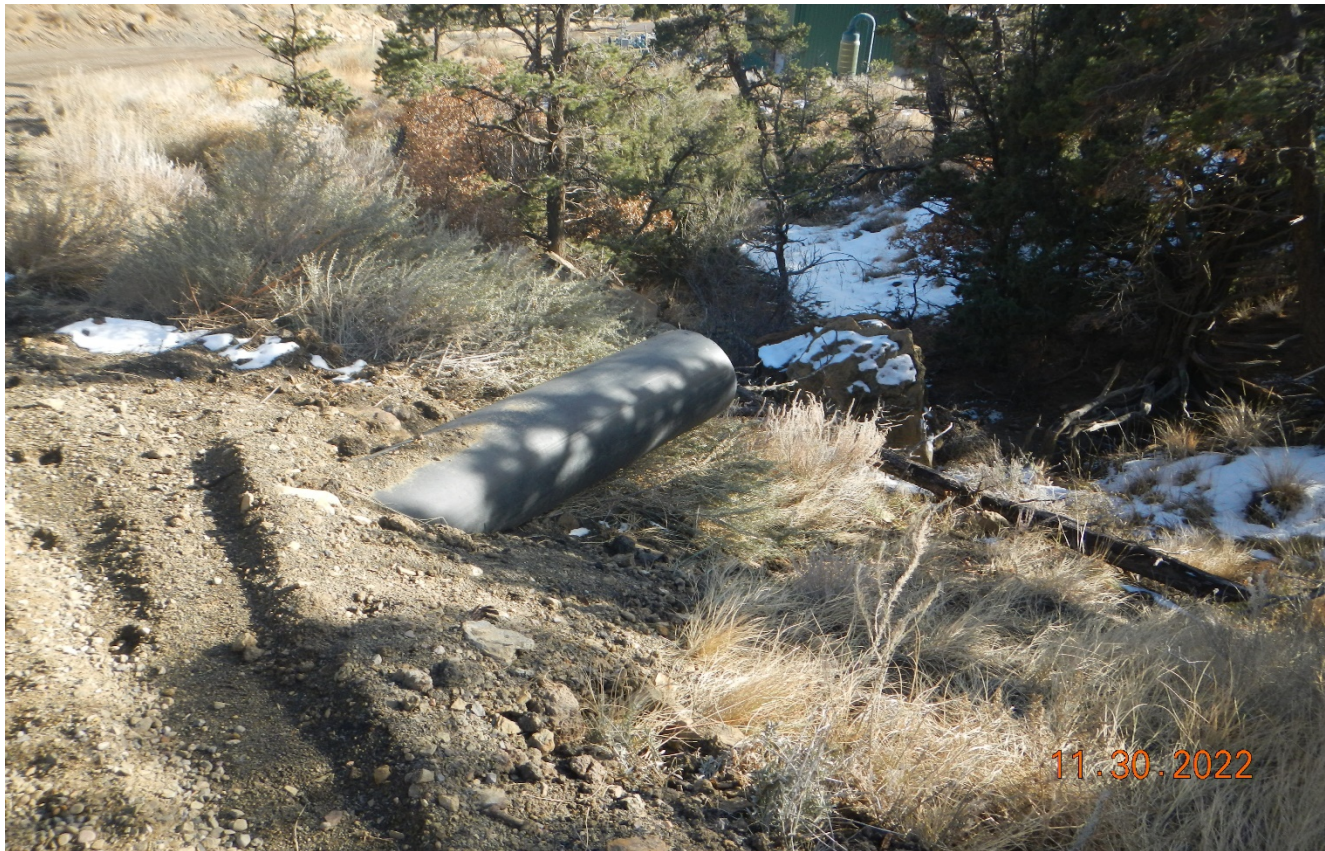
Photo 6. There is no outlet protection installed at the newly installed culvert.
