Taproot – Big Mountain Viper Pad – Produced Water Release

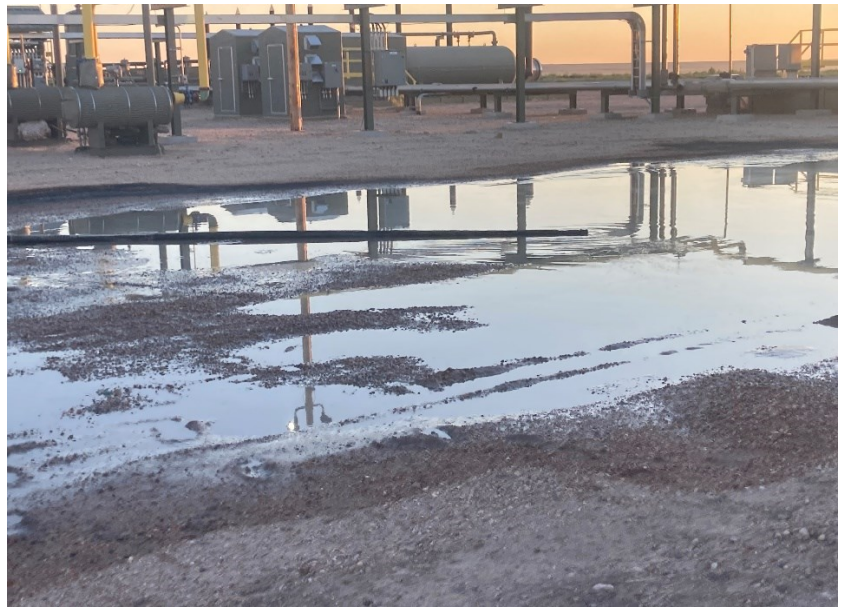
Photo: 1

Initial site conditions on 9/5 looking east.

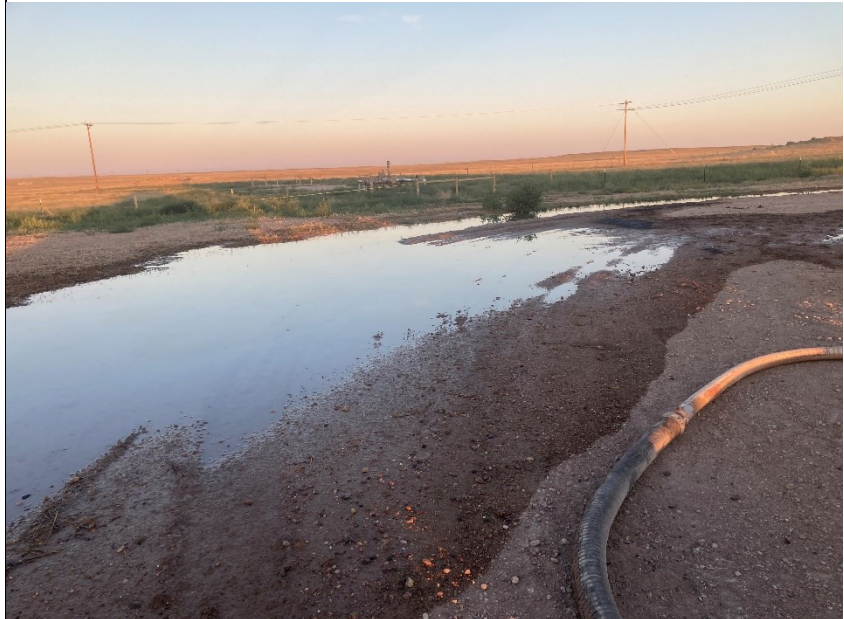
Photo: 2

Initial site conditions looking southwest.

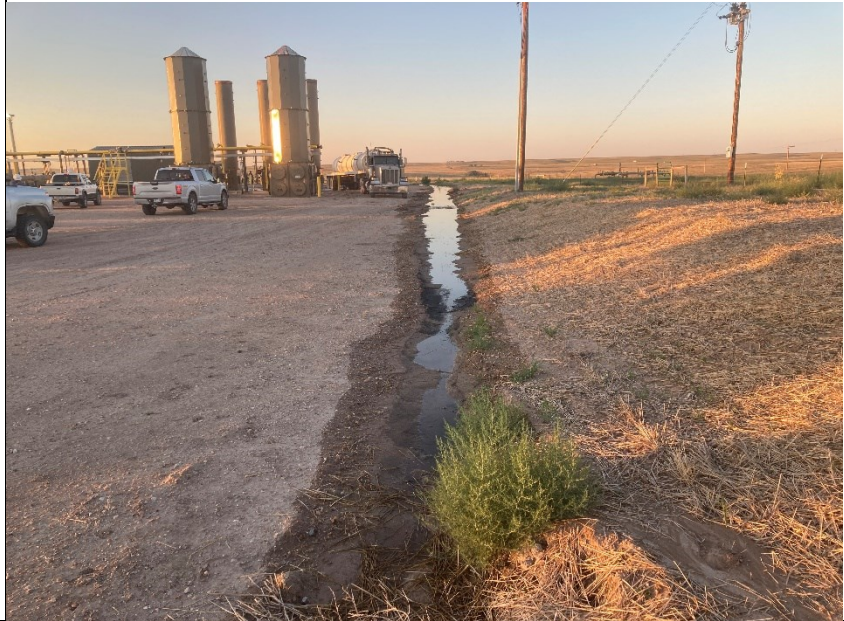
Photo: 3

Initial site conditions looking south.

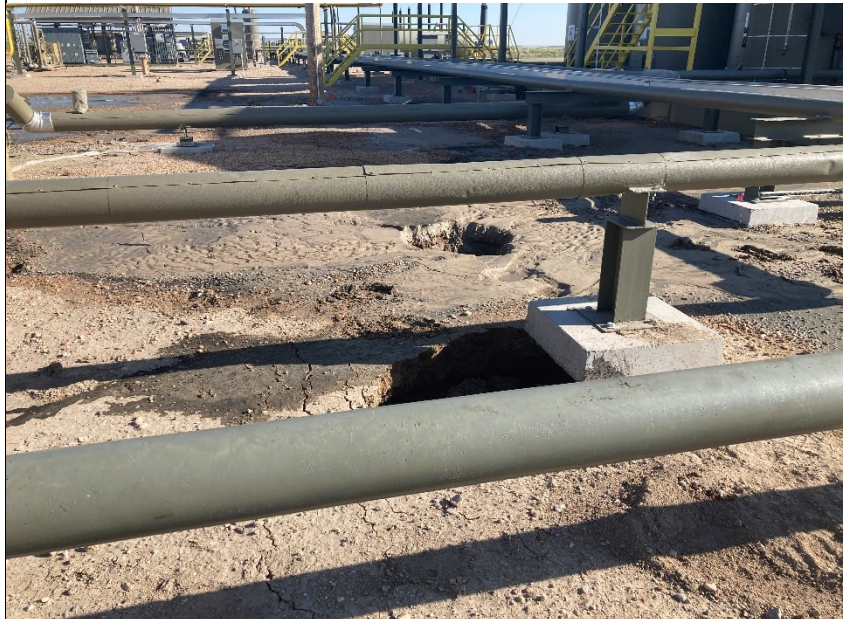
Photo: 4

Release location.

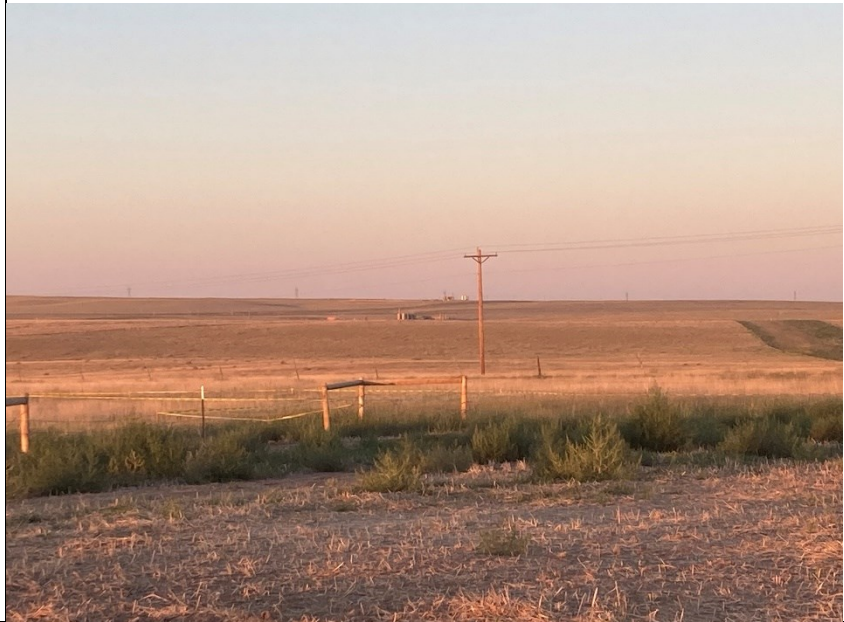
The outlined impacted area of the adjacent property to the southwest.

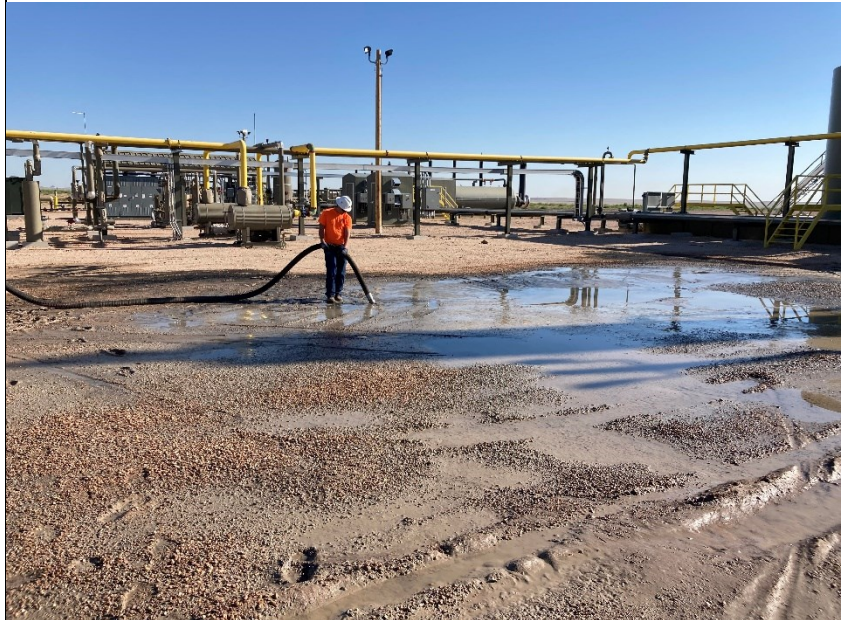
Liquid Vac Truck Operator working to remove free liquids.

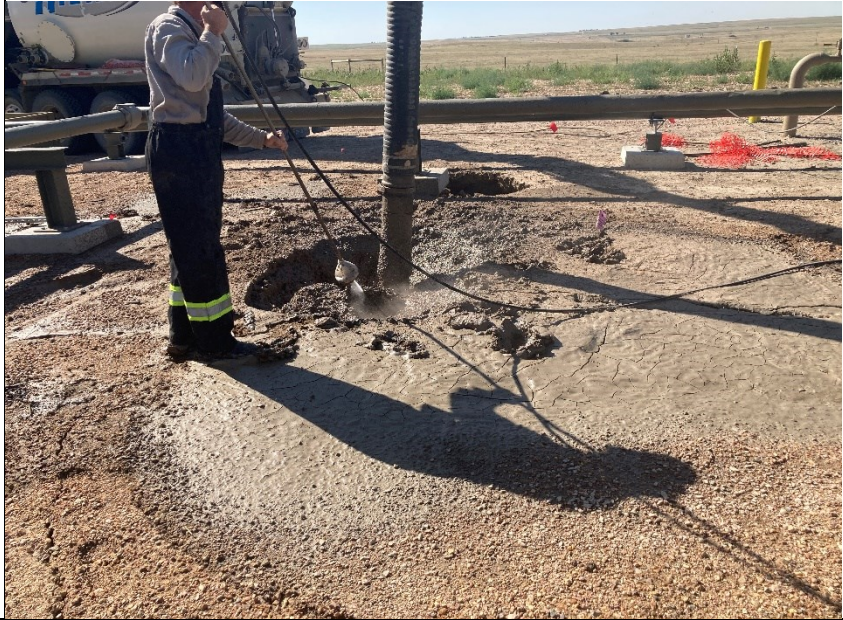
Photo: 7

Hydro excavator working in the primary excavation area to locate the pipeline failure.

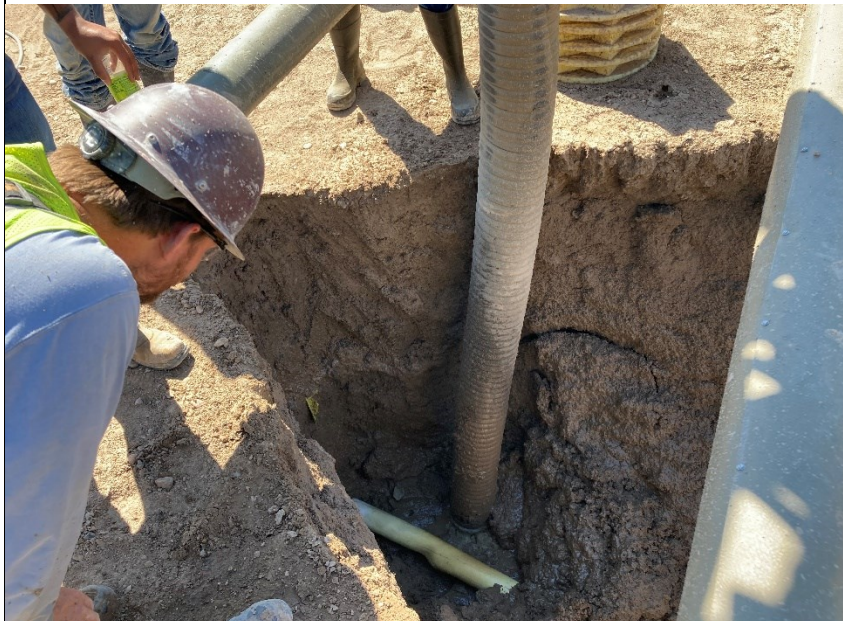
Photo: 8

Locating the failure in the pipeline.

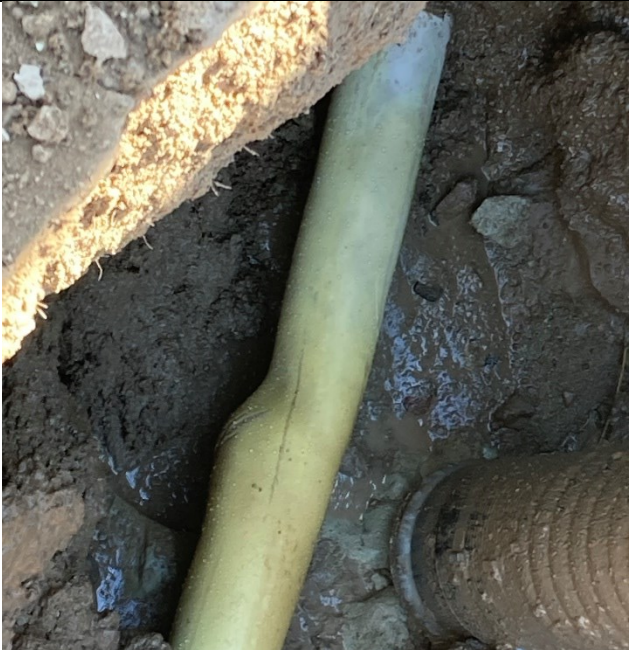
<p>Photo: 9</p> <p>Description:</p> <p>The failure in the pipeline. Deformed shawcore 4" pipe.</p>

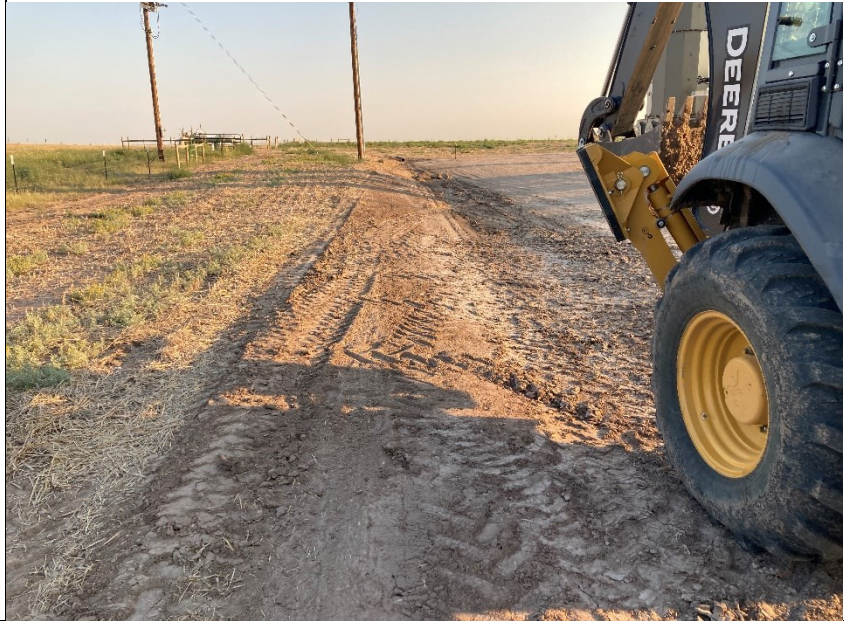
Photo: 11

Surface scrapping of impacted area to remove visible wet soil.

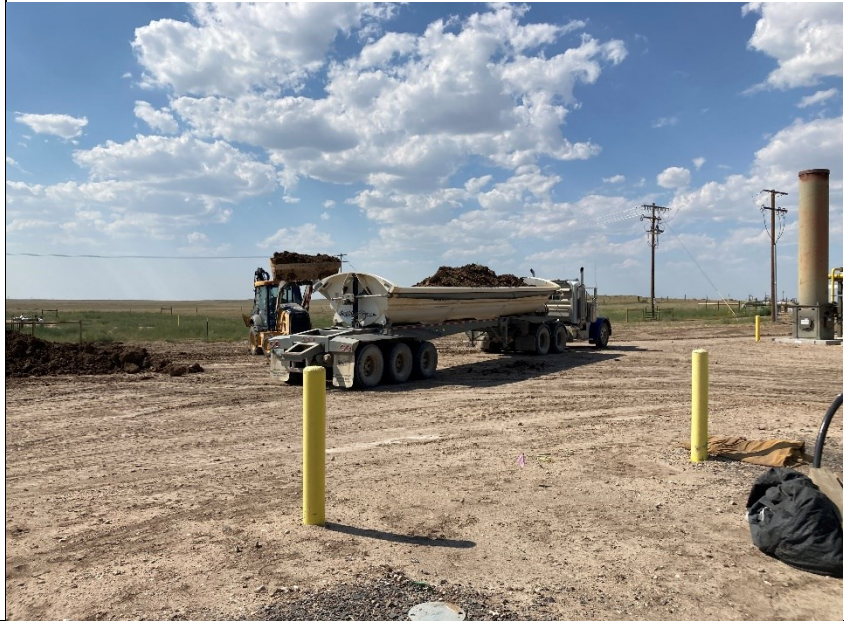
Photo: 12

Loading impacted soil for disposal.

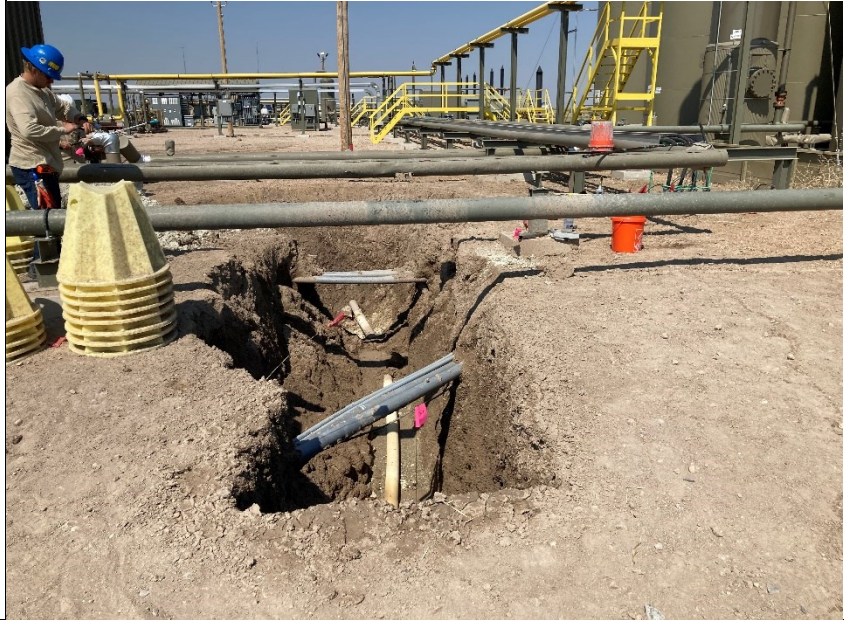
Photo: 13

Primary excavation area after exposing failed pipeline. View looking north.

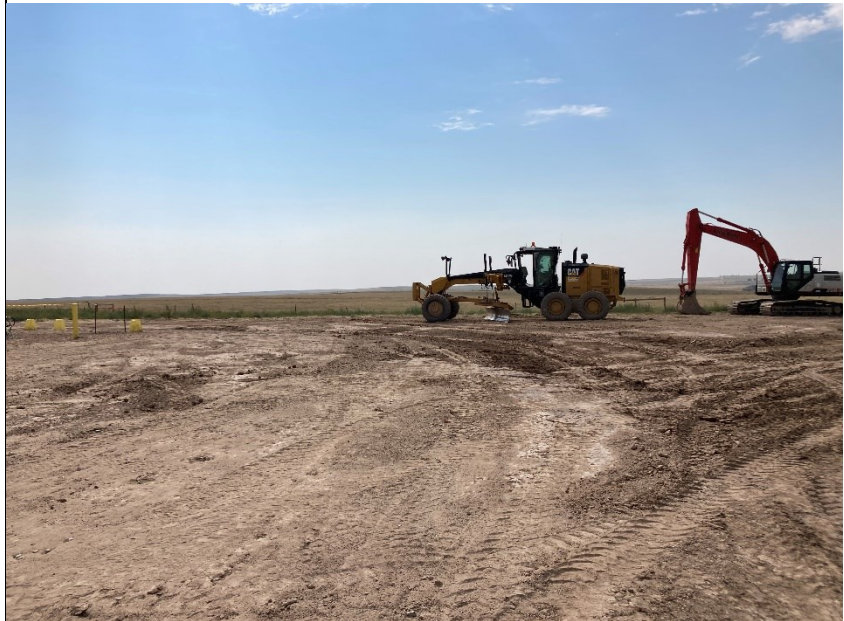
Photo: 14

Secondary excavation area after surface scrape looking west.

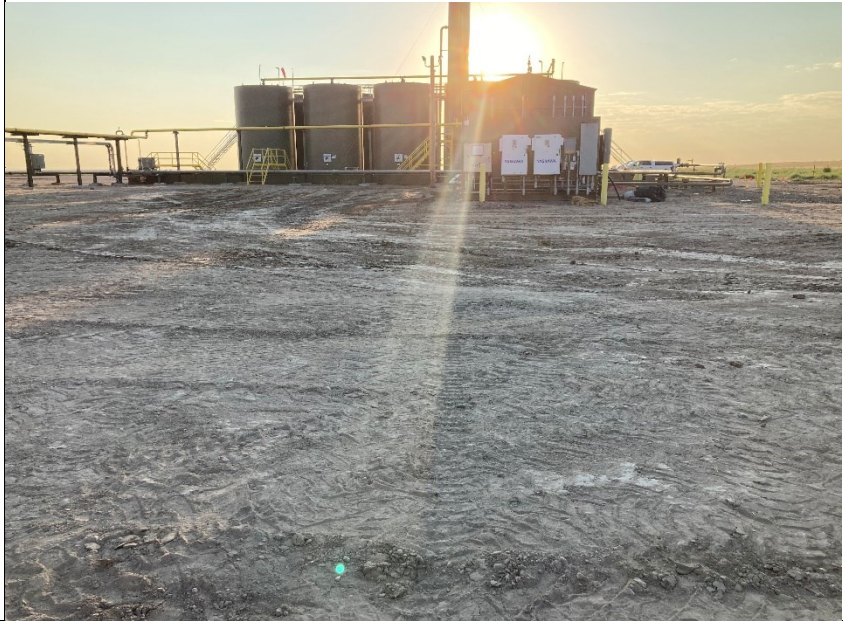
Photo: 15

Secondary excavation area
after surface scrape,
looking east.

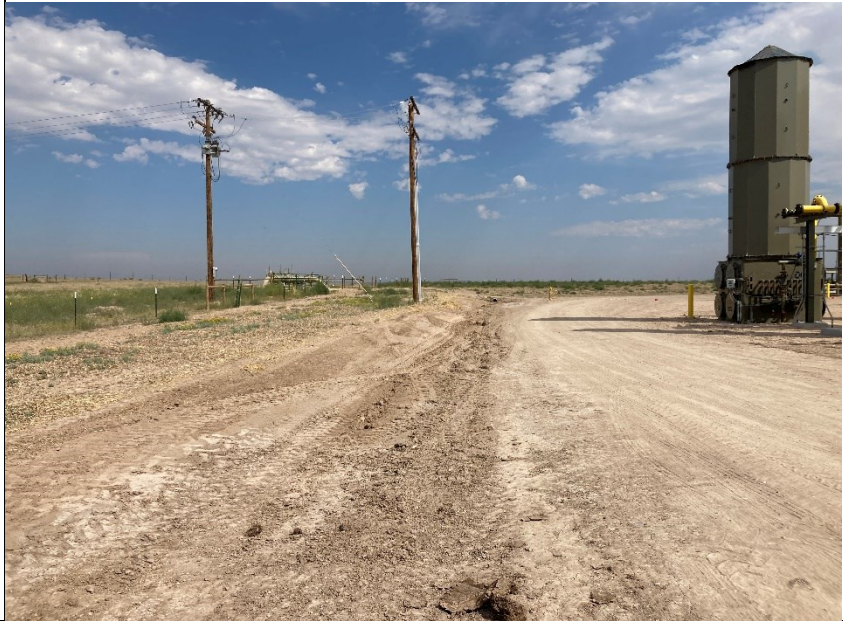
Photo: 16

Secondary excavation area
after surface scrape
looking north.

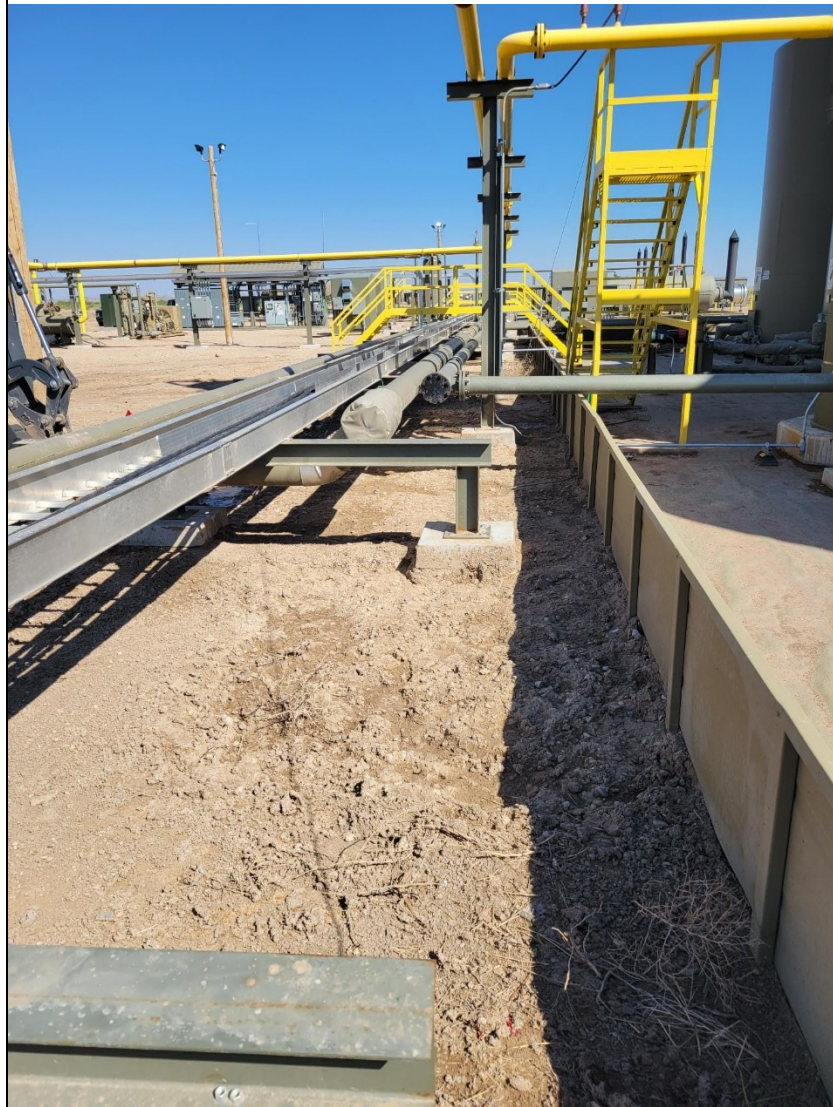
Photo: 19

Area of surface impacts to the east of the primary excavation. Hand digging and hydroexcavation performed until no observed impacts. View looking north.
