PROJECT REPORT**REPORT NUMBER:** TAP-101122-1**DATE:** November 30, 2022**CLIENT INFORMATION**Taproot Energy Partners
555 17th Street, Suite 800
Denver, CO 80202
Attn: Dale Hunt**SAMPLE DESCRIPTION**

Three (3) samples of 4" Shawcor Flexpipe (FP301W) were received from the client on 10/11/2022. These three (3) samples were reportedly removed from the "Big Mountain Viper" pipeline and consisted of a ruptured section approximately 10 feet long with the rupture at the approximate center of the sample, as well as two undamaged sections approximately 8 feet long which were removed from locations near the failure. The samples contained the following printline:

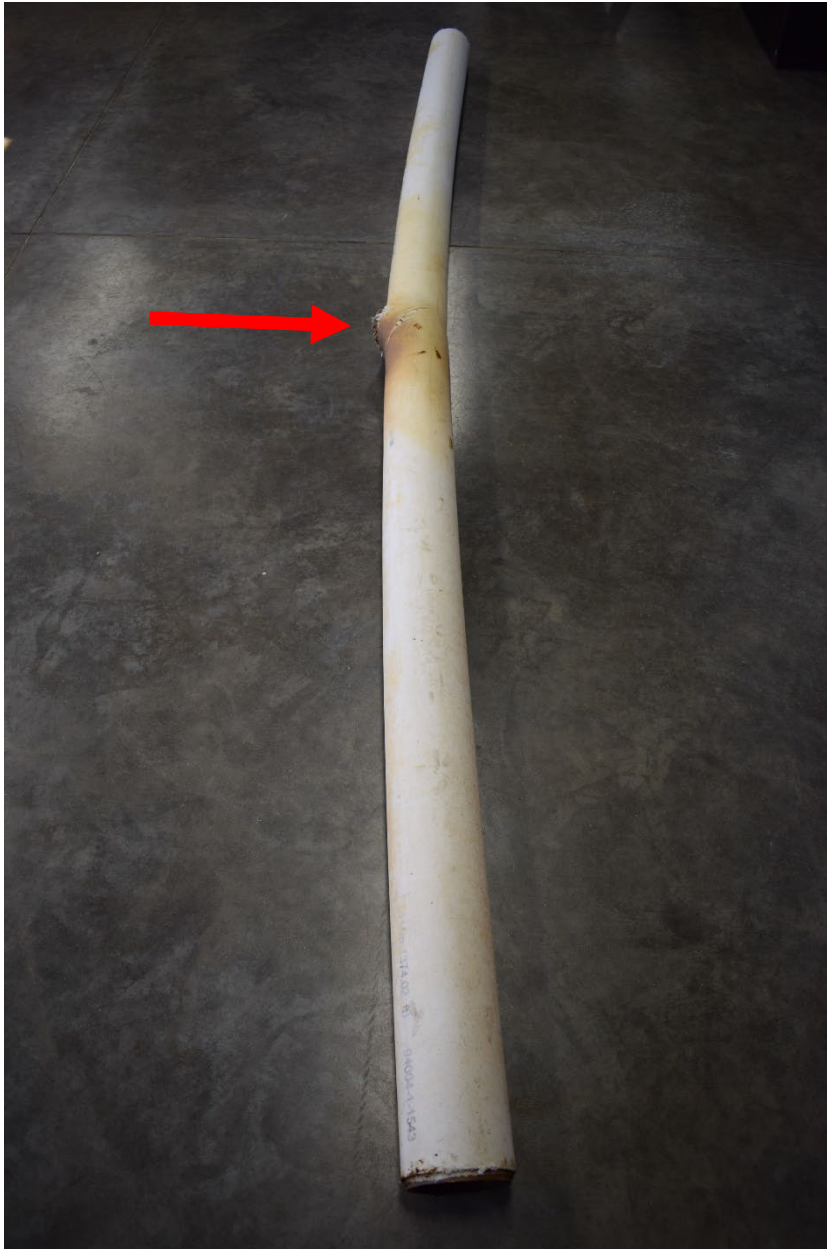
Figure 1. Ruptured sample as-received. Note failure location at approximate mid-length of the sample indicated by red arrow.

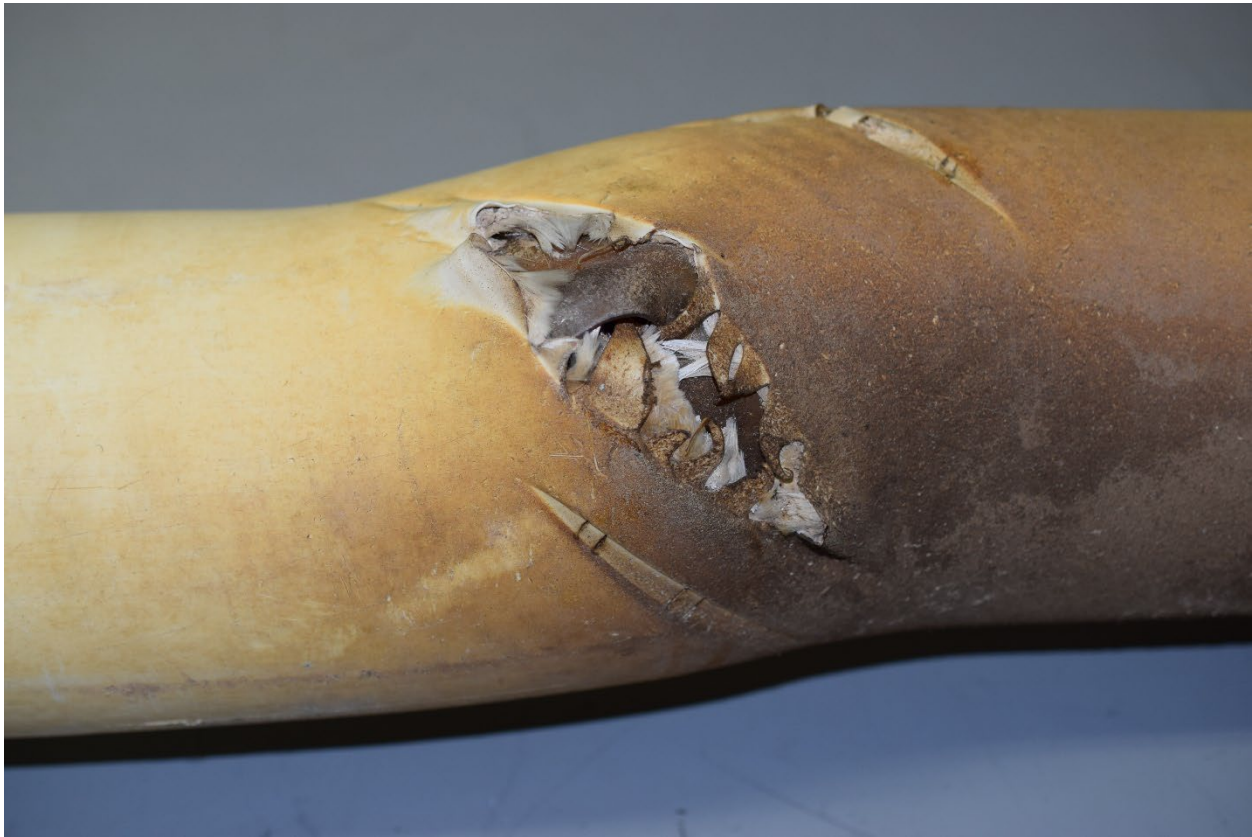
Figure 2. Close-up image of the failure location on the ruptured sample shown in Figure 1. Note pipe axis deviation centered on the failure locus.

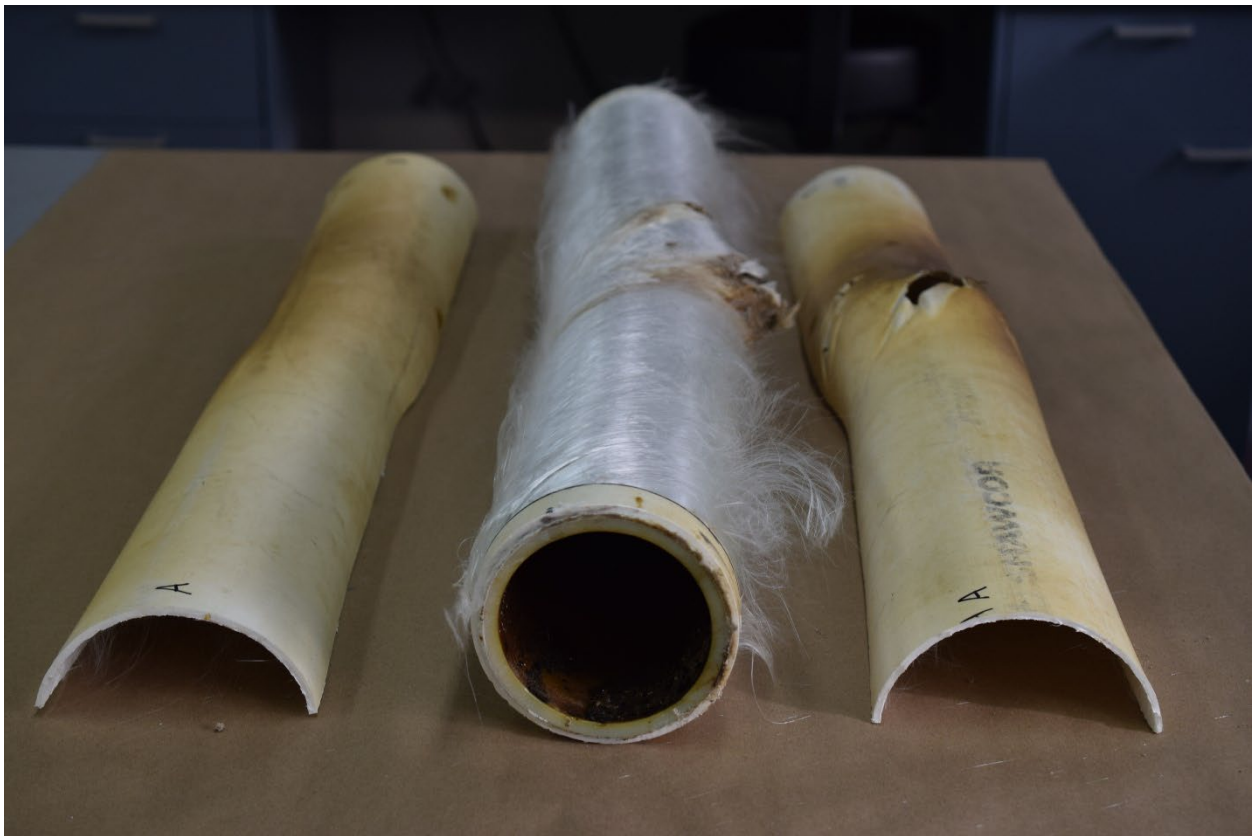
Figure 6. The rupture section following removal of the outer jacket.

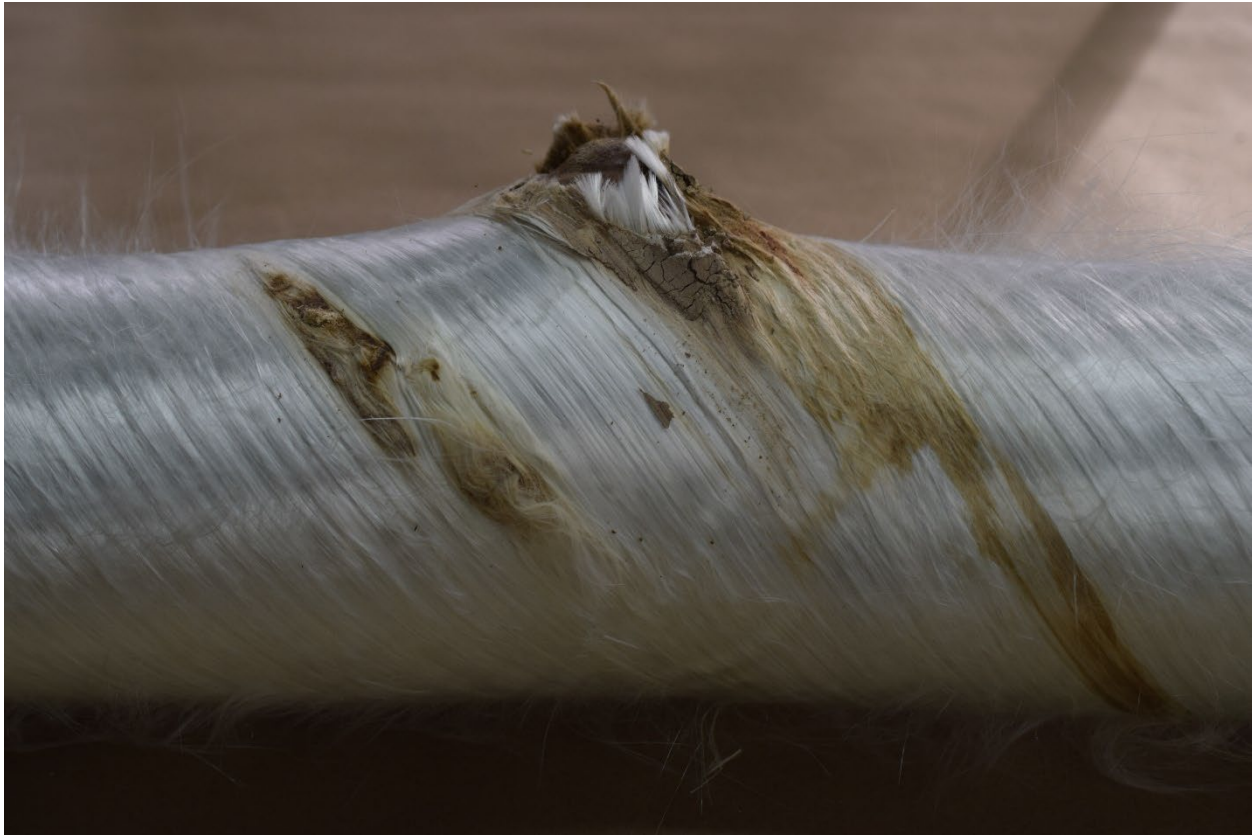
Figure 7. Close-up image of the rupture location with the outer jacket removed. Note separation of the outer fiberglass reinforcement surrounding the leakage locations.

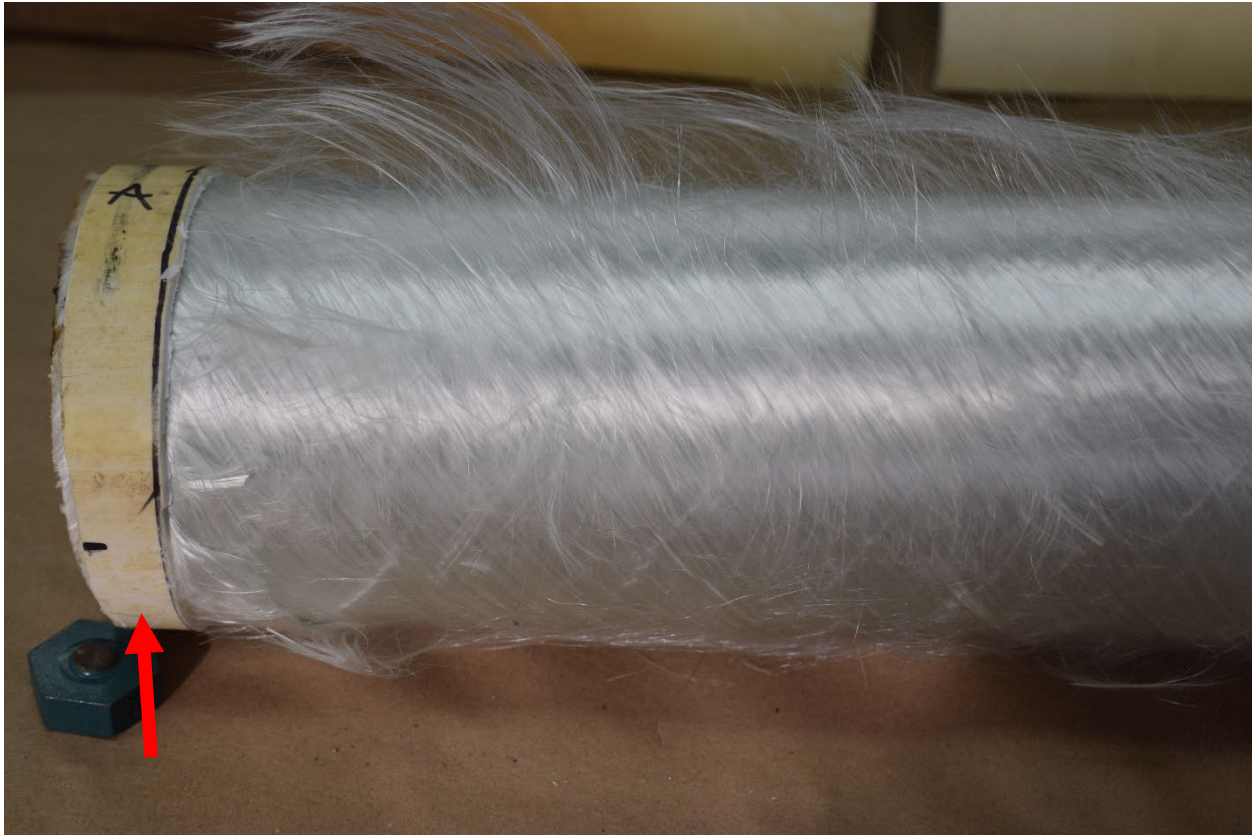
Figure 8. Fiberglass reinforcement at one end of the rupture section following removal of the outer jacket. Note uniformity of the reinforcement layer just outside of the rupture location.

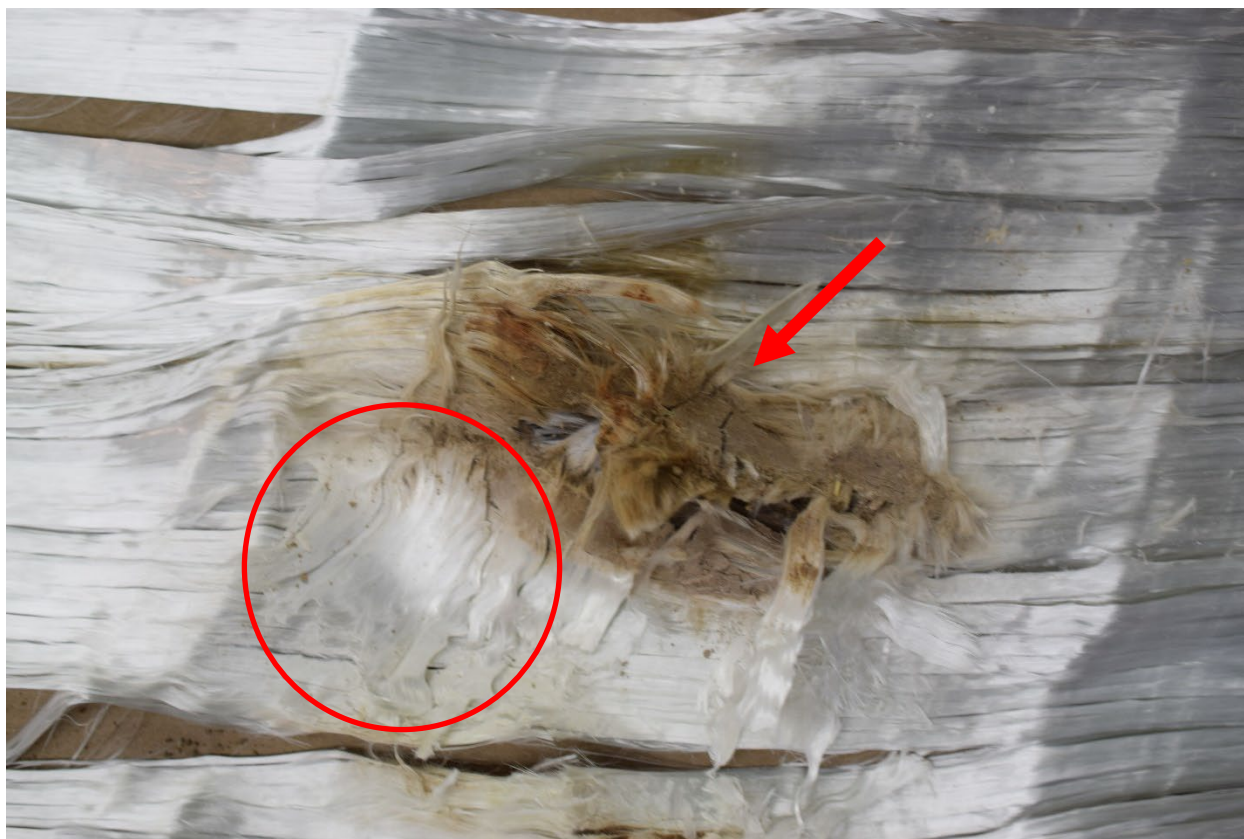
Figure 9. Inner view of the outer fiberglass reinforcement layer following removal from the liner. Note main rupture location at red arrow and broken inner fiberglass reinforcement layer pieces at red circle. Also note uniformity of fiberglass reinforcement just outside of the rupture location.

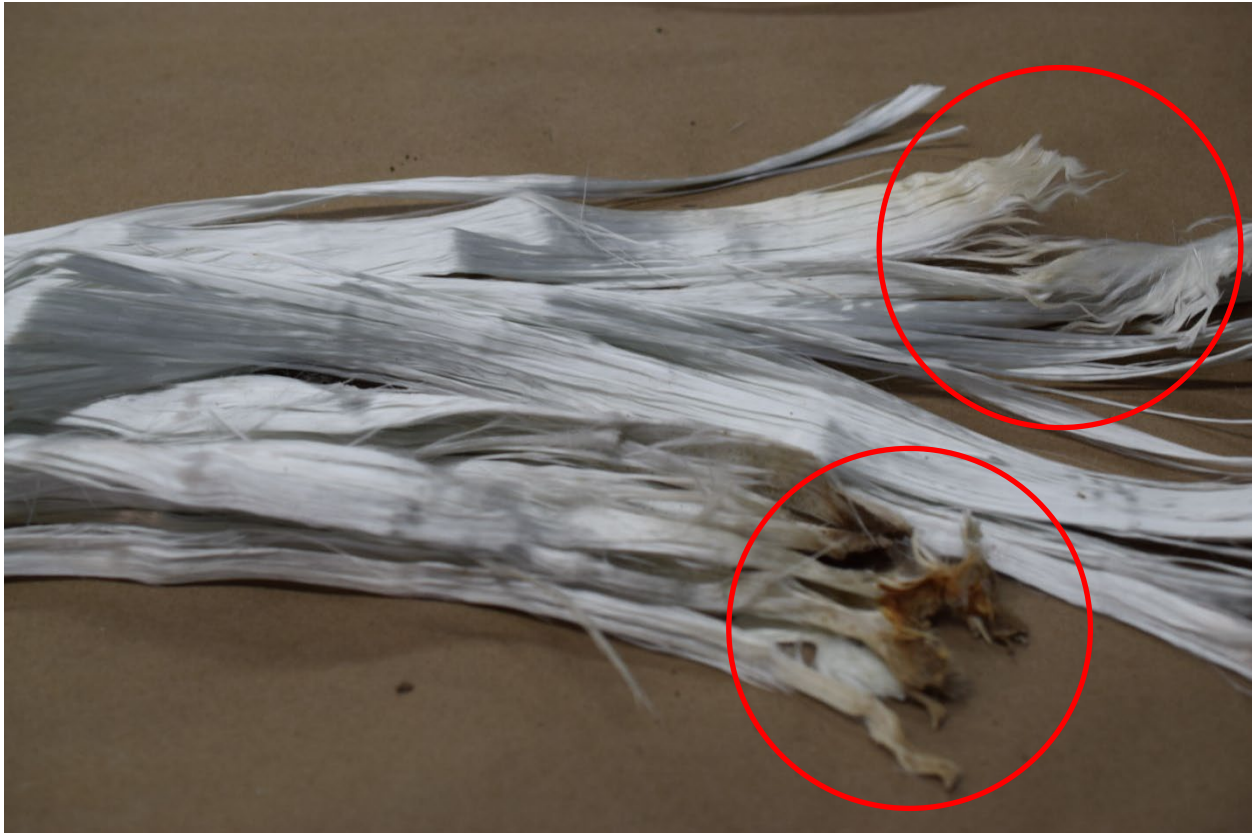
Figure 10. Inner view of the inner fiberglass reinforcement layer following removal from the liner. Note random, i.e., not straight or aligned, breaks of the fiberglass reinforcement layer at red arrows.

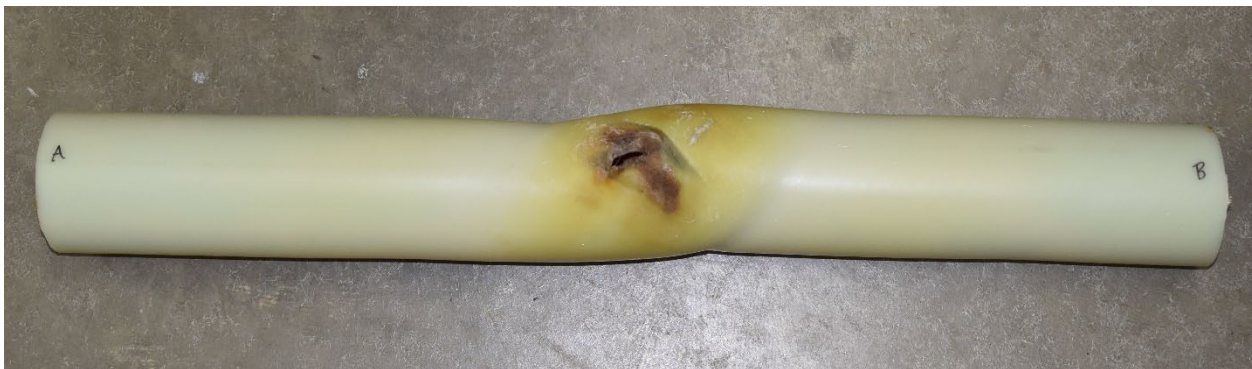
After removal of the fiberglass reinforcement layers, the HDPE liner was then exposed. The liner showed the failure mode to be torsional in nature (see Figures 11, 12, and 13).

Figure 11. HDPE liner following removal of the fiberglass reinforcement layers. Note rupture and discoloration at the center of the liner section.

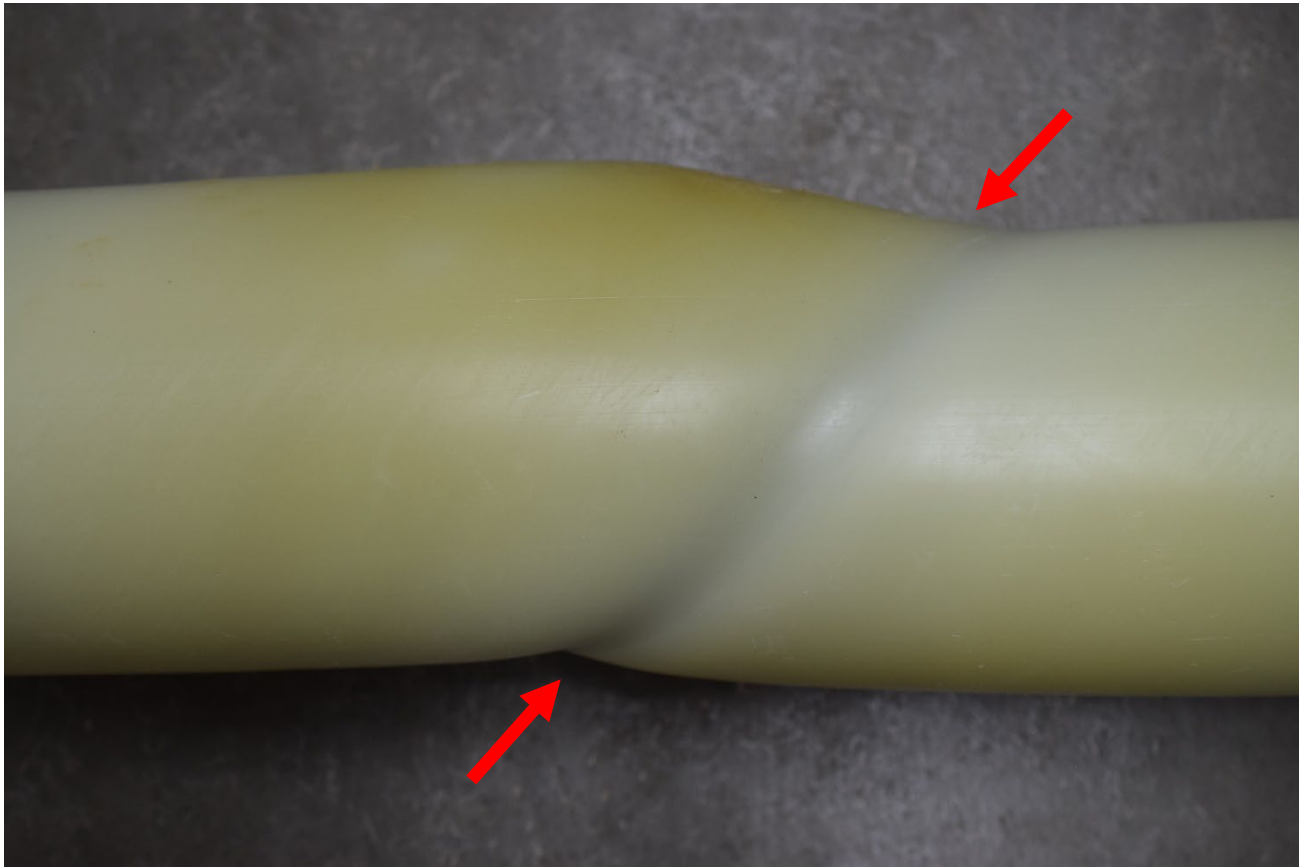
Figure 12. Close-up image of the HDPE liner opposite the rupture location. Note ductile deformation on the pipe between red arrows corresponding to torsional yield of the liner.

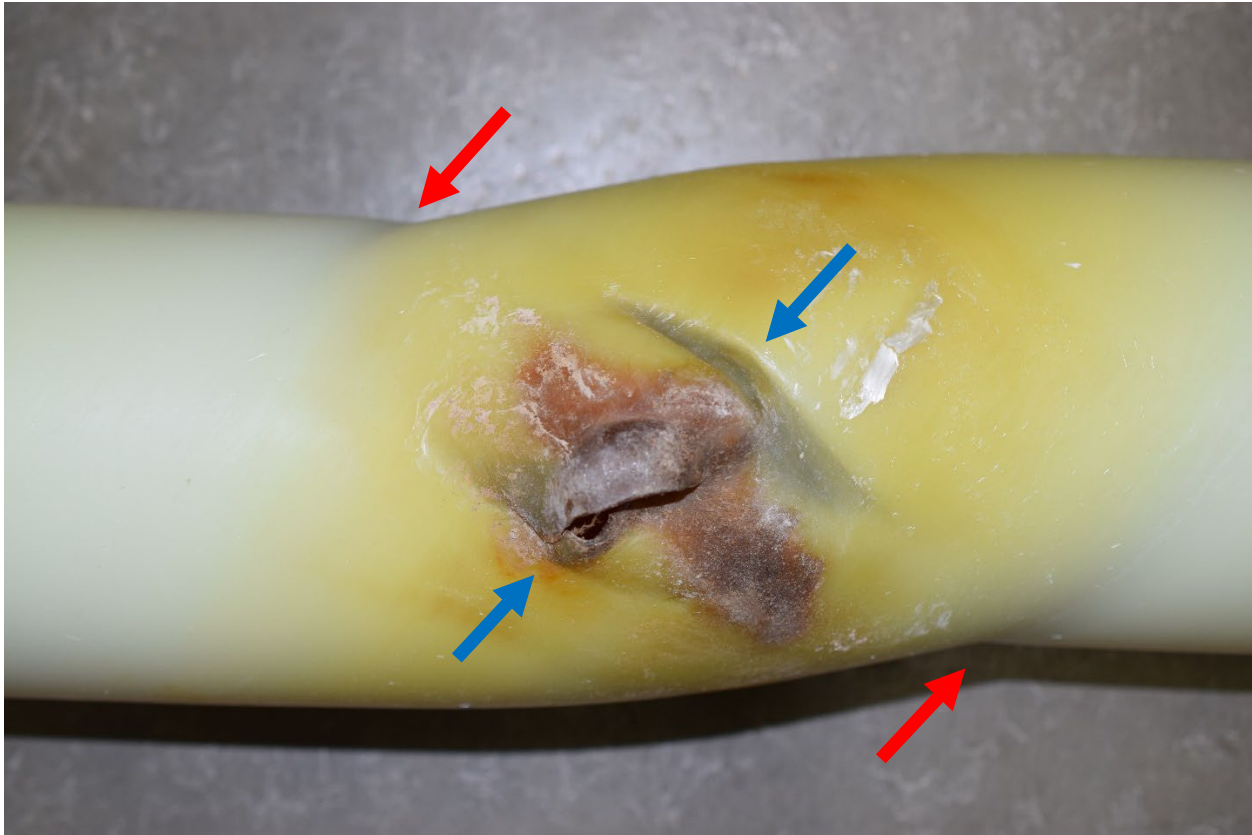
Figure 13. Close-up image of the rupture location seen in Figure 11. Note ends of the torsional yield shown in Figure 12 at red arrows. Also note edges of the ductile rupture location at blue arrows.

The failure observed on the Shawcor Flexpipe rupture sample is consistent with a torsional failure mode. More specifically, the failure very closely resembles what is referred to as “birdcaging”. In this failure mode, torsional forces cause the inner reinforcement layer to be put in tension, while the outer reinforcement layer is put in compression. This in turn reduces the contact pressure between the two layers and allows displacement of the outer reinforcement layer. This description of the failure is consistent with the observations made, i.e., the inner fiberglass reinforcement layer was in the same direction as the applied torque and would be expected to be put in tension. Similarly, the outer fiberglass layer was in the opposite direction of the applied torque and expected to be put in compression; the 90 degree crossed helixes shown in Figure 13 are the expected result of these stress orientations.

Displacement of the outer reinforcement layer then left areas of pipe with reduced reinforcement capacity, allowing creep and subsequent ductile rupture of the liner as seen in Figure 13. “Unwinding” of the outer reinforcement layer effectively reduced the reinforcement by half at the failure locus. Note that during this process, i.e., elimination of half of the outer reinforcement and increase of stress on the inner reinforcement, the inner reinforcement layer would experience significantly greater tensile stresses, resulting in the breaks of the fibers seen in Figure 10. Additionally, the edges of the ductile rupture location indicated by the blue arrows in Figure 13 are running along the same direction as the outer fiberglass reinforcement layer. This provides further evidence of displacement of the outer fiberglass reinforcement layer, i.e., the failure location was well reinforced just outside of the ductile rupture location. A schematic of the “birdcaging” failure mode can be seen below in Figure 14.

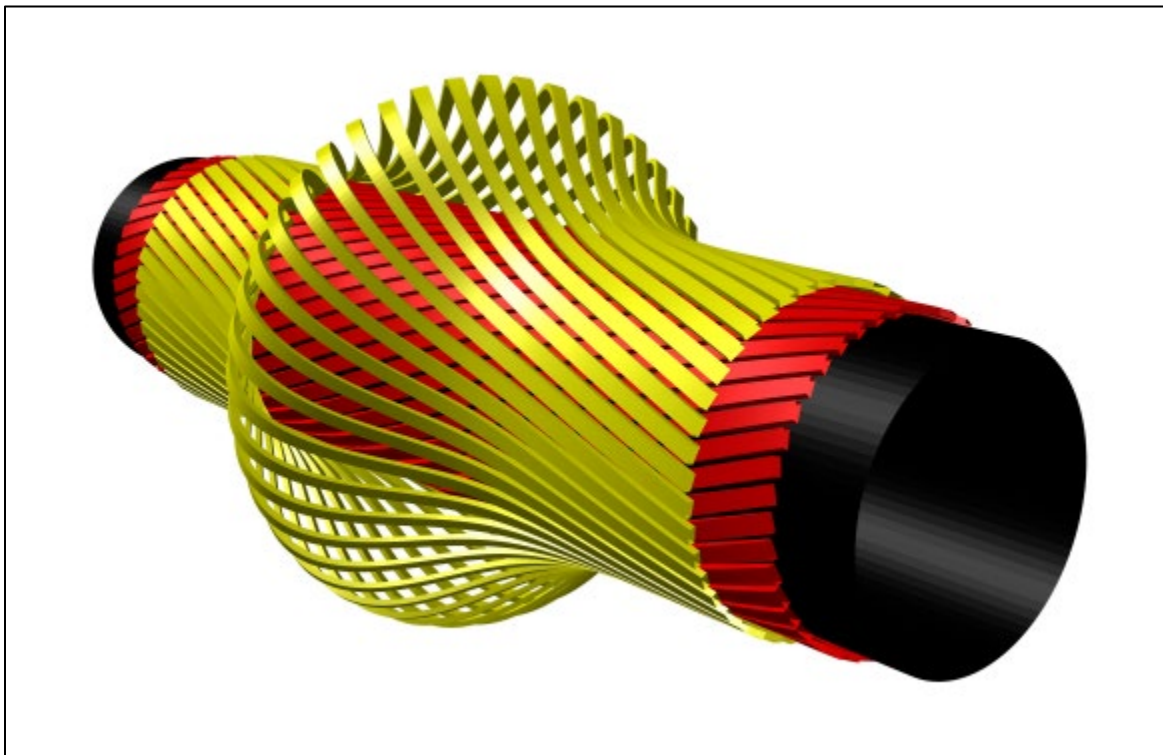
Figure 14. Schematic demonstrating the effects of “birdcaging” due to torsional forces on the flexible pipe. Note that this graphic is exaggerated due to the fiberglass reinforcement layer being bound by the outer jacket.
