Inspection Photos

API: 043-06122

Operator: JAVERNICK OIL

Inspection Date: 12/1/2022

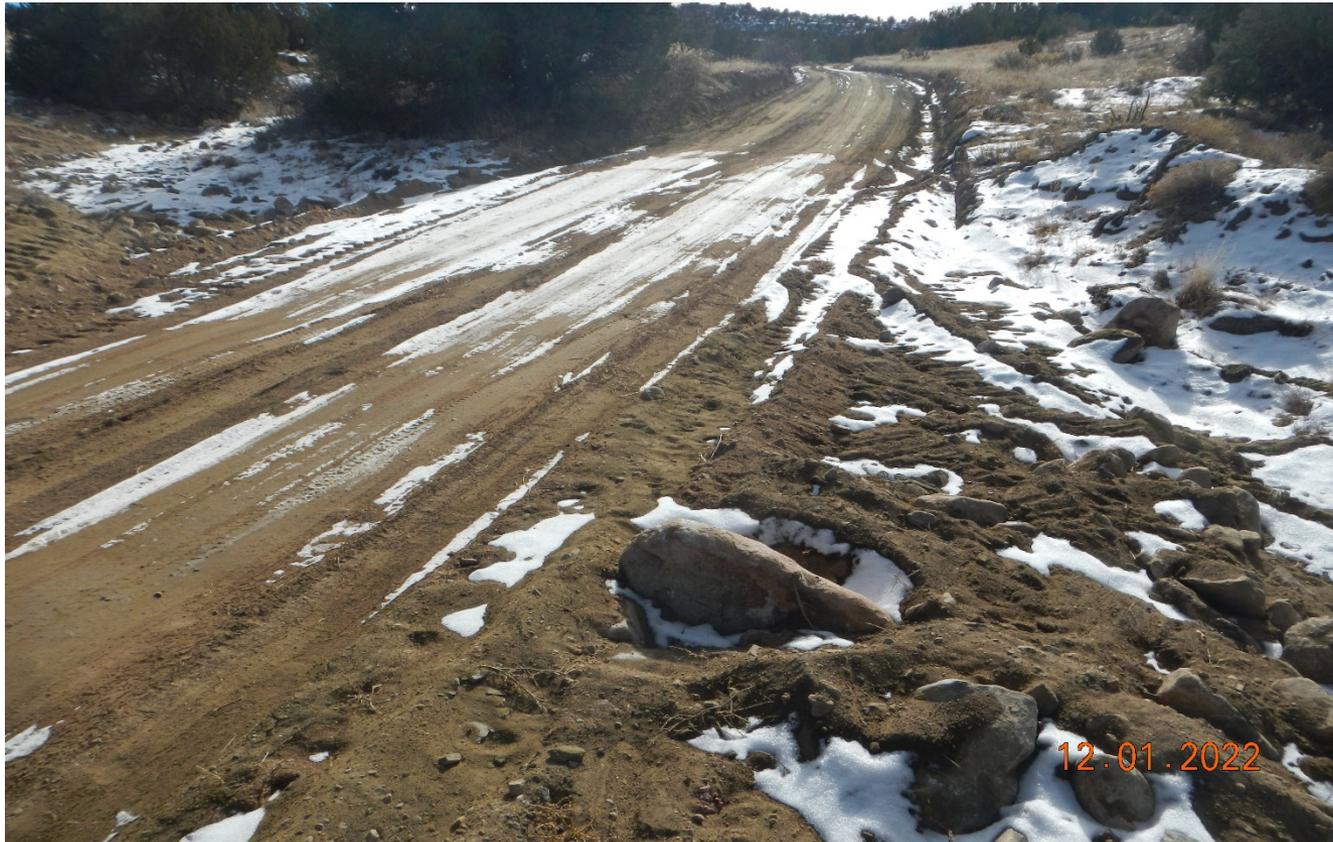
Photo 1. Facing southeast long the access road. This drainage crossing must have BMP's installed to accommodate seasonal storm event to prevent material from washing out. BMP may include culvert, rip/rap, ect.

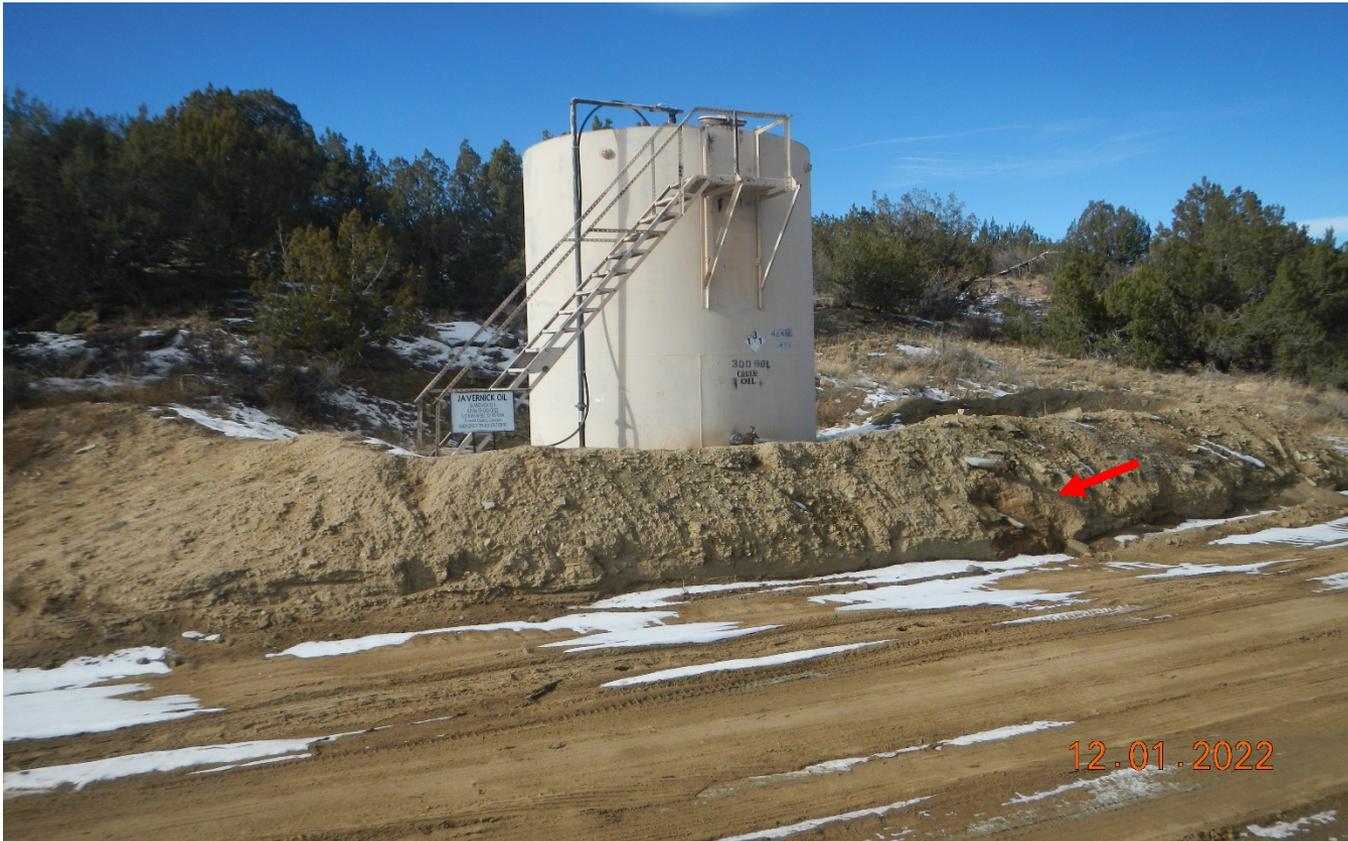
Photo 2. Facing toward the tank battery. There is still stained soils at the berm.

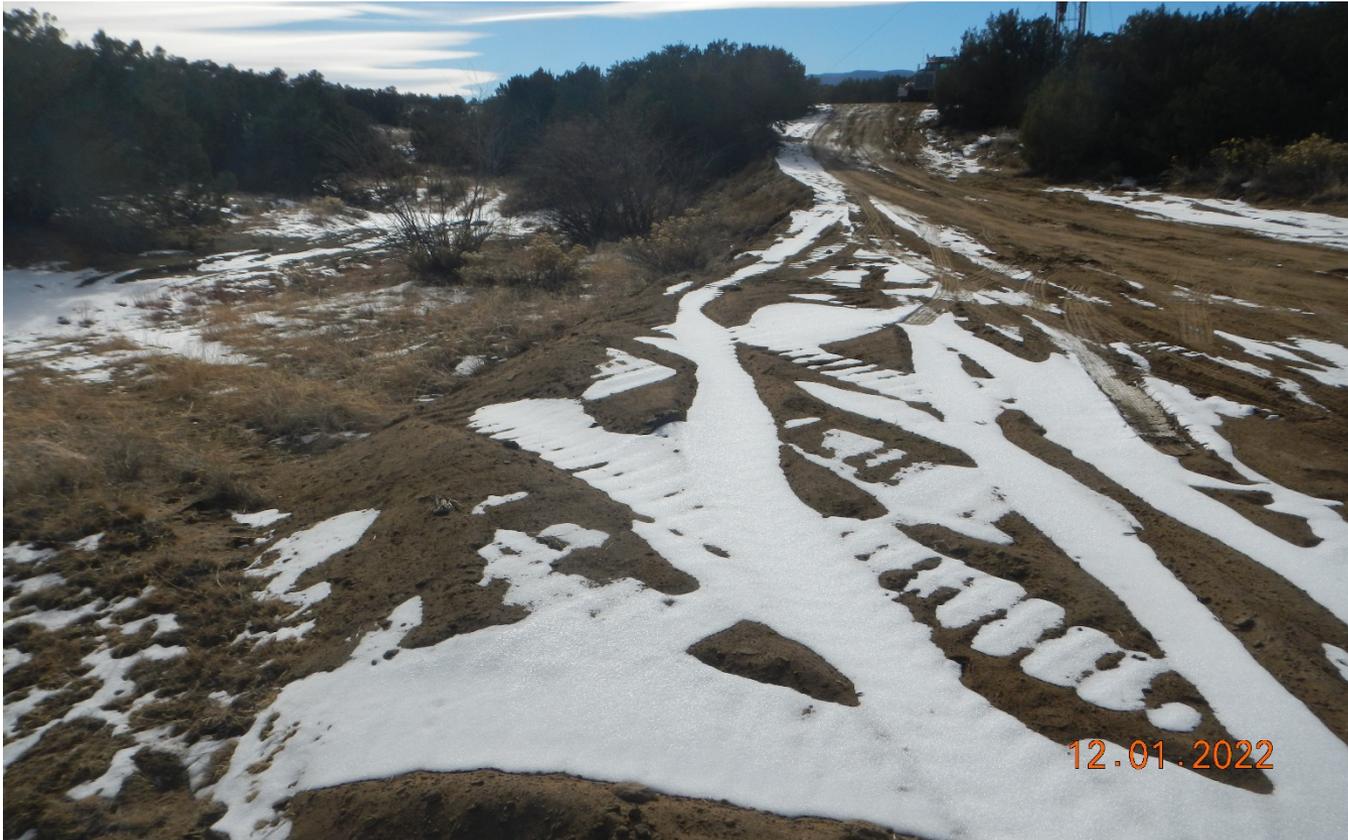
Photo 3. Facing southeast along the access road. The soils have been pushed out and disturbed and are susceptible to erosion.

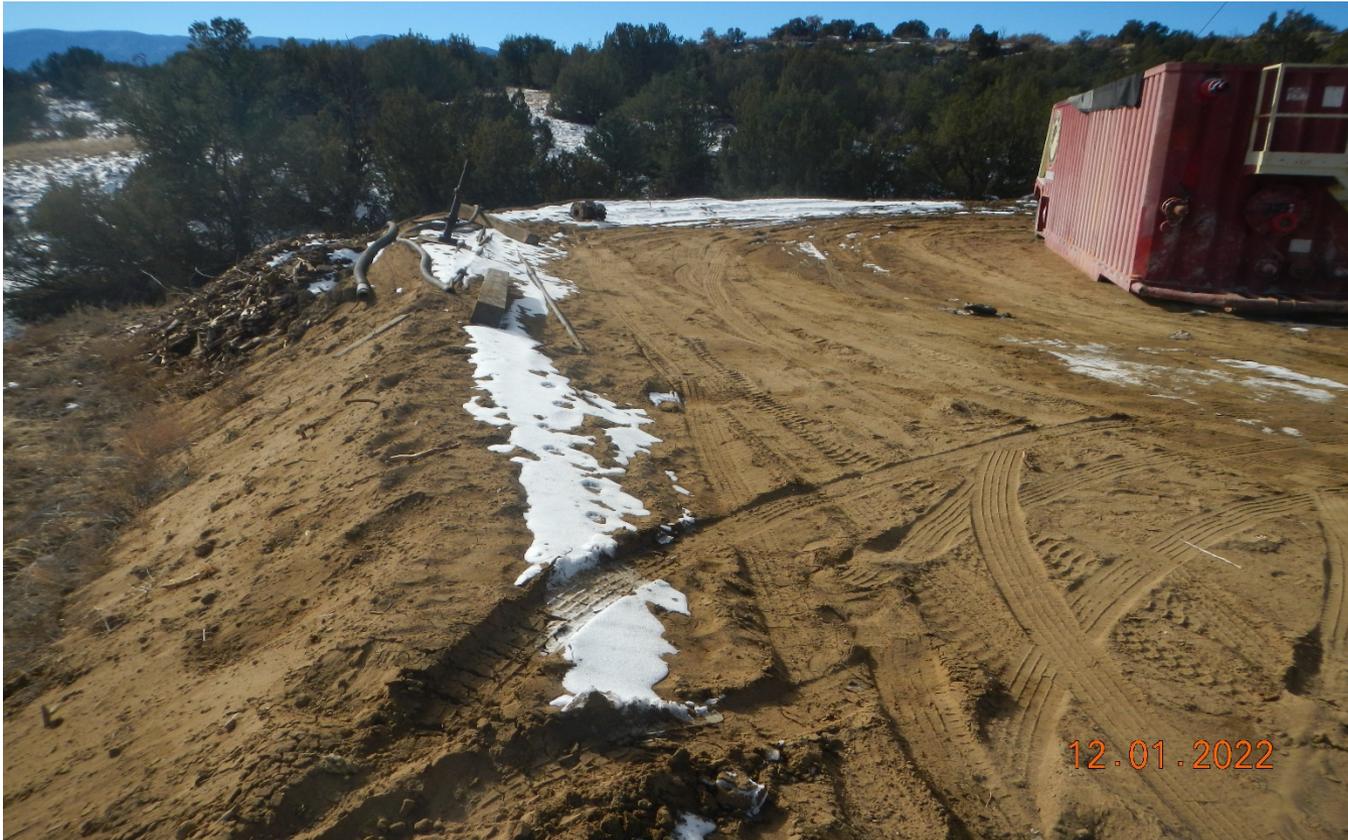
Photo 4. Facing southeast along the fill slope of the pad. The soils have been pushed out and disturbed and are susceptible to erosion. Disturbed soils need to be stabilized.

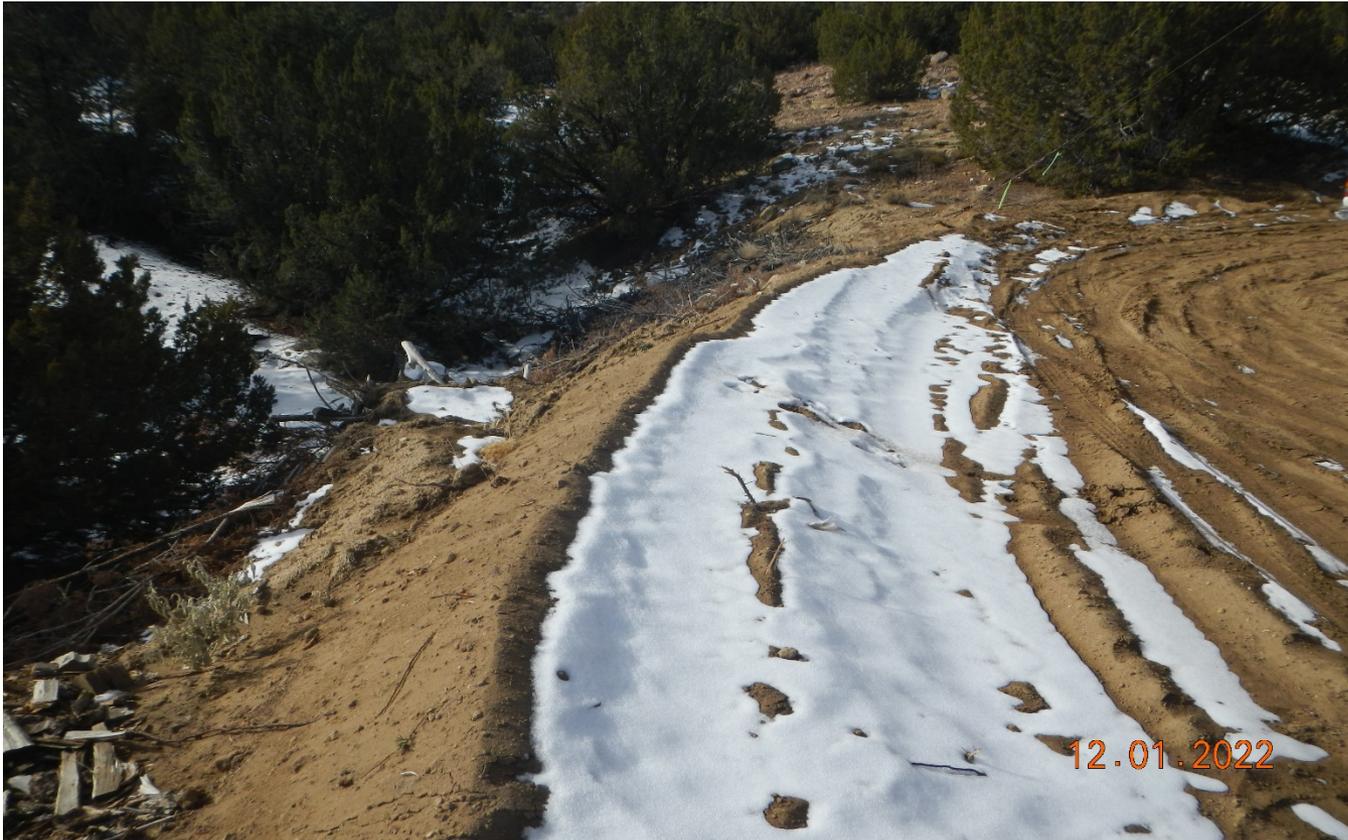
Photo 5. The soils have been pushed out and disturbed and are susceptible to erosion. Disturbed soils need to be stabilized.
