Environmental Inspection

November 22, 2022

Operator: WESTERN OPERATING CO - #95620

PIT FACILITY IDs: 256304 and 100310; Propst 1A

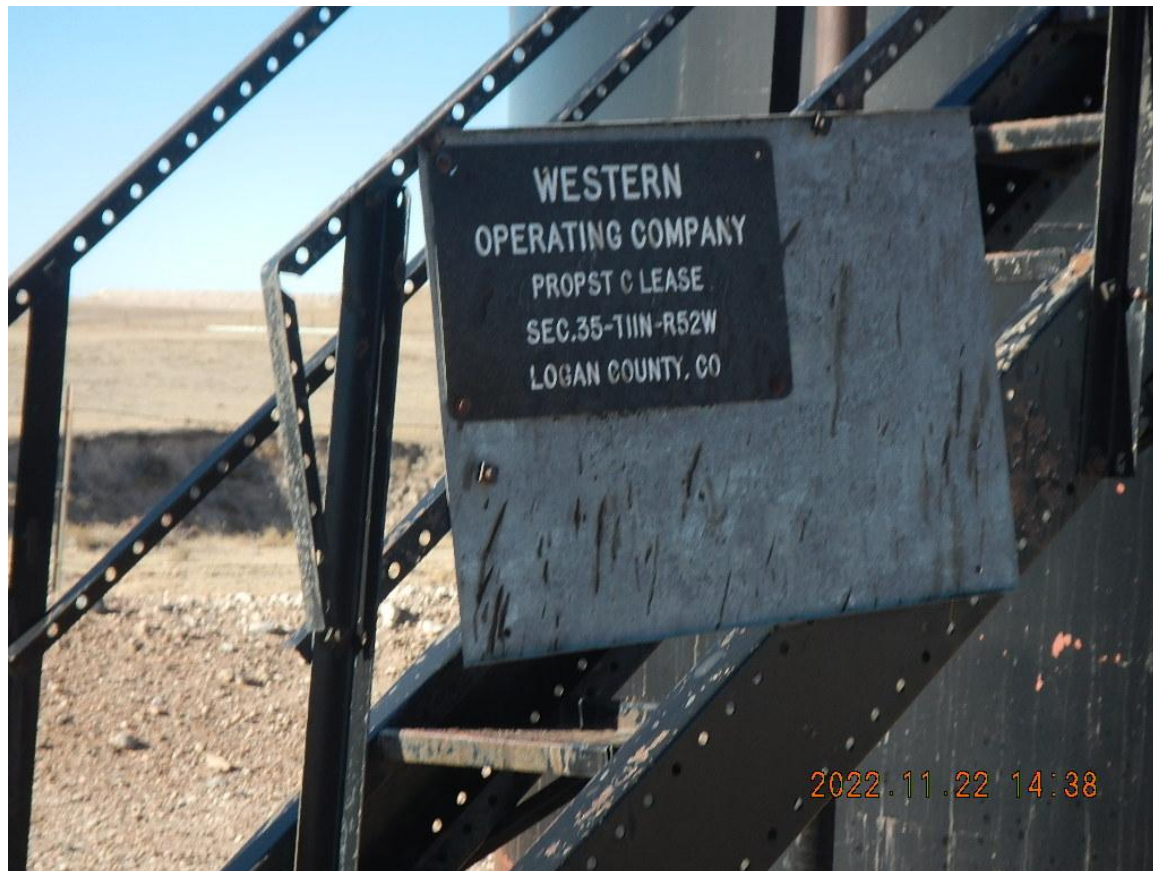
Photo 1. Sign at tank battery.

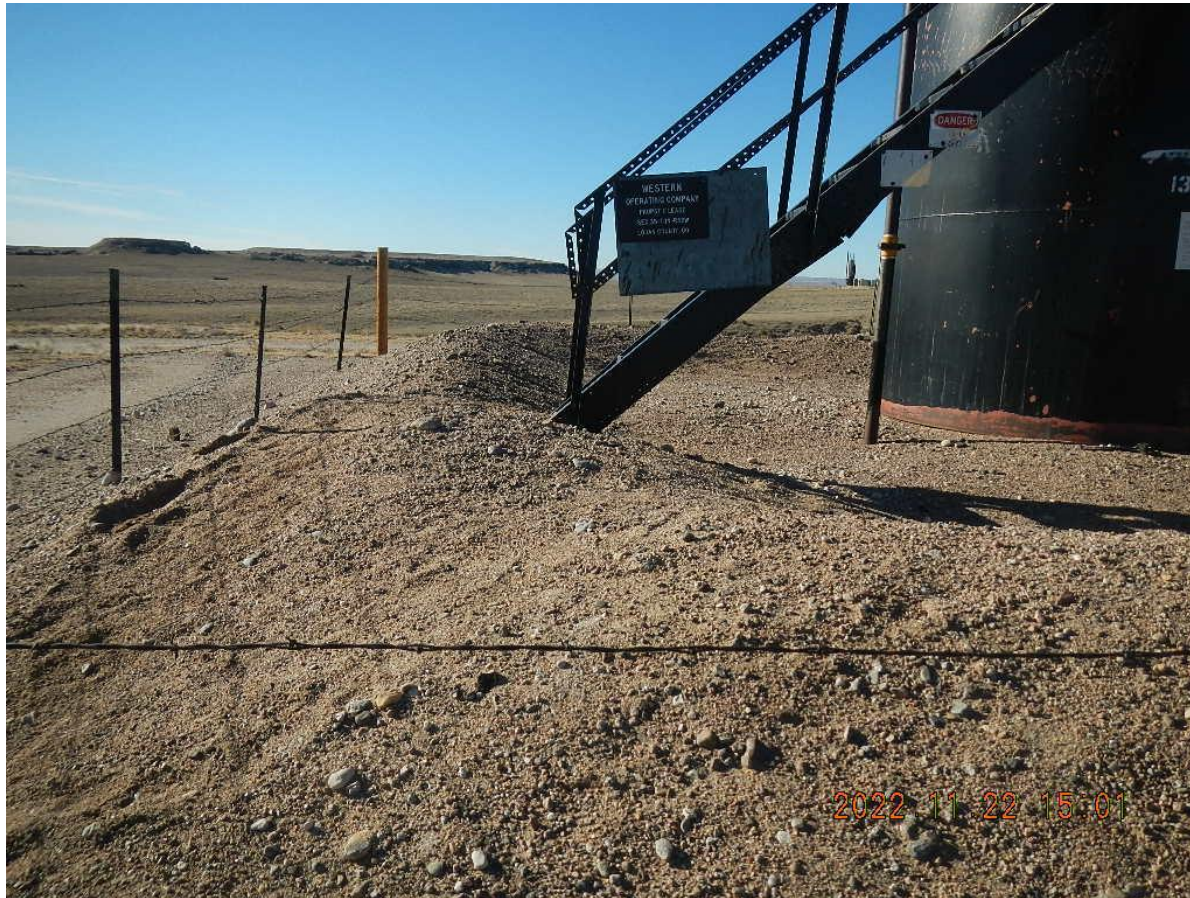
Photo 2. Berms do not appear to be adequate to contain volume of tank.

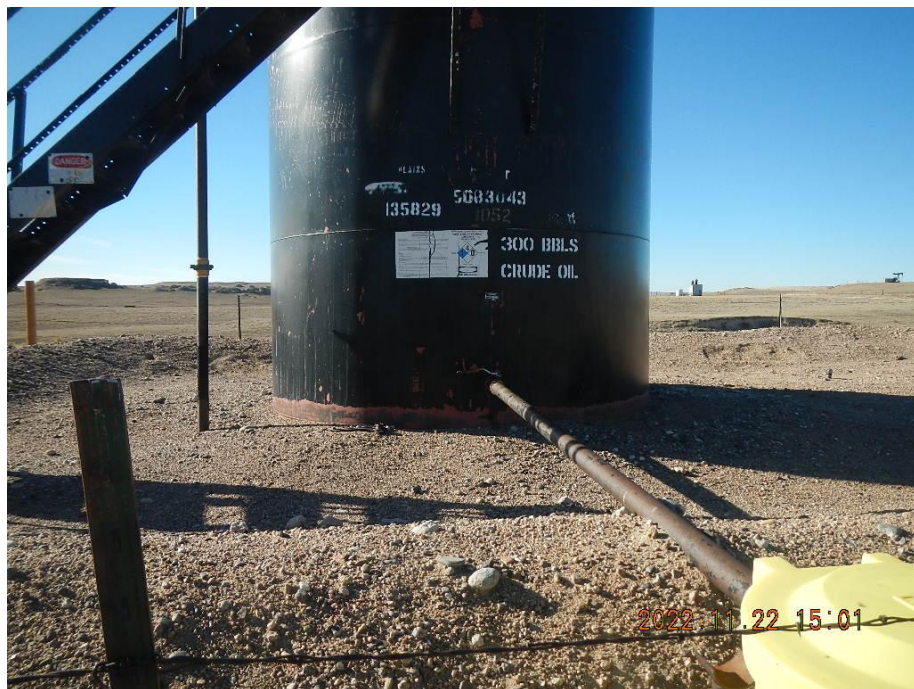
Photo 3. Placard labeling getting faded. Note: Emergency Contact # illegible from a distance.

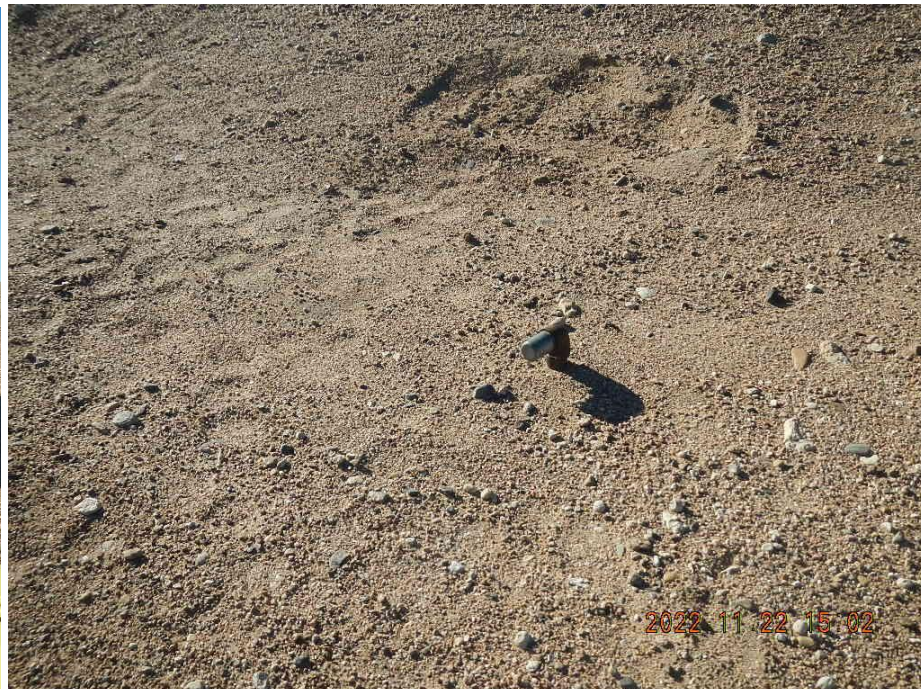
Photo 4. Unmarked flowline riser.

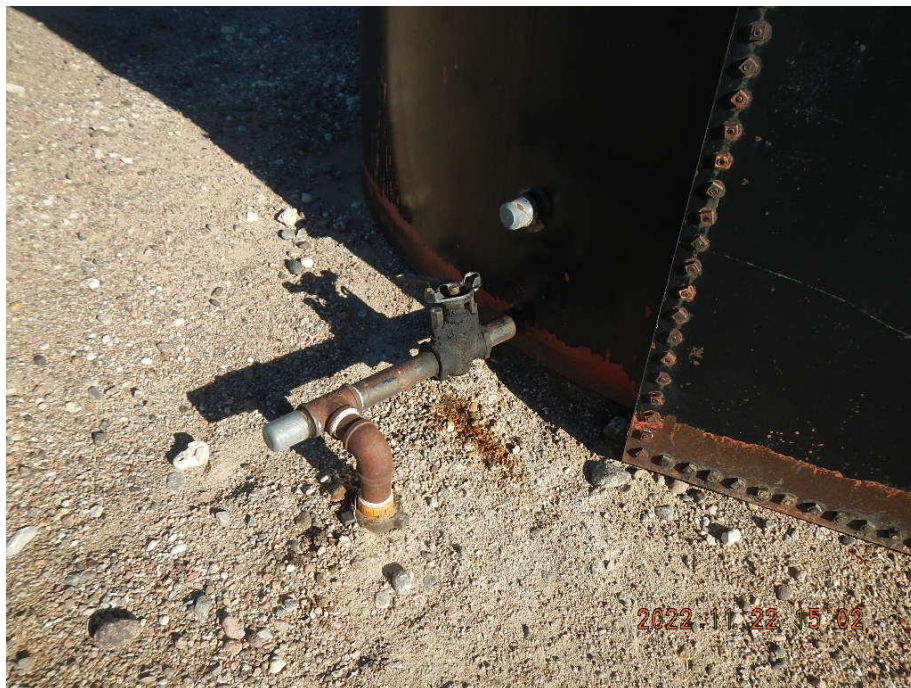
Photo 5. Oil weeping from valve.

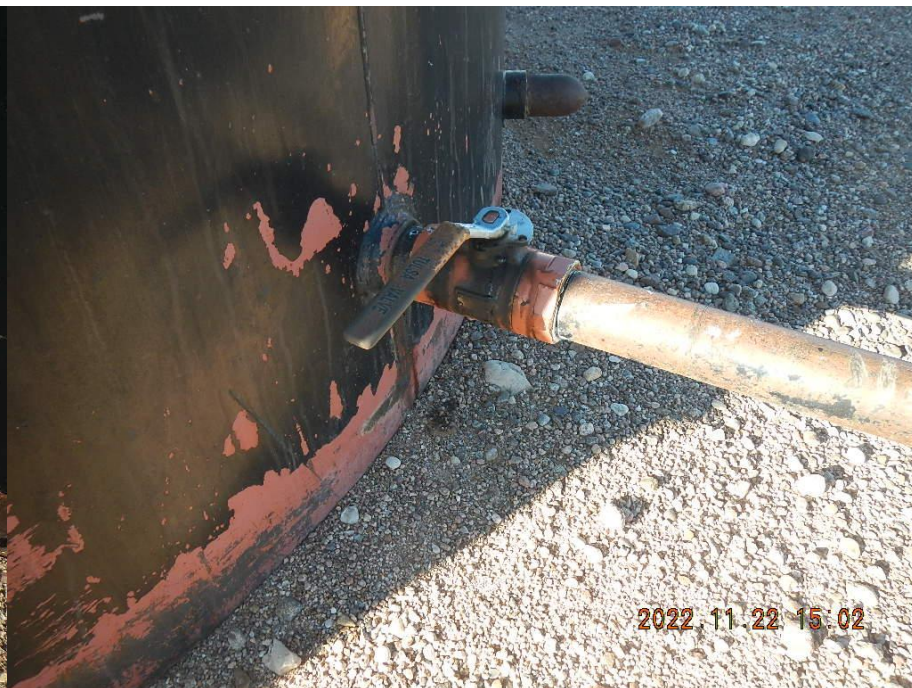
Photo 6. Oil weeping from valve and fittings.

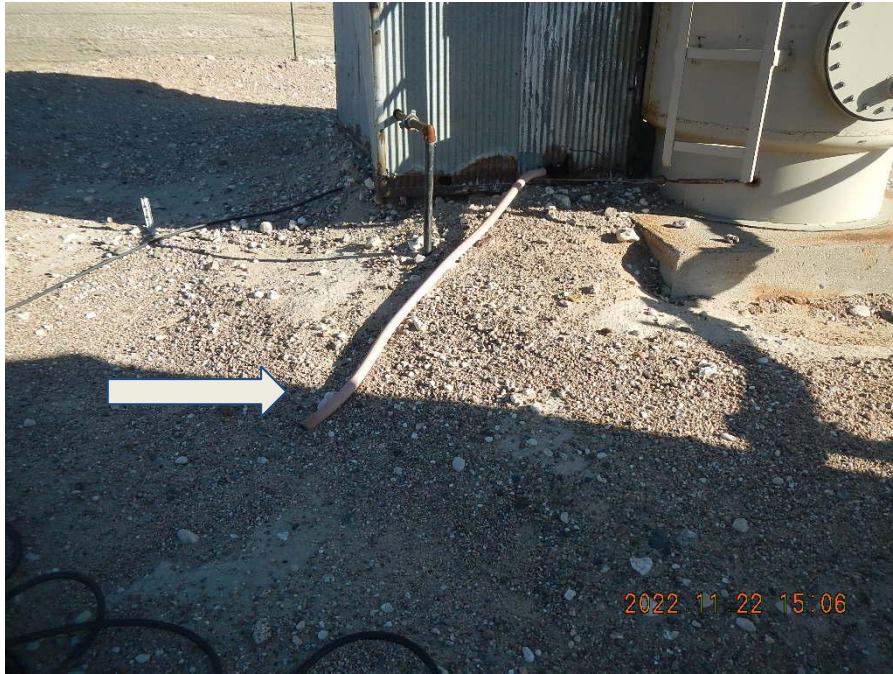
Photo 7. Discharge line to ground surface. Any discharge to the ground surface is considered a Spill. Discharge should be to secondary containment,

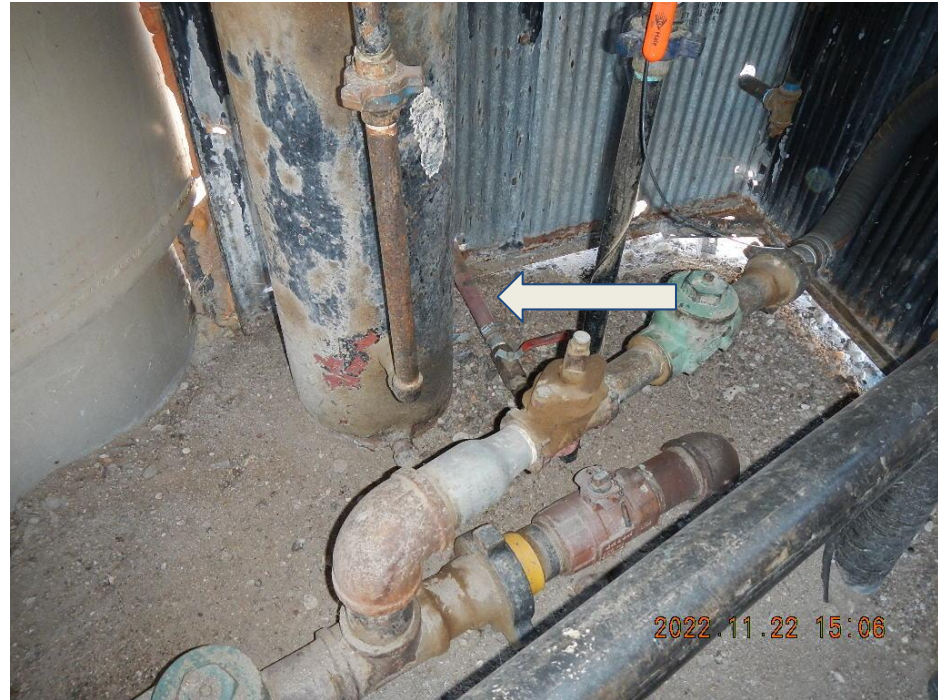
Photo 8. Discharge line from previous photo.

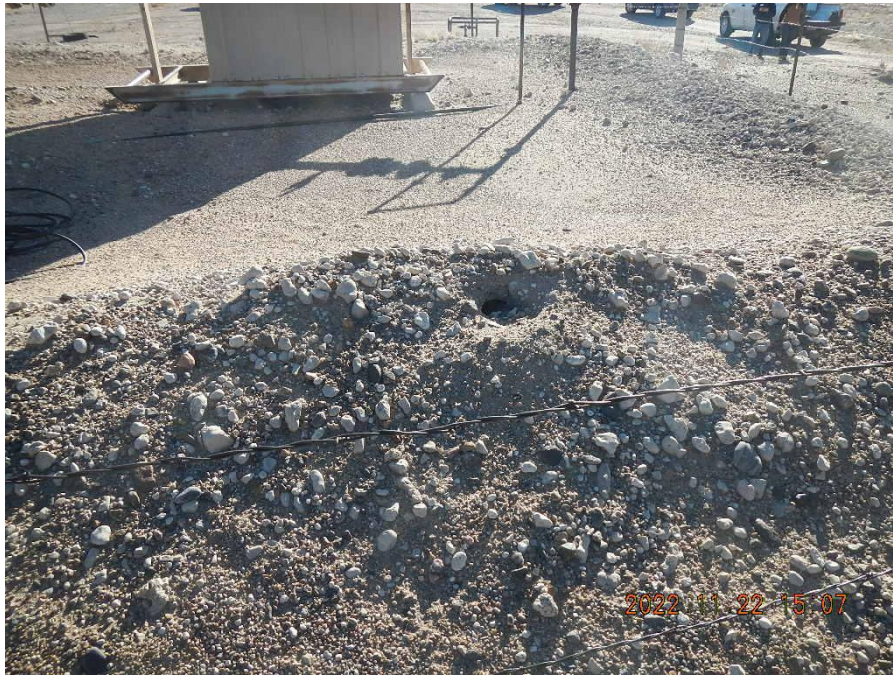
Photo 9. Burrows compromising secondary containment berm.

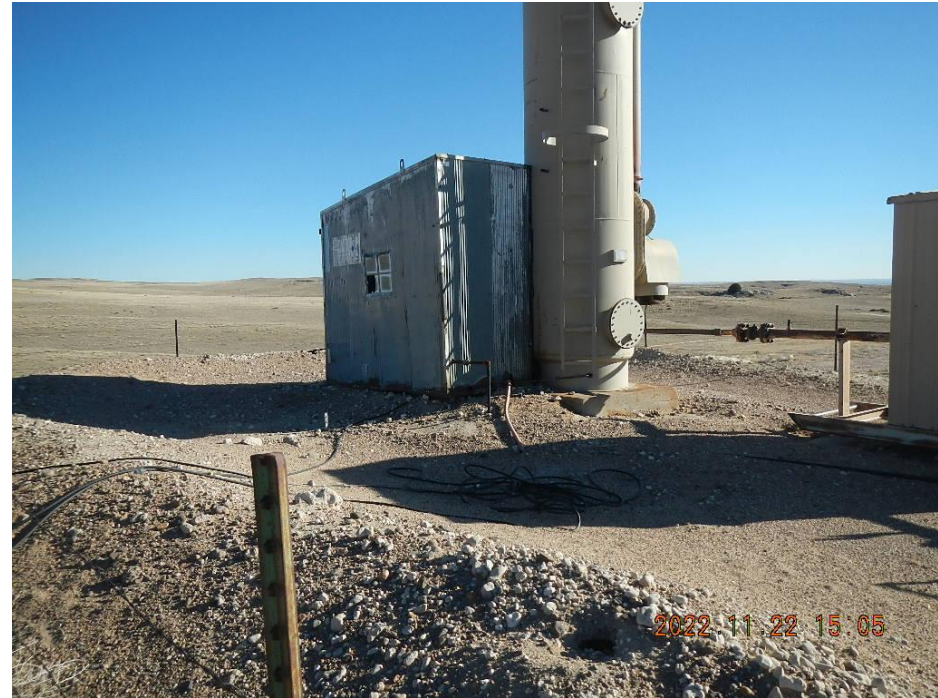
Photo 10. Vertical separator. Placard and signage on shed in disrepair and cannot be read from a distance.

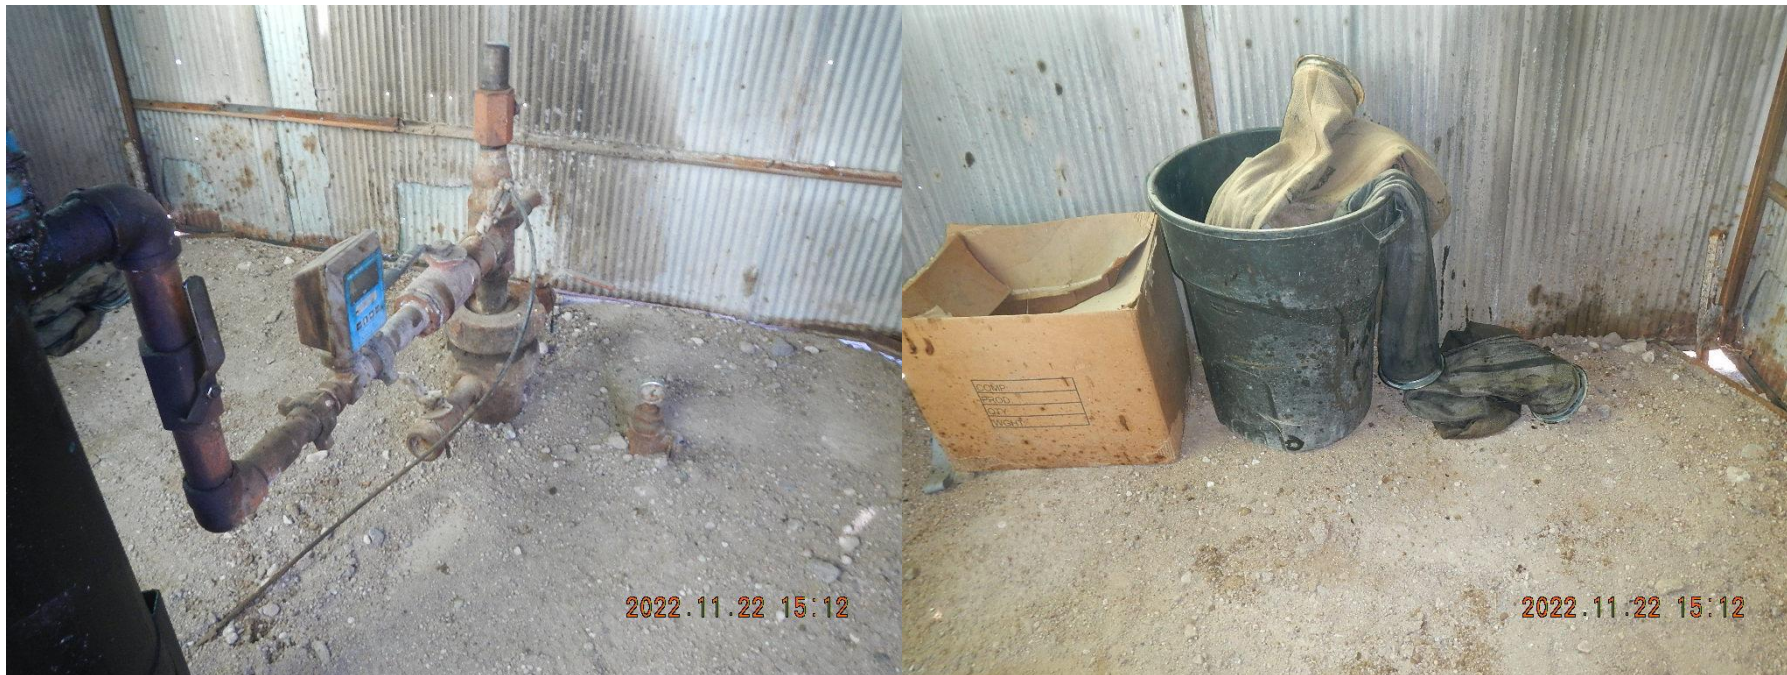
Photo 11. Probst 1 UIC well; API 075-09204

Photo 12. Used filter socks in and out of secondary containment. Socks are considered E&P waste. Some oil staining on the ground.

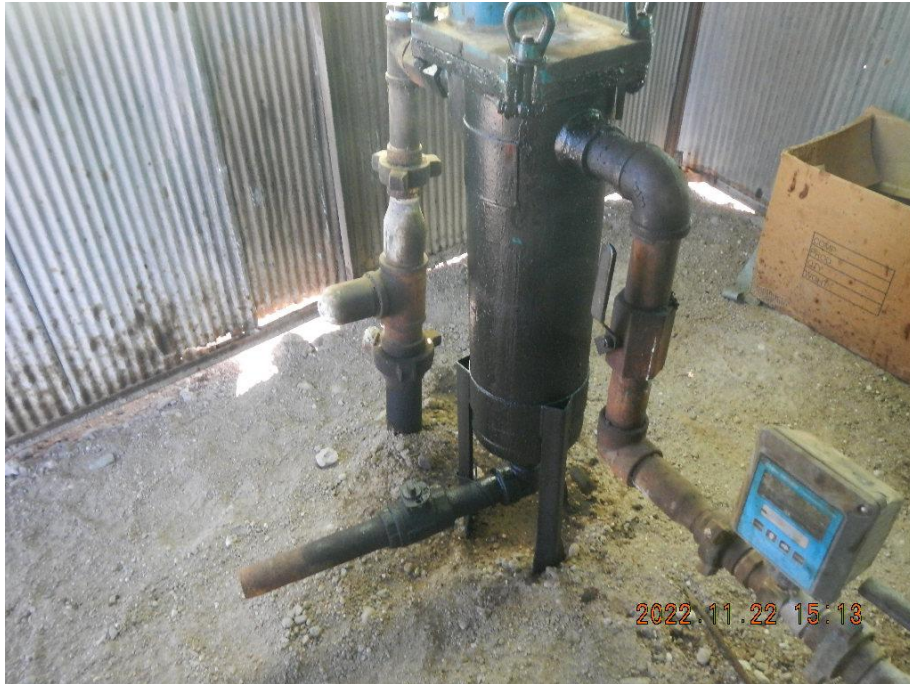
Photo 13. Filter with oil staining and oil staining on the ground.

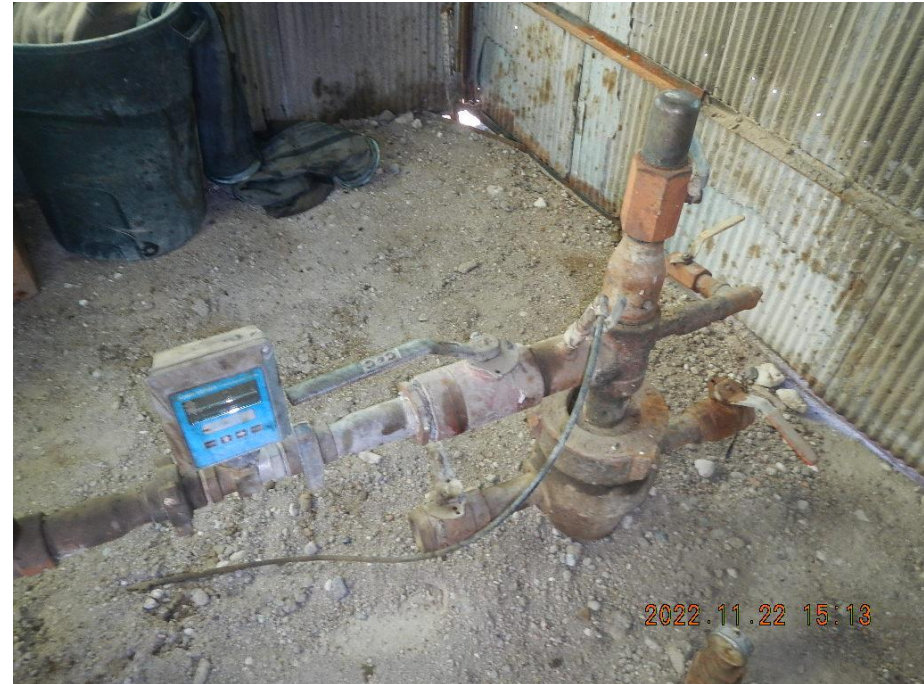
Photo 14. Oil staining around valve threads and on the ground.

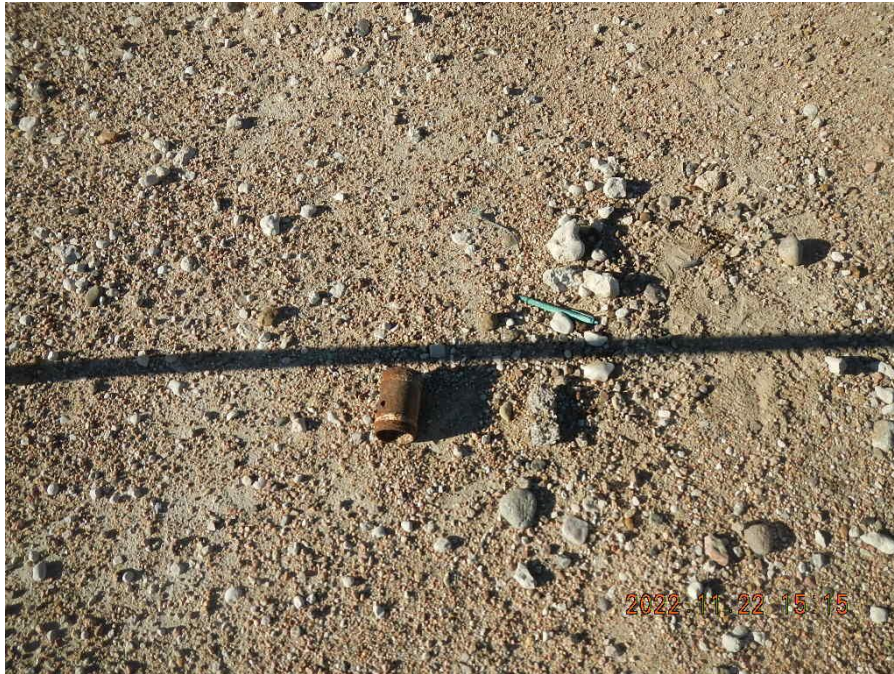
Photo 15. Trash and debris near pit.

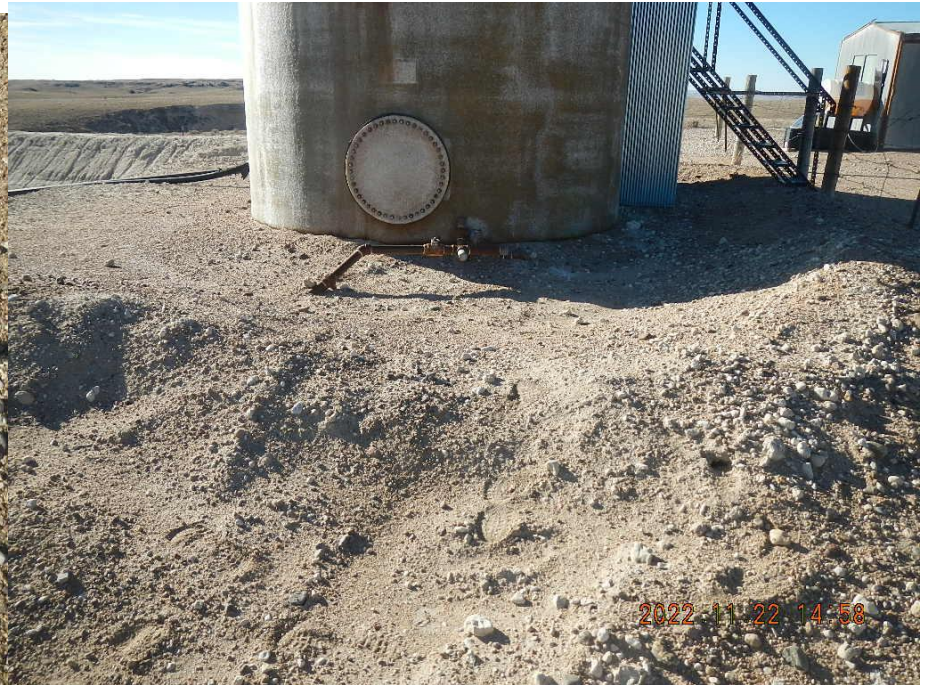
Photo 16. Berms do not appear to be adequate to contain volume of tank.

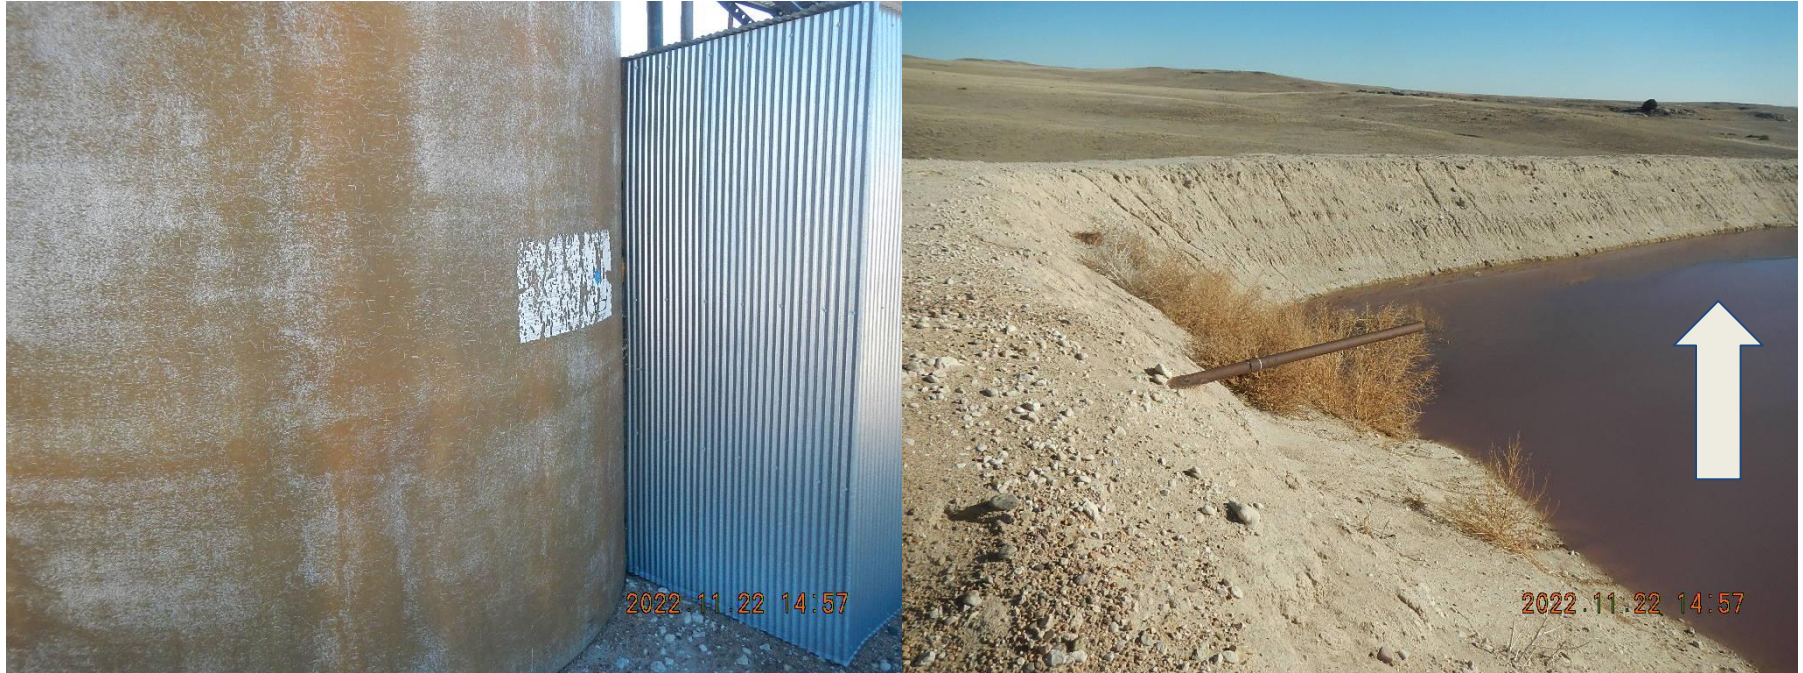
Photo 17. Signage and label illegible.

Photo 18. Weeds in Pit Facility ID 256304 complex.
Hydrocarbon sheen covering approximately 5% of the fluid surface. Per Rule 909.e.(1) Immediately upon discovery or notification, Operators will remove any accumulation of oil or condensate, including free product or hydrocarbon sheen, from a Pit.

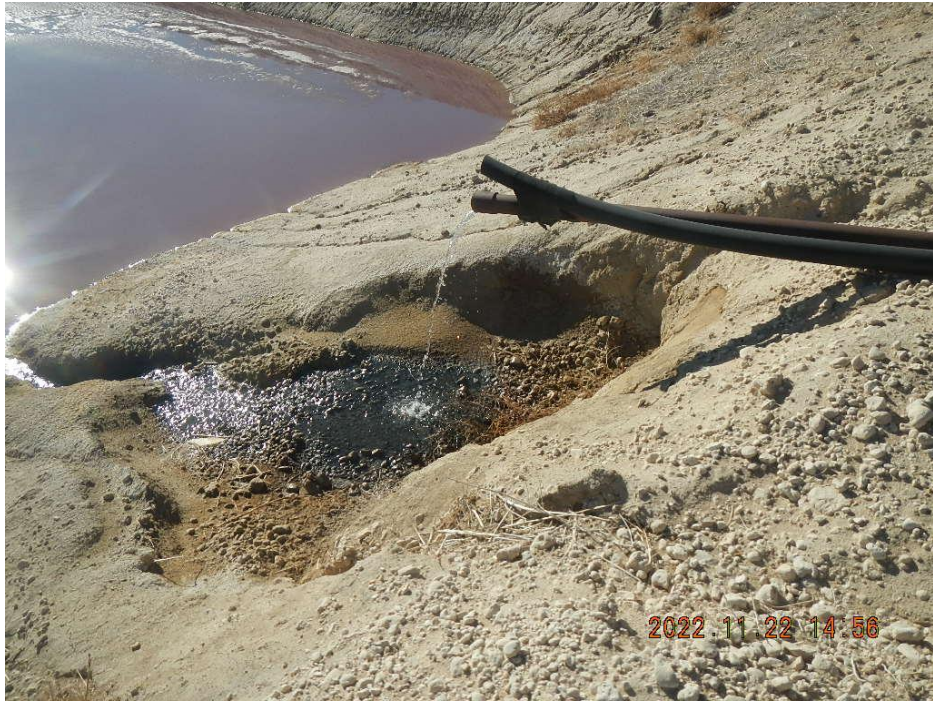
Photo 19. Fluid discharge to Pit Facility ID 256304. Not erosion and hydrocarbon staining. Strong HC odors were noted at time of inspection. Flow into pit estimated to be approximately 20 gpm.

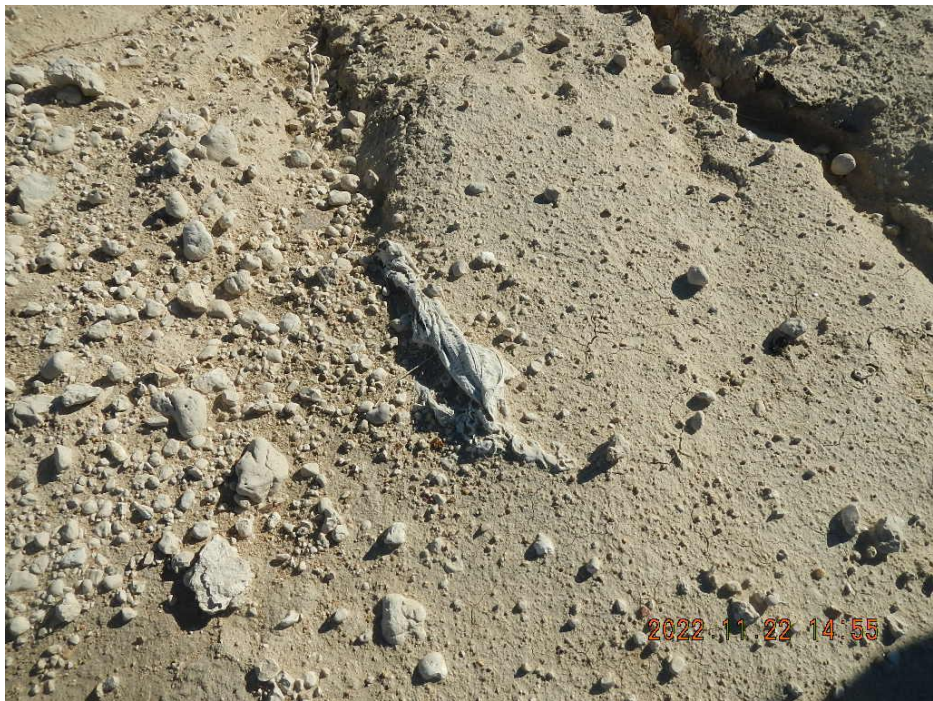
Photo 21. Trash near pit.

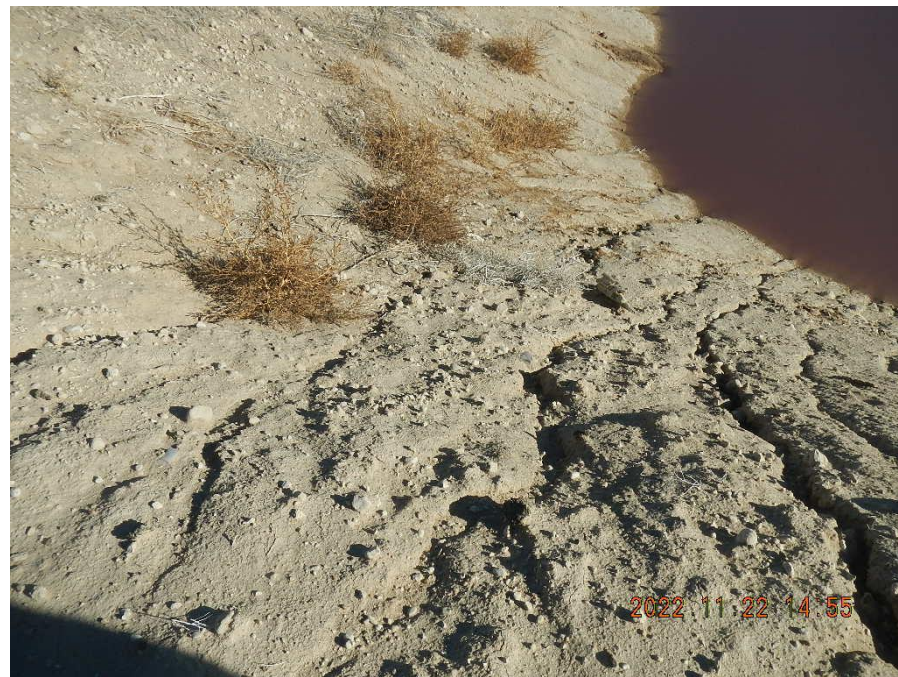
Photo 22. Erosional rills into pit. There should not be any surface runoff into the pit.

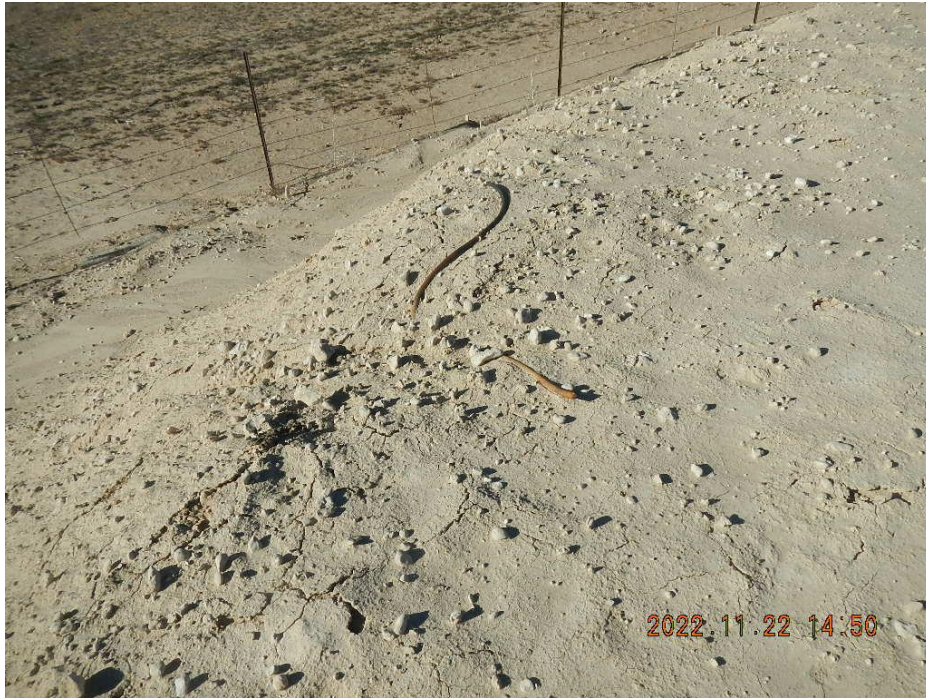
Photo 23. Trash/debris inside the pit complex.

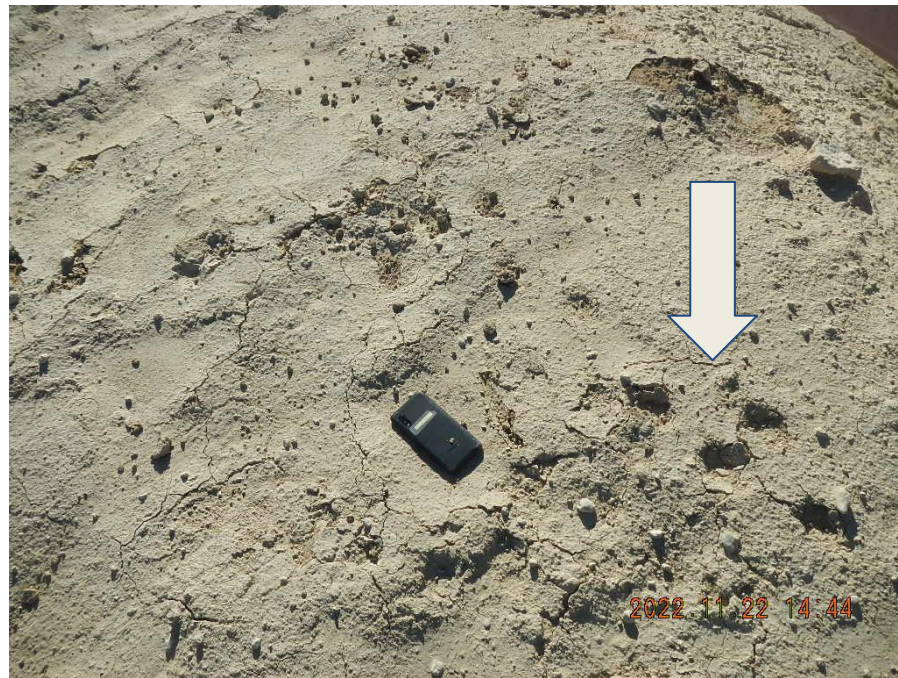
Photo 26. Signs of wildlife inside pit facility complex.

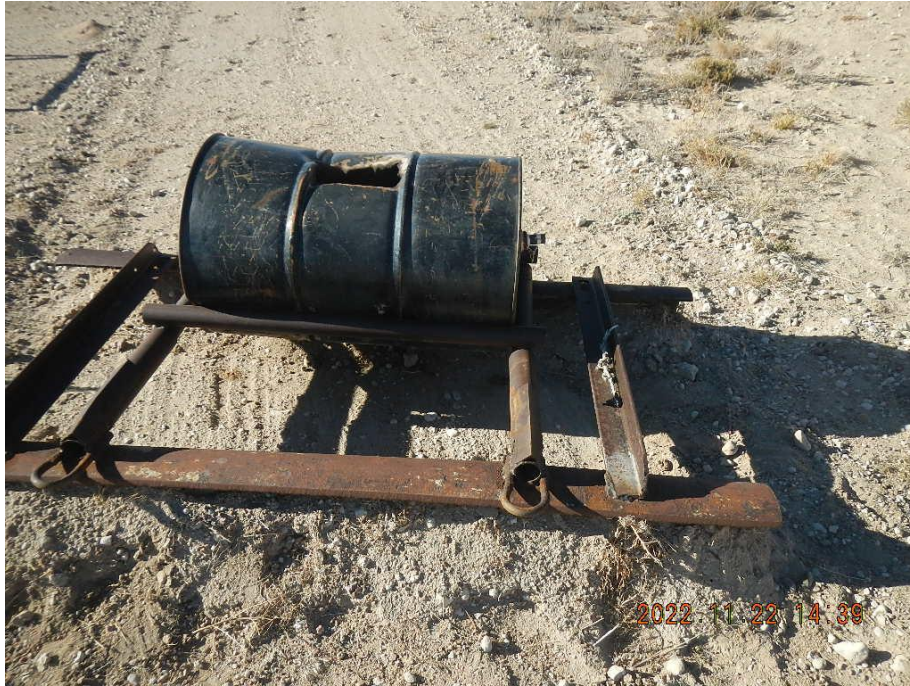
Photo 27. Unused equipment. Note: The 55-gallon drum was partially full of oil and paraffin. Contents to be removed and disposed of as E&P waste.

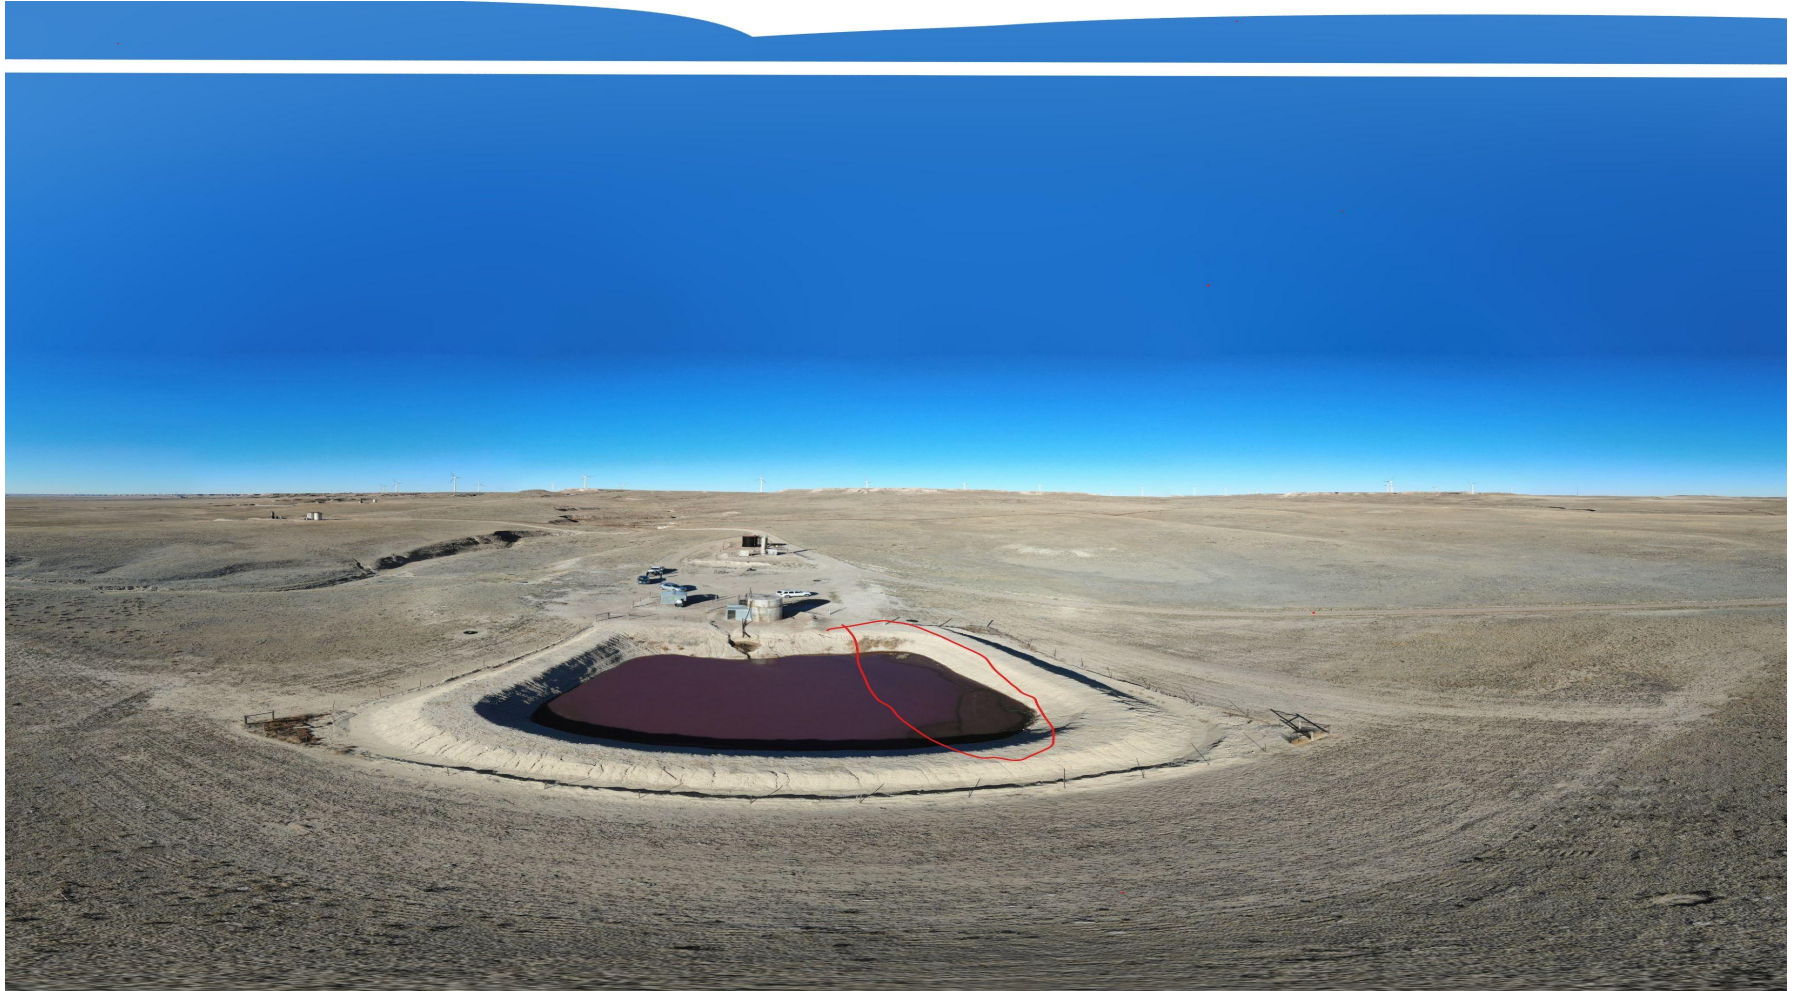
Photo 29 Drone aerial imagery taken south of the location.
Photo illustrates HC on pit fluid surface.
