**Subject:** LDAR Results for Inspections Performed on 11/16/2022

On 11/16/2022, Quandary Consultants (Quandary) performed leak detection and repair (LDAR) surveys on behalf of Longs Peak Resources, LLC at the following facilities:

Pismo East 35-26-23-2-1CH (Pismo)  
Oxnard East 0607-8CH Tank Battery (Oxnard)  
Motu East 28-21-16-1CH (Motu)

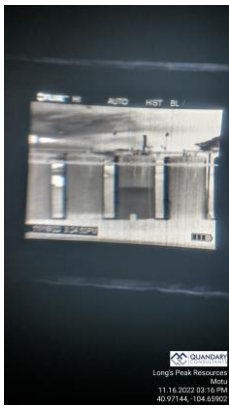
Motu East 28-21-16-1CH GPS Site Photo for Inspection Performed On 11/16/2022

No leaks found. No deviation from monitoring plan. OOOOa tank inspection performed with no corrective actions needed. Crude oil loadout lines inspected with no leaks found.

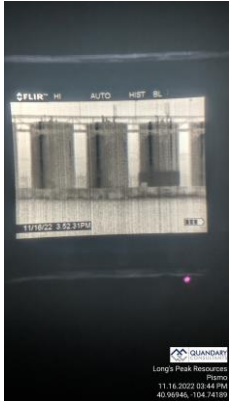
Pismo East 35-26-23-2-1CH GPS Site Photo for Inspection Performed On 11/16/2022

Site operating. Combustor pilot running. No leaks. No deviations from monitoring plan. Crude oil loadout lines inspected with no leaks found.

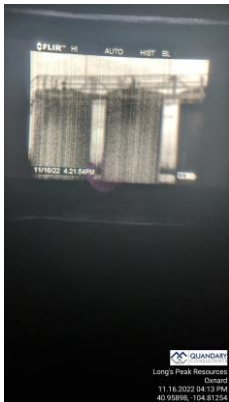
Oxnard East 0607-8CH Tank Battery GPS Site Photo for Inspection Performed On 11/16/2022

Site operating. No leaks found, no deviation from monitoring plan. Crude oil loadout lines inspected with no leaks found.
