Inspection Photos

Operator: UTAH GAS OP LTD DBA UTAH GAS

Location #322479

Garfield County, CO

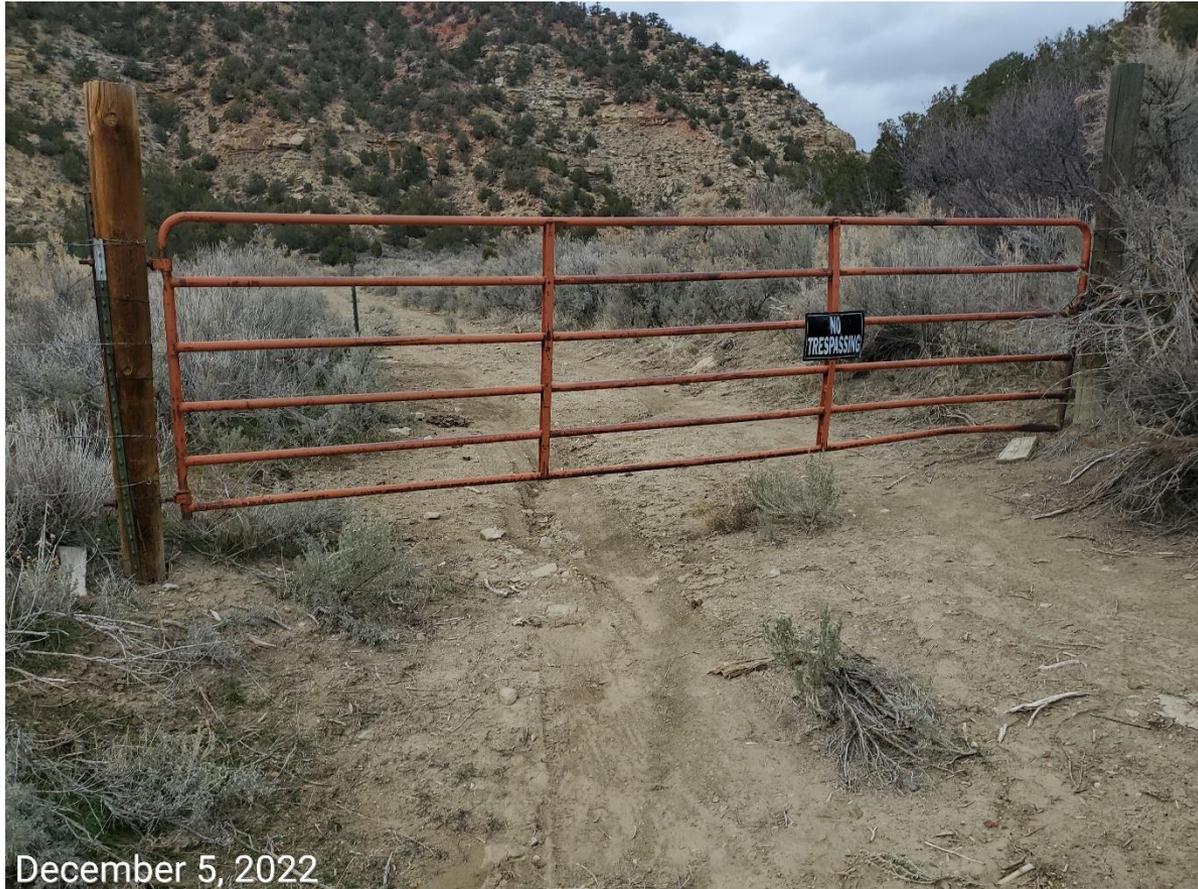
Photo 1: Photo shows locked gate encountered along access road; gate combinations on had failed to unlock gate.

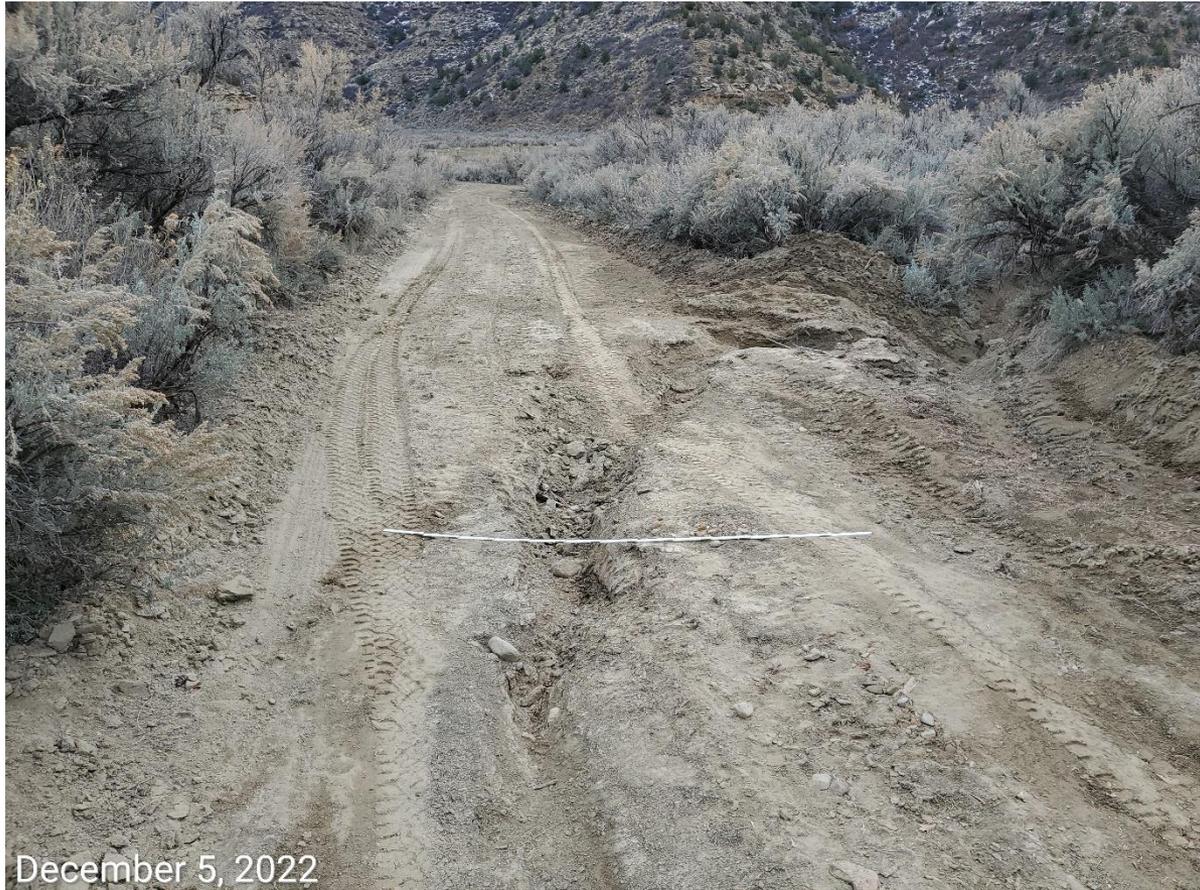
Photo 2: Photo taken from the access road. Photo shows erosion degradation along the access road due to stormwater runoff remains evident; work to maintain access road, and BMPs to stabilize road, and properly manage runoff in a manner that minimizes erosion, degradation and sediment transport are missing or insufficient. 6 ½ foot measuring stick in photo used for reference.

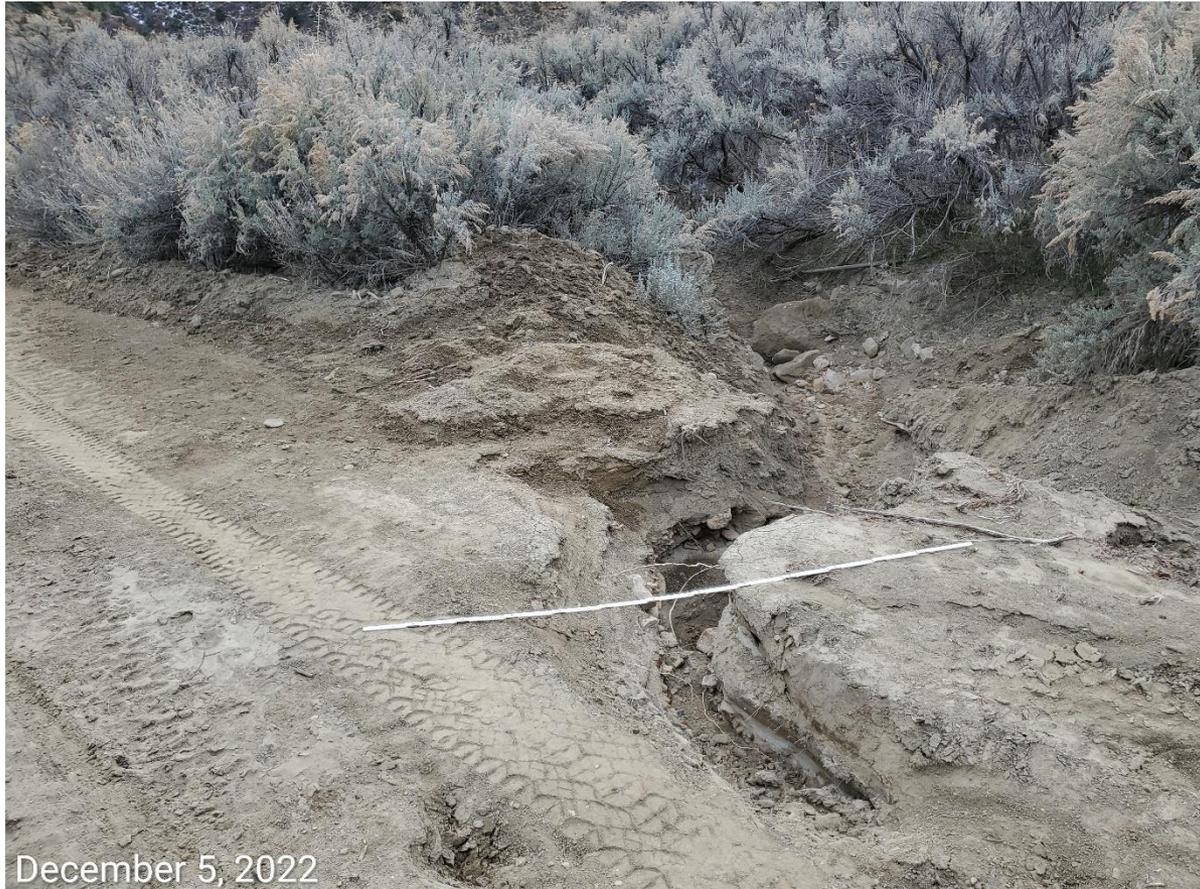
Photo 3: Photo taken from the access road. Photo shows erosion degradation along the access road due to stormwater runoff remains evident; work to maintain access road, and BMPs to stabilize road, and properly manage runoff in a manner that minimizes erosion, degradation and sediment transport are missing or insufficient. 6 ½ foot measuring stick in photo used for reference.

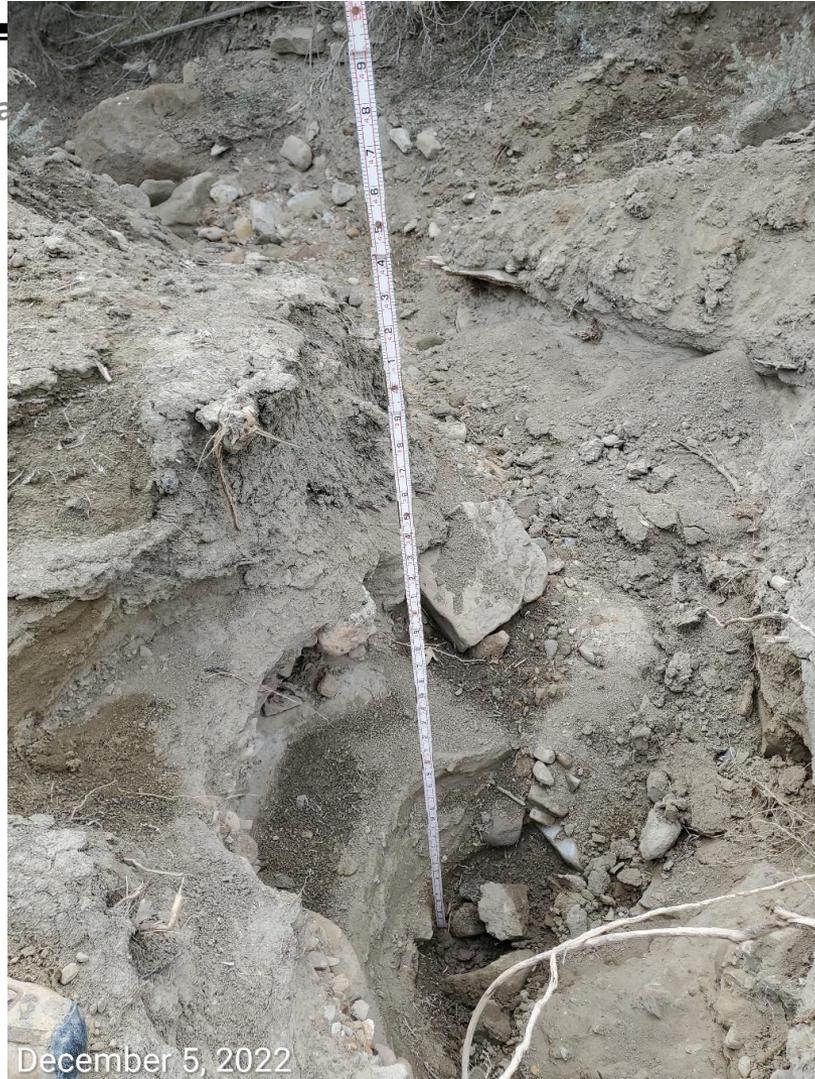
Photo 4: Continued from photo 3. Erosion observed at access road ~3.5 to 4 feet deep.

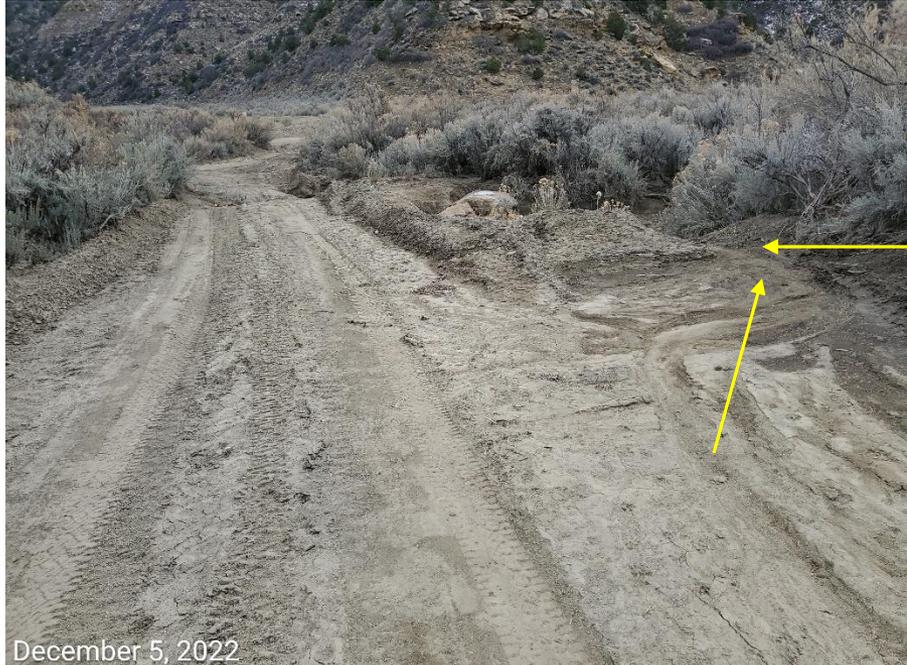
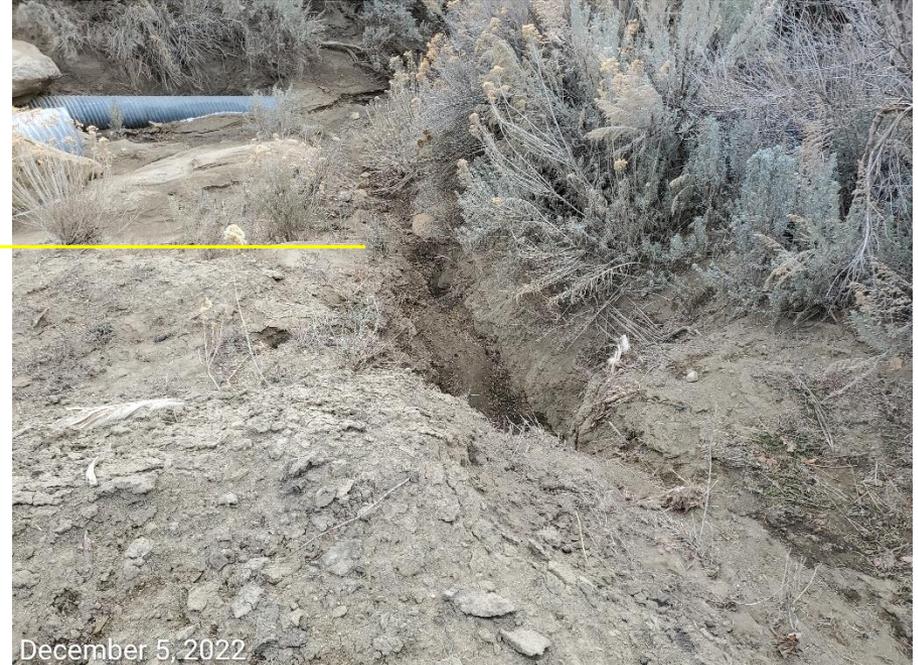
Photo 5: Photo taken from the access road. Photo shows erosion degradation along the access road due to stormwater runoff remains evident; work to maintain access road, and BMPs to stabilize road, and properly manage runoff in a manner that minimizes erosion, degradation and sediment transport are missing or insufficient. BMPs to allow proper discharge at point where stormwater is diverted from access road is missing, resulting in continued degradation.

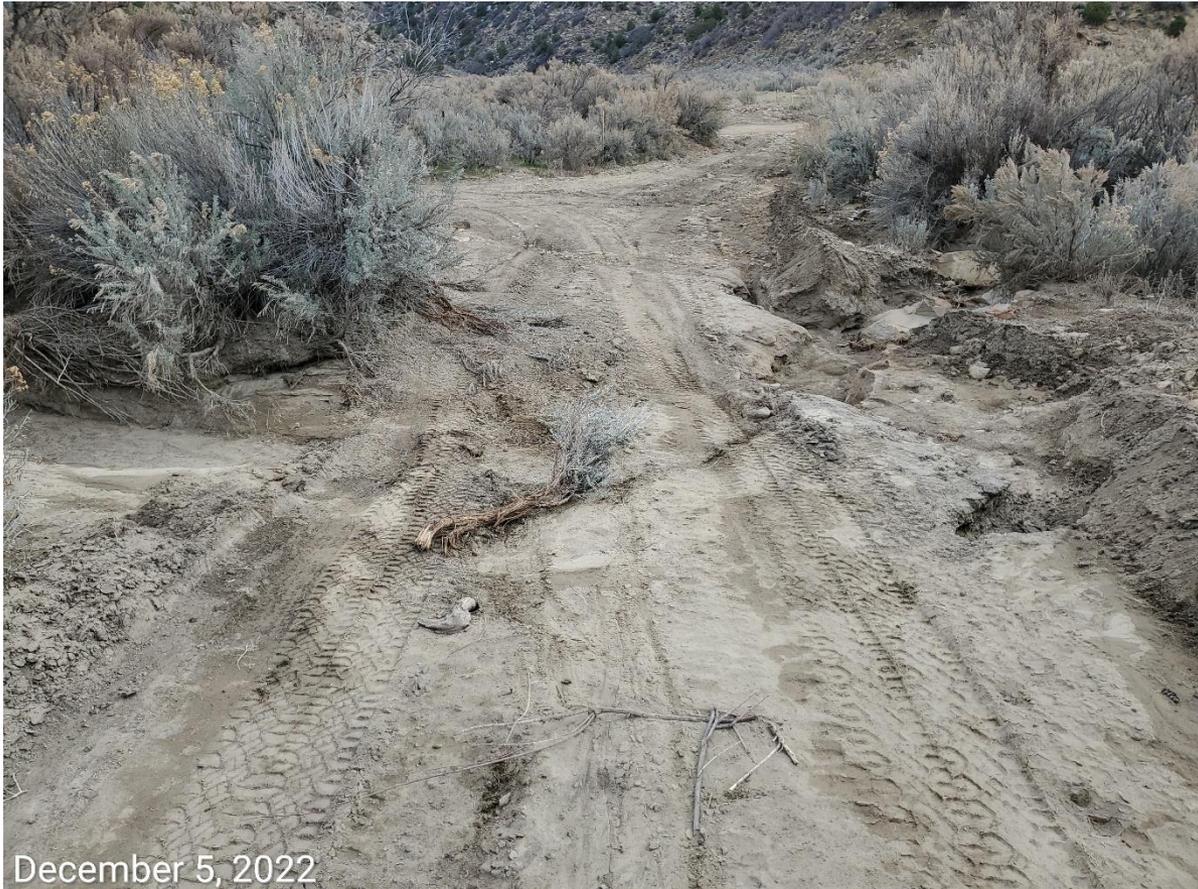
Photo 6: Photo taken from the access road. Photo shows erosion degradation along the access road due to stormwater runoff remains evident; work to maintain access road, and BMPs to stabilize road, and properly manage runoff in a manner that minimizes erosion, degradation and sediment transport are missing or insufficient. 6 ½ foot measuring stick in photo used for reference.

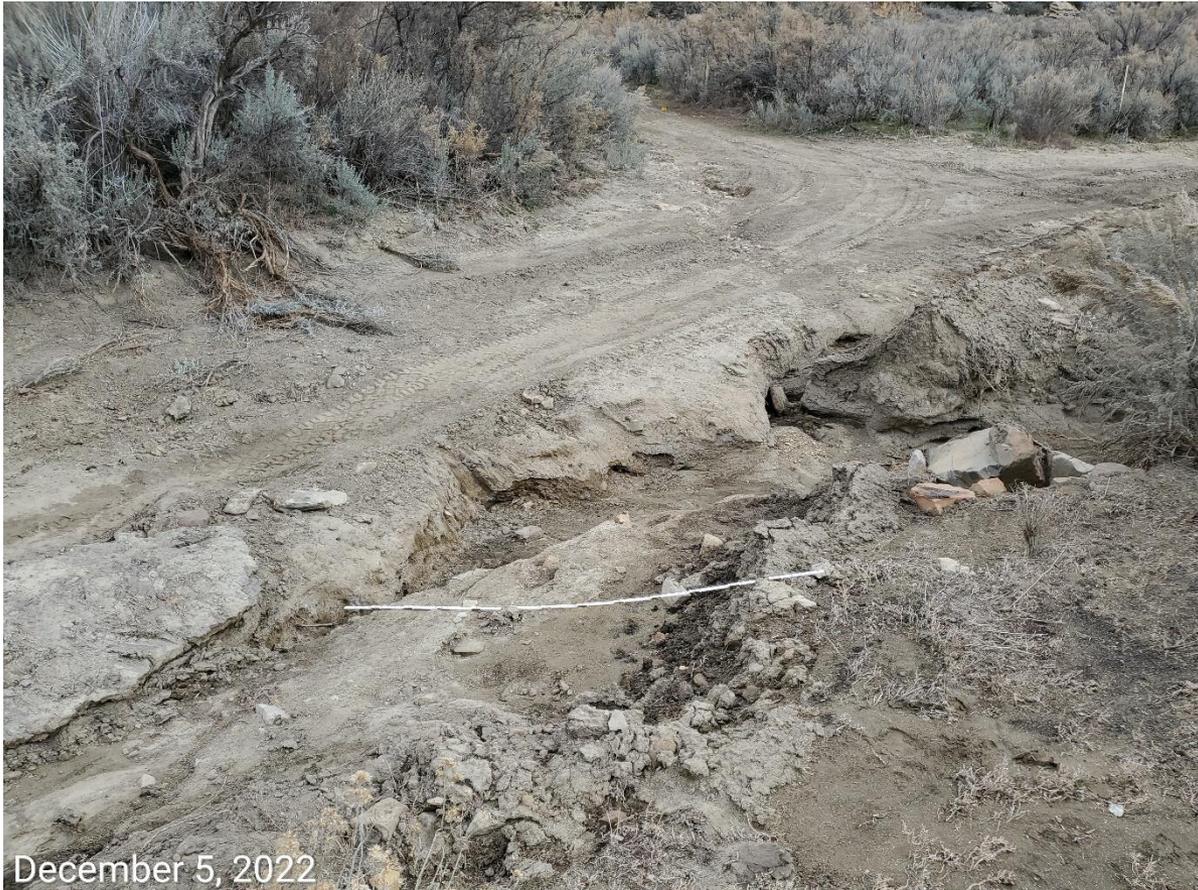
Photo 7: Photo taken from the access road. Photo shows erosion degradation along the access road due to stormwater runoff remains evident; work to maintain access road, and BMPs to stabilize road, and properly manage runoff in a manner that minimizes erosion, degradation and sediment transport are missing or insufficient. 6 ½ foot measuring stick in photo used for reference.

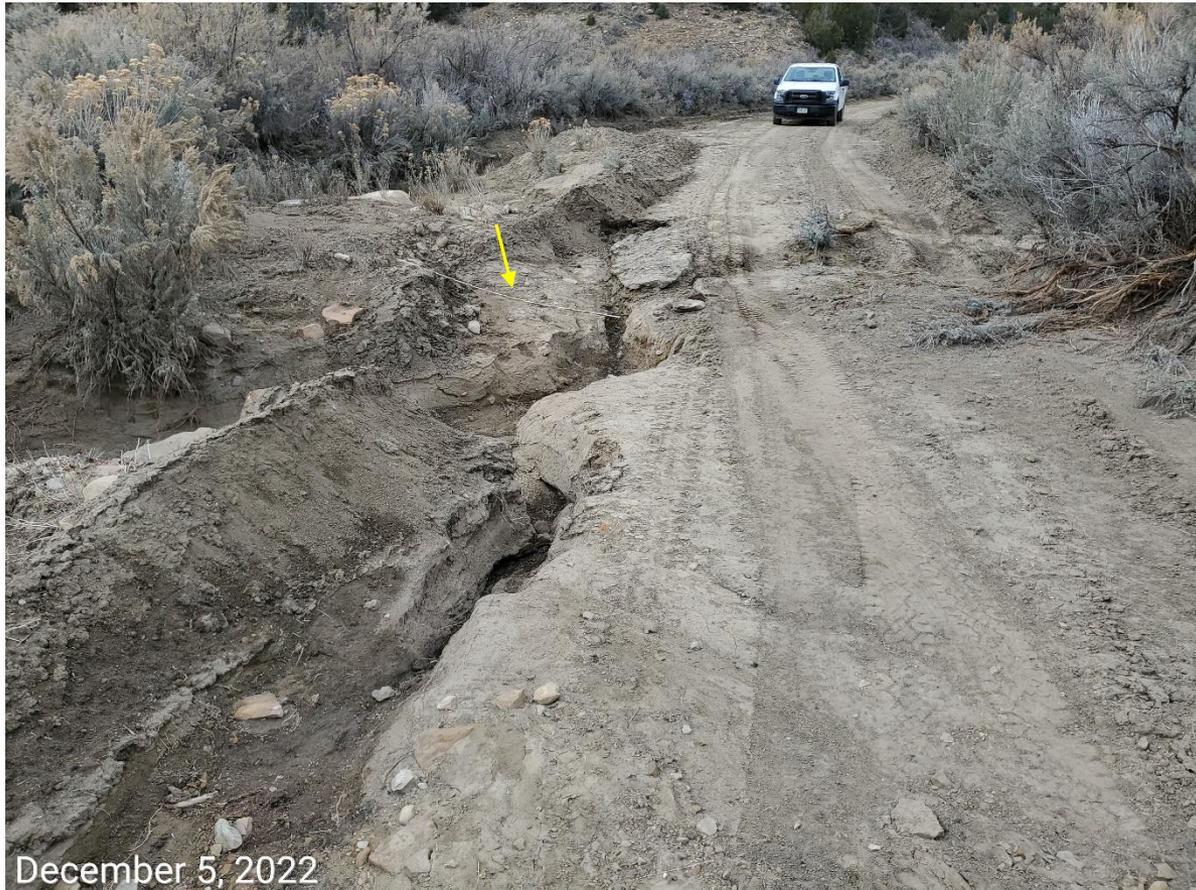
Photo 8: Photo taken from the access road. Photo shows erosion degradation along the access road due to stormwater runoff remains evident; work to maintain access road, and BMPs to stabilize road, and properly manage runoff in a manner that minimizes erosion, degradation and sediment transport are missing or insufficient. 6 ½ foot measuring stick in photo (arrow) used for reference.

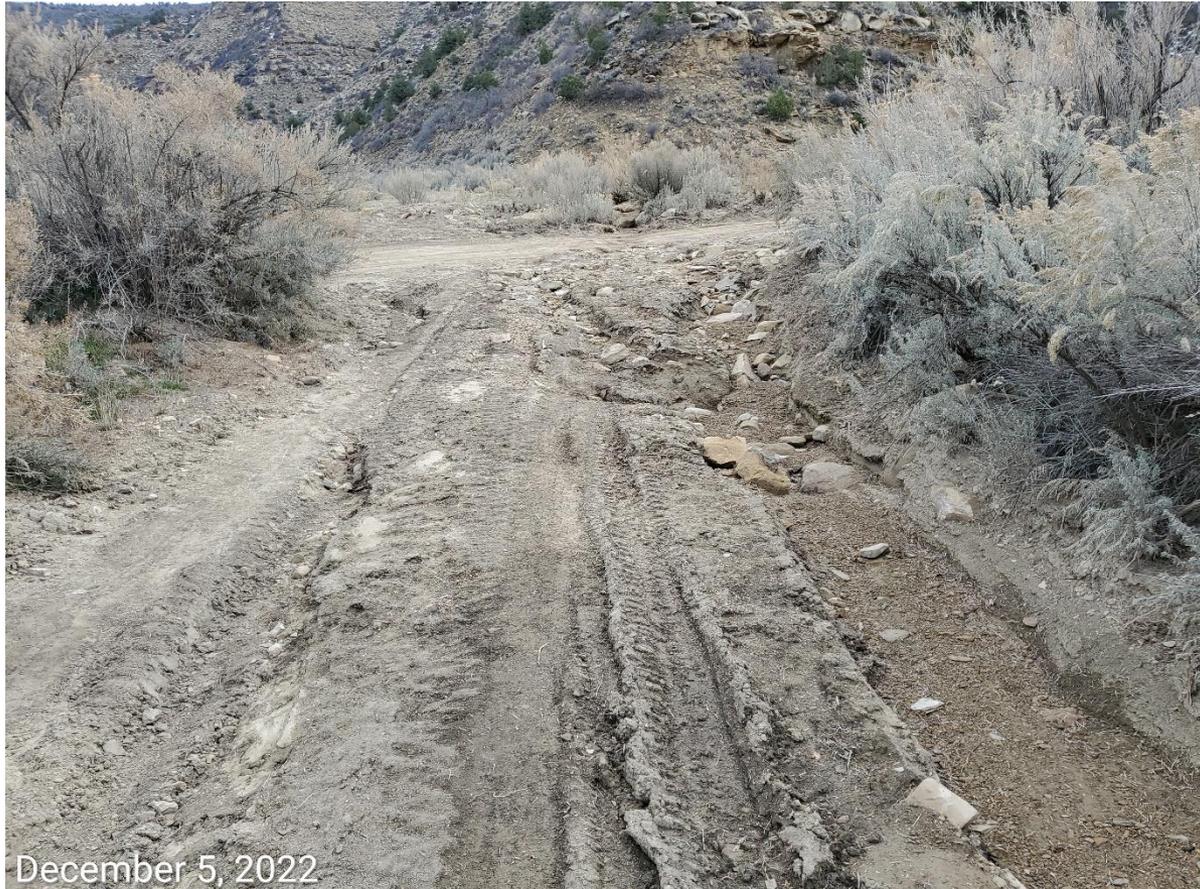
Photo 9: Photo taken from the access road. Photo shows erosion degradation along the access road due to stormwater runoff remains evident; work to maintain access road, and BMPs to stabilize road, and properly manage runoff in a manner that minimizes erosion, degradation and sediment transport are missing or insufficient.

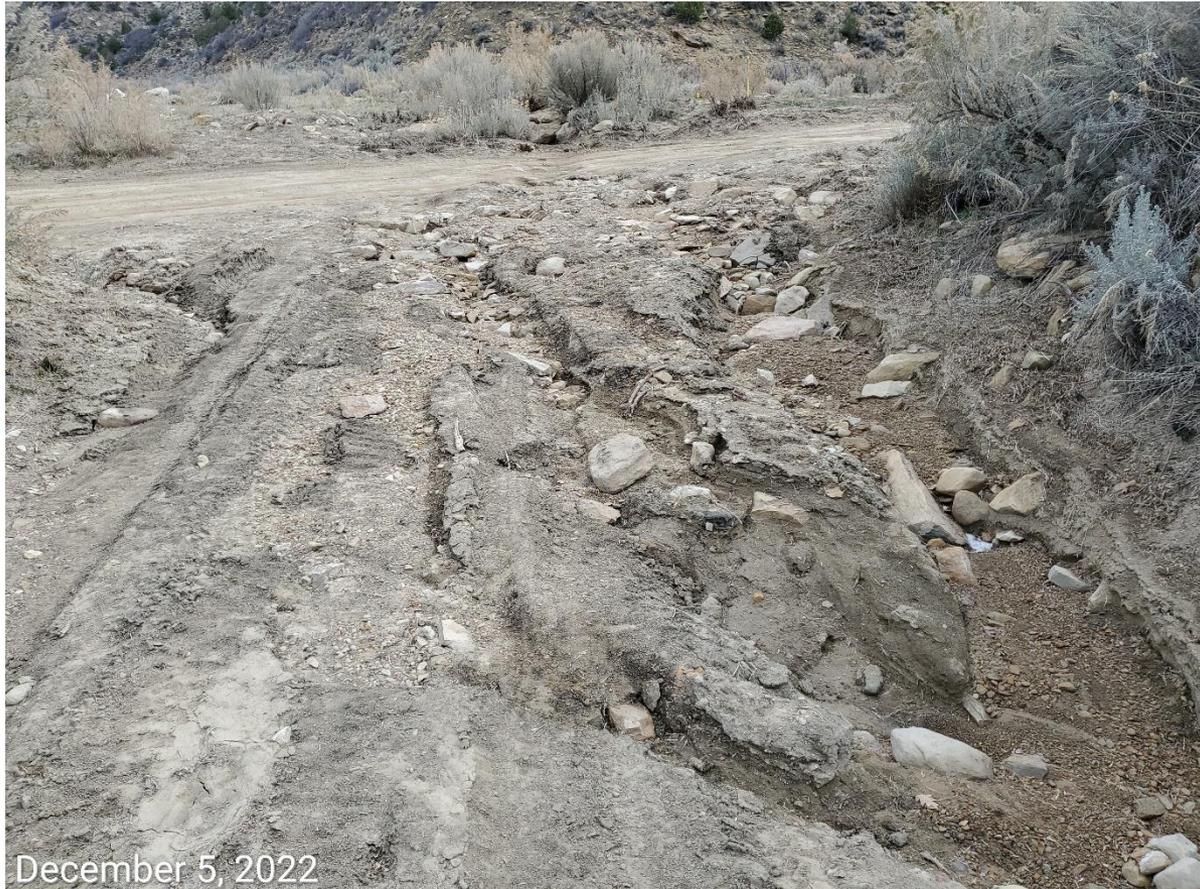
Photo 10: Photo taken from the access road. Photo shows erosion degradation along the access road due to stormwater runoff remains evident; work to maintain access road, and BMPs to stabilize road, and properly manage runoff in a manner that minimizes erosion, degradation and sediment transport are missing or insufficient.
