Construction and Stormwater Inspection

Operator: VERDAD RESOURCES LLC - 10651

Location ID: 457136

Location Name: ROHN 9-60/14A

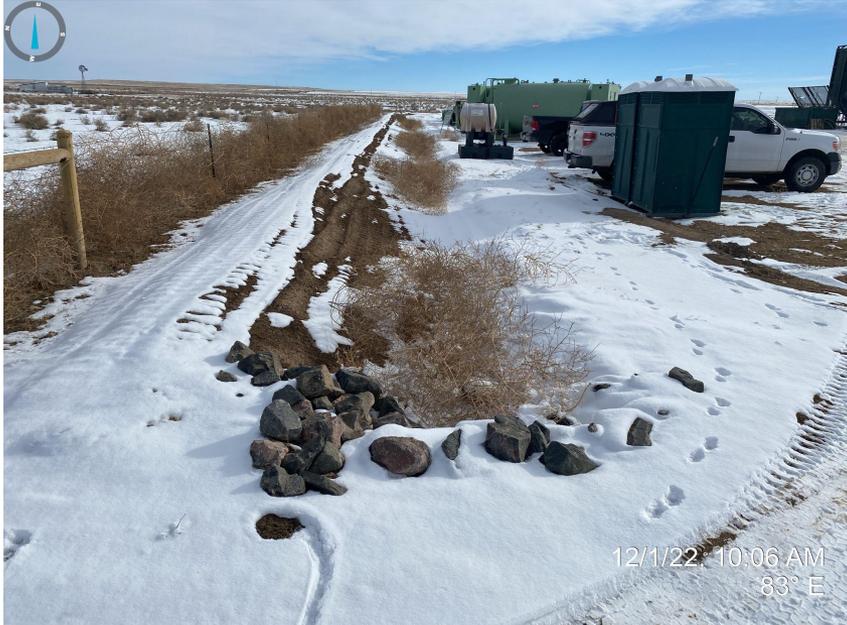
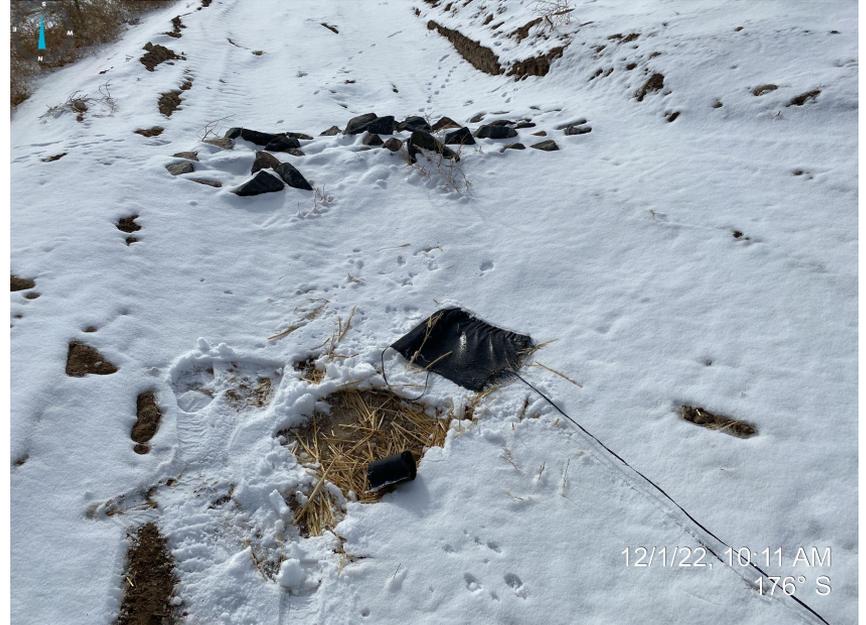
Photos 1 & 2. Photos depict trash and debris observed throughout the location during inspection. Photo 1 taken near entrance; Photo 2 taken near sediment trap.

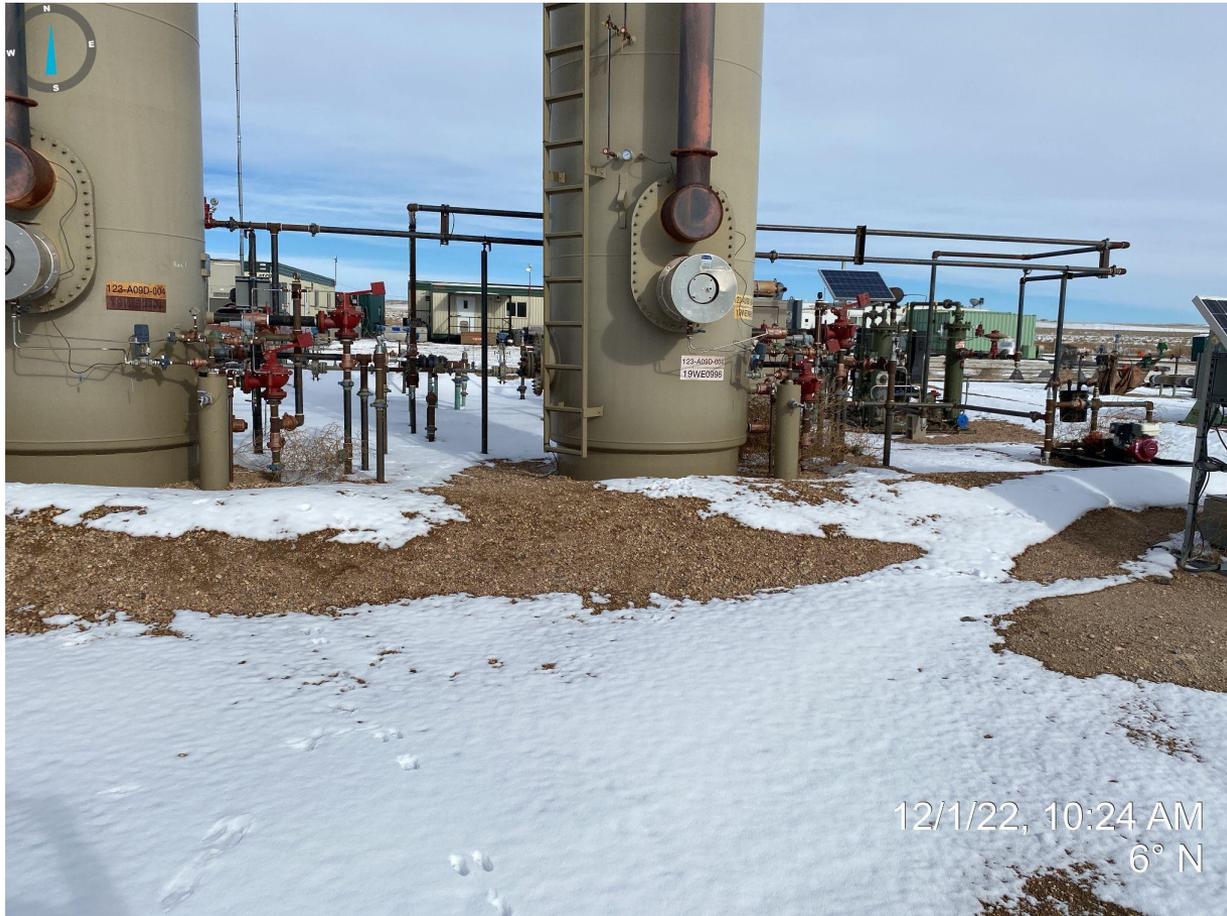
Photo 3. Taken near the western portion of the location, facing north. Photo illustrates tumbleweeds piled up against equipment.

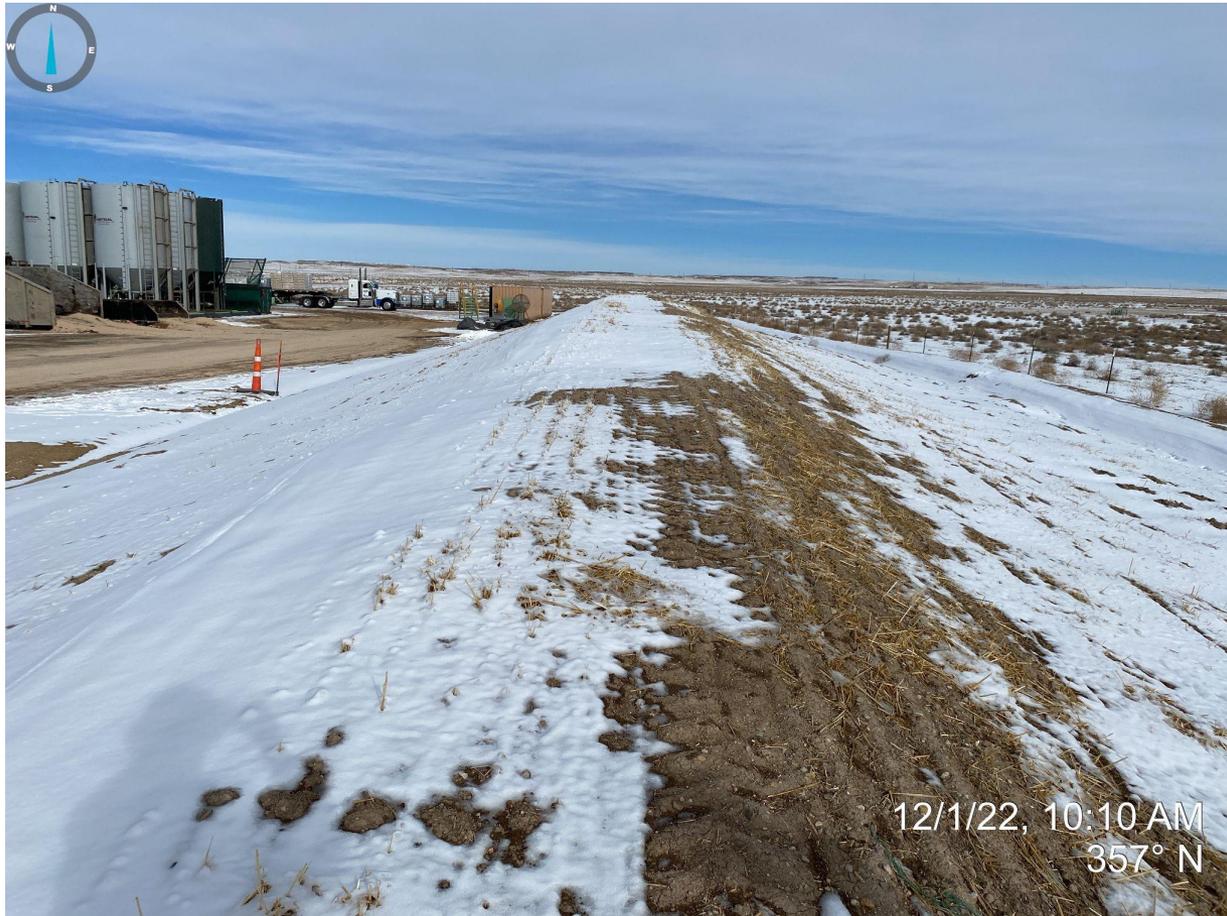
Photo 4. Facing north from topsoil stockpile. Photo illustrates the stockpile has been temporarily stabilized with evidence of drill rows and crimped straw mulch.

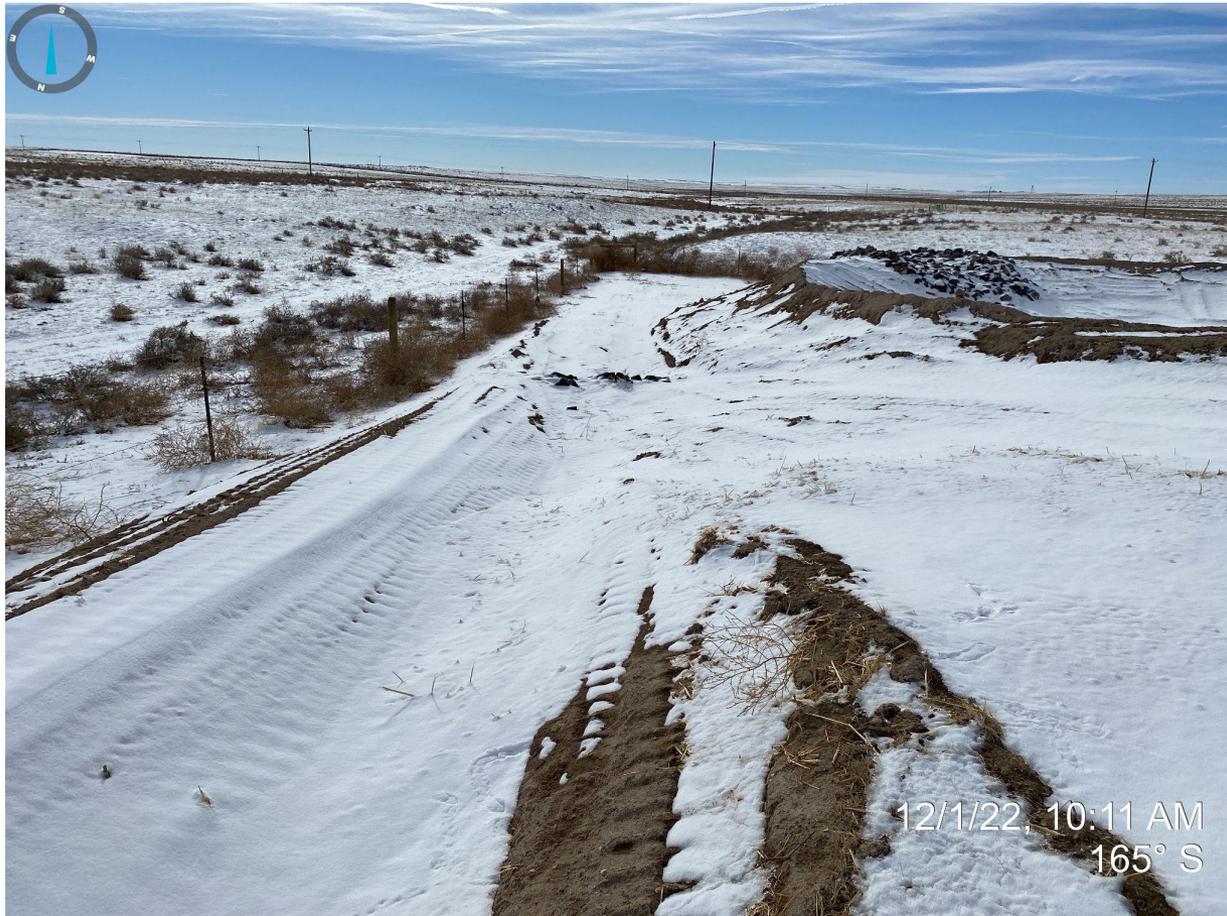
Photo 5. Facing south from topsoil stockpile. Photo shows stormwater BMPs (e.g. perimeter ditch and berm, and sediment trap, etc) have been installed during the construction phase of the location.

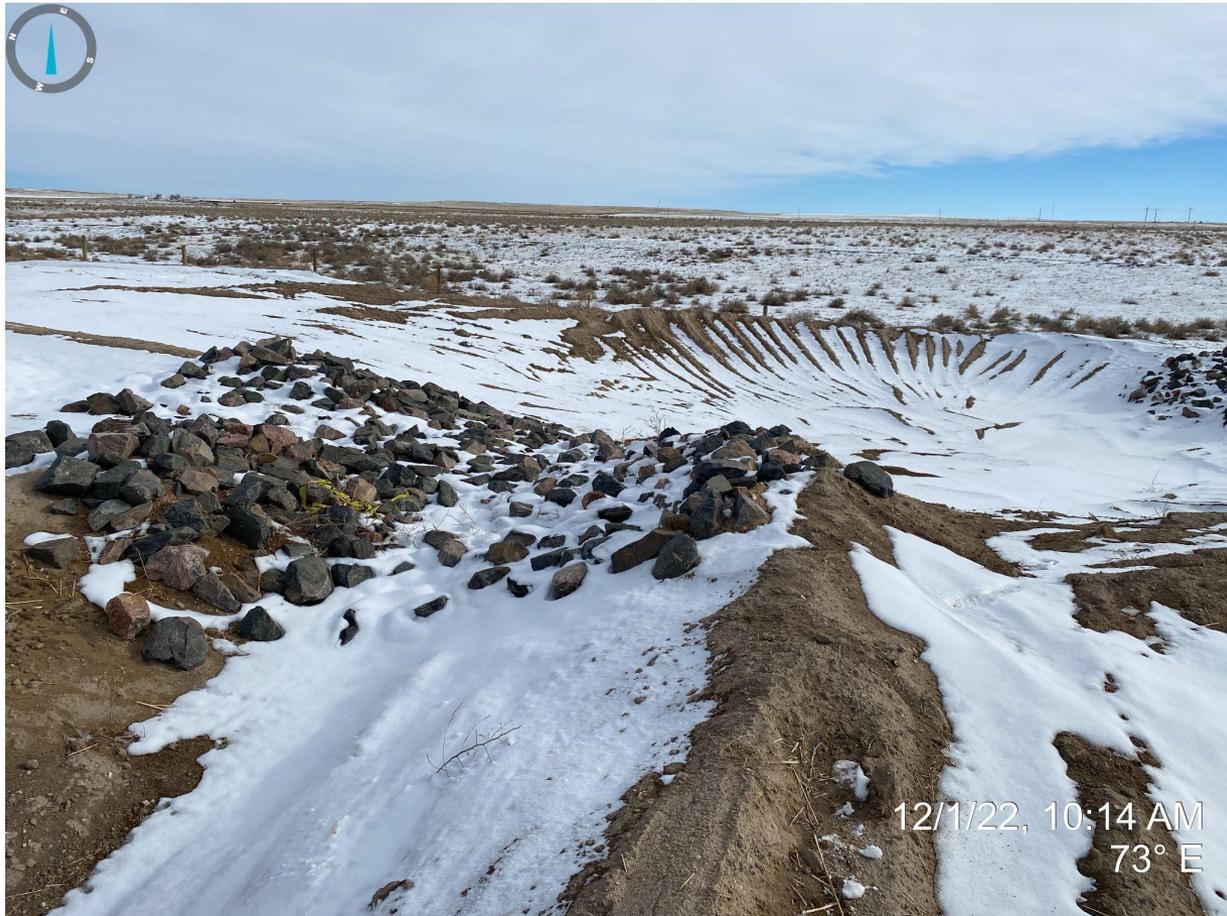
Photo 6. Facing east from sediment trap, see comments in Photo 5.

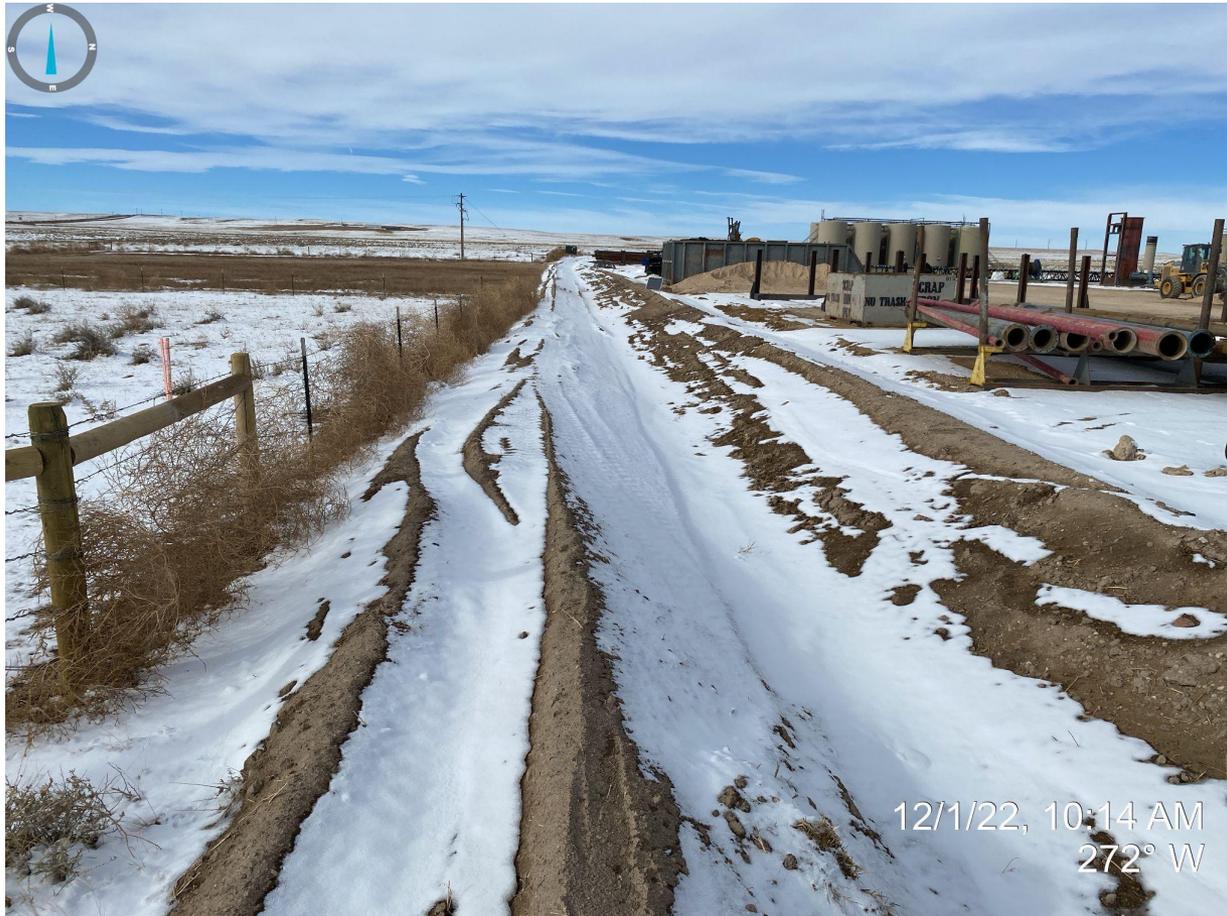
Photo 7. Facing west from sediment trap, see comments in Photo 5.

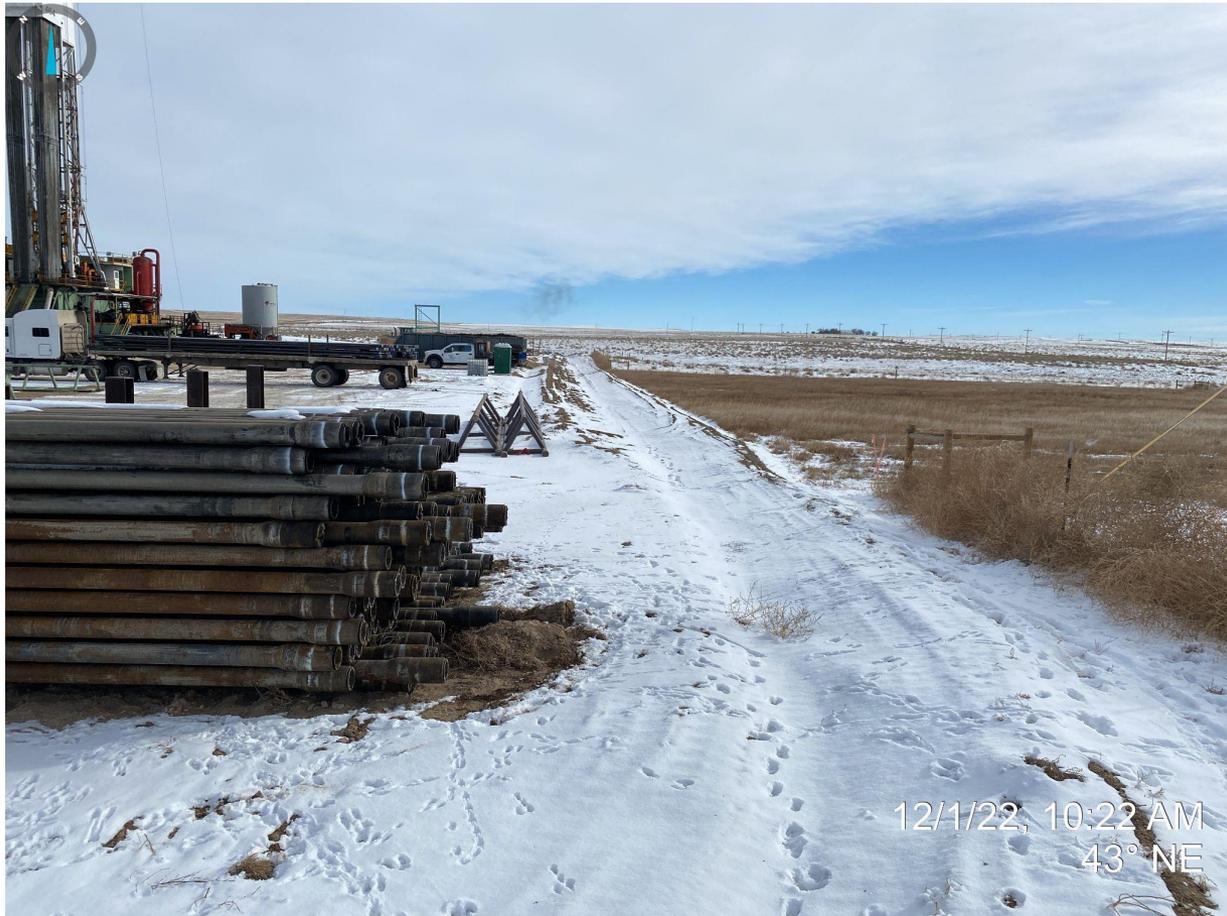
Photo 8. Facing northeast from the southwest corner of location, see comments in Photo 5.

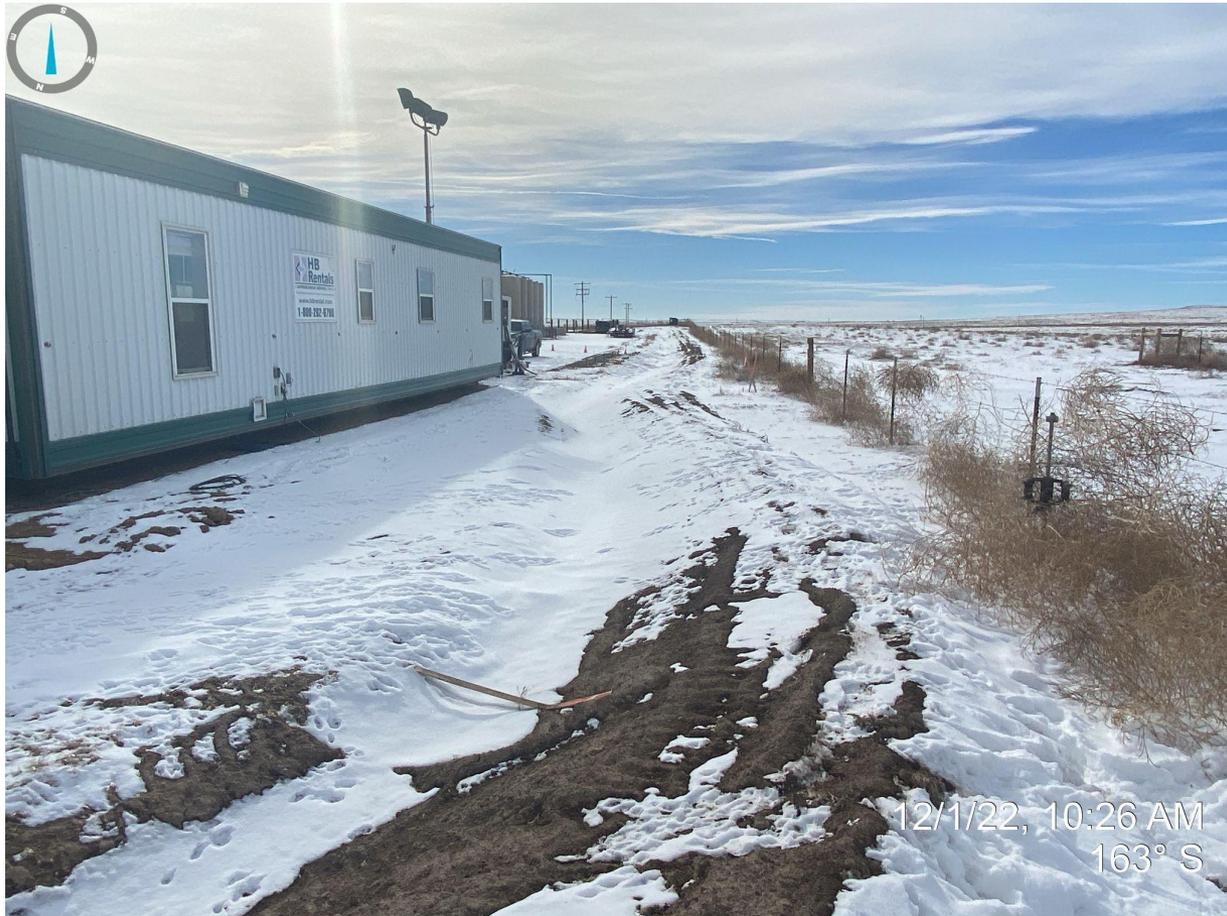
Photo 9. Facing south from northwest corner, see comments in Photo 5.

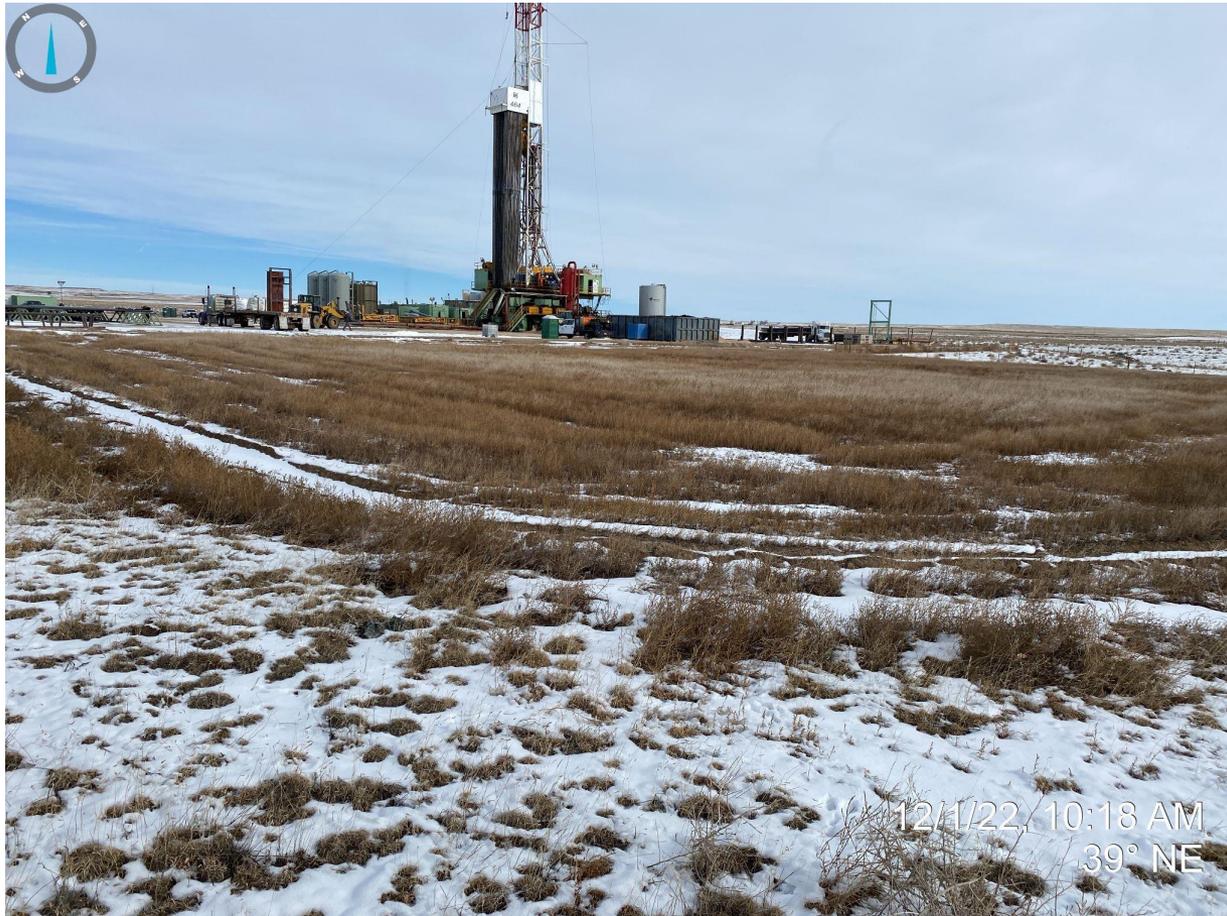
Photo 10. Taken from the southwest corner of location, facing northeast. Photo illustrates presence of undesirable vegetation (e.g. russian thistle and kochia) in a portion of the interim area of the location. A follow-up interim reclamation inspection will be conducted at a later date to ensure compliance with 1003 Rules.
