Inspection Photos

API: 071-07915

Operator: WAPITI OPERATING LLC

Inspection Date: 12/7/2022

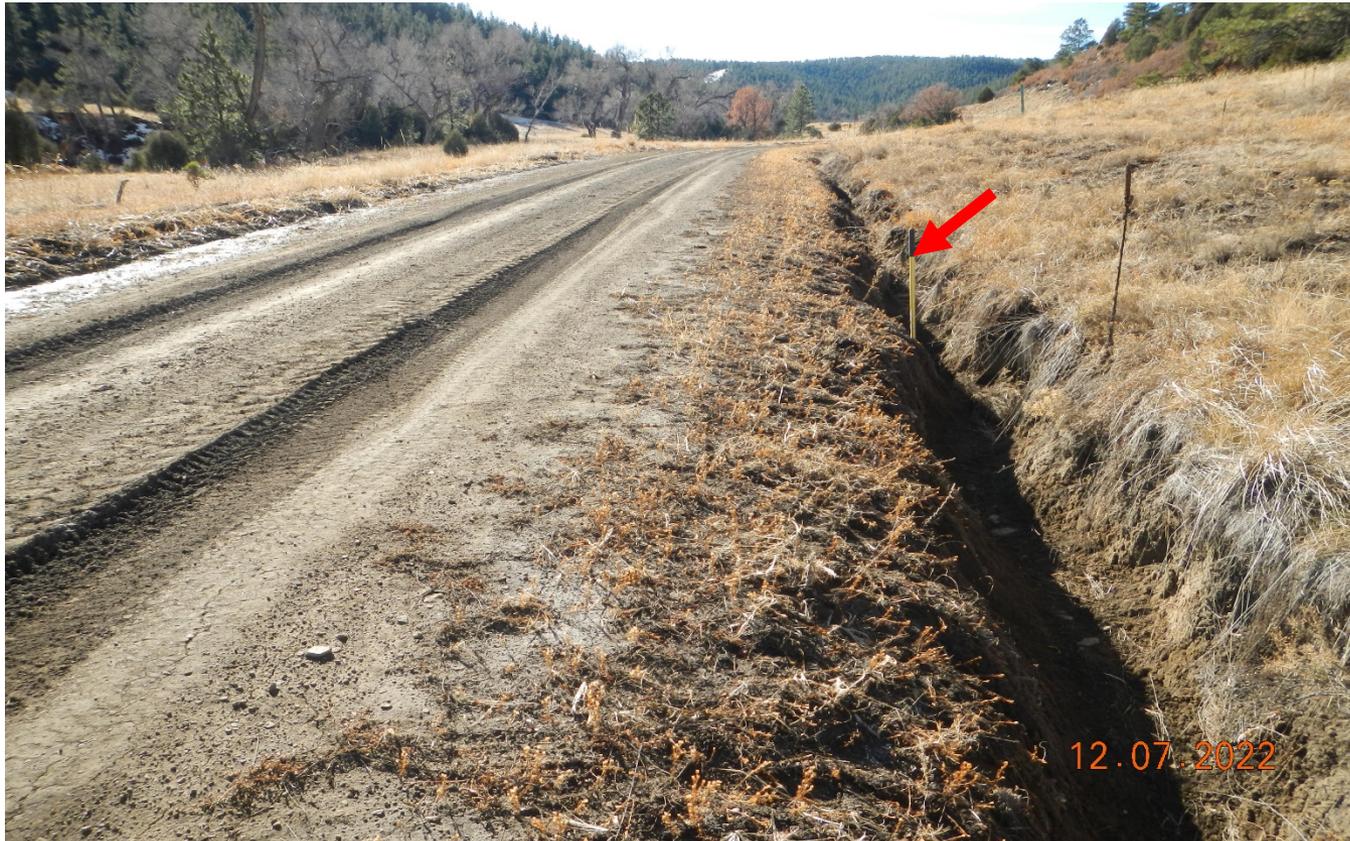
Photo 1. Facing south along the main road. There is erosion occurring along the road side. BMP's need to be installed to prevent erosion. Red arrow points to 4.5' shovel. Previous corrective action not completed.

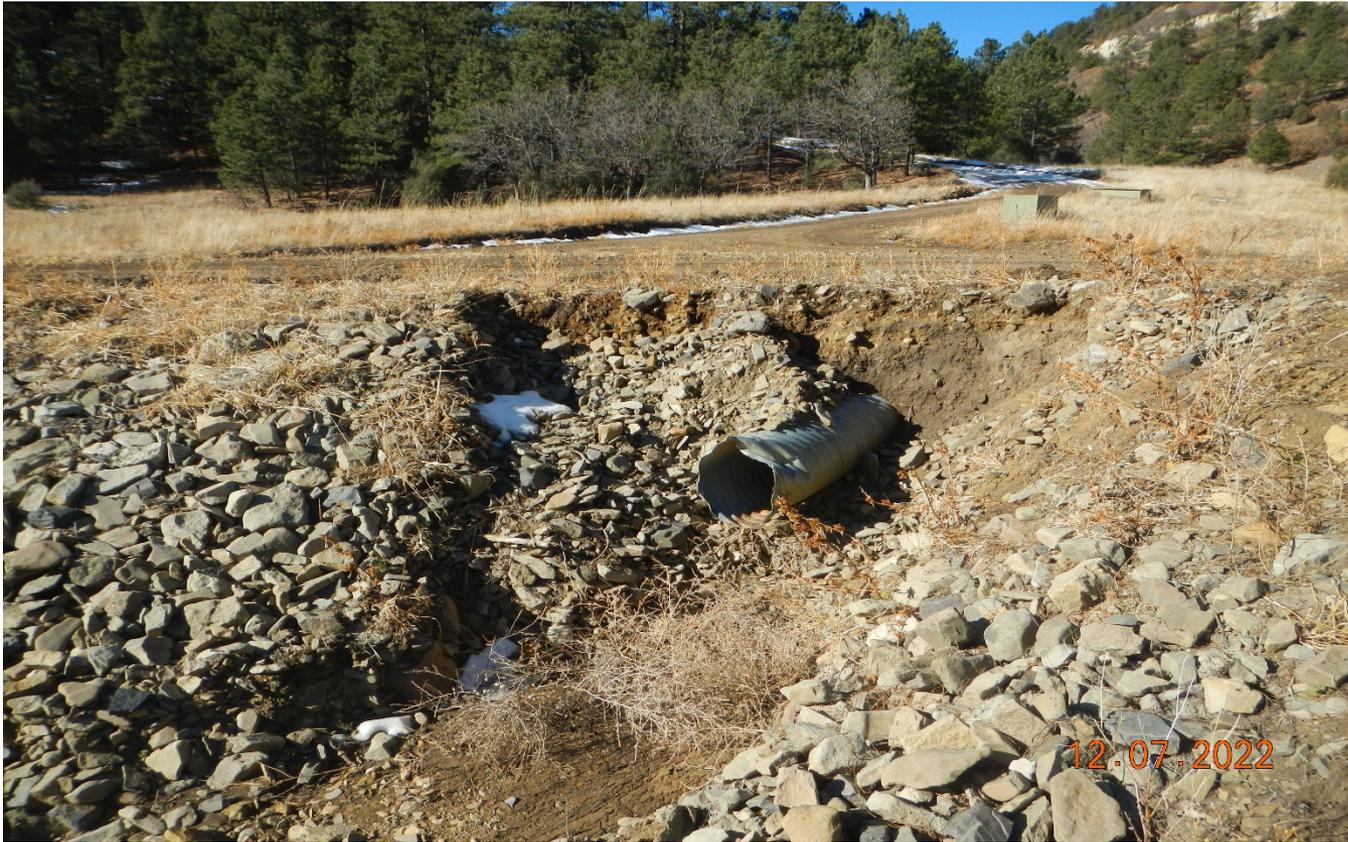
Photo 2. Facing west toward near the access road ascending the hillside. The culvert outlet has been washed out from recent storm event. It appears a larger culvert is needed along with larger rock rip/rap outlet protection. Previous corrective action not completed.

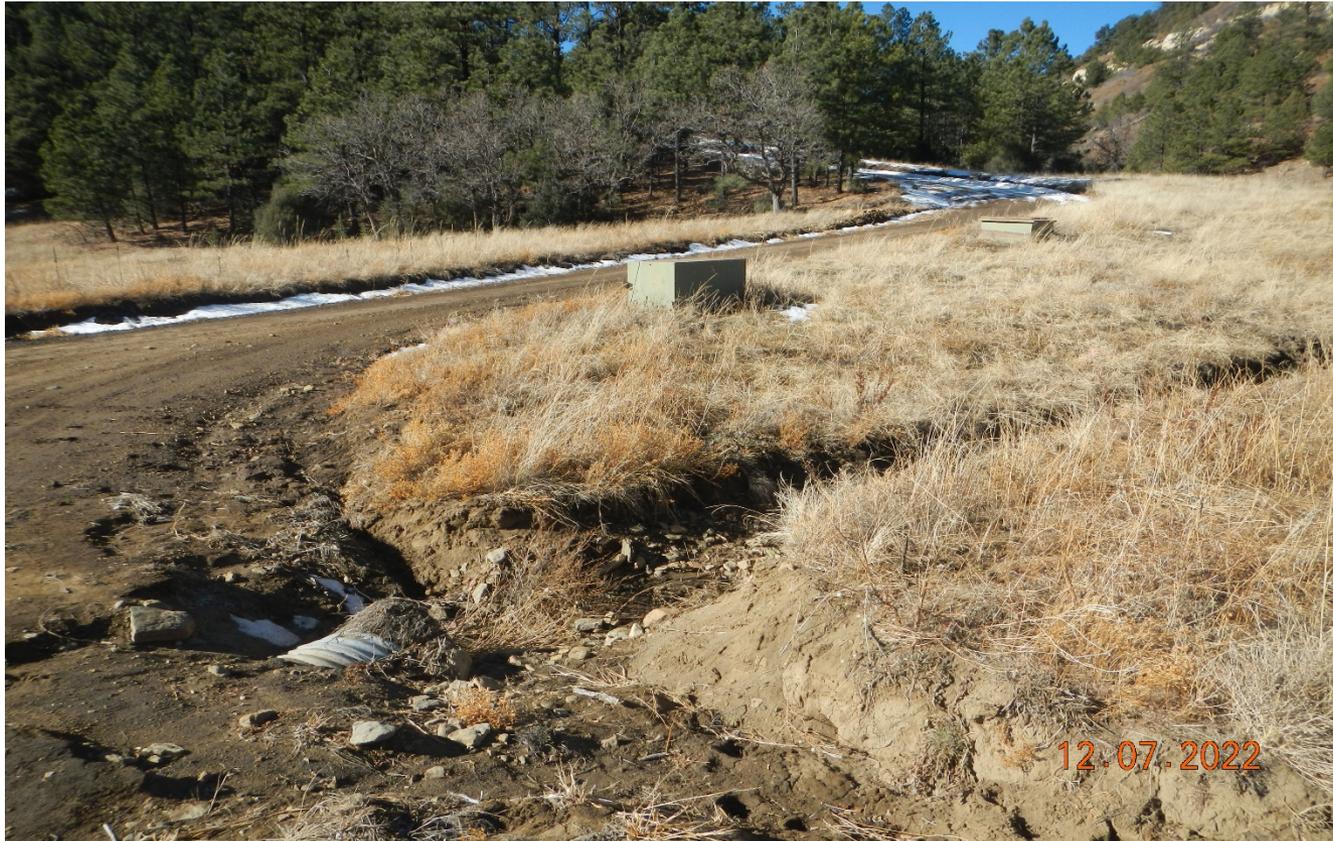
Photo 3. The culvert inlet is filled in with sediment and debris. It appears a larger culvert is needed at this area to handle stormwater coming off the road and drainage. Previous corrective action not completed.

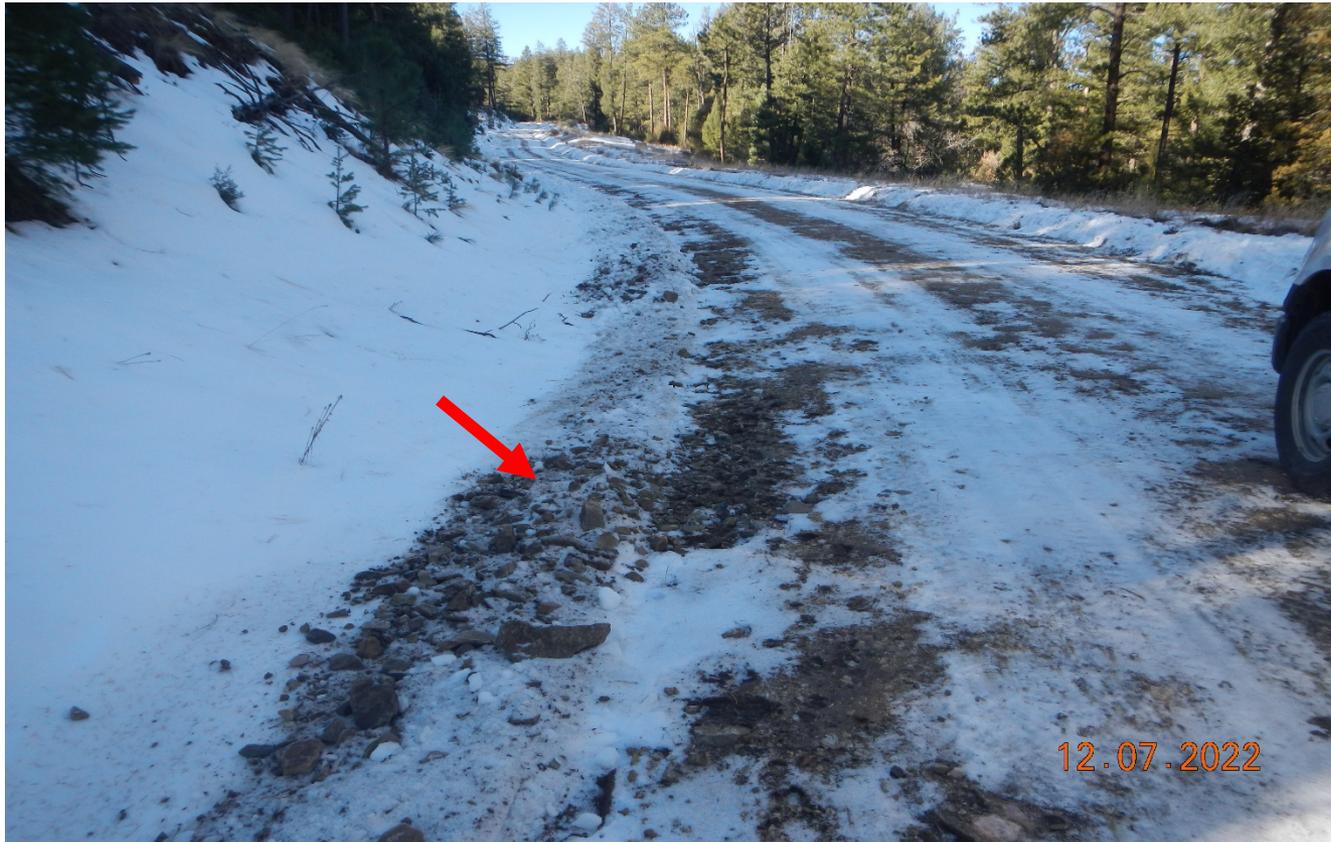
Photo 4. Facing west along the access road. The snow has been recently graded off the road. There erosion issues previously observed are now obscured by snow cover, Grading of the road has pushed some of the rock dams up shown at red arrow.

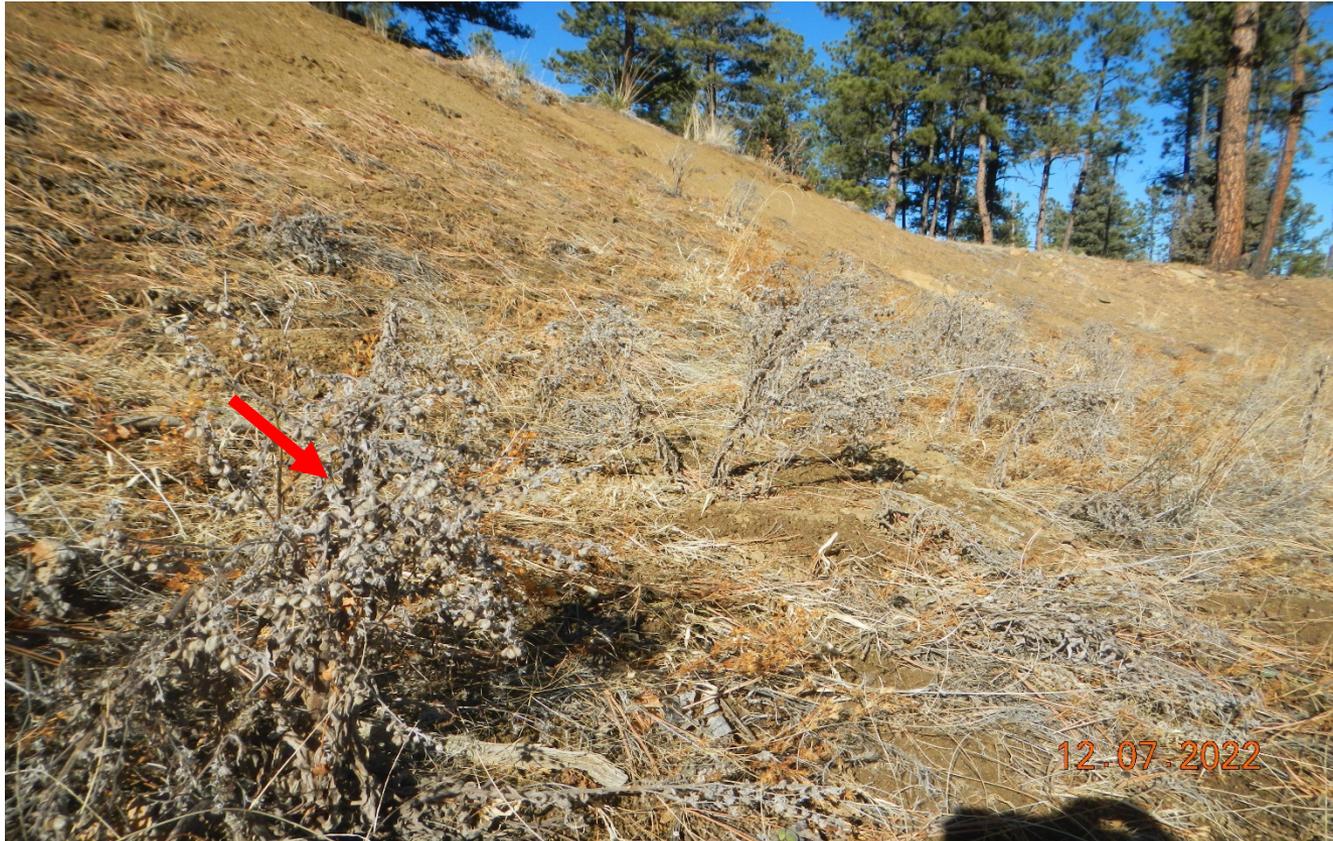
Photo 7. There are still noxious weeds Hounds tongue and Canada thistle which have not been controlled. The noxious weeds have produced seed so the weeds should have been bagged and removed. Red arrow points to Hounds tongue List B noxious weed.
