SITE NAME: Koch Kenneth E A1 O SA							DATE: 12/7/2022		REM. PROJECT #:		WEATHER: 38 Degrees, Sunny	
SITE DIRECTIONS: CO Hwy 52 & CR 3, S 5/10, W Into							CLIENT: Oxy					
LEGALS AND LAT/LONG: 40.079631, -105.038060							TASMAN PERSONNEL: Logan Molson					
SOIL TYPES: Clayey Sand - SC							SURFACE GRADIENT: West					
SOIL SAMPLING							FACILITY INFRASTRUCTURE					
Date/Time	Soil Sample ID	PID (ppm)	Visual	Olfactory	Photo?	Grab or Lab Sample?	EQUIPMENT		Quantity			
							Above Ground Storage Tank (AST)		3			
12/7/2022 10:30	PW1-B01@5'	0.4	Organic Content	Organic Odor	Yes	Lab	Buried or Partially Buried Vessel		1			
12/7/2022 10:35	PW1-N01@3'	0.5	No Staining	No Odor	Yes	N/A	Separator		1			
12/7/2022 10:37	PW1-S01@3'	0.2	No Staining	No Odor	Yes	N/A	Emission Control Device (ECD)		1			
12/7/2022 10:39	PW1-E01@3'	2.5	No Staining	No Odor	Yes	Lab	Dump Line		1			
12/7/2022 10:41	PW1-W01@3'	0.4	No Staining	No Odor	Yes	N/A	Wellhead

Photographic Log

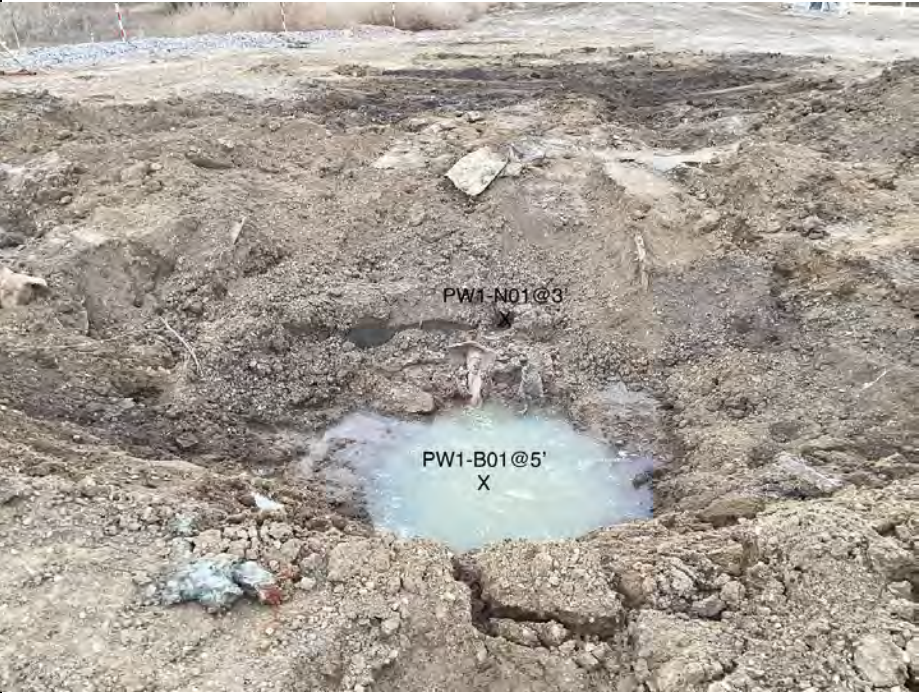
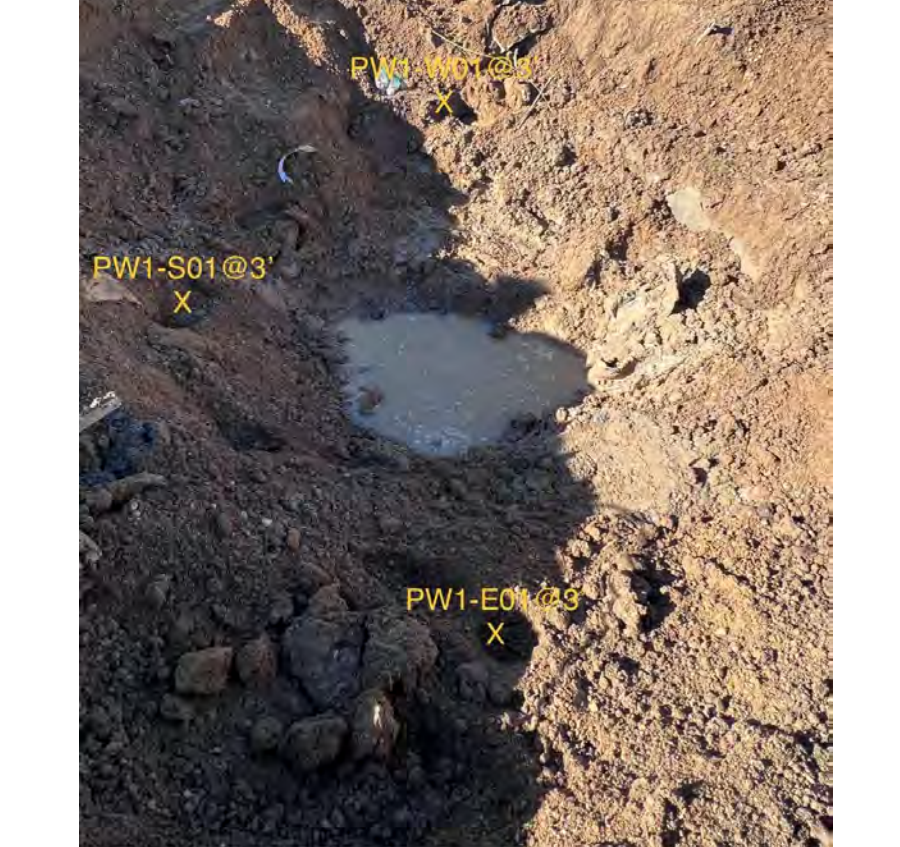
Equipment ID:		Equipment Type:		Equipment ID:		Equipment Type:	
Material:	Volume:	Contents:	Material:	Volume:	Contents:		
Notes/Conditions: Rain water and snow melt collected around the PWV prior to removal and filled into pit afterward. Pictured water is not groundwater			Notes/Conditions:

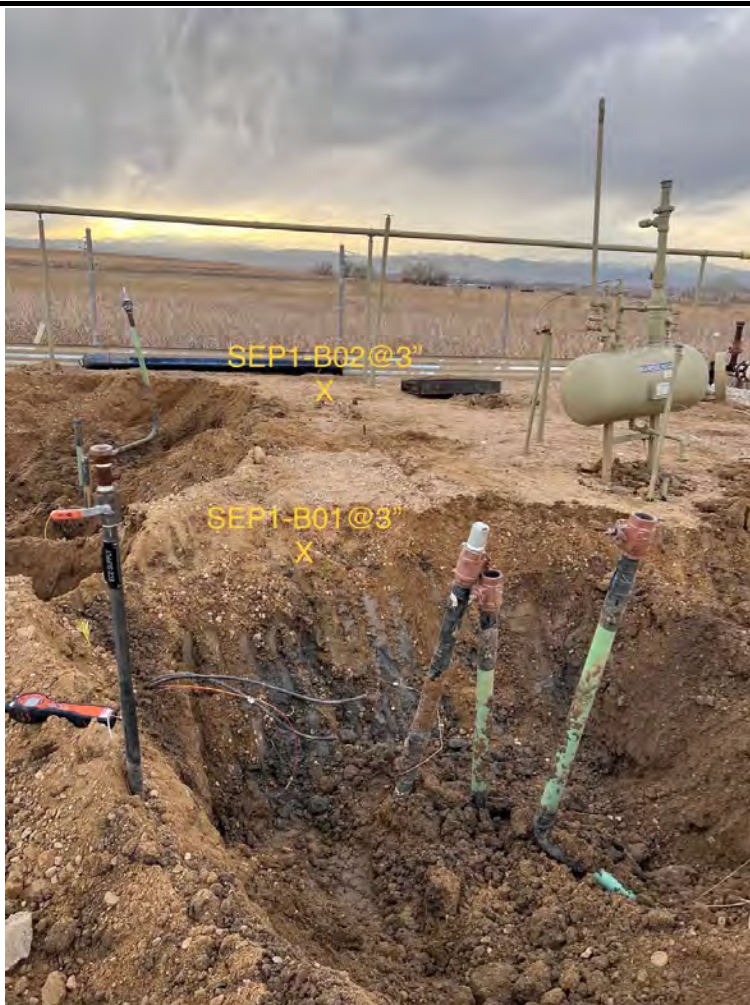
Equipment ID:		Equipment Type:	
Material:	Volume:	Contents:	
Notes/Conditions: Prior sampling location of 3" dug down to expose dump lines for removal
