Inspection Photos

Location Name: TEP ROCKY MOUNTAIN LLC JOLLEY FED (MDP PAD #12) /22D-20-691

Location ID: 414522

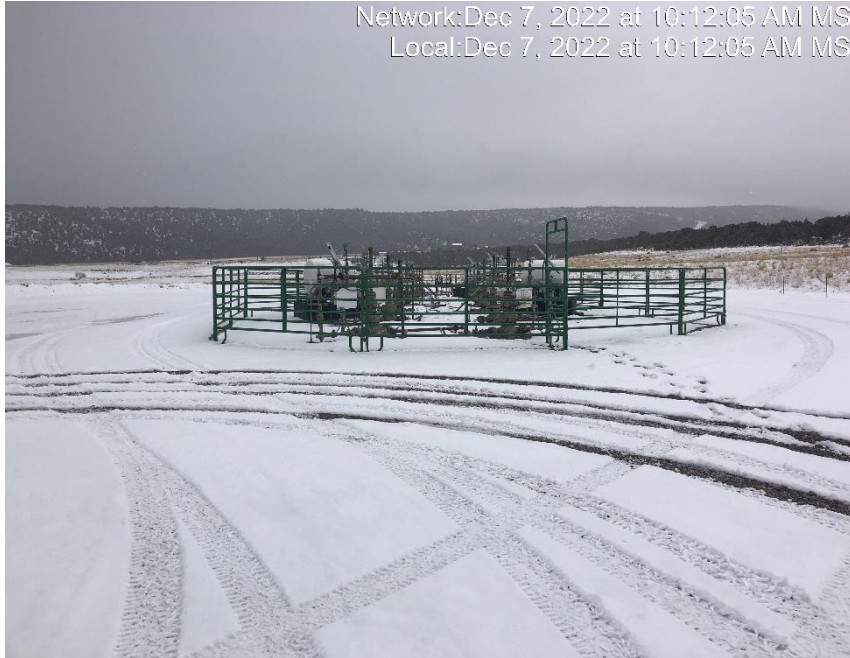
Photo #8557 From entrance to location.

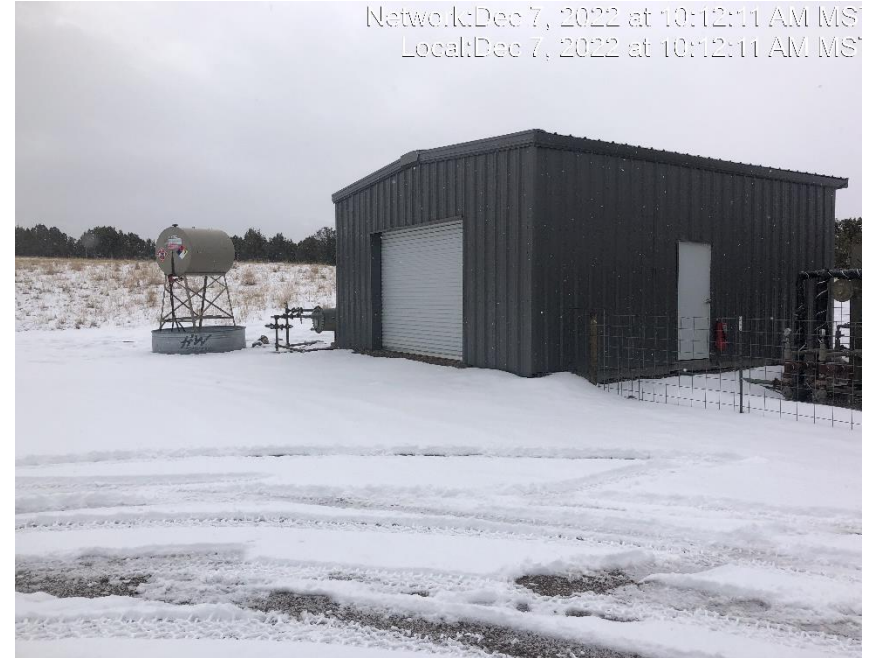
Photo #8558 From entrance to location

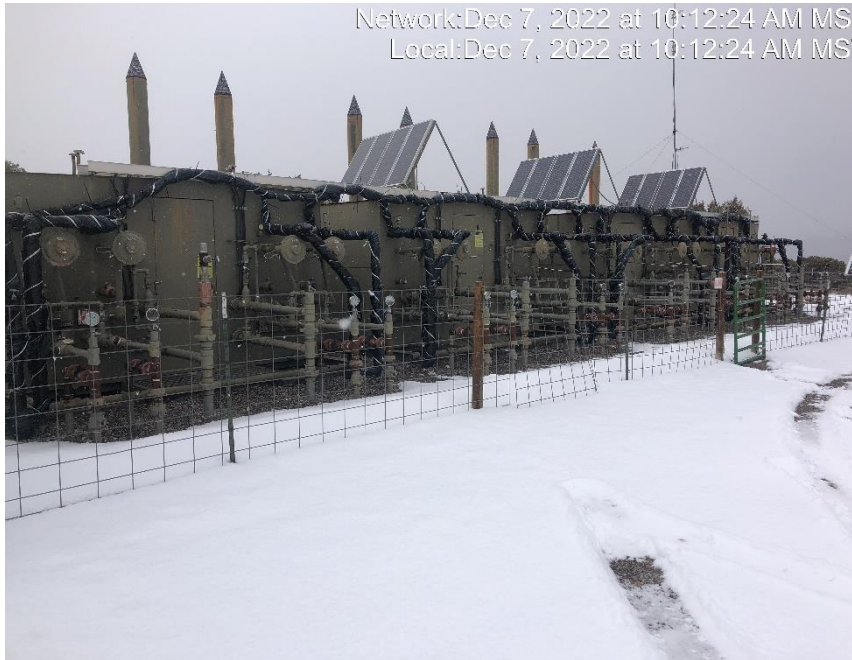
Photo #8559 From entrance to location.

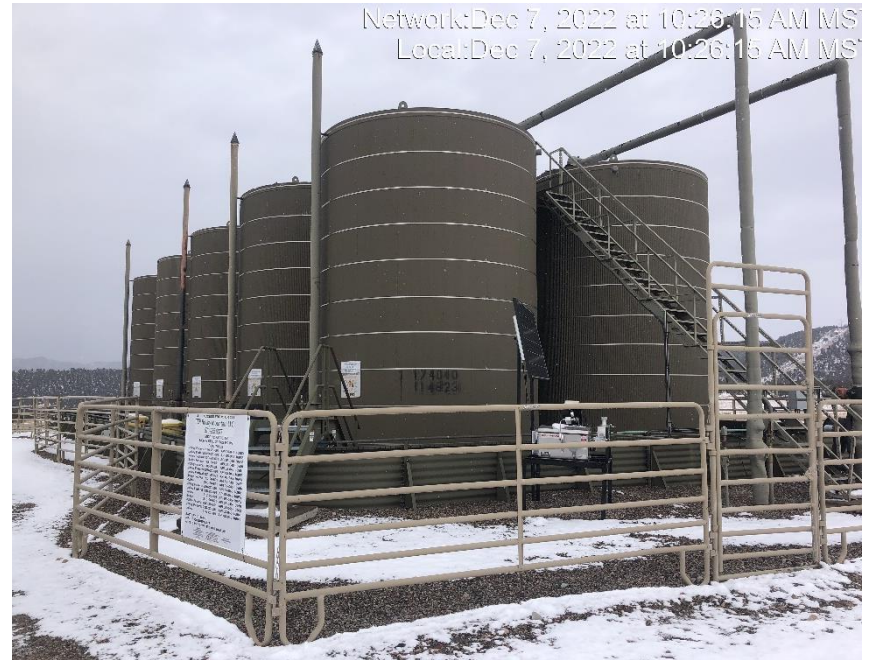
Photo #8563 From entrance to location.

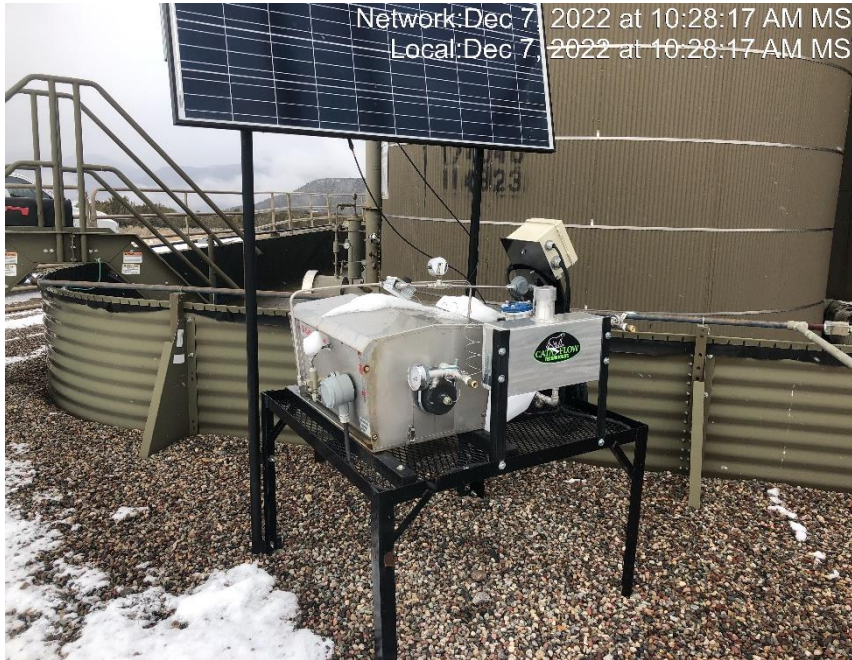
Photo #8564 Multiple places with unused equipment.

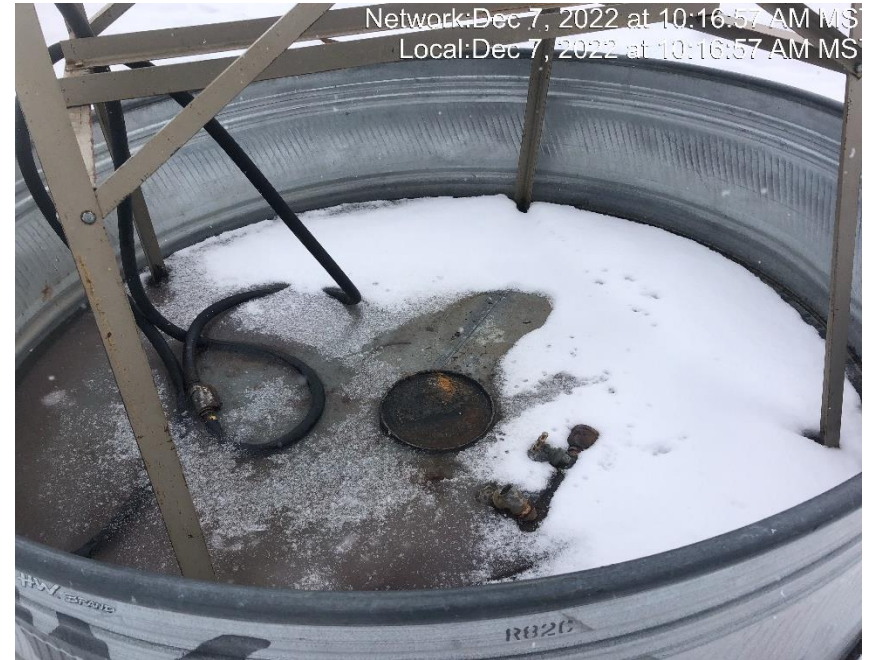
Photo #8560 Multiple places with unused equipment.

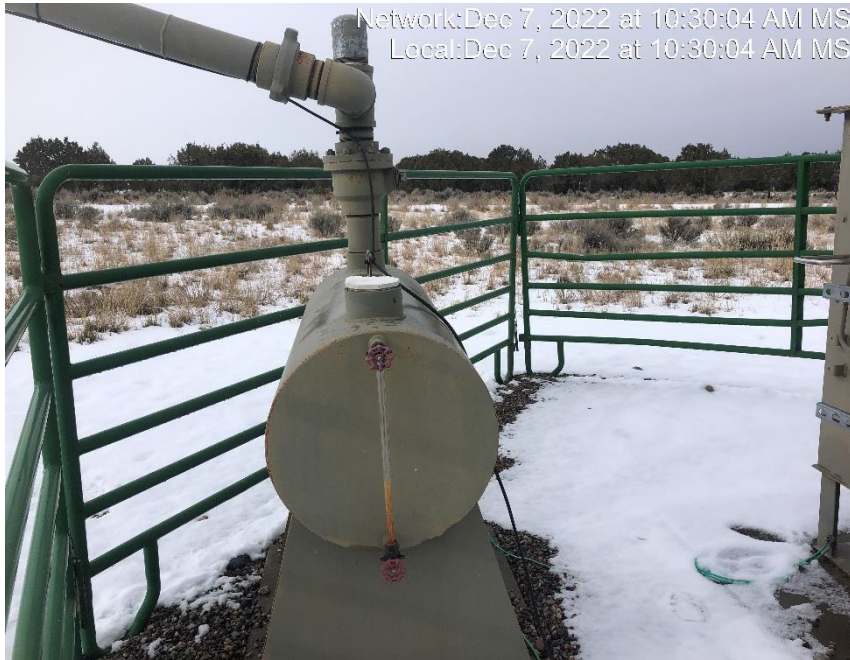
Photo #8565 Stored equipment.

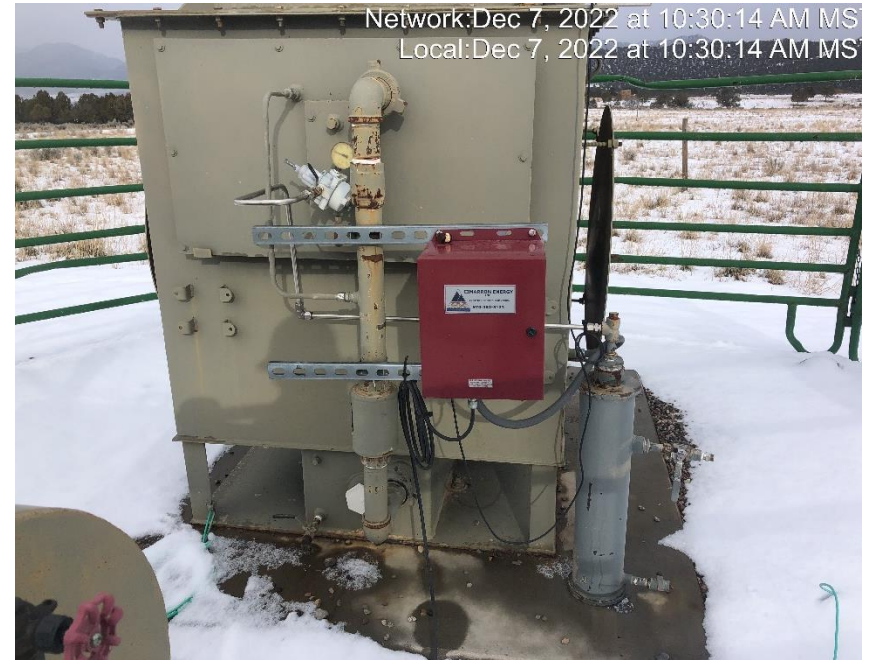
Photo #8566 Stored equipment.

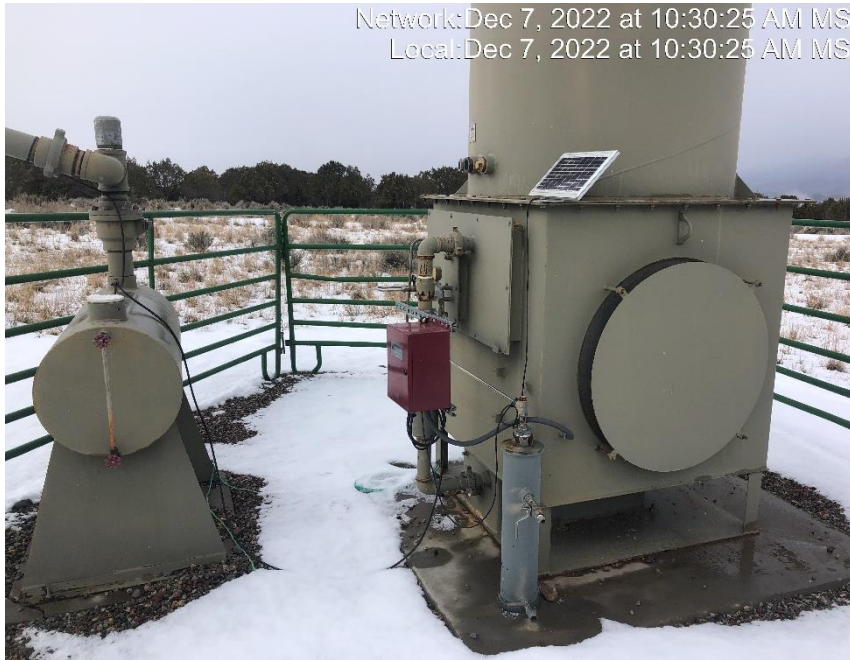
Photo #8567 Stored equipment.

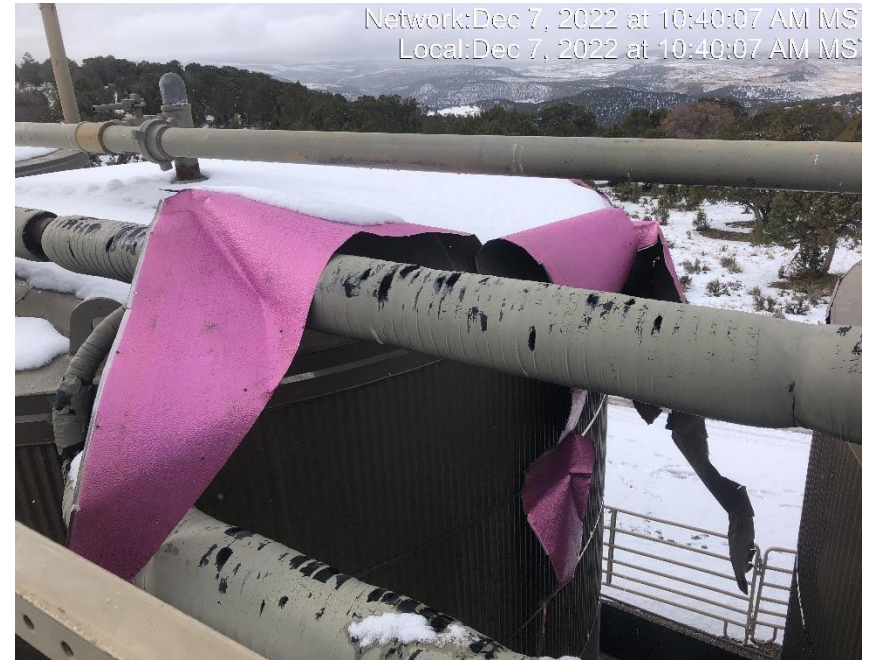
Photo #8570 Tank insulation needs repaired.

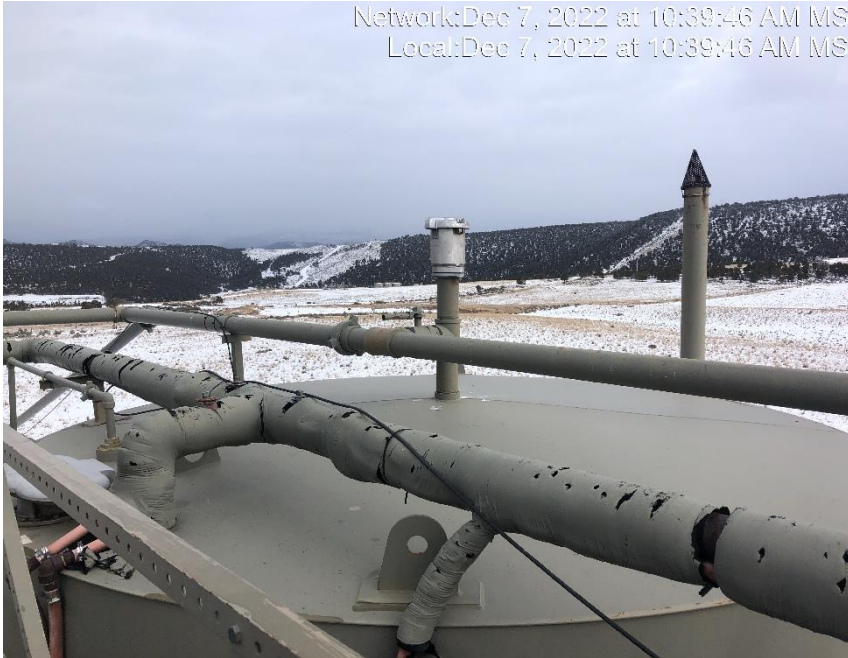
Photo #8569 PRV leaking Referto OGIS.

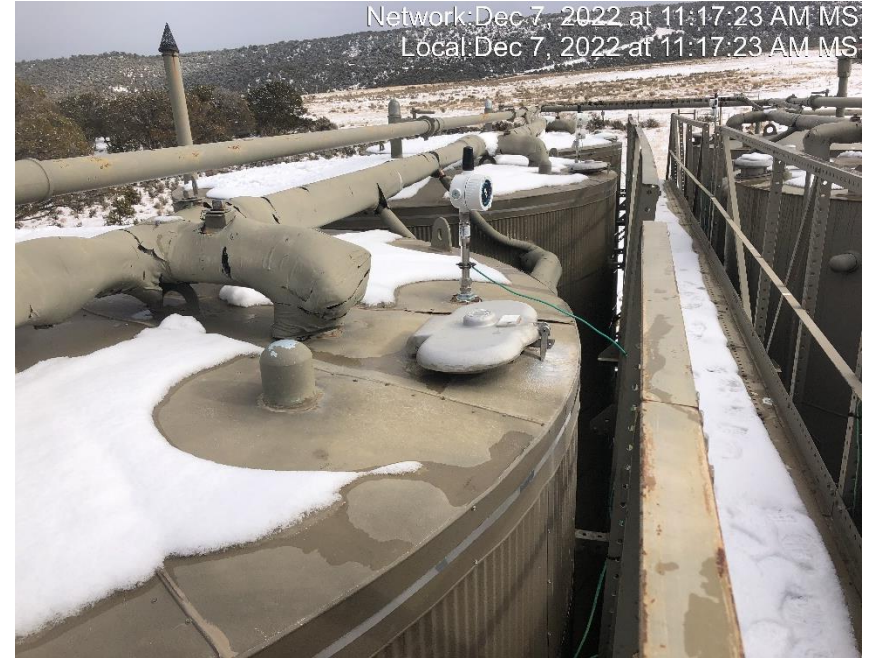
Photo #8570 Multiple thief hatches leaking refer to OGIS.
