Inspection Photos

Location Name: TEP ROCKY MOUNTAIN LLC GGU FED (MDP PAD #10) /23A-20-691

Location ID: 417399

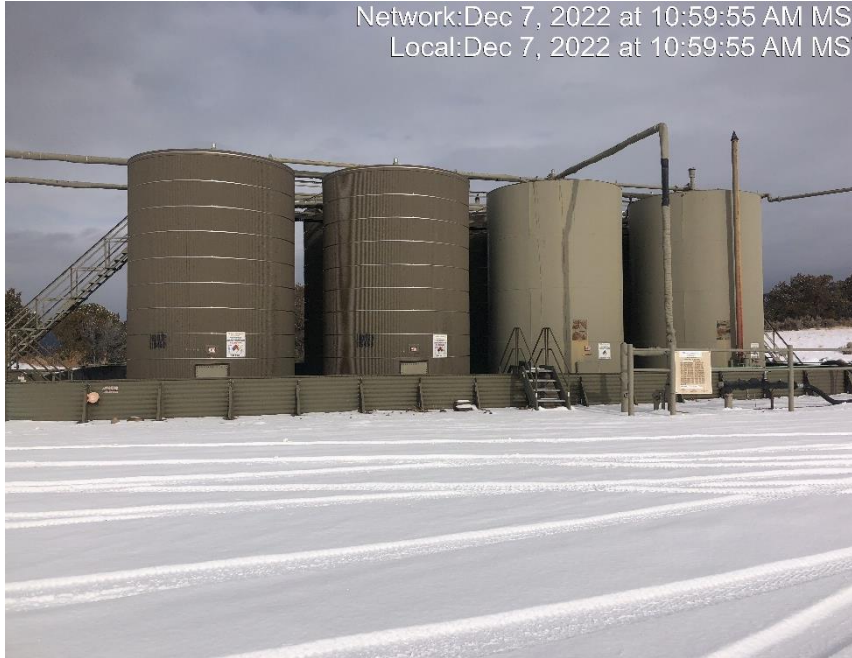
Photo #8571 From entrance to location.

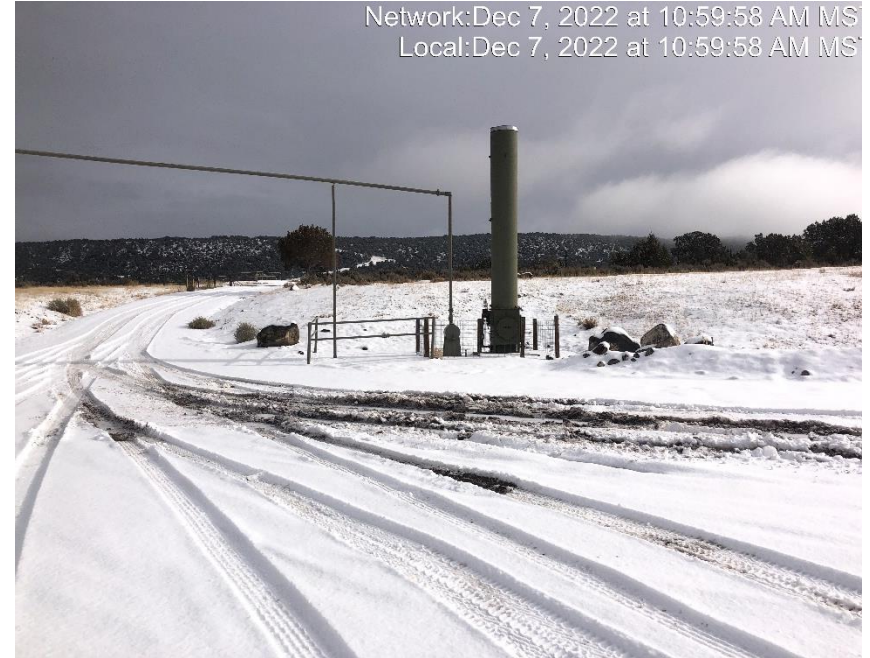
Photo #8572 From entrance to location

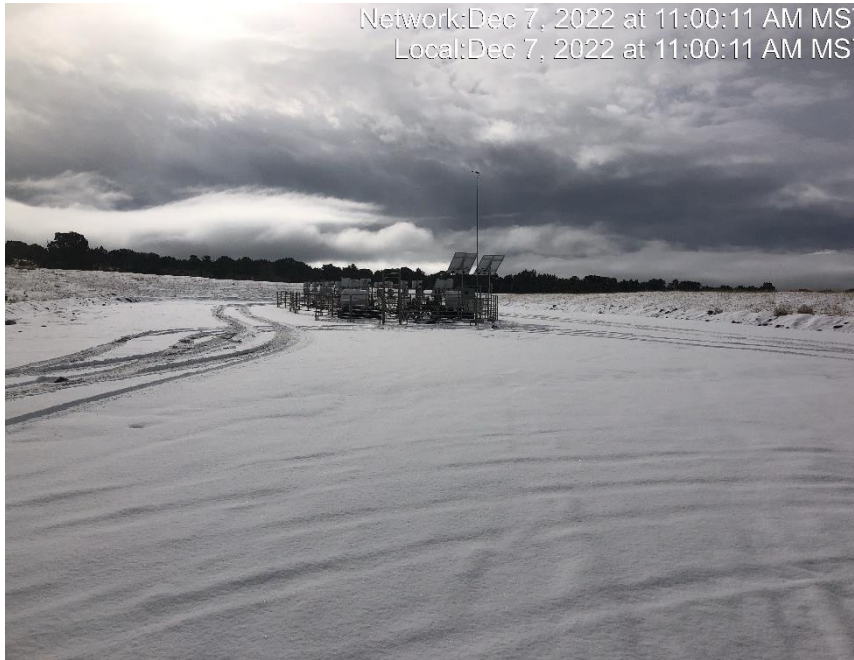
Photo #8573 From entrance to location.

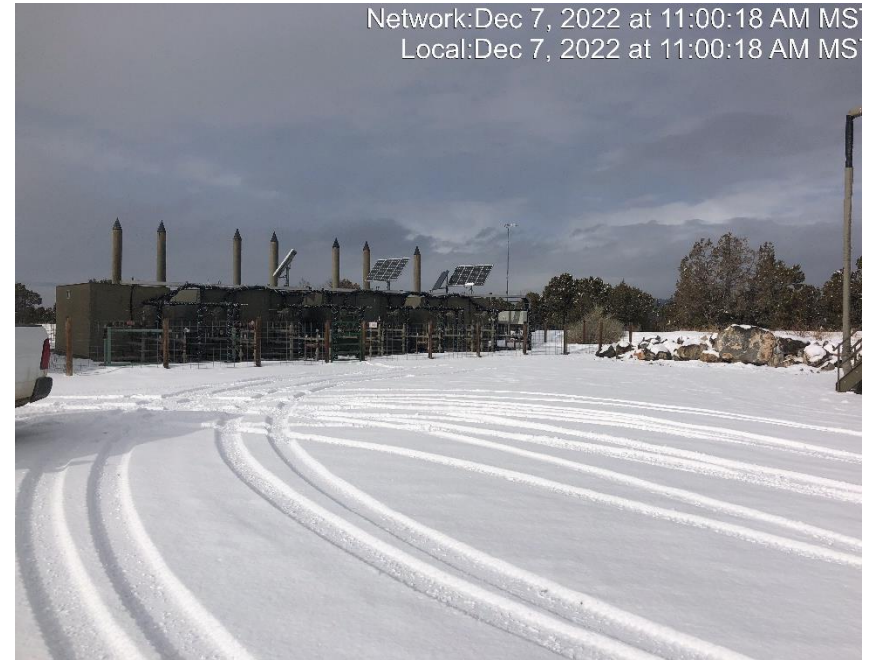
Photo #8574 From entrance to location

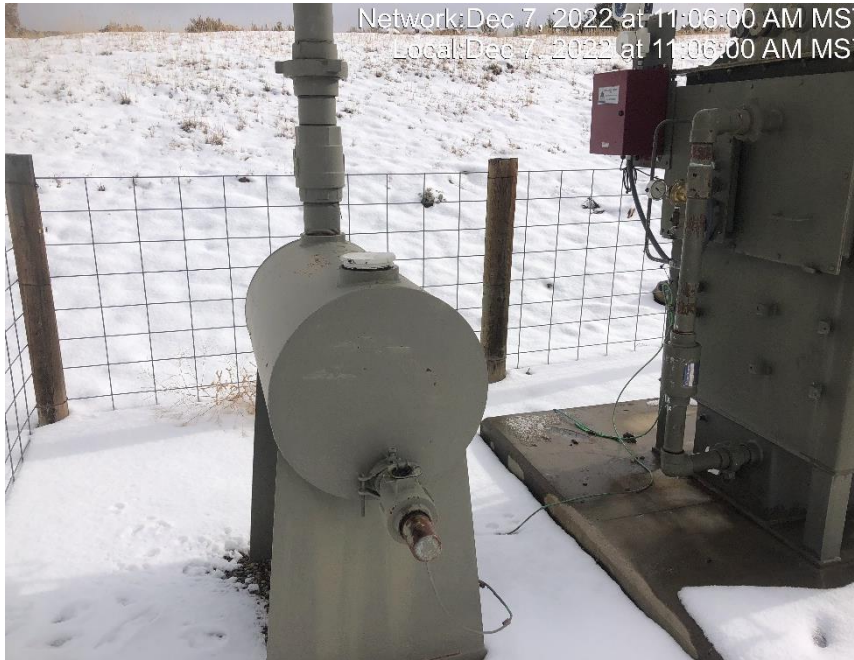
Photo #8576 Unused equipment.

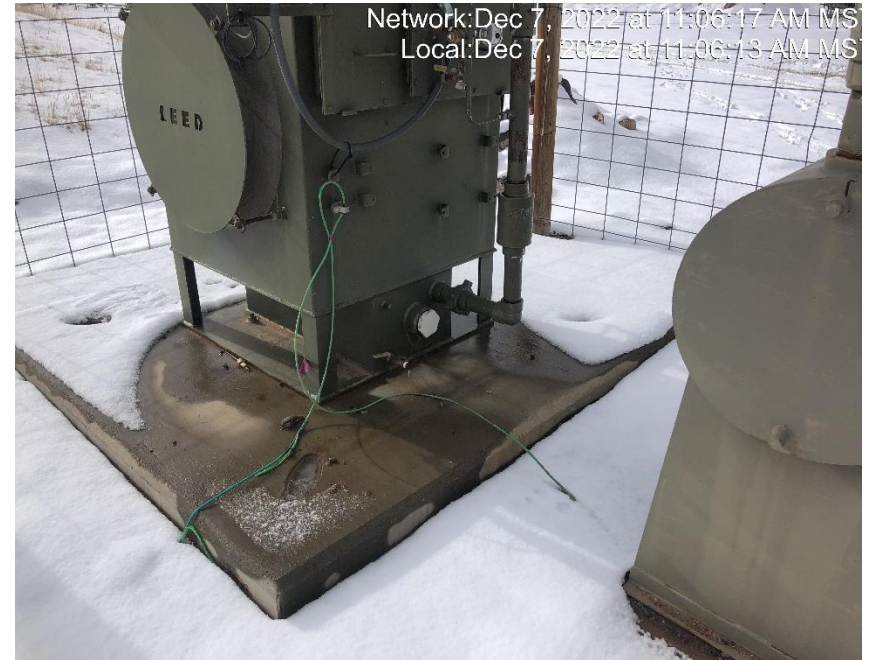
Photo #8577 Unused equipment.

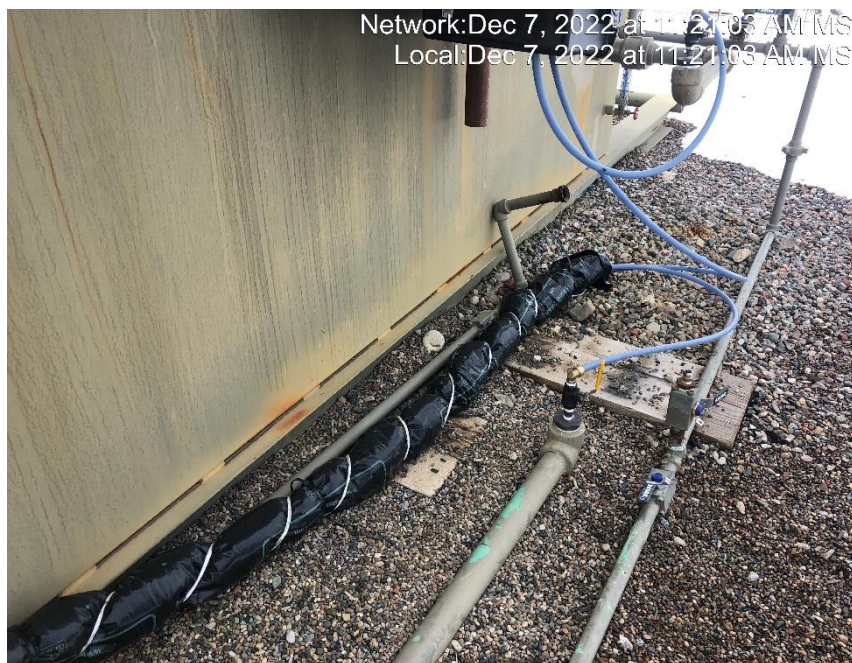
Photo #8584 Multiple places with unused equipment.

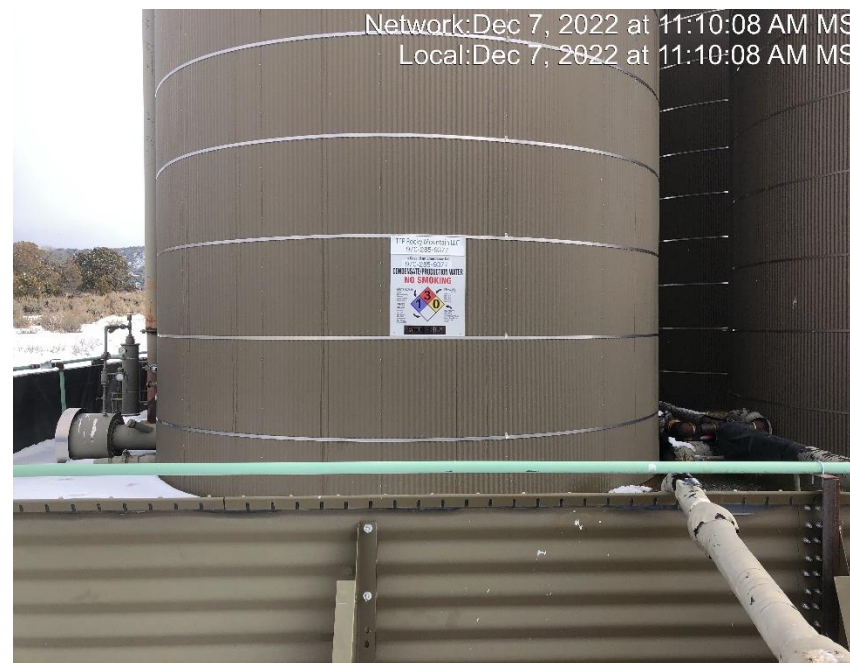
Photo #8579 Tank label weathered and not legible.

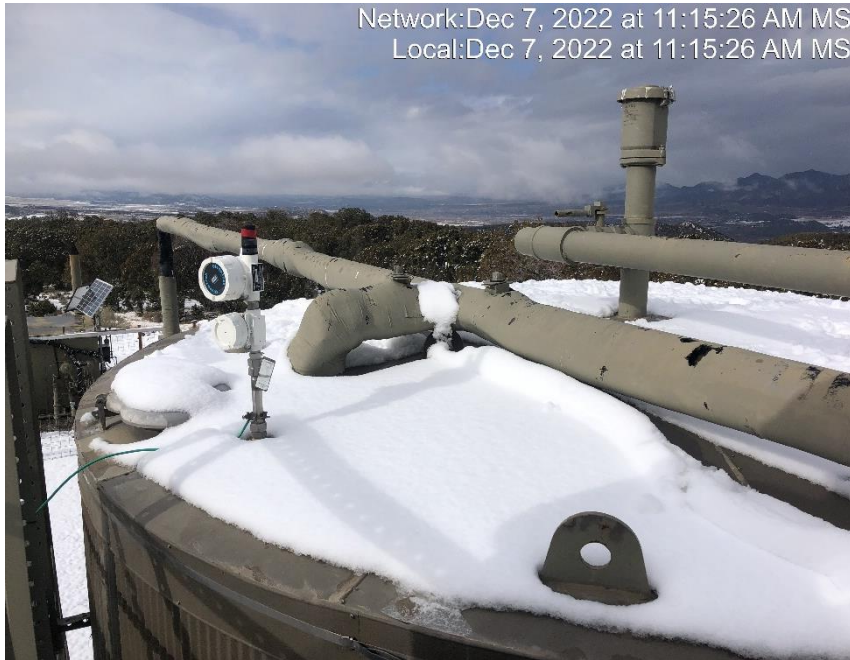
Photo #8580 Leaking PRV refer to OGIS.

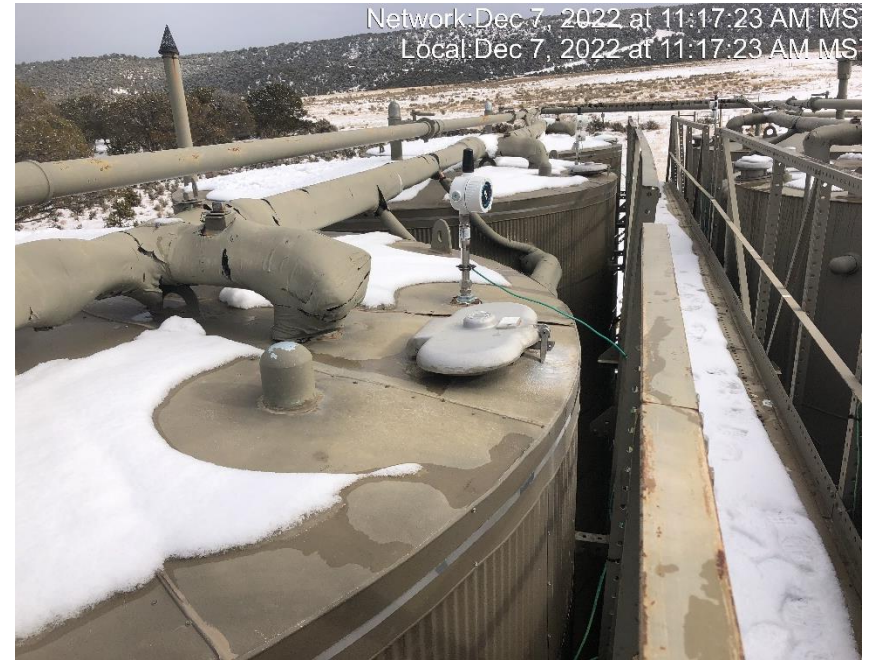
Photo #8581 Multiple leaking Gauge hatches refer to OGIS
