Inspection Photos

Operator: Caerus Piceance LLC - #10456

Location Name: MILLER-67S93W/14NWNE

Inspection Document #: 702801037

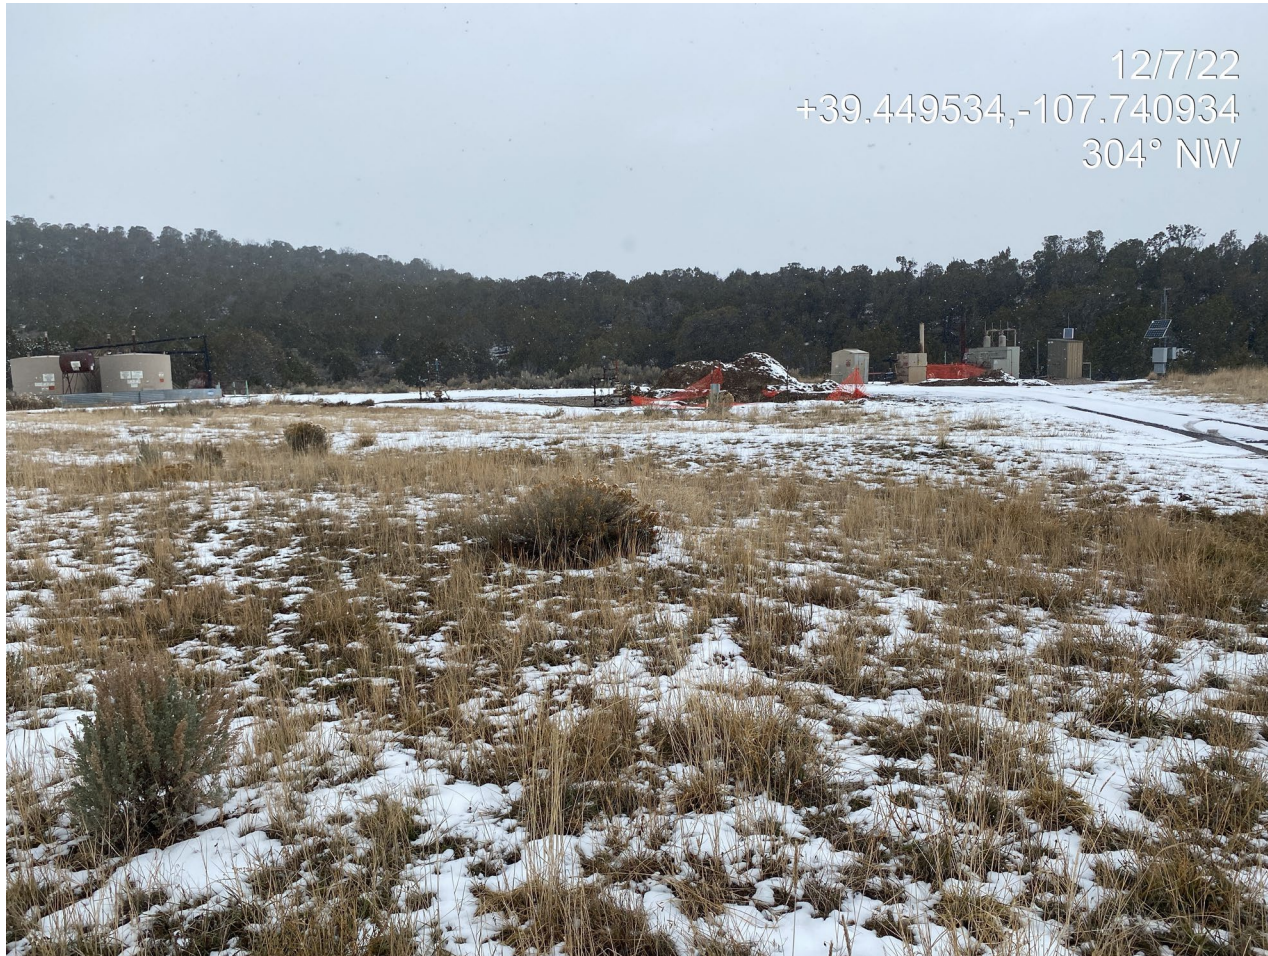
Photo 1. Photo taken from the south shows an overview of the location, including interim areas.

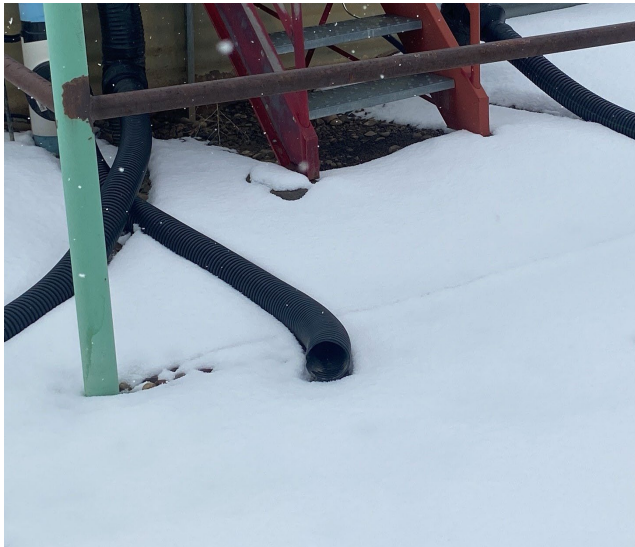
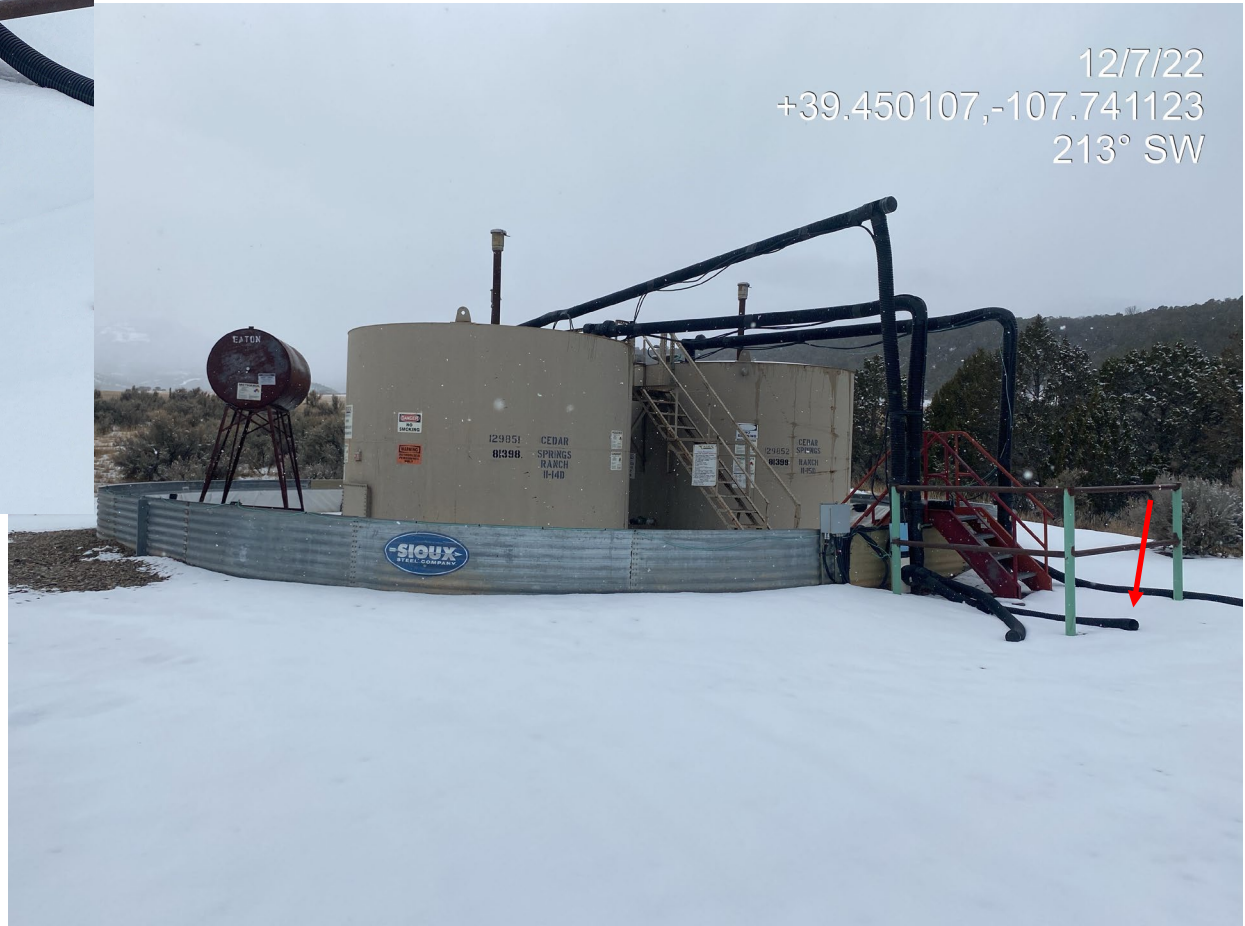
Photo 2. Photo shows production areas. Piping is open ended/uncapped allowing for wildlife access.

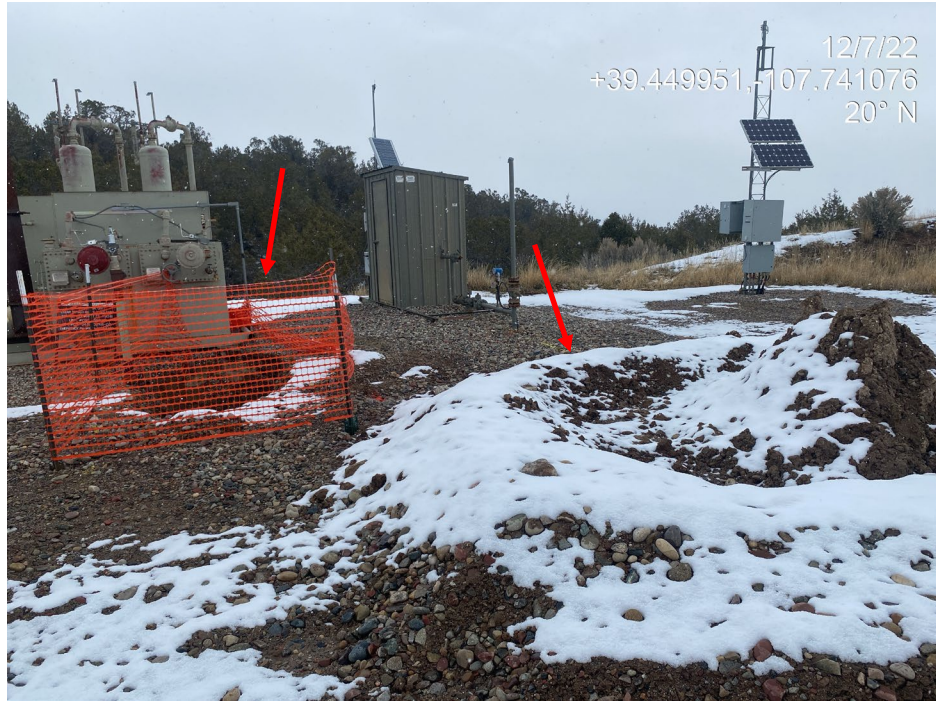
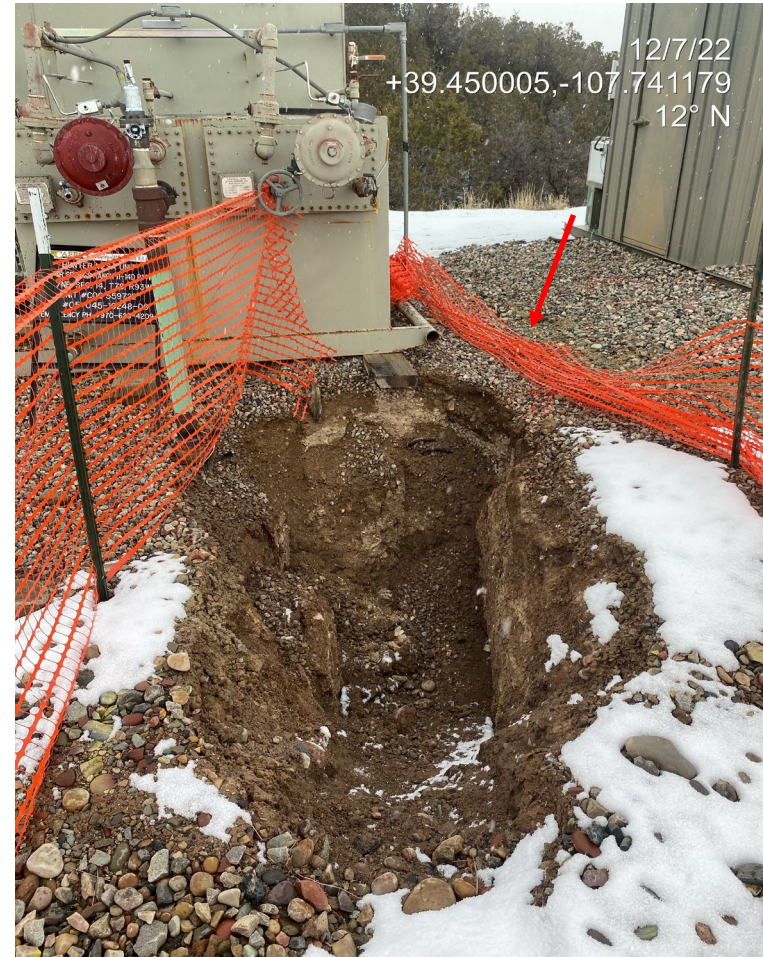
Photo 3. Photos show production areas and an excavation at separators. Excavated soil is surrounded by a berm of loose, unconsolidated soil. Orange safety fence is in disrepair/not properly installed to exclude entry into trench.

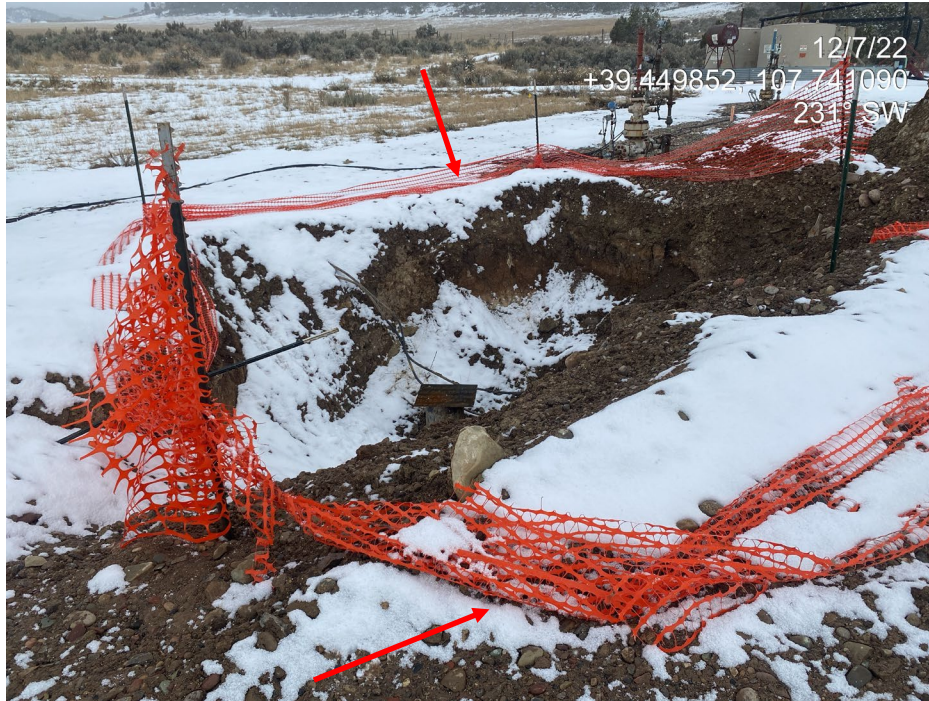
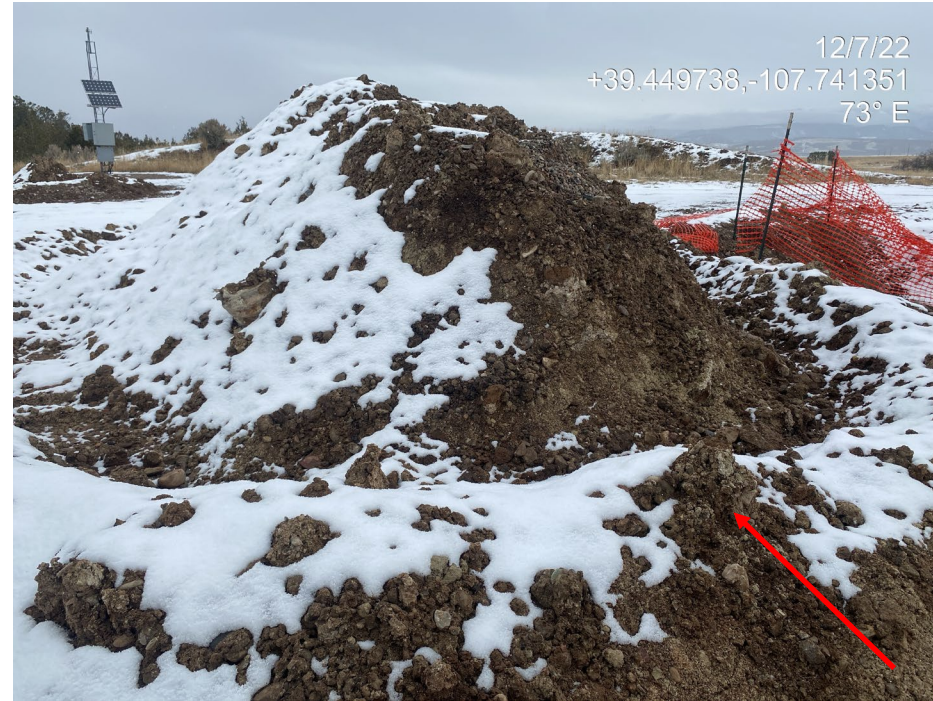
Photo 4. Photos an excavation at well API #045-10247. Excavated soil is surrounded by a berm of loose, unconsolidated soil. Orange safety fence is in disrepair/not properly installed to exclude entry into trench.

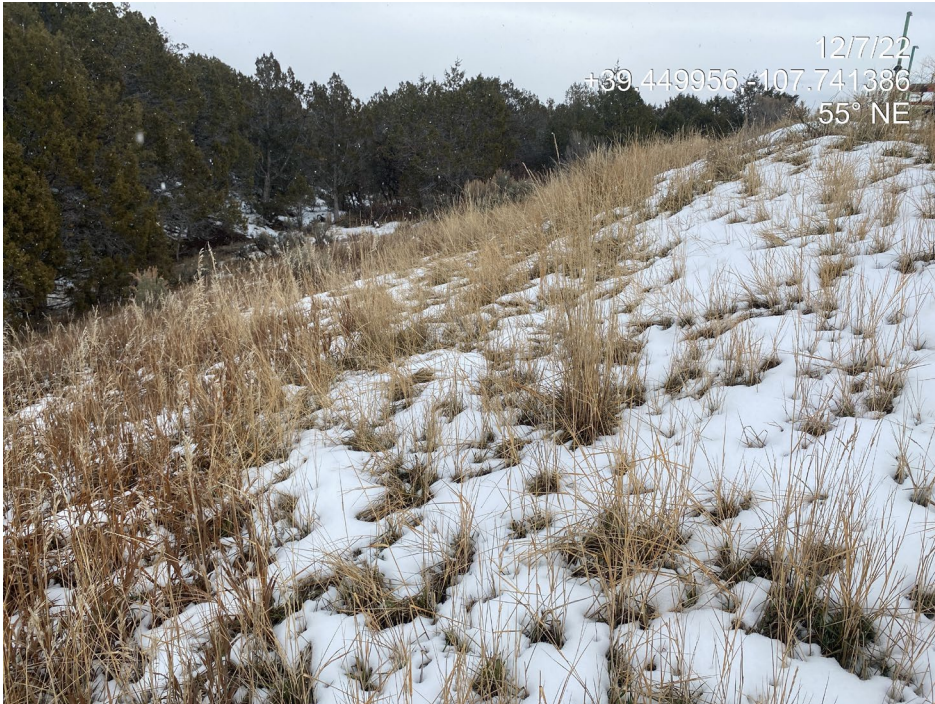
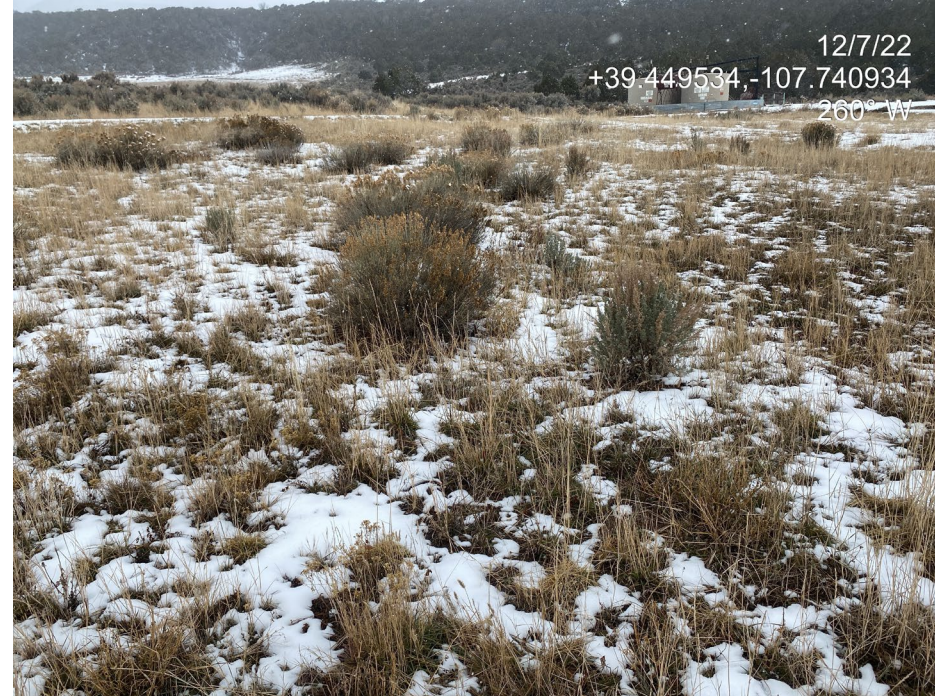
Photo 5. Photos show interim areas to the north (left) and south (right) appear dominated by introduced perennial grasses.
