Inspection Photos

API: 071-08113

Operator: EVERGREEN NATURAL RESOURCES

Inspection Date: 12/12/2022

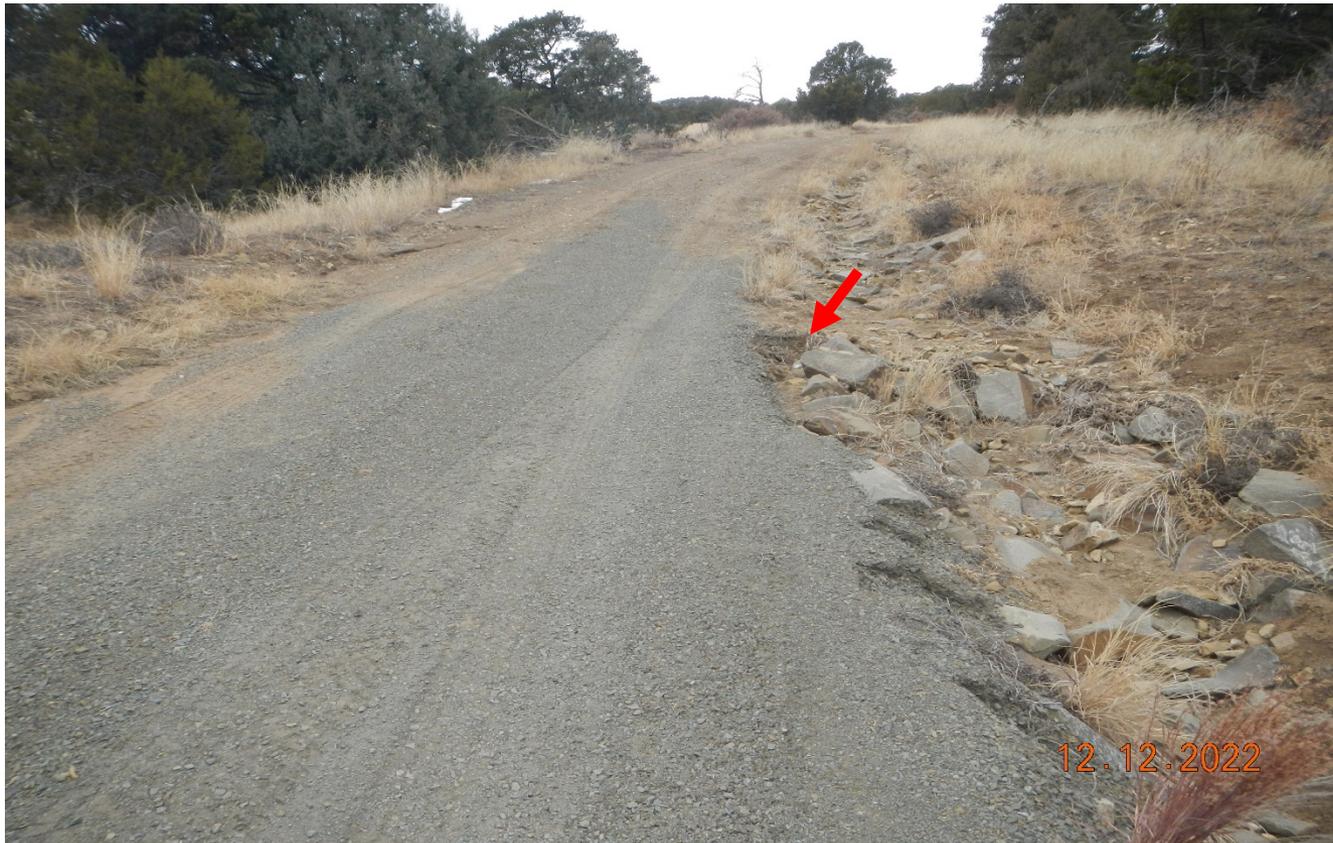
Photo 1. Facing west at the beginning of the access road. Stormwater is flowing around the rock check dam at the red arrow and is in need of maintenance.

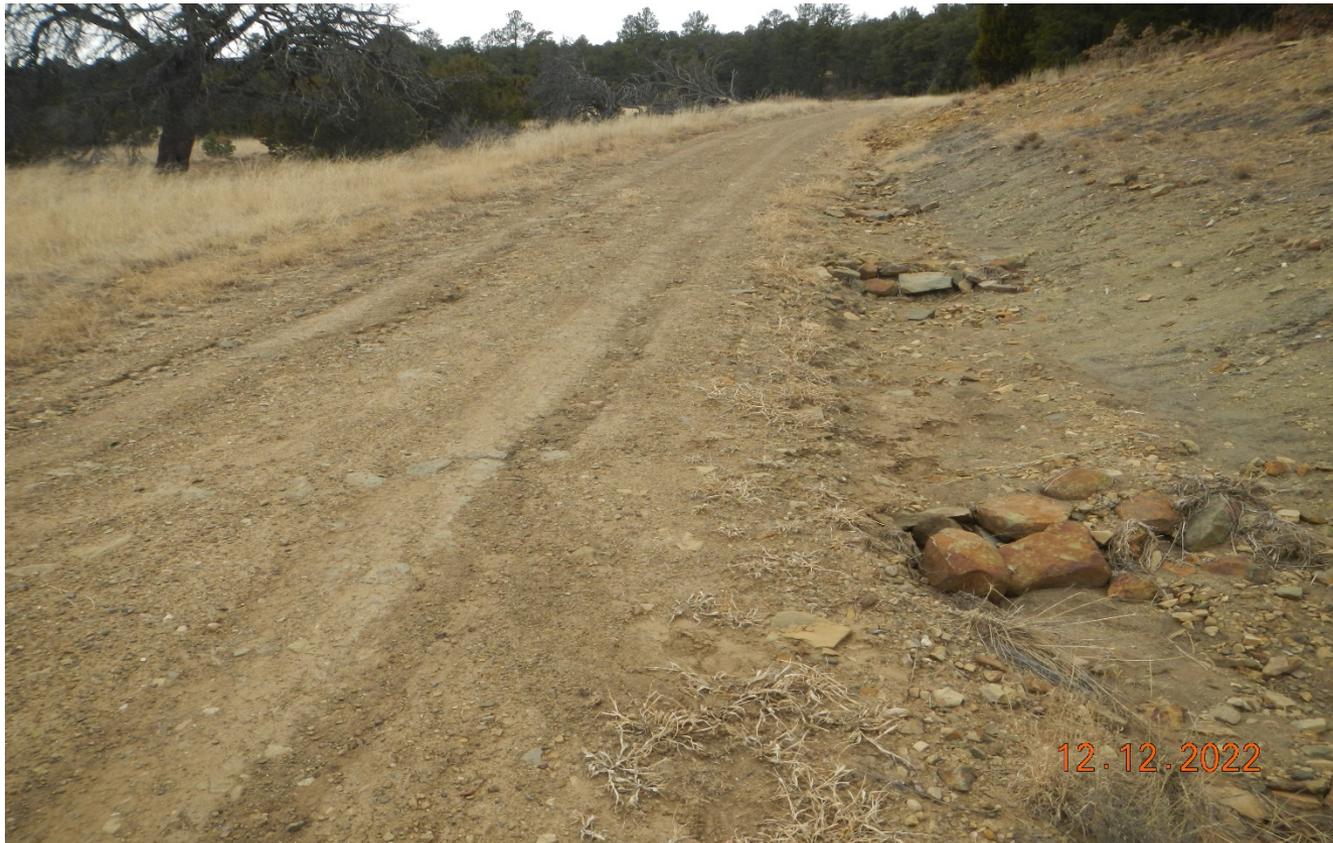
Photo 2. Facing northwest along the access road. The rock check dams have filled in with sediment and are in need of maintenance.

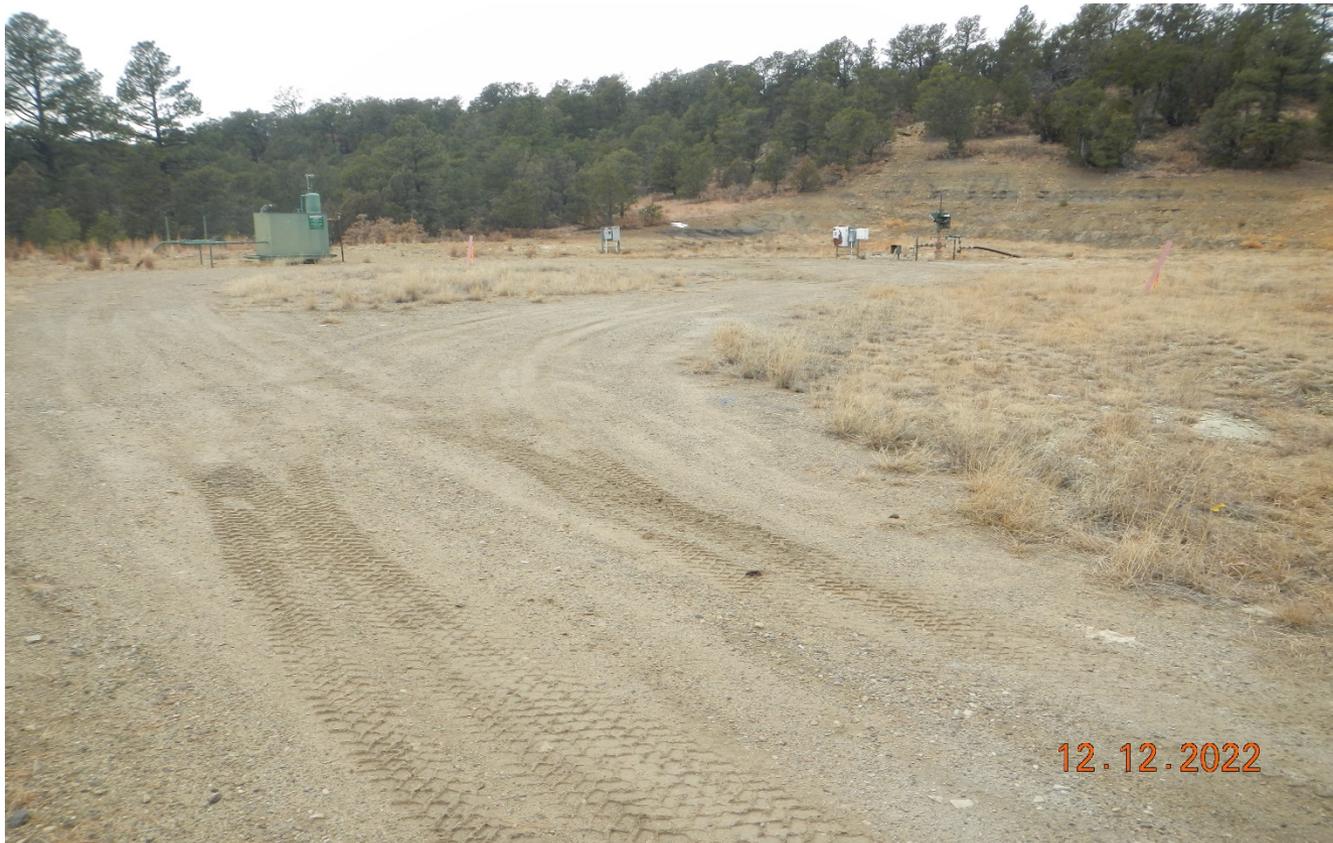
Photo 3. Facing southwest toward the well site.

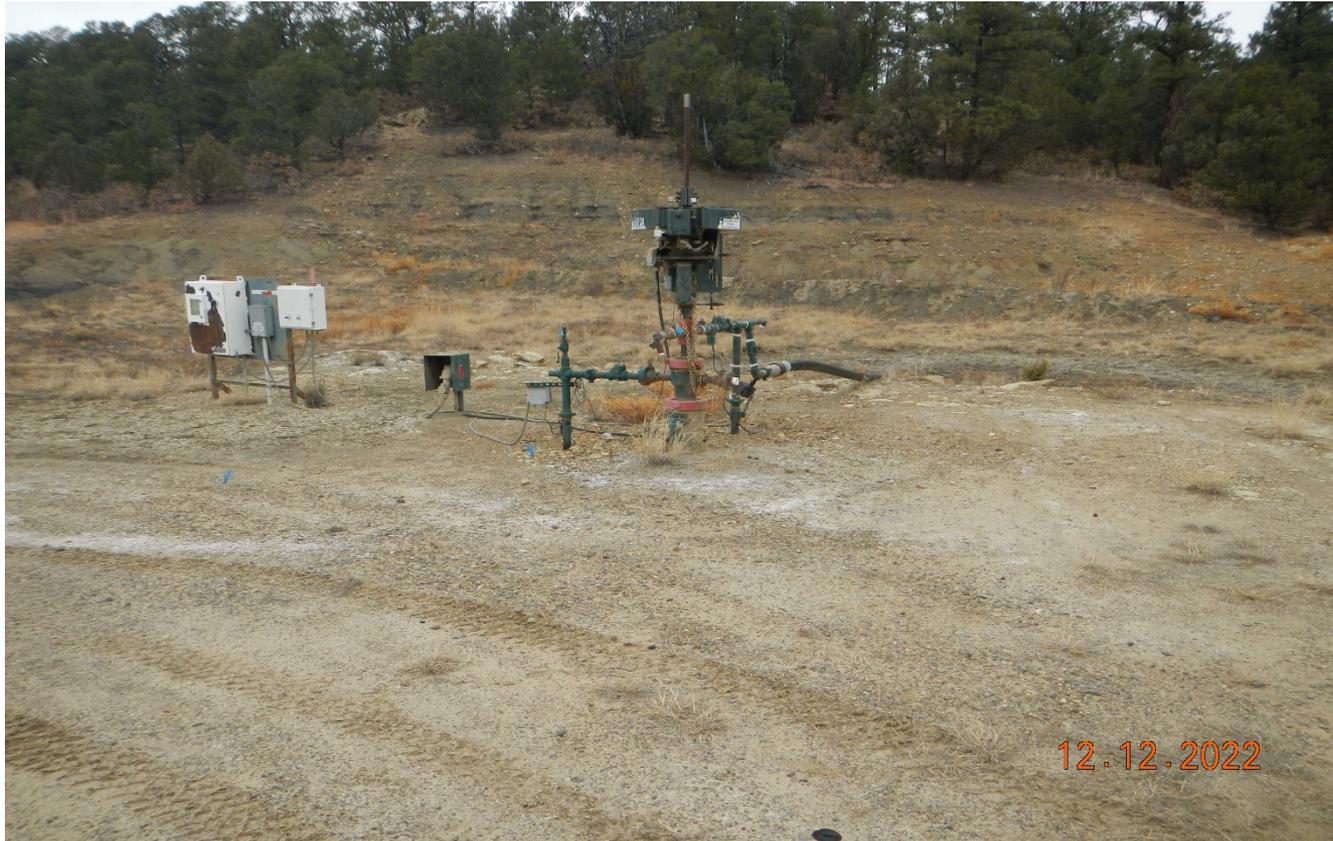
Photo 4. Facing west toward the well and pit.

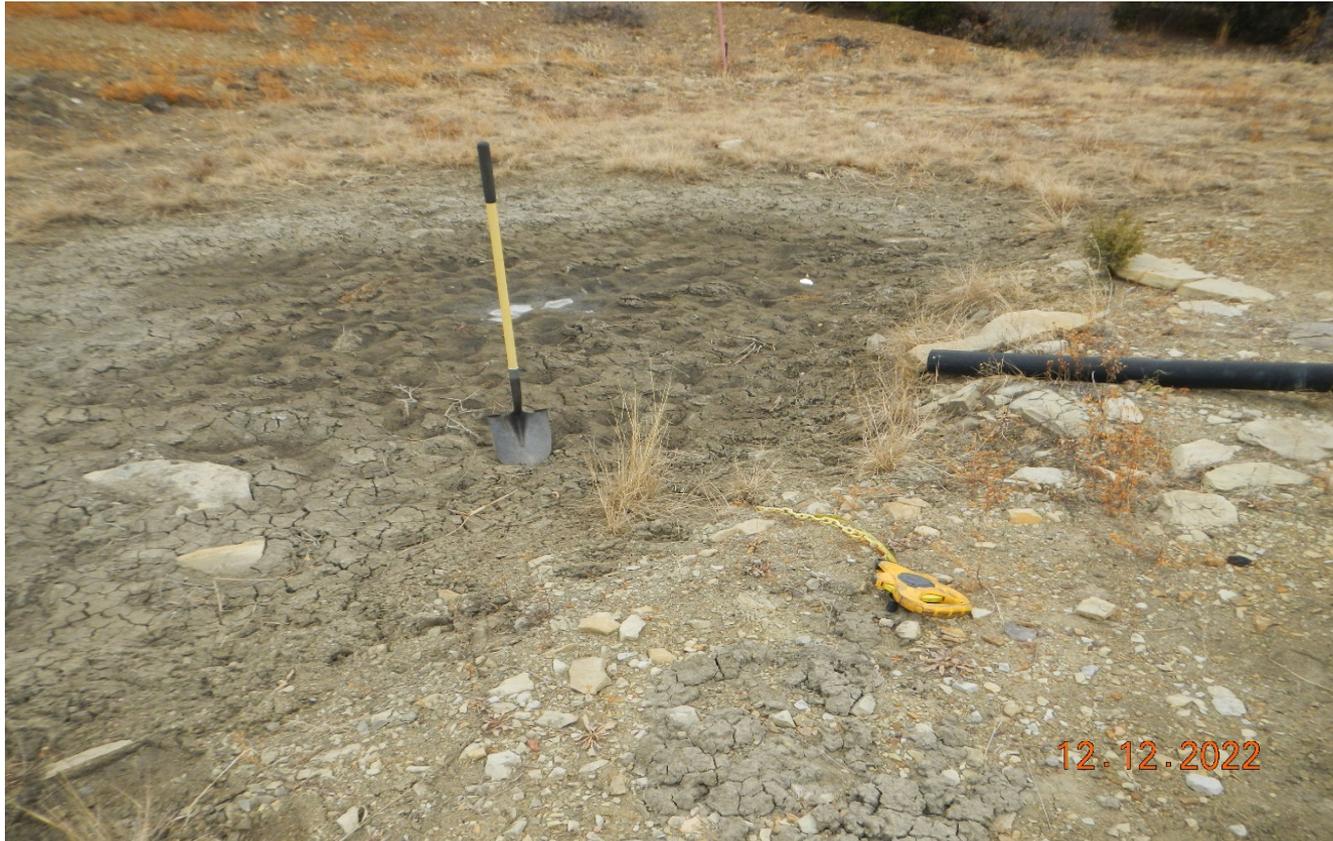
Photo 5. Facing toward the pit. The pit is shallow; less than 2 ft. deep and needs to be constructed to allow 2 ft. freeboard. Previous corrective action was not completed.

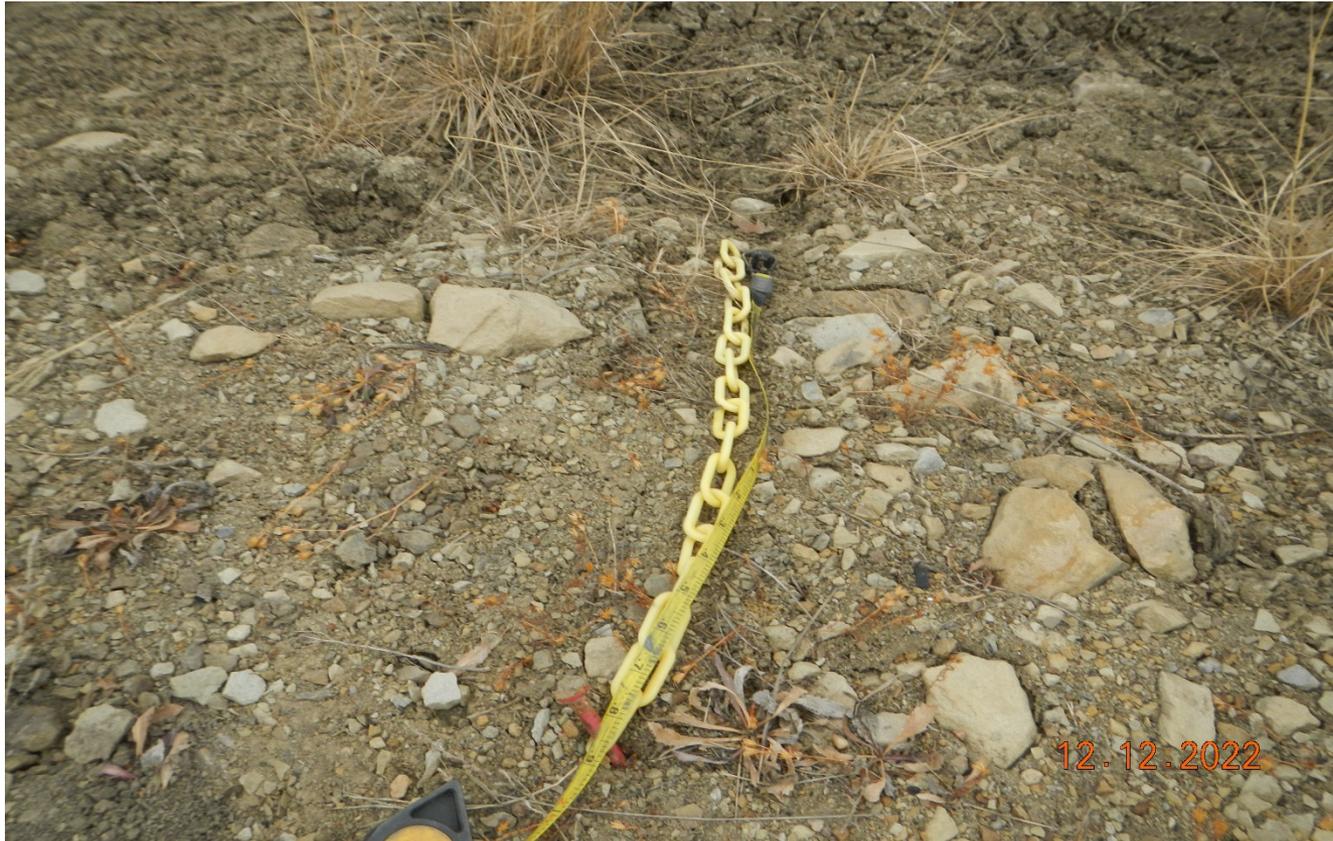
Photo 6. The freeboard marker is not is not 2ft. In length and does not show the vertical depth where it is installed. (Lays horizontal on the ground)
