Inspection Photos

API: 071-09079

Operator: EVERGREEN NATURAL RESOURCES

Inspection Date: 12/12/2022

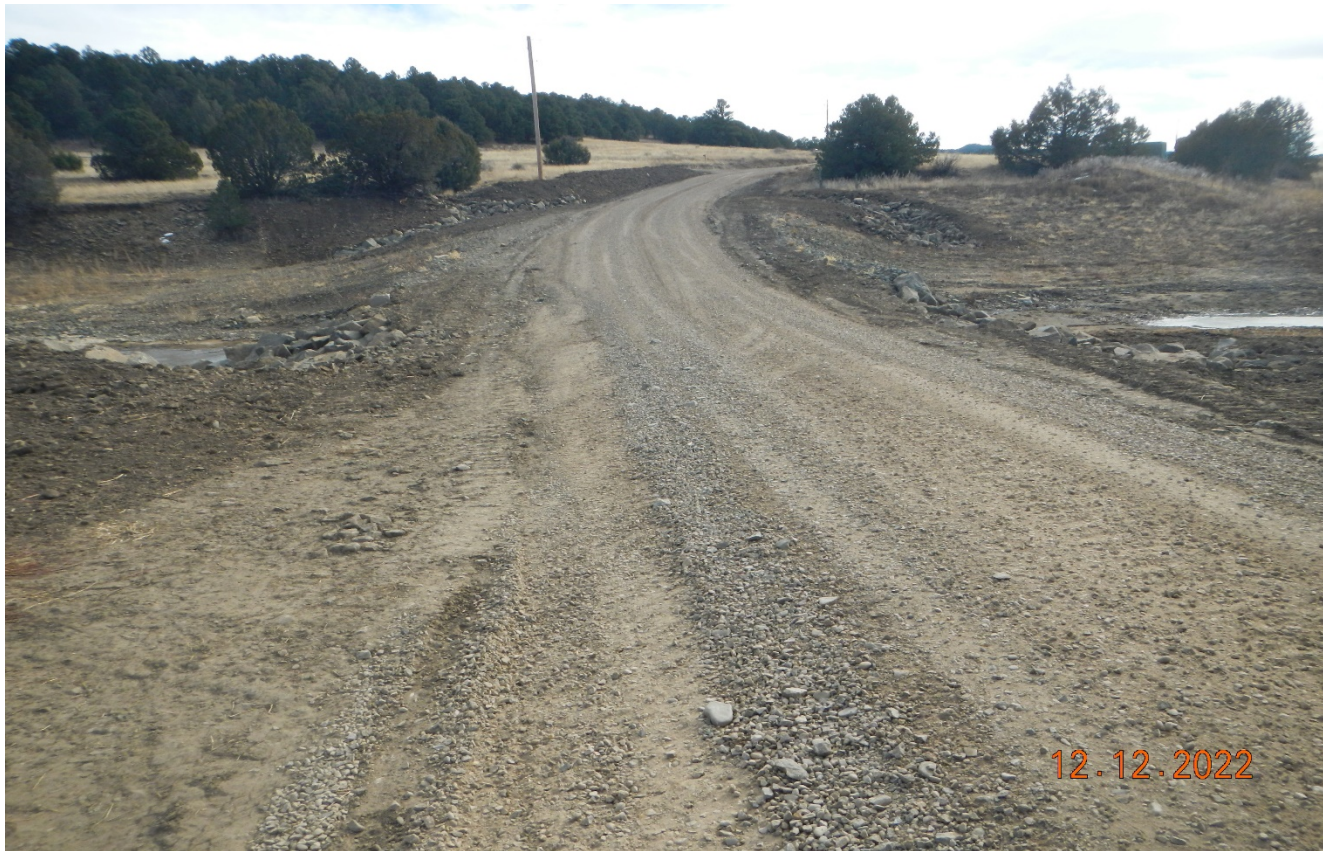
Photo 1. Facing southeast toward the Longs Canyon drainage crossing.

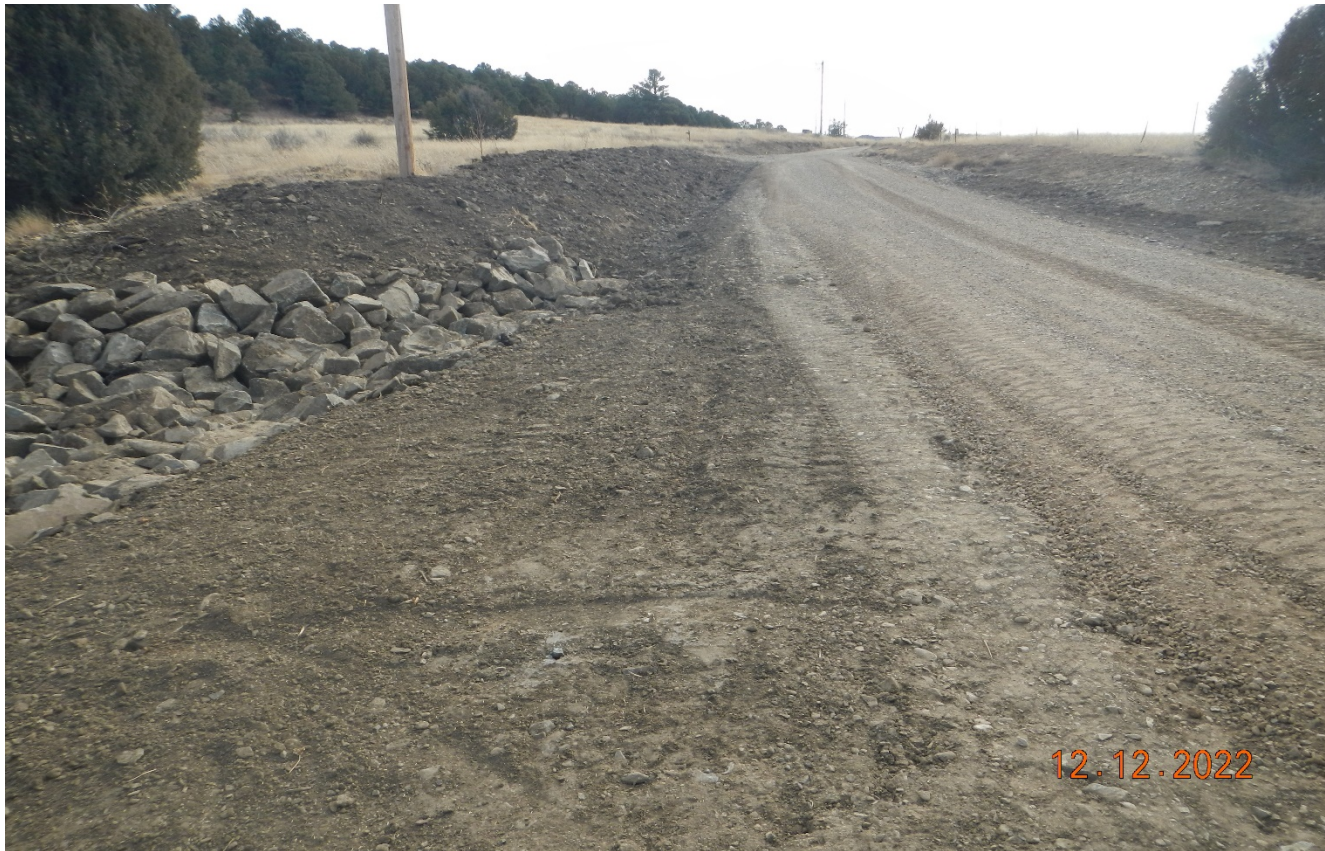
Photo 2. Facing southeast along the main road. Recent work has been performed along the road. Disturbed areas have been seeded.

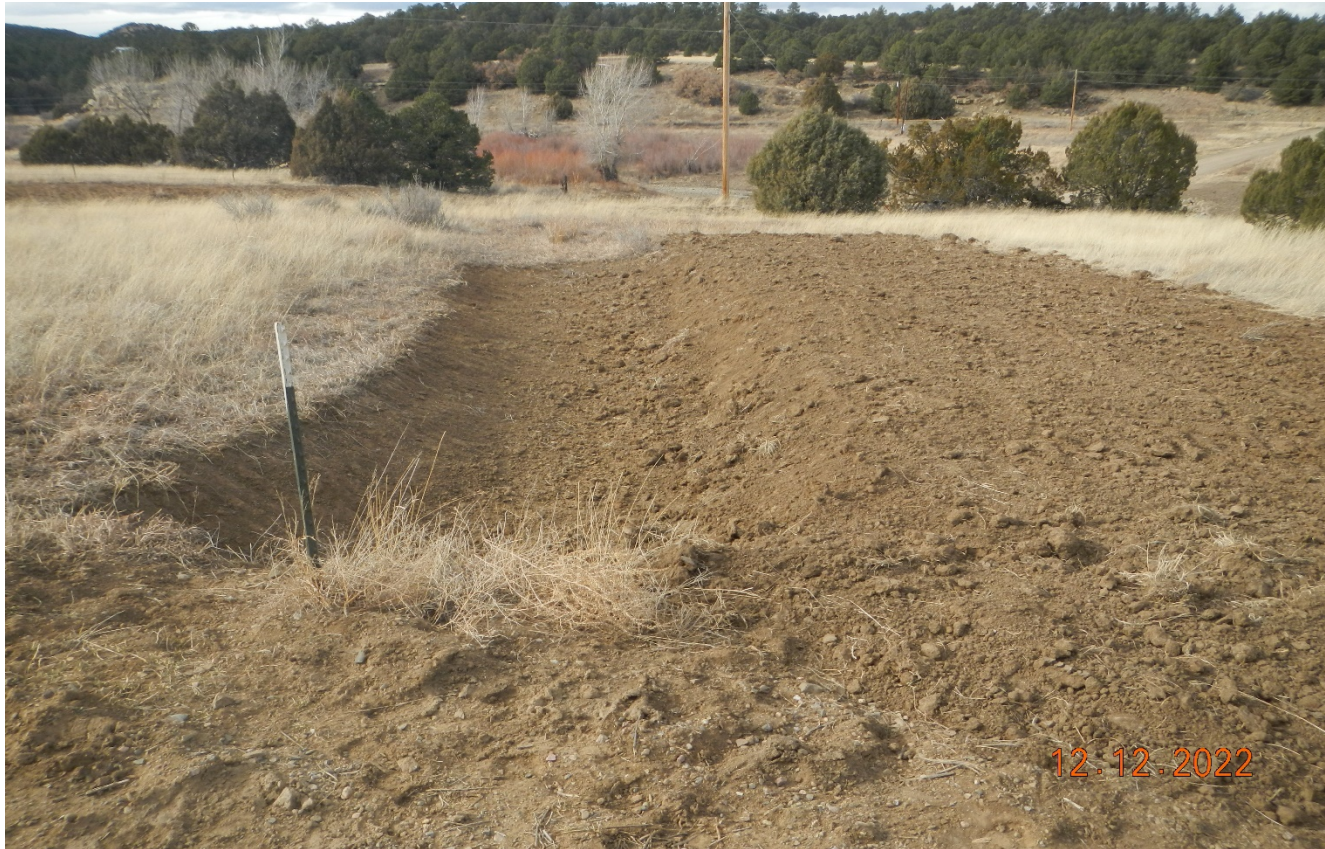
Photo 3. This culvert outlet along the road has been cleaned out and soils were seeded. Outlet protection should be installed to prevent erosion.

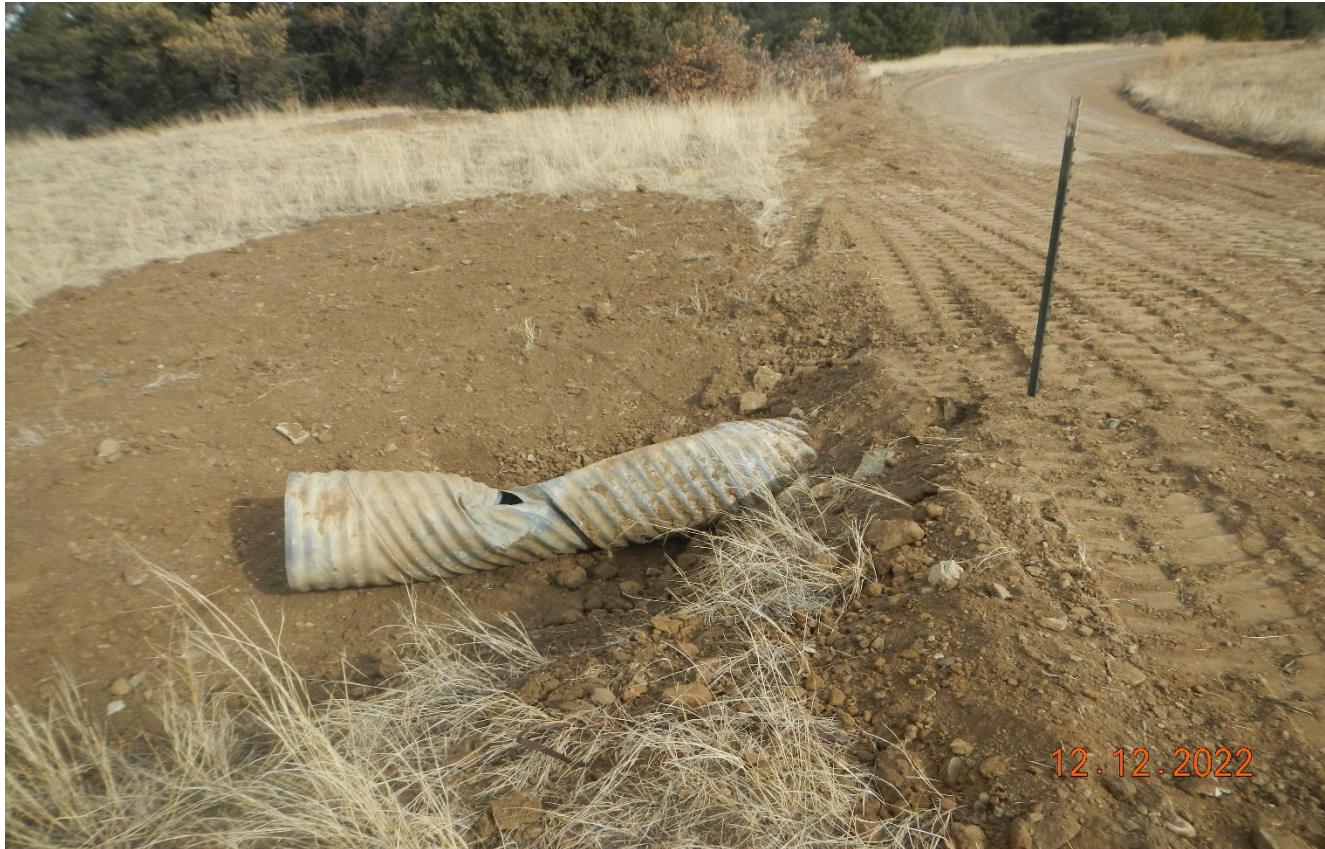
Photo 4. This culvert along the road has been cleaned out however the damage portion needs to be cut off so it doesn't plug up with sediment.

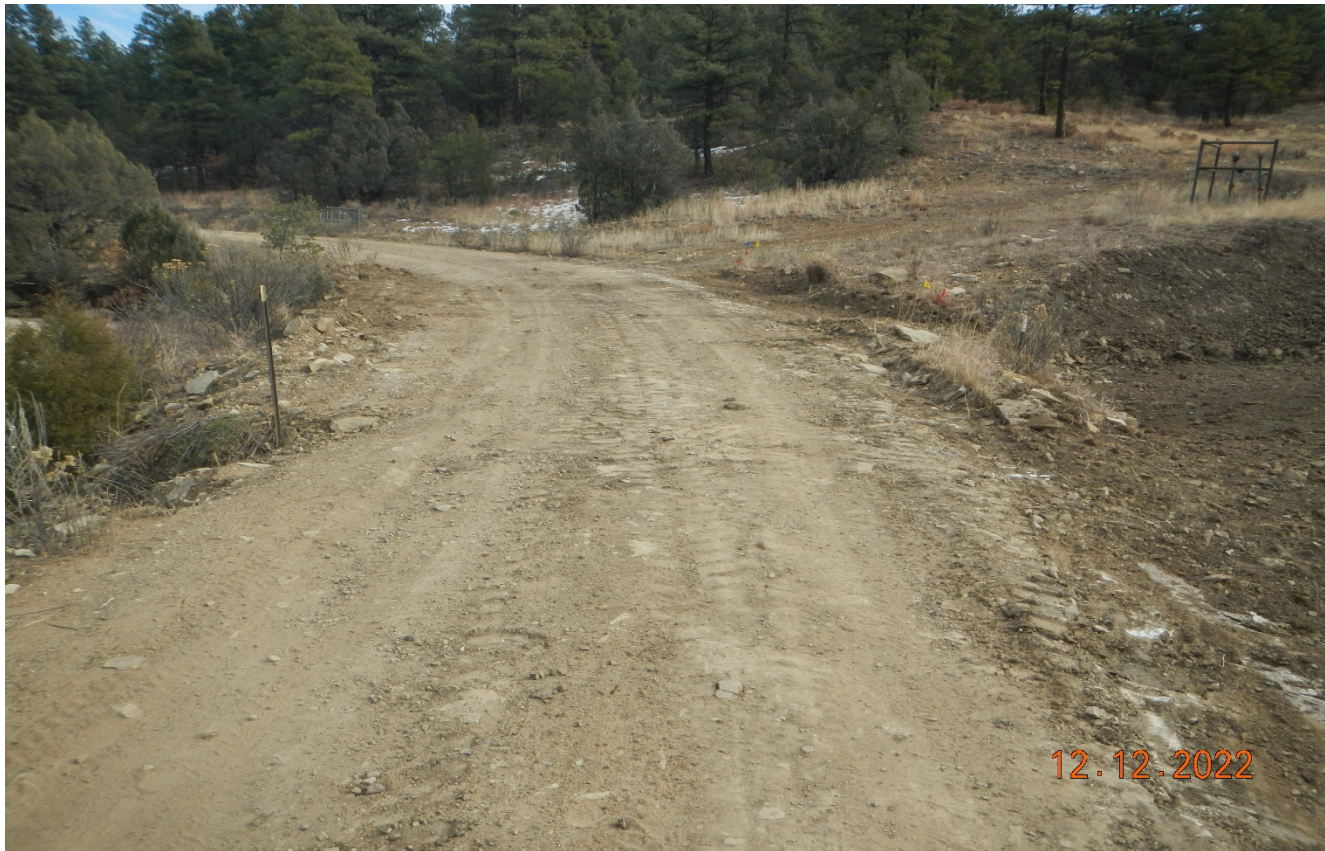
Photo 5. The culverts along the access road have recently been cleaned out.

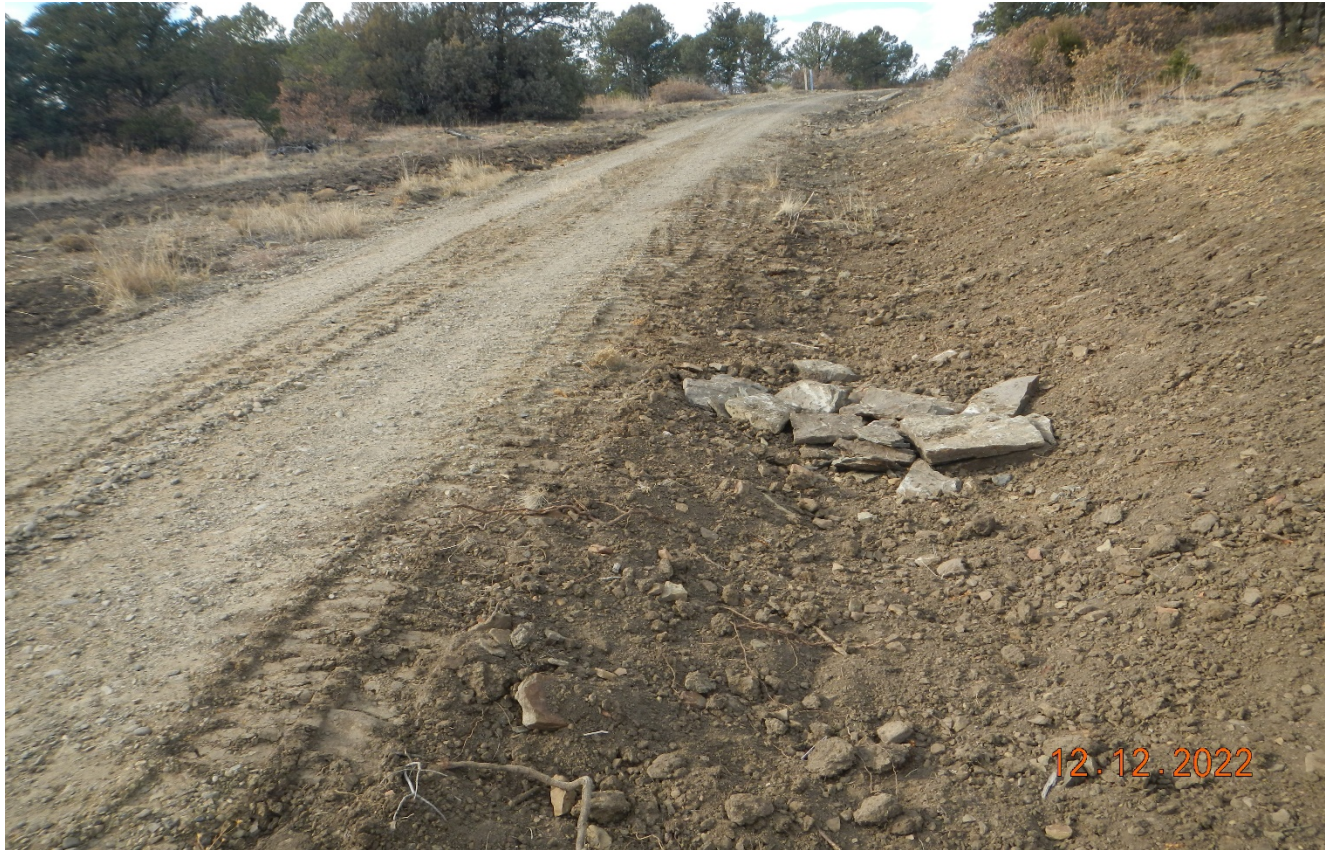
Photo 6. Facing northeast along the access road. Repairs have recently been performed along the road. The check dam is not sufficiently installed and more BMP's are needed in this area. Does not appears disturbed soils were seeded.

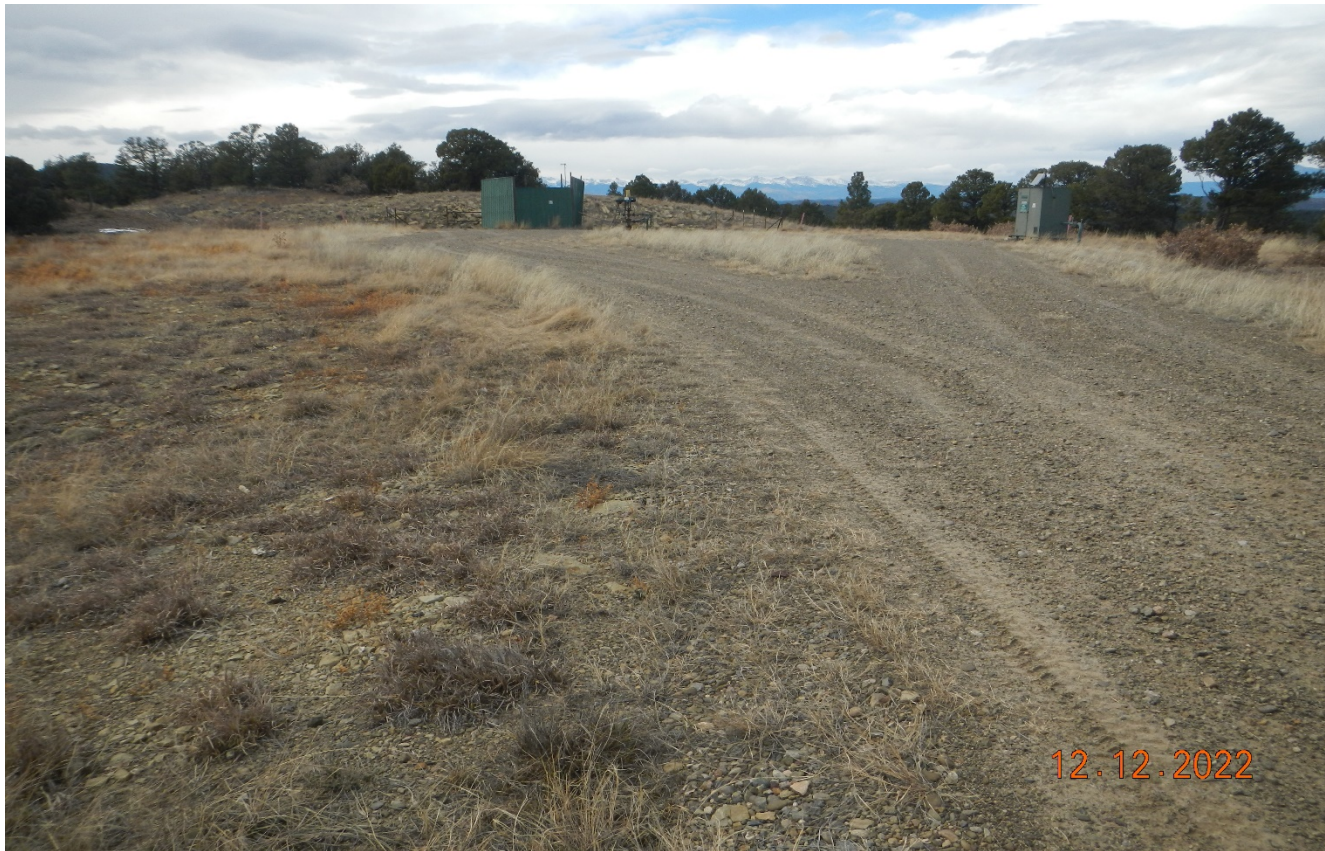
Photo 7. Facing west toward the well site.
