# Site Inspection Report

**Site: UPRR 43 PAN AM I5**  
12/12/2022

SITE/LOCATION	DATE	TIME	INSPECTOR
UPRR 43 PAN AM I5	12/12/2022	11:40 AM	COGCC Representative
Comments			
Work Activity Notes			
Changes since previous inspection?	No	Drive by inspection	No
Actively being worked?	No		
Fieldwork Oversight Performed?	No	Oversight Type	
Were Oversight Samples Collected?	No	Sample Details

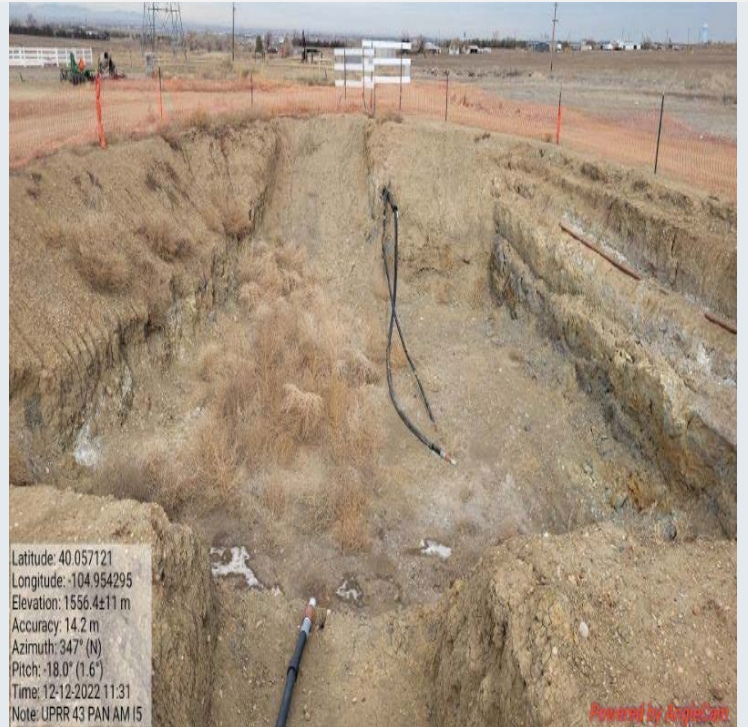
Remediation Activity Checklist	
	Photo
<b>Question:</b> Open excavation(s)? Note: Approximate size(s) (Length x Width x Depth, ft) <b>Response:</b> Yes <b>Notes:</b> 88'x54'x15'

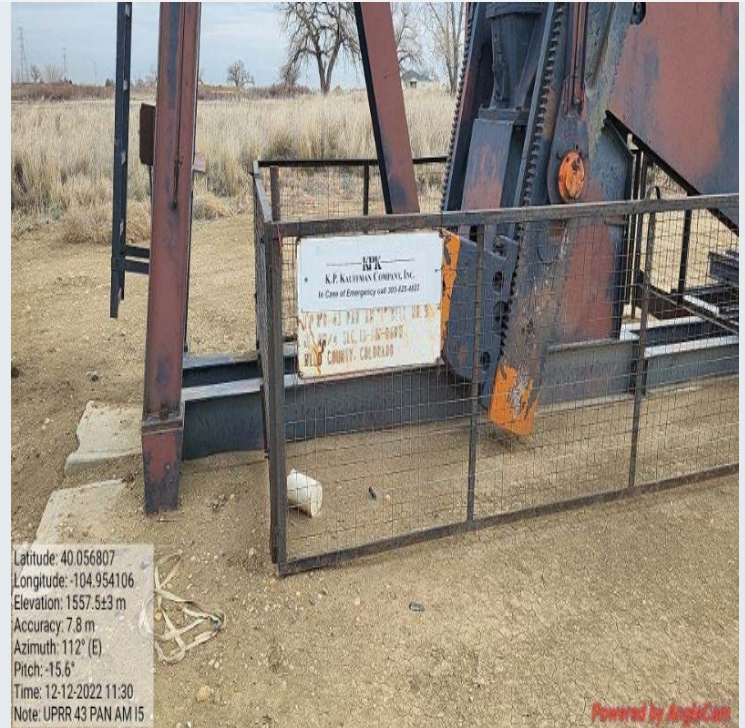
**Question:** Emergency signage in compliance with 605.g.?

**Note:** Location of signage - Location entrance, Tank Battery, Wellhead(s).

**Response:** Yes

**Notes:** Pump jack.

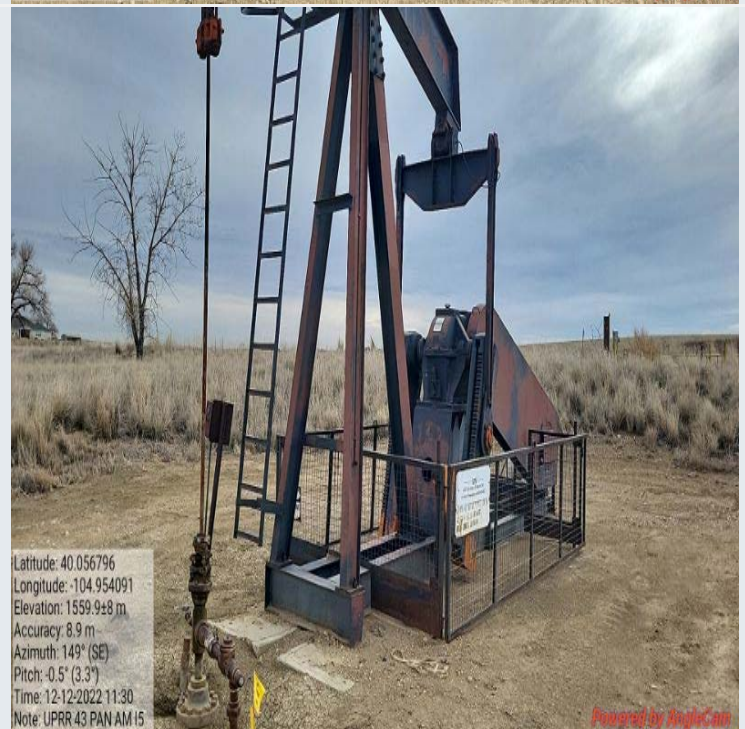
**Question:** Emergency signage in compliance with 605.g.?

**Note:** Location of signage - Location entrance, Tank Battery, Wellhead(s).

**Response:** Yes

**Notes:** Pump jack.

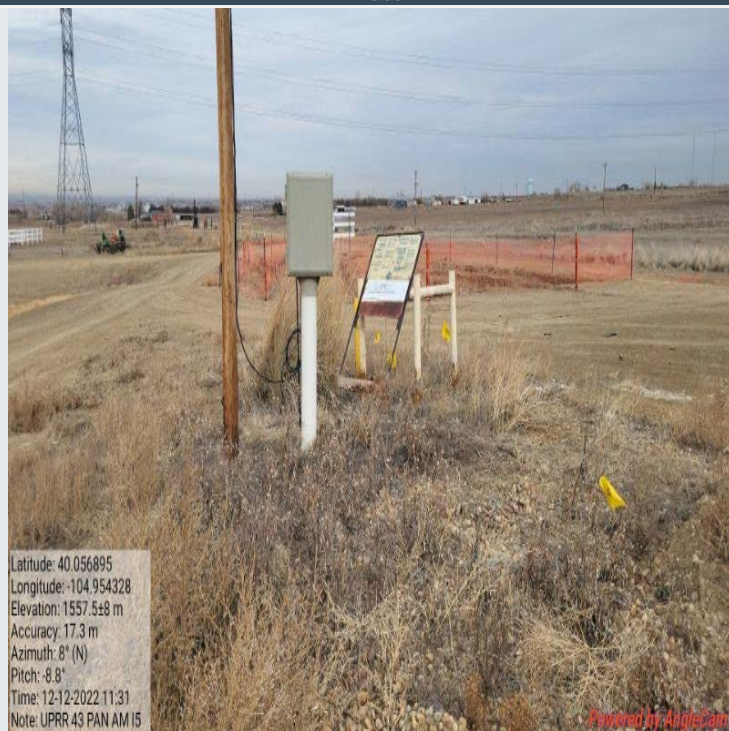
**Question:** Emergency signage in compliance with 605.g.?  
**Note:** Location of signage - Location entrance, Tank Battery, Wellhead(s).

**Response:** Yes

**Notes:** Pump jack.

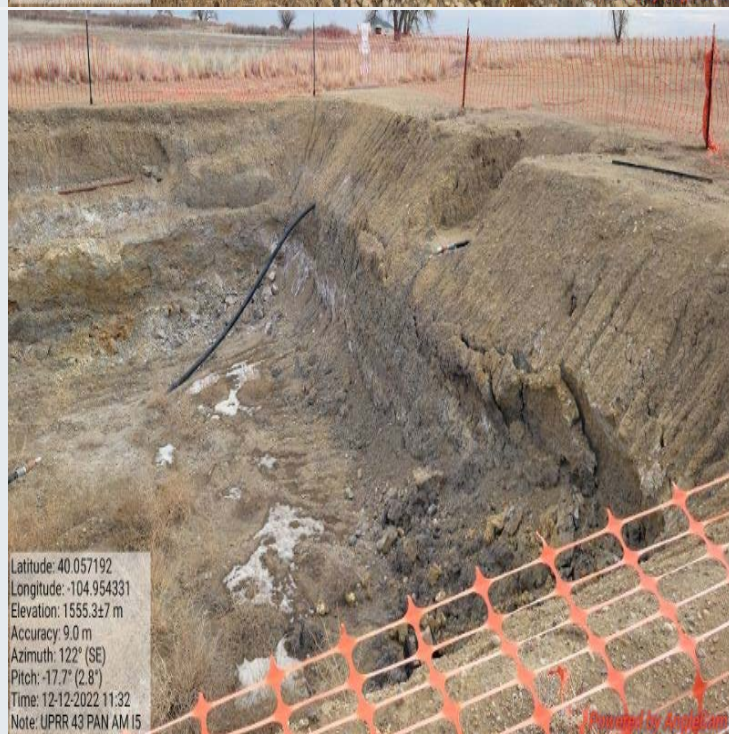
**Question:** Ground surface appears clean (no evidence of new equipment leaks, oil leaks, spills, or releases)?

**Response:** Yes

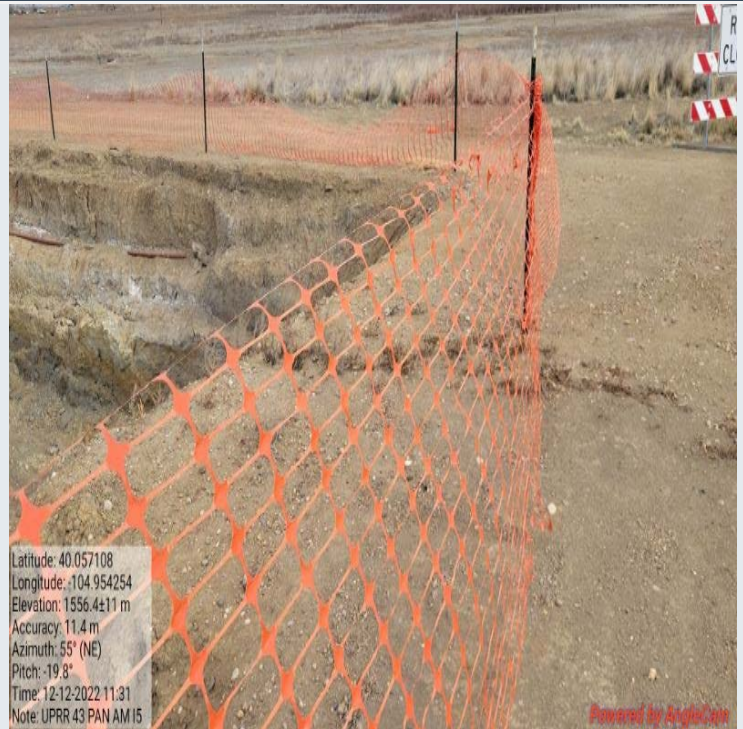
**Question:** Open excavation properly fenced/covered (in accordance with Rule 913.b.(5)B.i.)?

**Response:** Yes

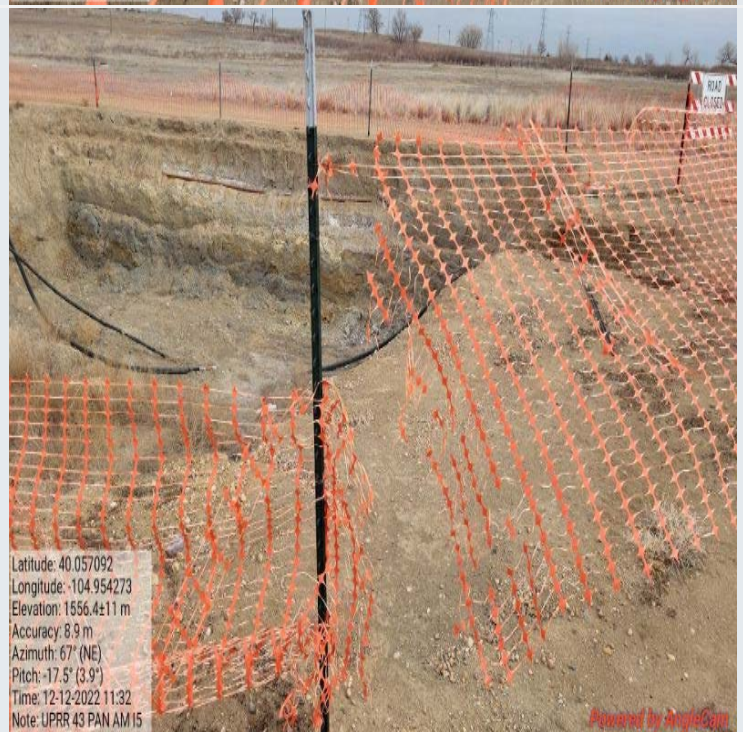
**Question:** Is fencing adequate/appropriate for site and well(s) and maintained?

**Response:** No

**Notes:** Worn and gaps in fencing. Falling down in spots.

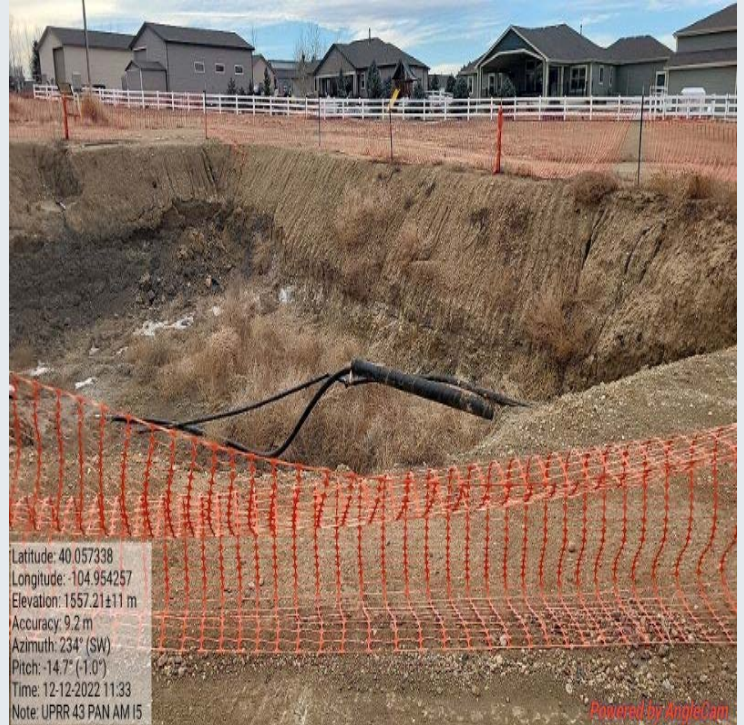
**Question:** Is fencing adequate/appropriate for site and well(s) and maintained?

**Response:** No

**Notes:** Worn and gaps in fencing. Falling down in spots.

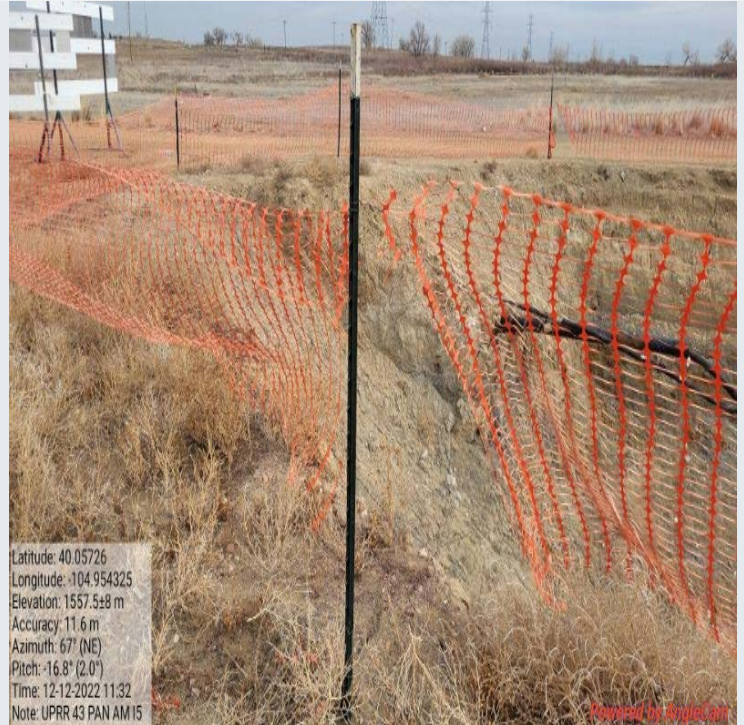
**Question:** Is fencing adequate/appropriate for site and well(s) and maintained?

**Response:** No

**Notes:** Worn and gaps in fencing. Falling down in spots.

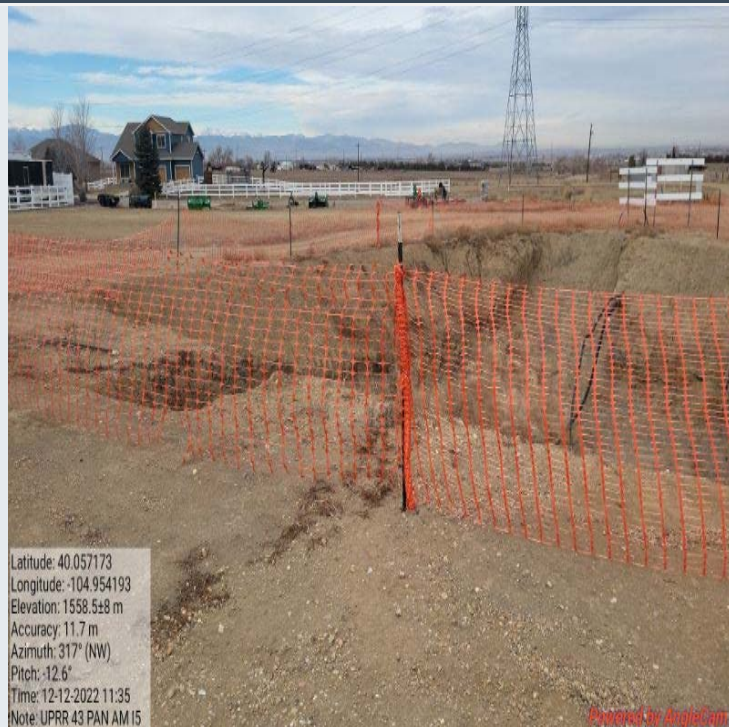
**Question:** Is fencing adequate/appropriate for site and well(s) and maintained?

**Response:** No

**Notes:** Worn and gaps in fencing. Falling down in spots.

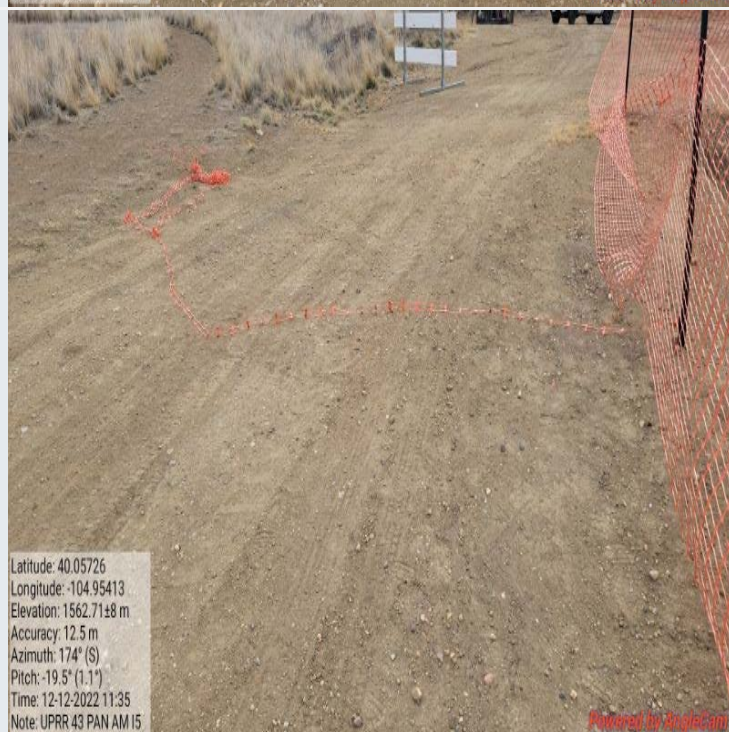
**Question:** Is fencing adequate/appropriate for site and well(s) and maintained?

**Response:** No

**Notes:** Worn and gaps in fencing. Falling down in spots.

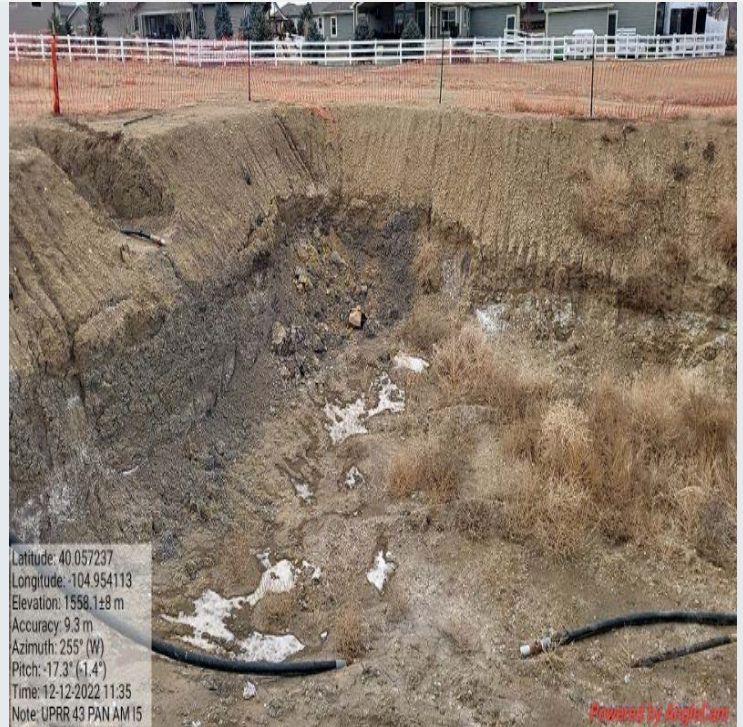
**Question:** Exposed buried/underground flowlines within excavation?

**Response:** Yes

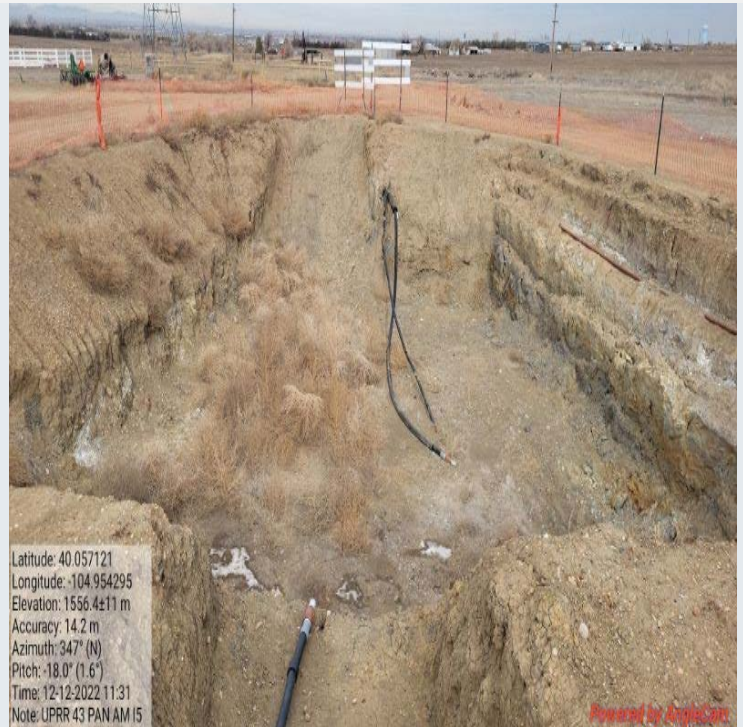
**Question:** If flowlines are exposed are they properly capped (bullnose plug, etc.)?

**Response:** Yes

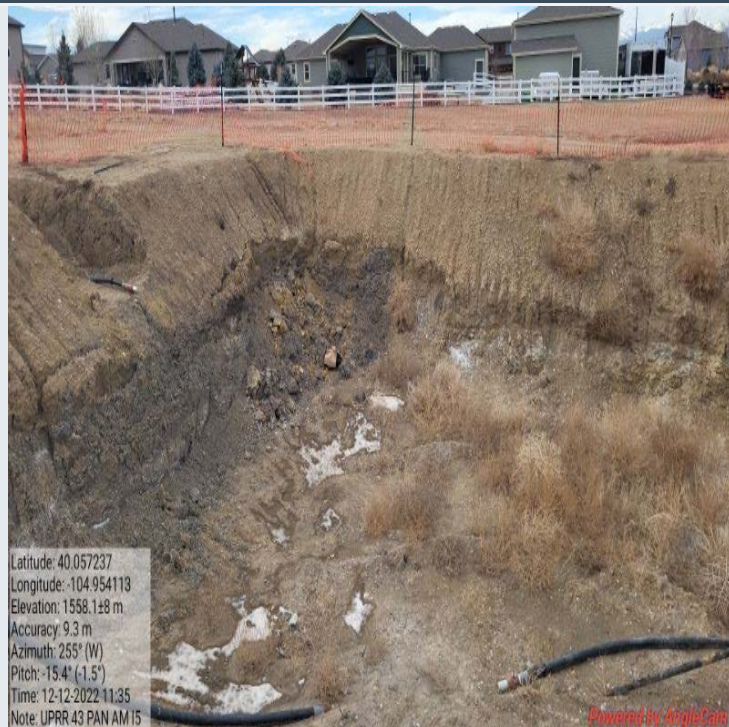
**Question:** If flowlines are exposed are they properly capped (bullnose plug, etc.)?

**Response:** Yes

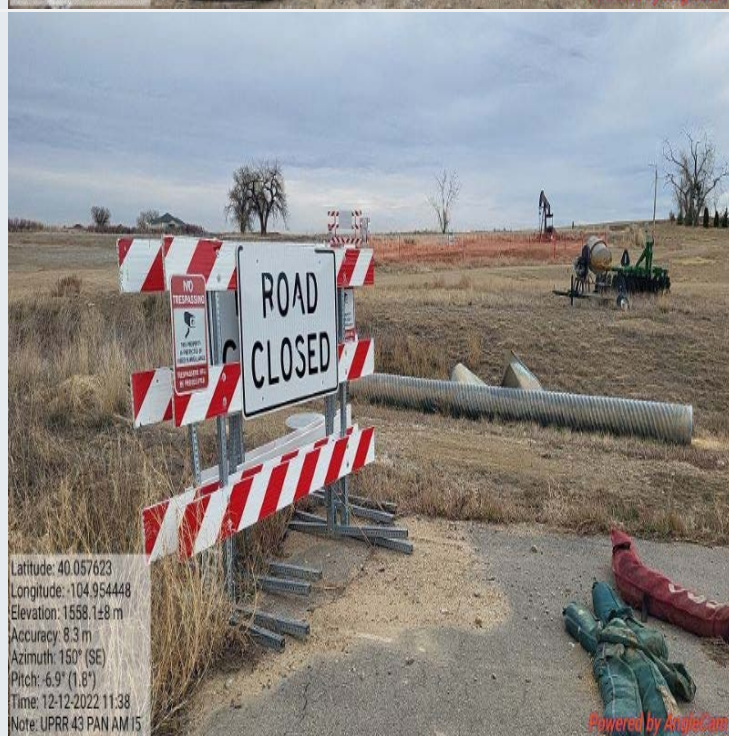
**Question:** Site is protected from vehicular traffic (properly fenced, gated or barricaded)?

**Response:** Yes

**Notes:** Is road closed and warning signs.

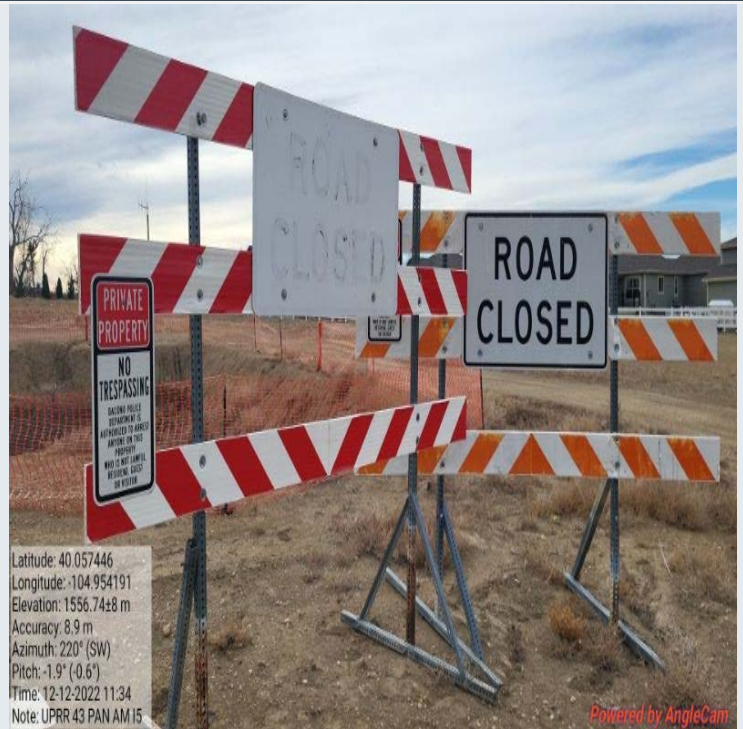
**Question:** Site is protected from vehicular traffic (properly fenced, gated or barricaded)?

**Response:** Yes

**Notes:** Is road closed and warning signs.

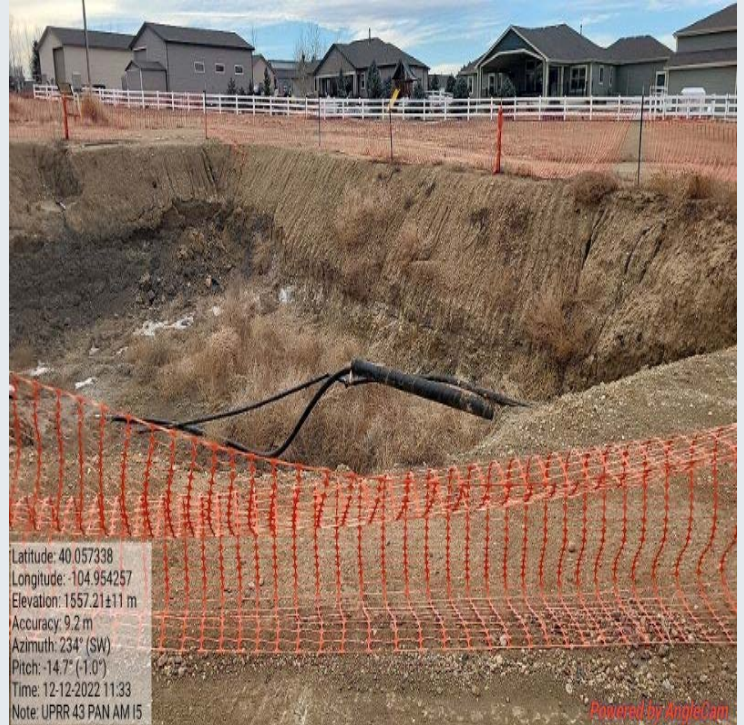
**Question:** Is location adjacent to any Potential Receptors?  
**Note:** Livestock, surface water, occupied structure, adjacent land use, etc.

**Response:** Yes

**Notes:** Neighborhood adjacent to the west of site.

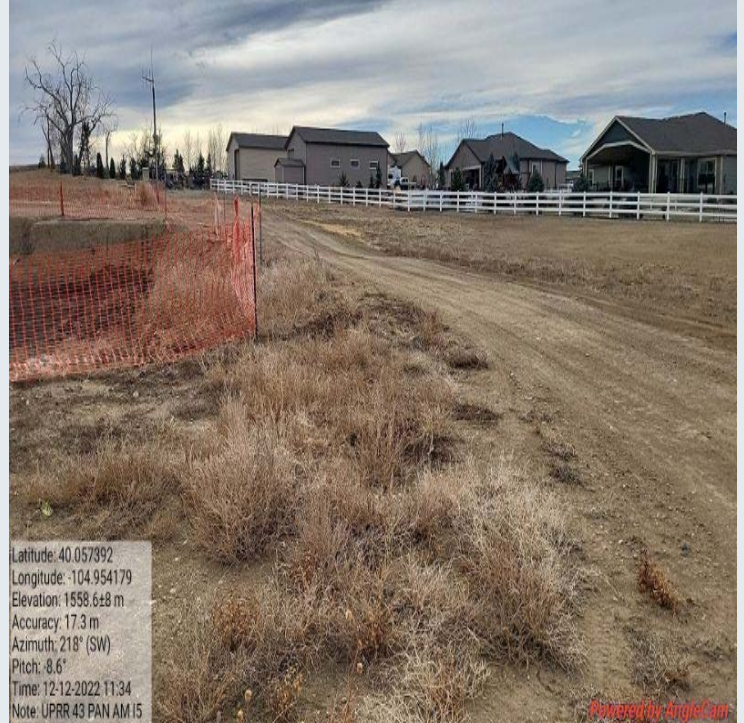
**Question:** Is location adjacent to any Potential Receptors?  
**Note:** Livestock, surface water, occupied structure, adjacent land use, etc.

**Response:** Yes

**Notes:** Neighborhood adjacent to the west of site.

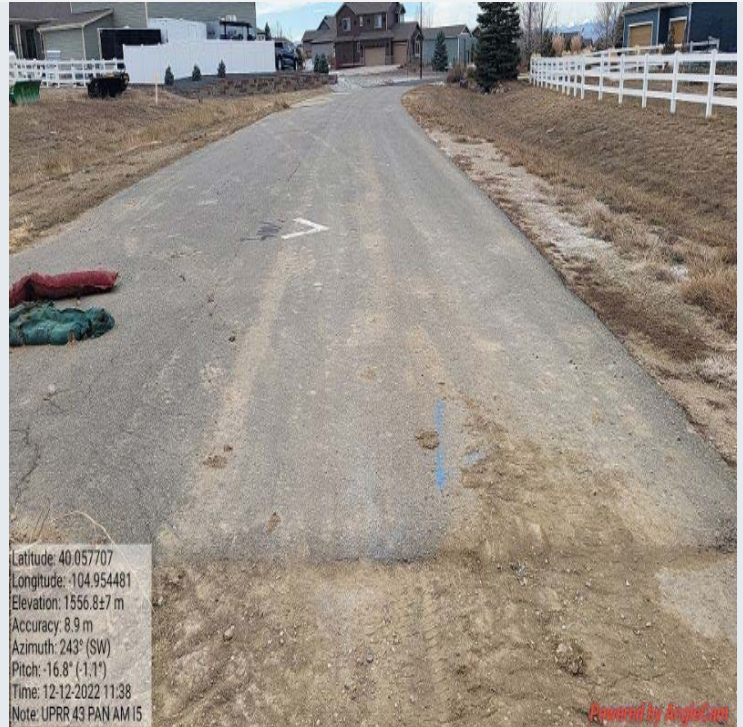
**Question:** Evidence of pollutants being discharged off-site?

**Response:** No

**Notes:** There is a dirt road that merges to a paved road.

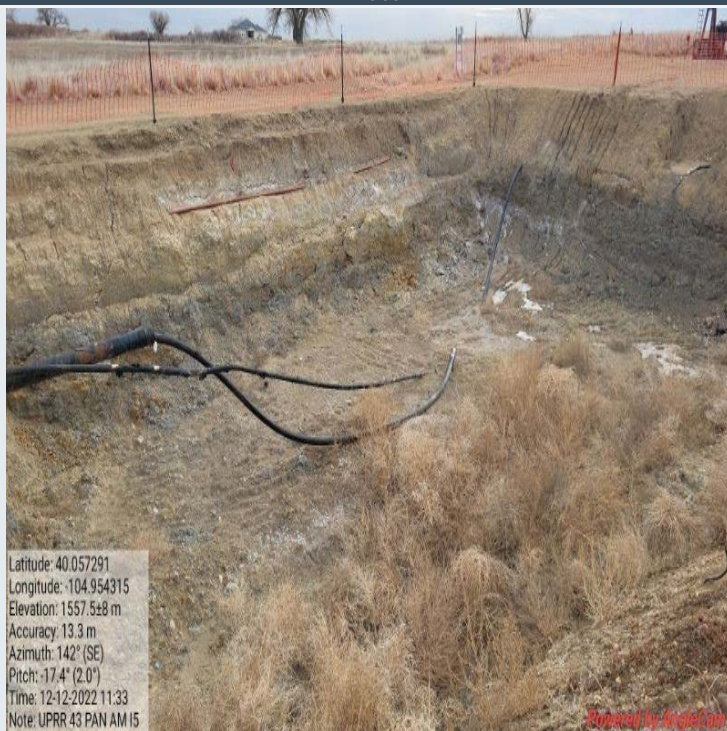
**Question:** Site free of unused equipment, weeds, debris/trash?

**Response:** No

**Notes:** Weeds in excavation.
