Inspection Photos
Location Name: Albert Martinez 1A
API: 007-06256

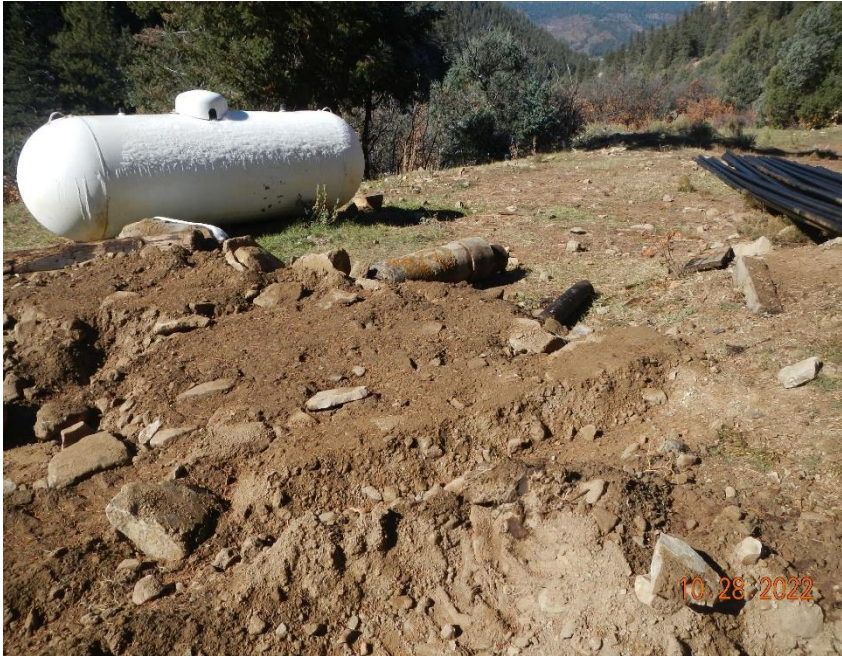
Cut-off stub and backfilled wellhead and propane tank

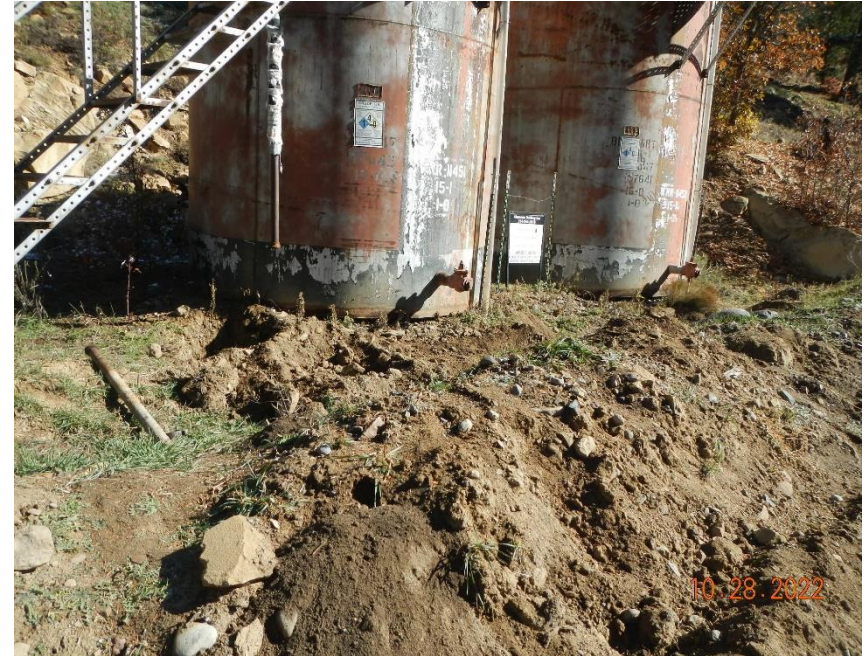
Tanks

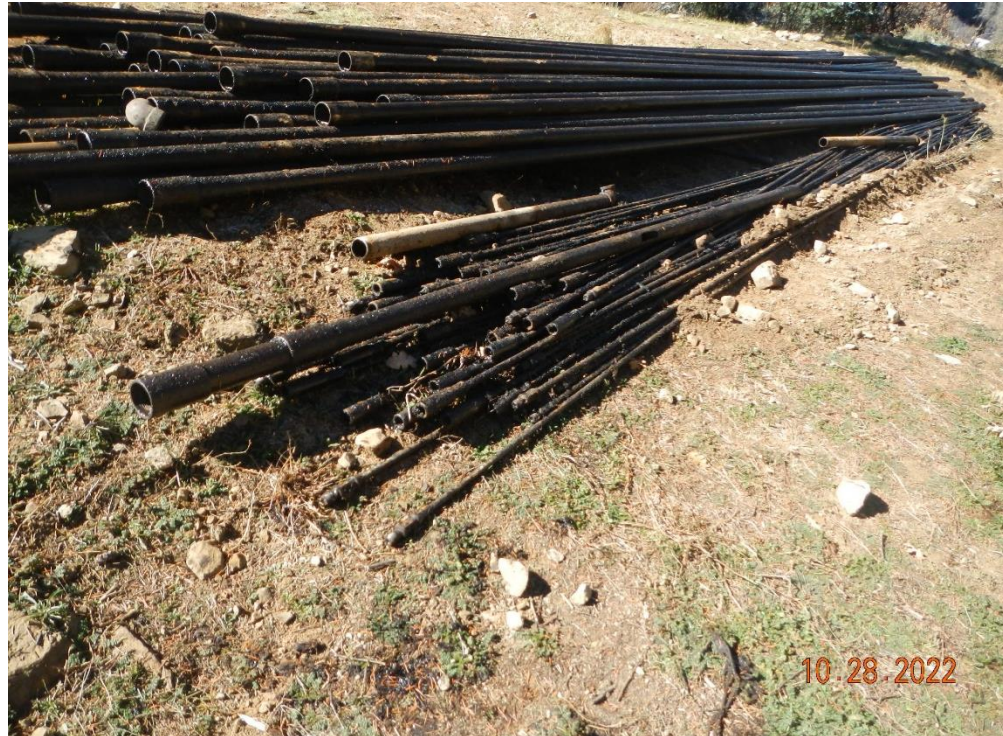
Tubing and rods coated in oily waste still stored on bare ground

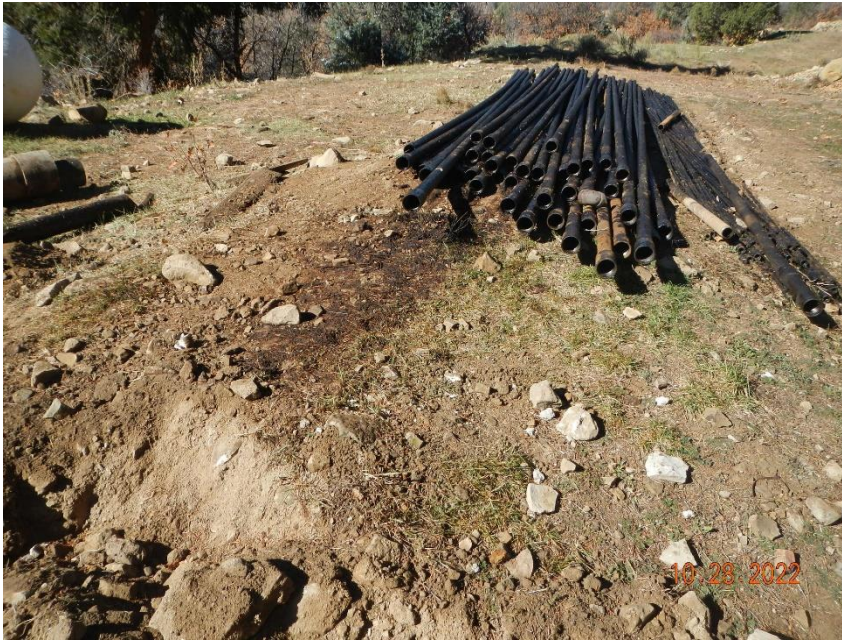
Oily waste on ground, no spill response approx. 18x40"

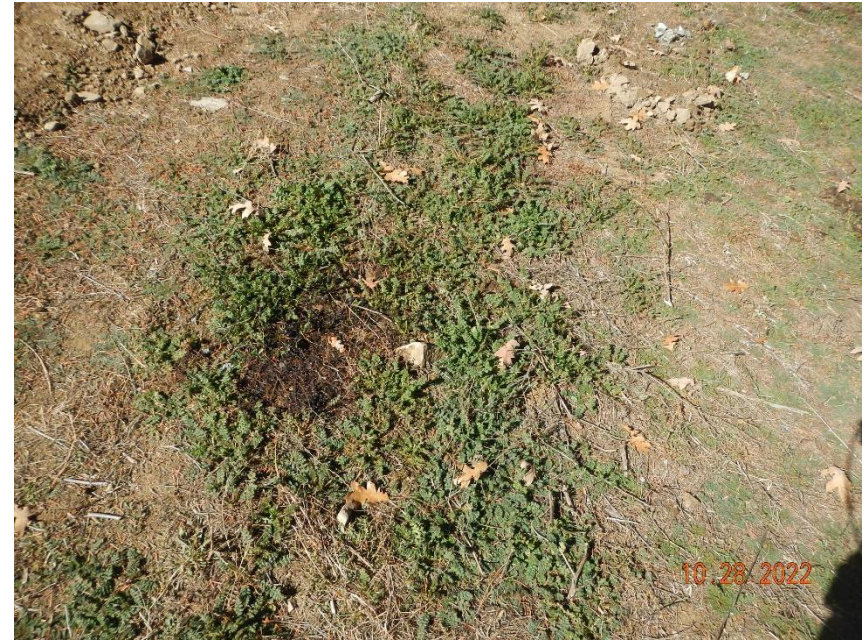
Oily waste 10-12" diameter
