Inspection Photos

Location Name: TEP ROCKY MOUNTAIN LLC MOBILE-66S92W /20NESW

Location ID: 322510

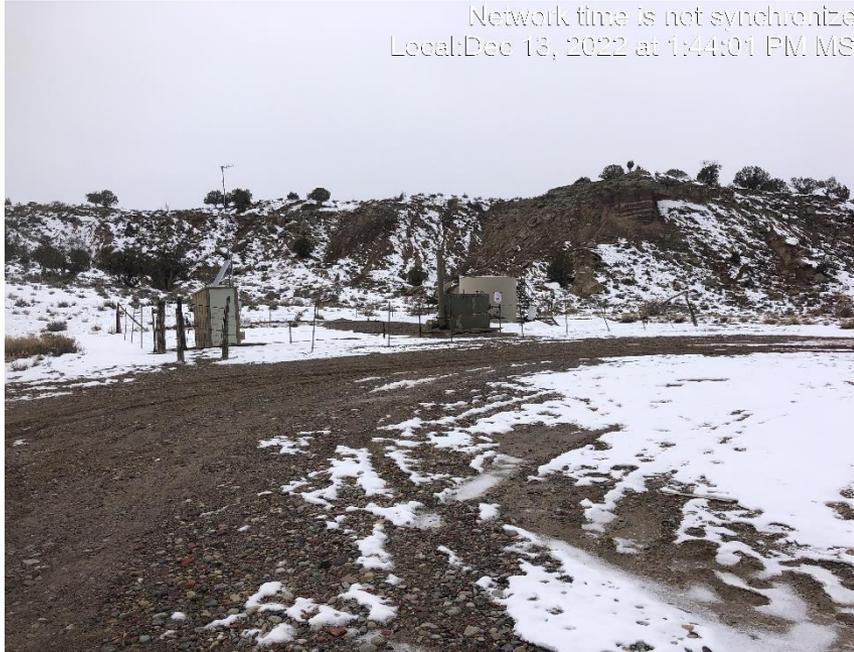
Photo #8666 From entrance to location.

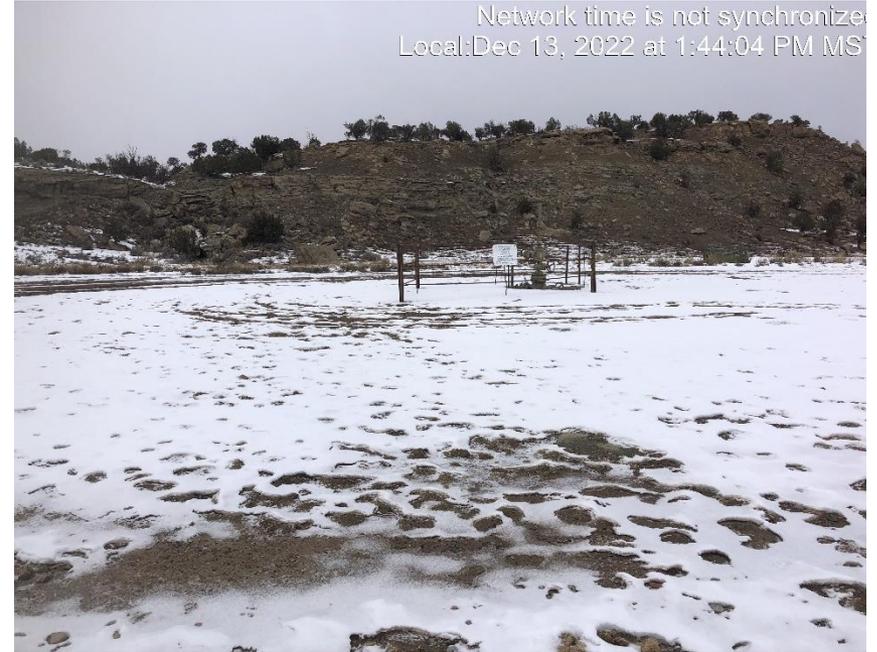
Photo #8667 From entrance to location

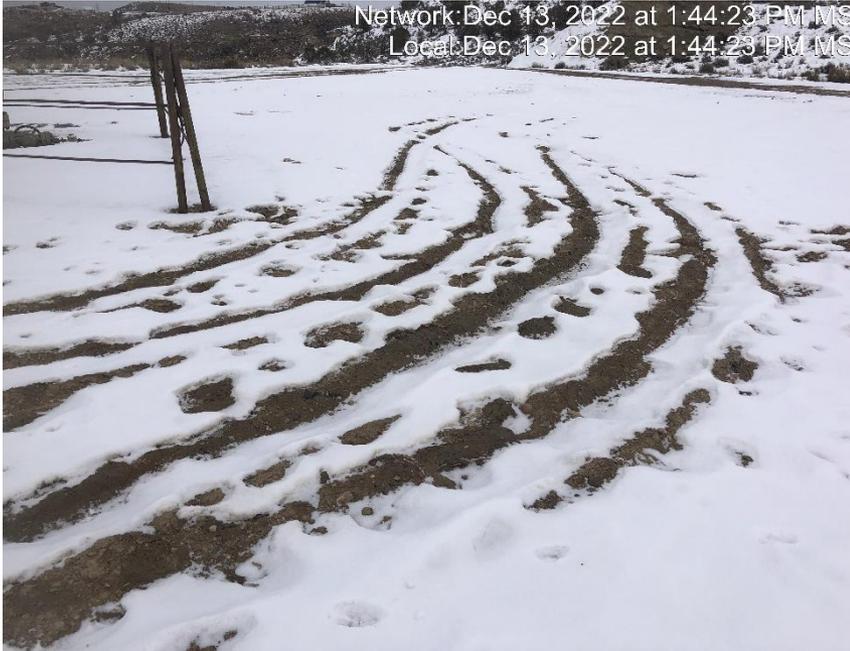
Photo #8668 Location lacks stabilization.

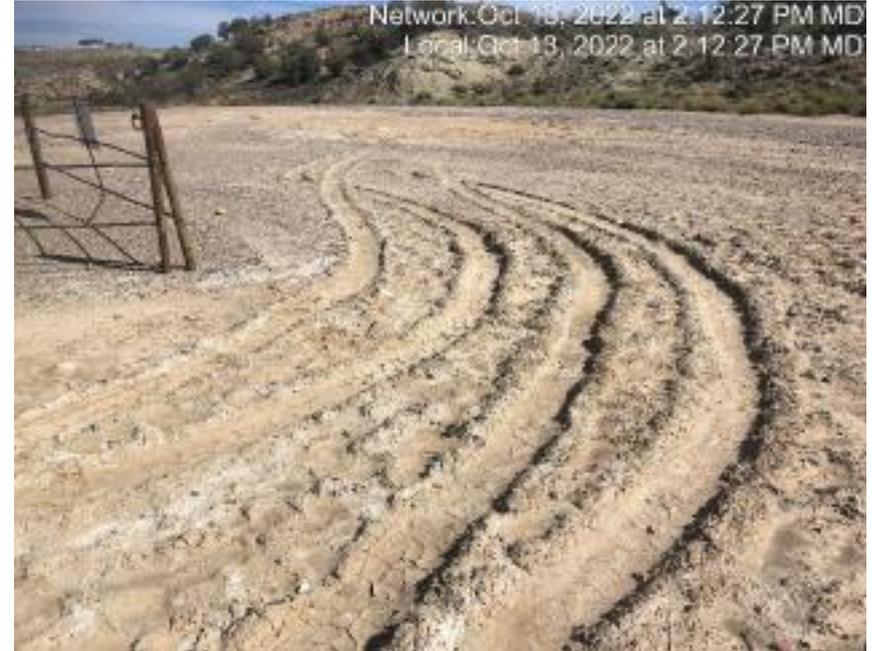
Photo #8062 From inspection #699805061 conducted on 10/13/22.

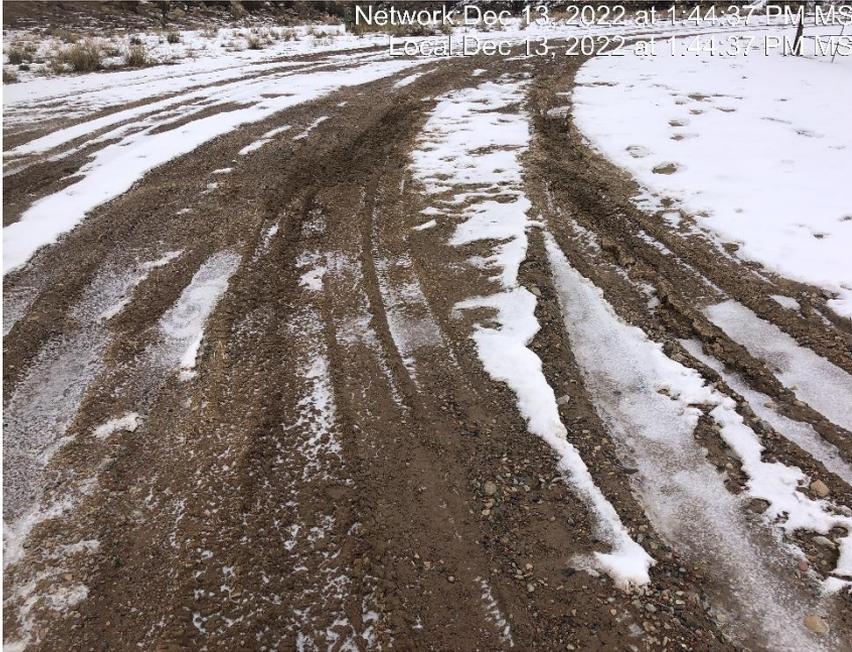
Photo #8669 Location lacks stabilization.

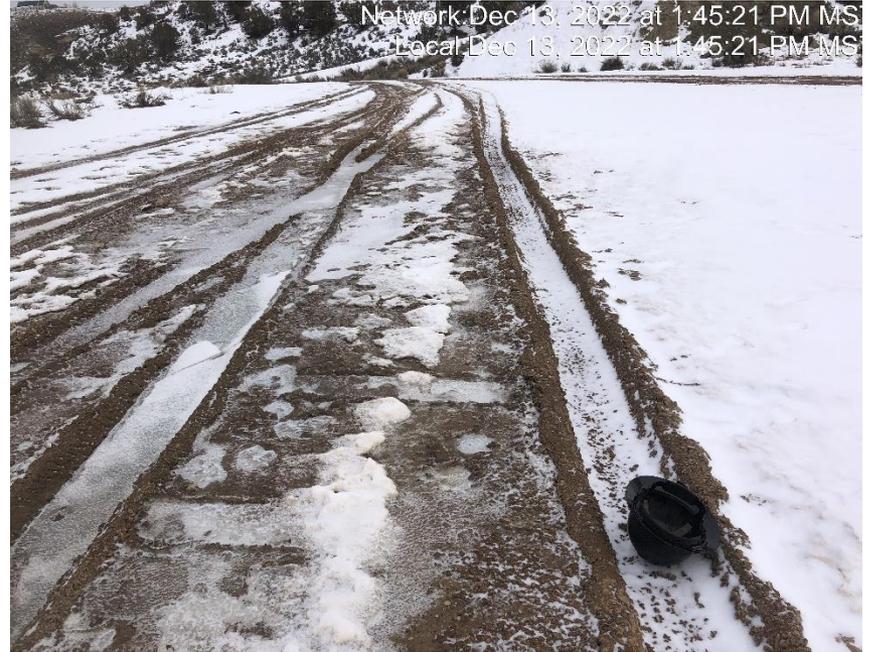
Photo #8672 Location lacks stabilization.

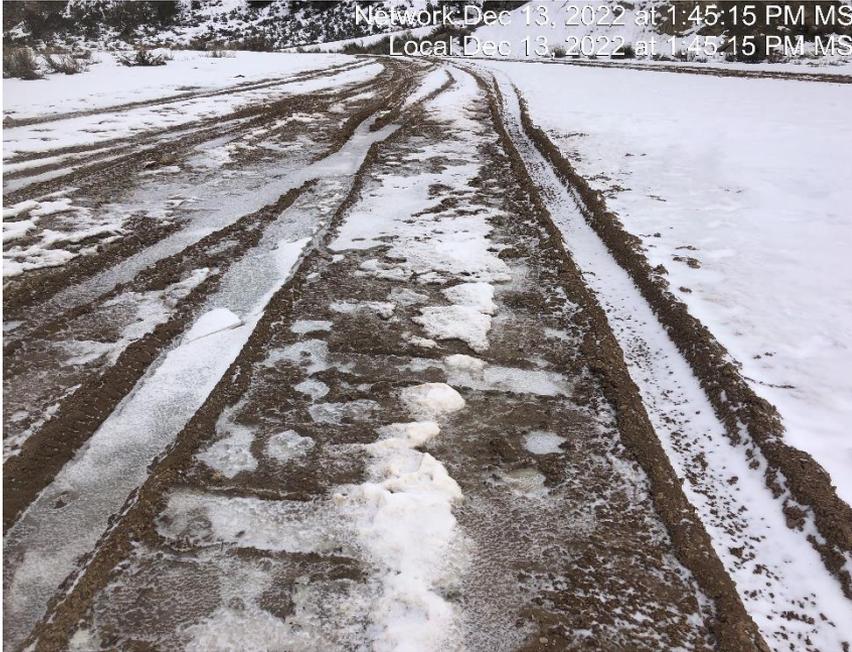
Photo #8671 Location lacks stabilization.

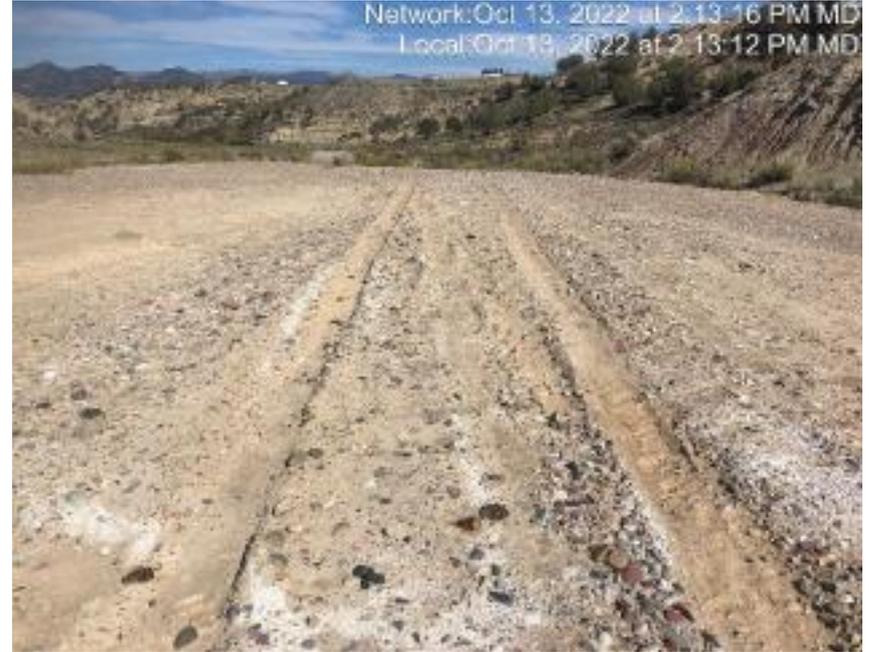
Photo #8064 From inspection #699805061 conducted on 10/13/22.

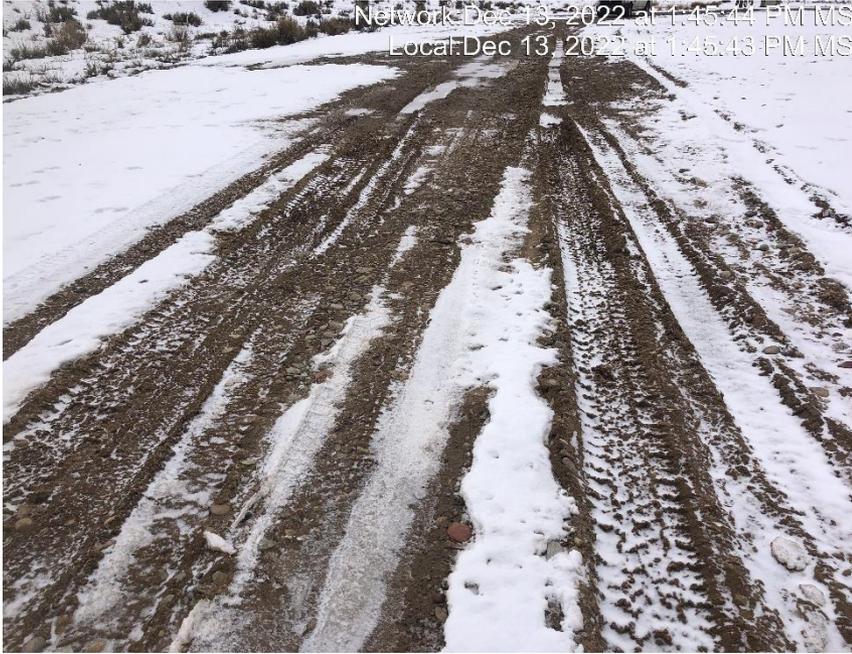
Photo #8674 Insufficient tracking BMP at entrance to location.
