Site Inspection Report

Site: MCDONALD UNIT #2
12/13/2022

SITE/LOCATION	DATE	TIME	INSPECTOR
MCDONALD UNIT #2	12/13/2022	09:33 AM	COGCC Representative
Comments	SW12@4' - sample from south end of excavation under the flowline. PID reading of 2.8 ppm. SW13@4' - sample from north end of excavation under the flowline. PID reading of 10.6 ppm.		
Work Activity Notes	KPK crew excavating further. They are also field screening at two spots by the flow lines at south and north end of excavation.		
Changes since previous inspection?	Yes	Drive by inspection	No
Actively being worked?	Yes		
Fieldwork Oversight Performed?	Yes	Oversight Type	Soil sampling and excavation
Were Oversight Samples Collected?	No	Sample Details

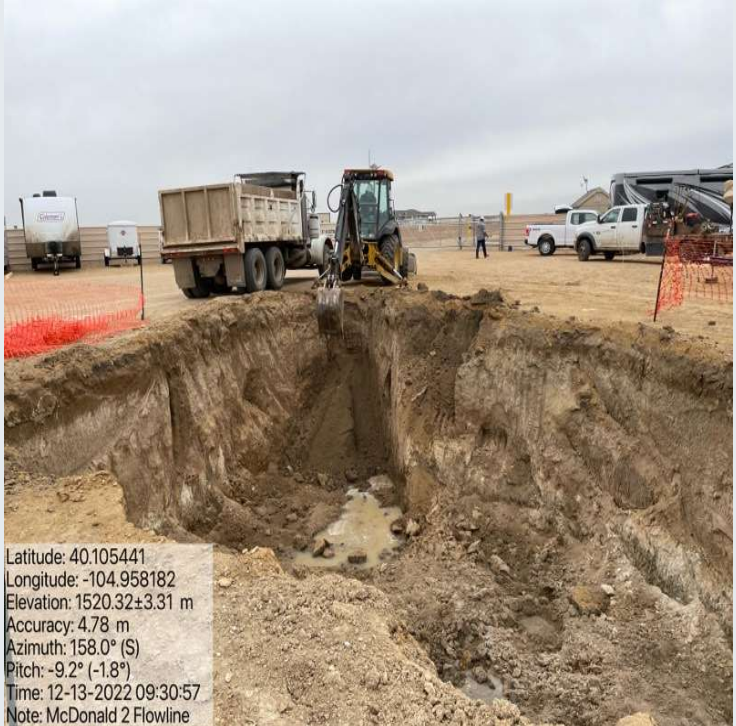
Photo
<p>Question: Open excavation(s)? Note: Approximate size(s) (Length x Width x Depth, ft)</p> <p>Response: Yes</p> <p>Notes: 42' x 40' (at the widest) x 12'. Coordinates of corners of excavation are as follows: CP1: 40.10536, -104.94824 CP2: 40.10543, -104.95821 CP3: 40.10538, -104.95813 CP4: 40.10532, -104.95817</p>

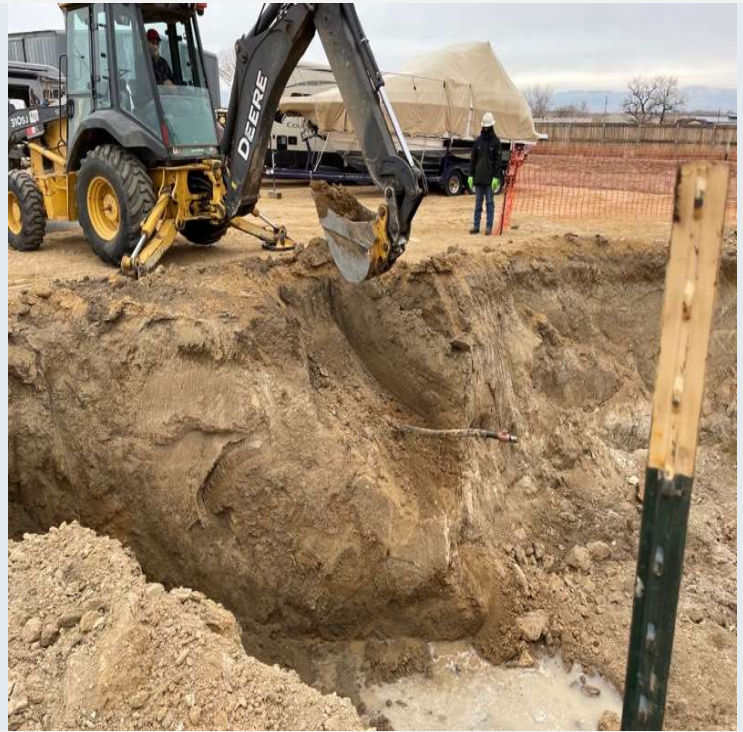
Question: Open excavation(s)? Note: Approximate size(s) (Length x Width x Depth, ft)

Response: Yes

Notes: 42' x 40' (at the widest) x 12'. Coordinates of corners of excavation are as follows:

- CP1: 40.10536, -104.94824
- CP2: 40.10543, -104.95821
- CP3: 40.10538, -104.95813
- CP4: 40.10532, -104.95817

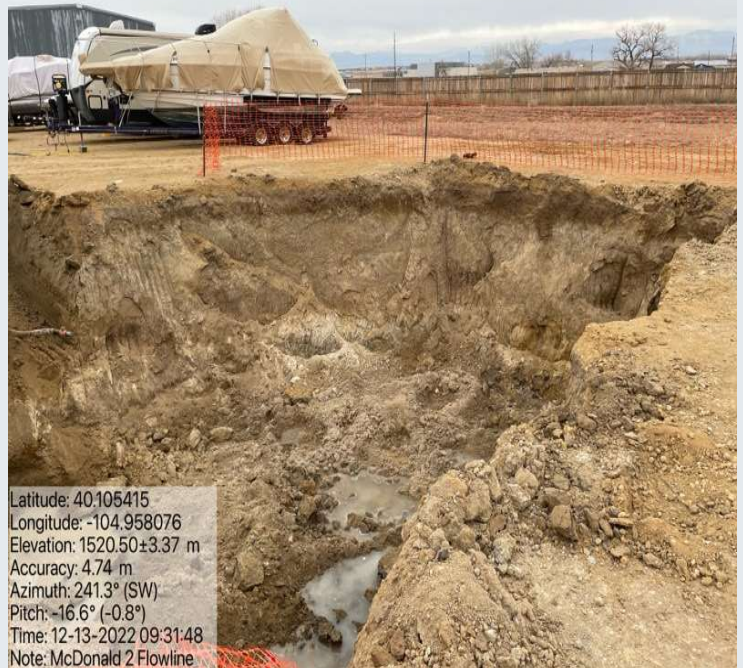
Question: Open excavation(s)? Note: Approximate size(s) (Length x Width x Depth, ft)

Response: Yes

Notes: 42' x 40' (at the widest) x 12'. Coordinates of corners of excavation are as follows:

- CP1: 40.10536, -104.94824
- CP2: 40.10543, -104.95821
- CP3: 40.10538, -104.95813
- CP4: 40.10532, -104.95817

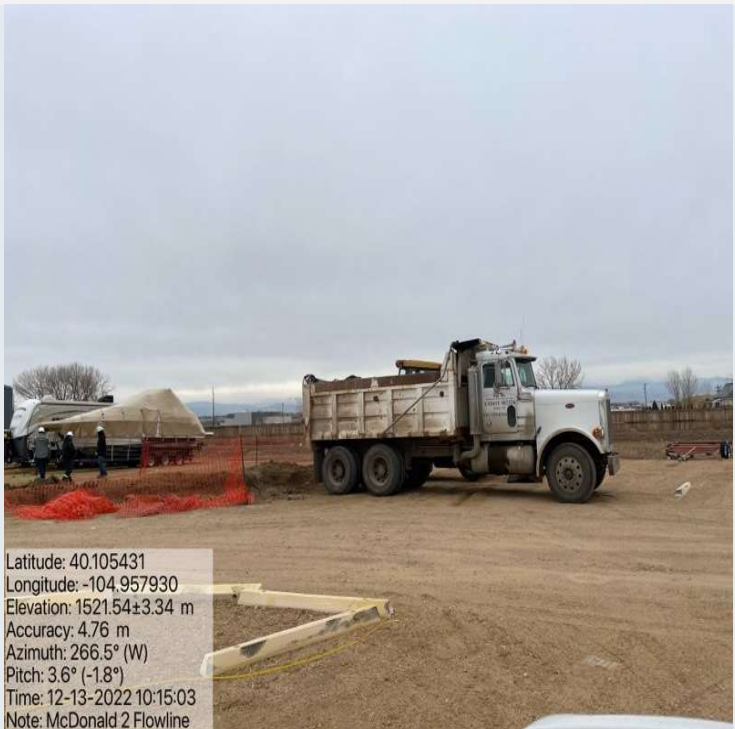
Photo
<p>Question: E&P waste signage present, legible, accurate and up to date (labelled per KPK CWMP)? Response: N/A Notes: No waste on site. It is being excavated directly into dump truck.</p>

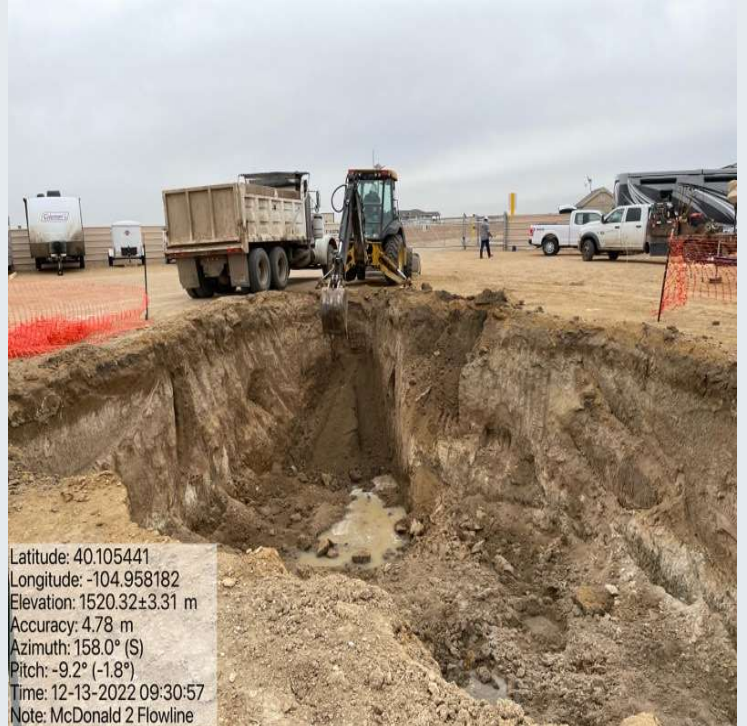
Question: Ground surface appears clean (no evidence of new equipment leaks, oil leaks, spills, or releases)?

Response: Yes

Notes: No contaminated soil or sheens are visible

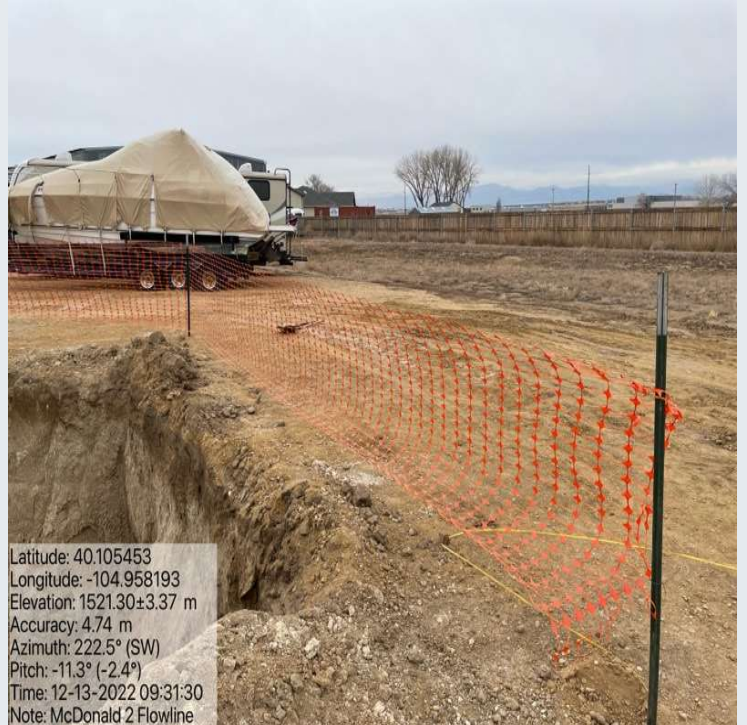
Question: Open excavation properly fenced/covered (in accordance with Rule 913.b.(5)B.i.)?

Response: Yes

Notes: It is fenced, with the fence itself being in good condition and posted everywhere where there isn't active work.

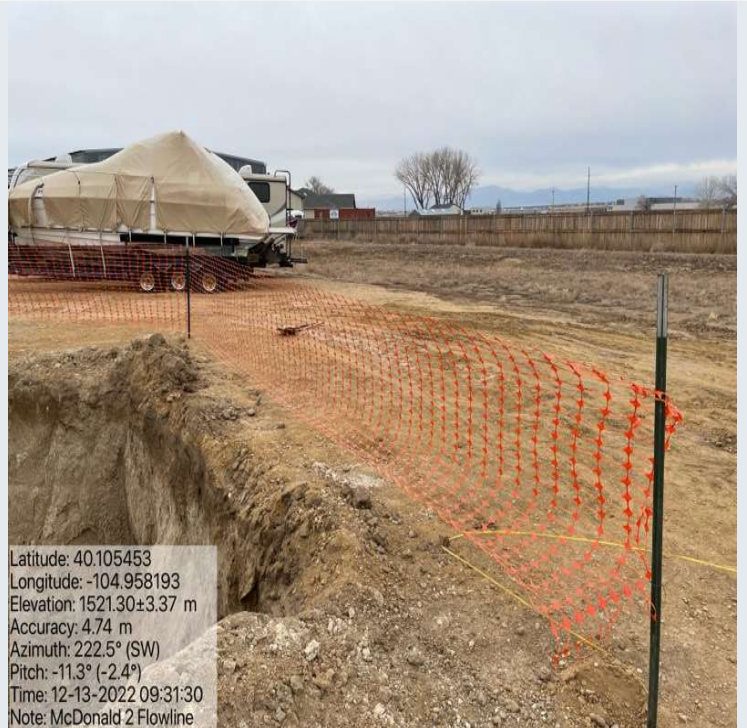
Question: Is fencing adequate/appropriate for site and well(s) and maintained?

Response: Yes

Notes: Fence is well maintained

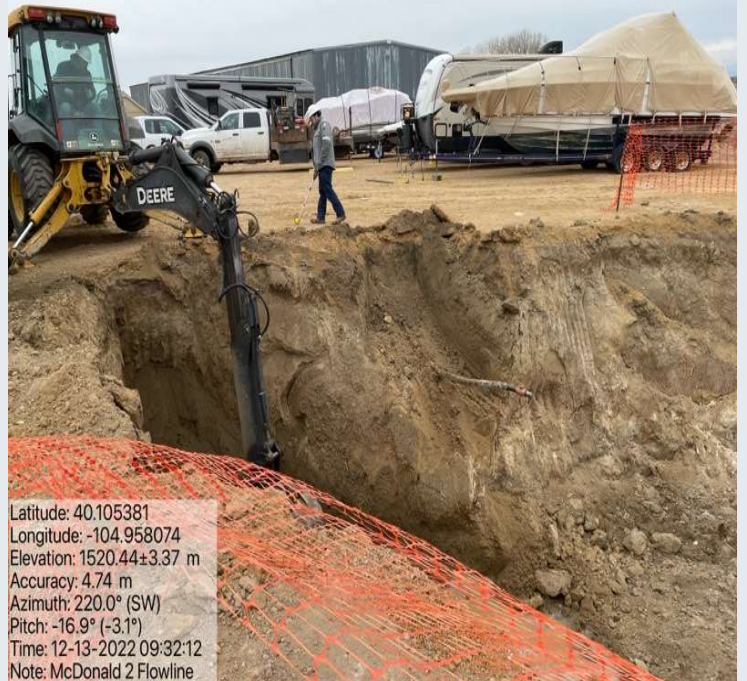
Question: Exposed buried/underground flowlines within excavation?

Response: Yes

Notes: The flowline is visible from the south end and the north end of the excavation.

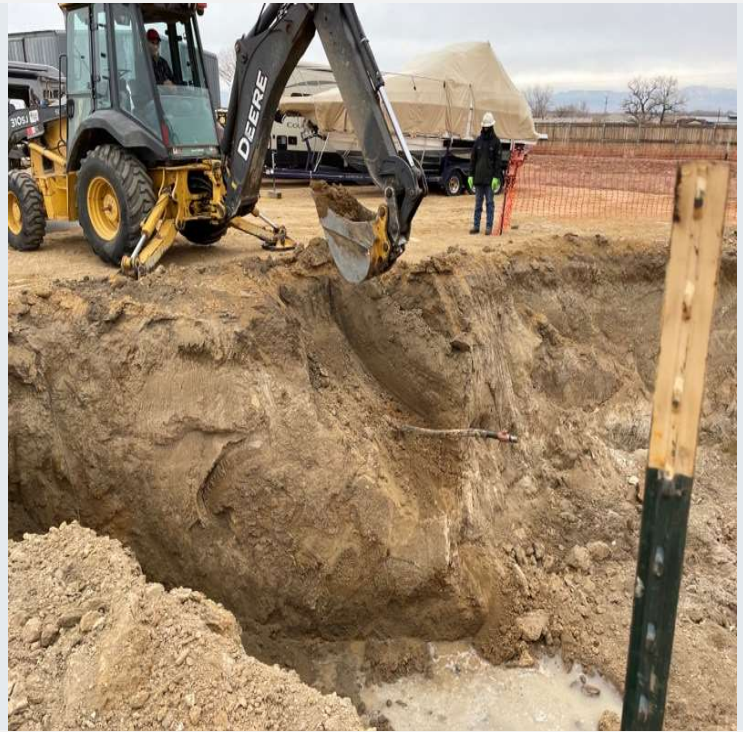
Question: If flowlines are exposed are they properly capped (bullnose plug, etc.)?

Response: Yes

Notes: They are capped properly.

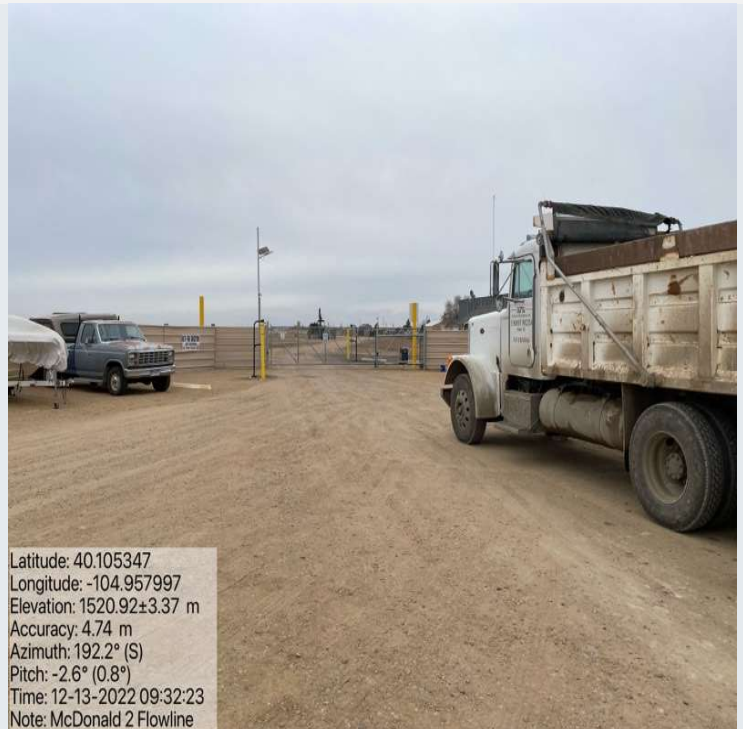
Question: Site is protected from vehicular traffic (properly fenced, gated or barricaded)?

Response: Yes

Notes: A gate requiring a passcode to access site (because of RV storage park)

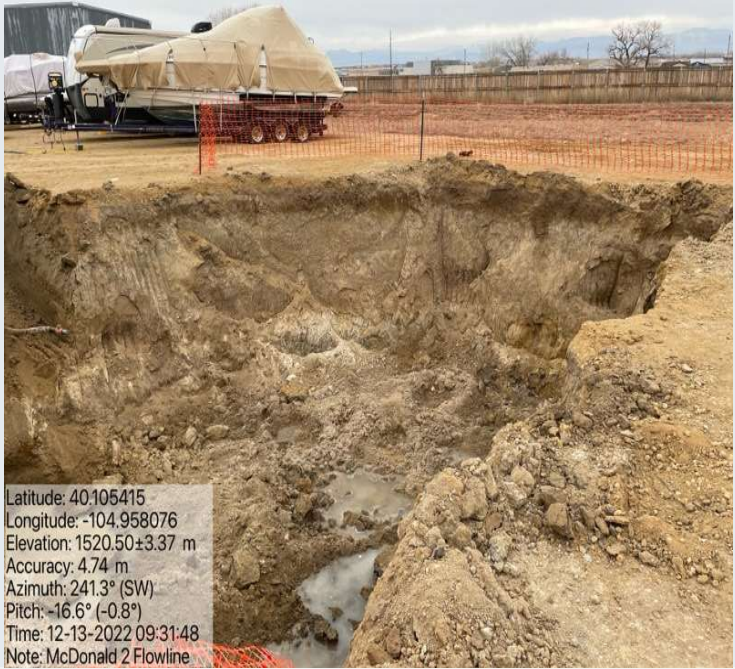
Photo
<p>Question: Is work being conducted in a minimal footprint? Note: Any property/crop damage Response: Yes Notes: Only footprint is the excavation itself.</p>
