Fwd: [EXTERNAL]Fwd: Site Inspection Request

Can you take a look at the KPK Cosslet #3 (Spill ID 474780). Our contractors at Apex noticed a leaking pipe during a recent inspection. See photos below:

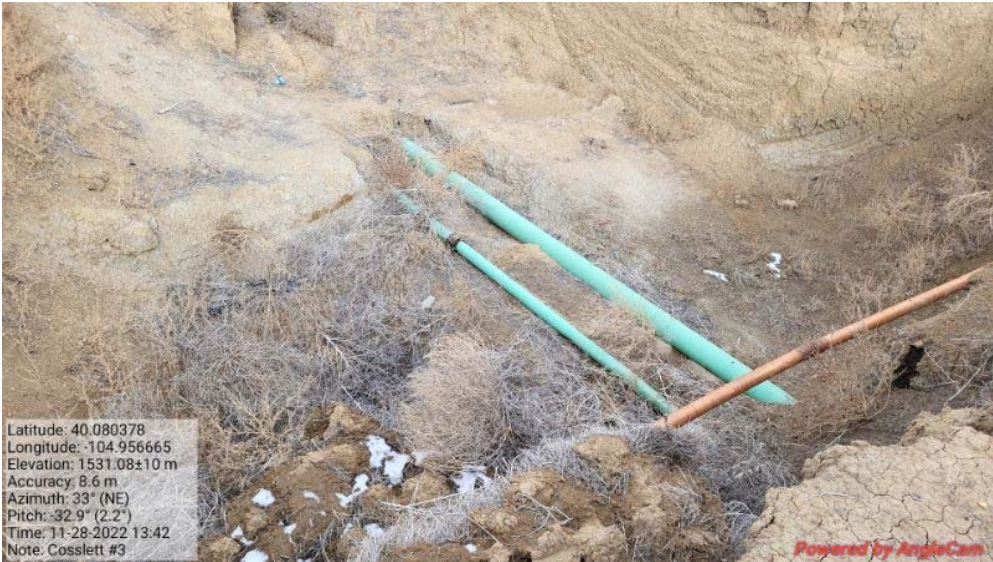
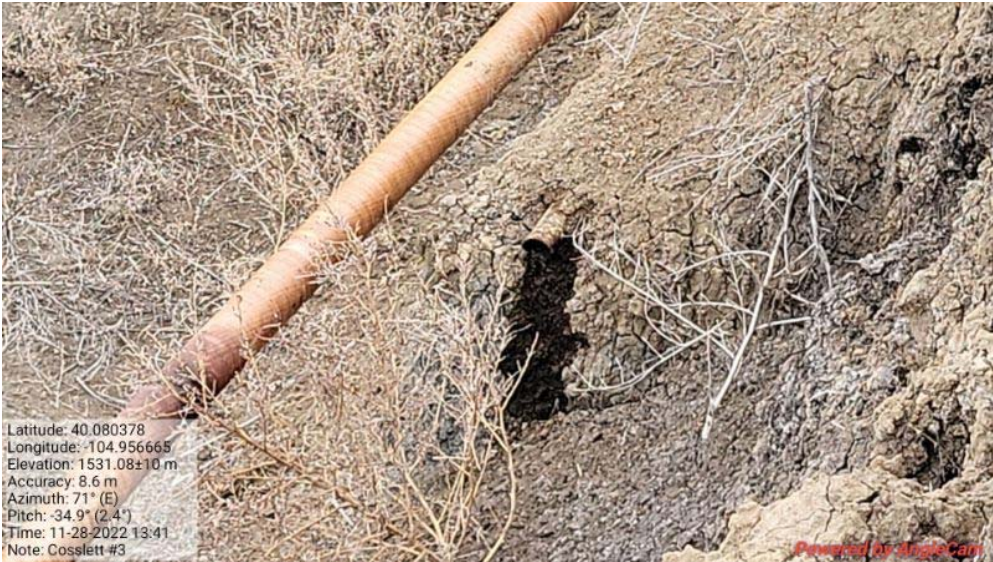
Just received these photos from Jeff Peterson via text per his response and actions at the site following our receipt of your email. From the photo taken by Apex below on 11/28/22, the surface staining is coming from an abandoned dry gas line and there was no visible staining when the crew arrived on site to respond today. The fiberglass line in the attached photos is the flowline and the pvc pipe is an abandoned supply gas line when the pumping units operated on natural gas. I'll provide some more information as Jeff shares with me as he is still doing some investigation into this matter. Just wanted to make sure you knew we did get out there today to respond. I plan to be in the field for part of the day tomorrow and will plan to go by and take some better photos to share than what has been attached along with any additional information.
