Inspection Photos
Location Name: Florence # 33-1
Location ID:322229

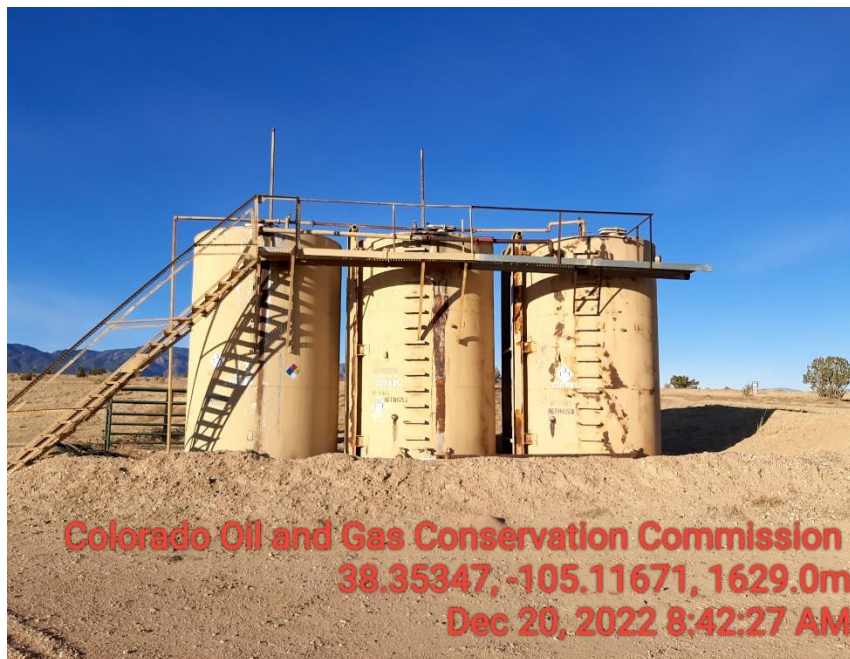
Photo 1 TNK BTRY No battery sign, No NFPA placards on two tanks

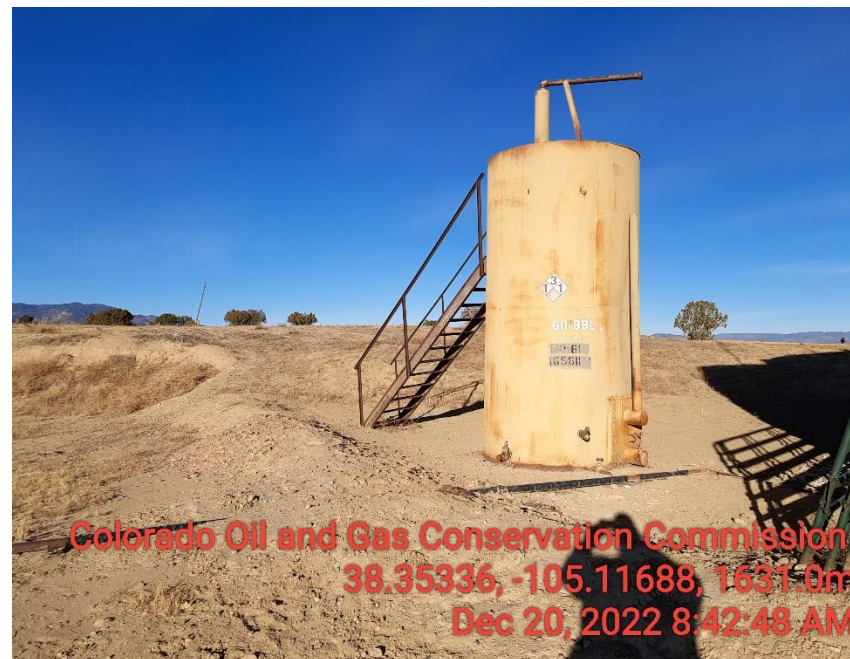
Photo 2 unused equipment: valves open on bottom of tank and tank not connected to any flow line

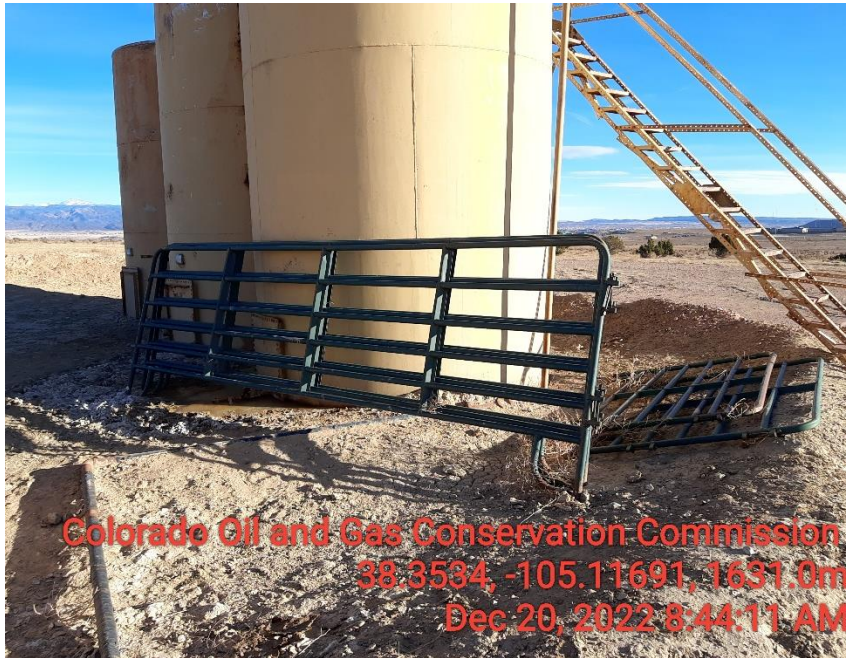
Photo 3 unused equipment: cattle panels in crude oil containment area

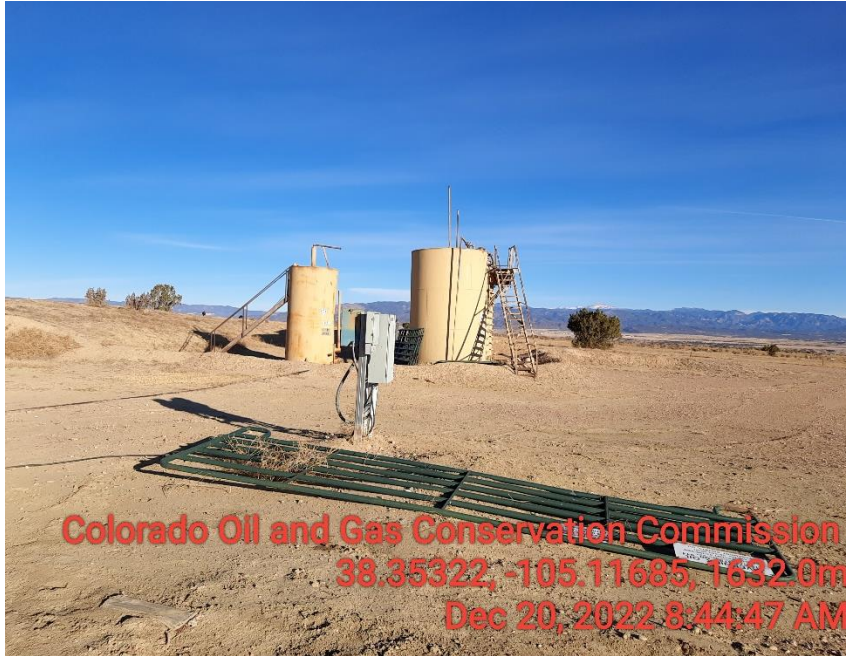
Photo 5 Unused equipment cattle panel on ground

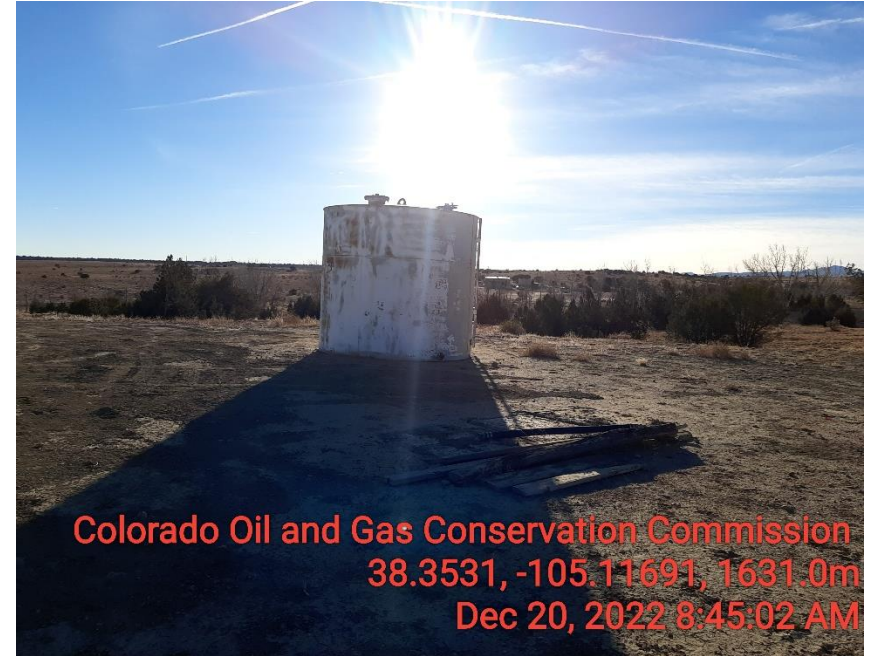
Photo 6 Trash and unused tank on location.
