WELLHEAD ABANDONMENT FORM

| SITE NAME: UPRR 42 Pan Am AT True 1 | | | | | | | DATE: 9/1/2022 | REM. PROJECT #: | | WEATHER: 90, Sunny | |
| SITE DIRECTIONS: CR 31 & CR 14, 0.1 W, 0.2 N, W Into | | | | | | | CLIENT: Oxy | | | | |

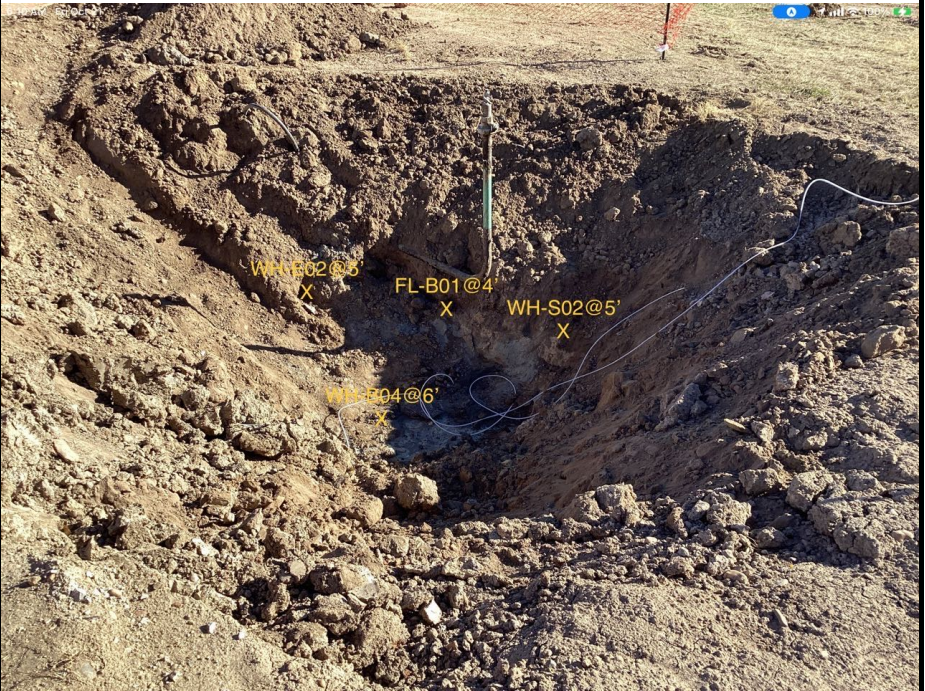
| Notes/Conditions: | | | Notes/Conditions: Discoloration at base of excavation area is concrete from cut and cap operations, NOT groundwater. Reference photo for sample WH-S03@5', illustrating NO groundwater in excavation area. | | |
