# Final Reclamation Inspection

Operator: PDC ENERGY INC - 69175

Location ID: 327499

Inspection Photos  
Location Name: Keiser 22-28  
Location ID: 327499

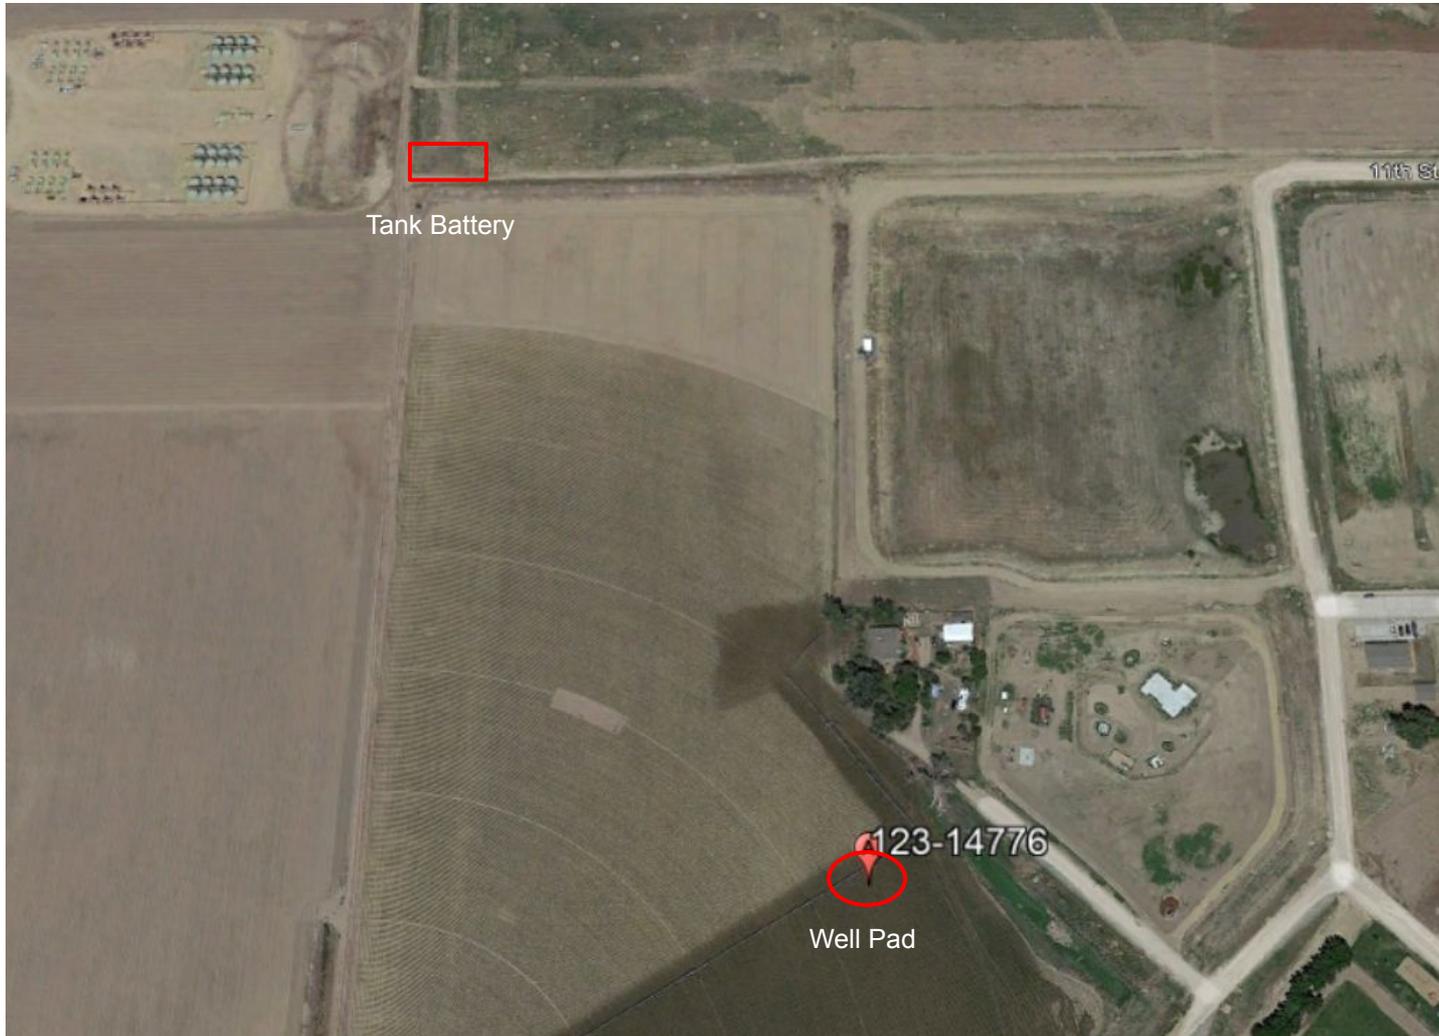
**Photo 1.** 2021 aerial imagery of the well pad and tank battery. Could not identify well pad access road from historical imagery.

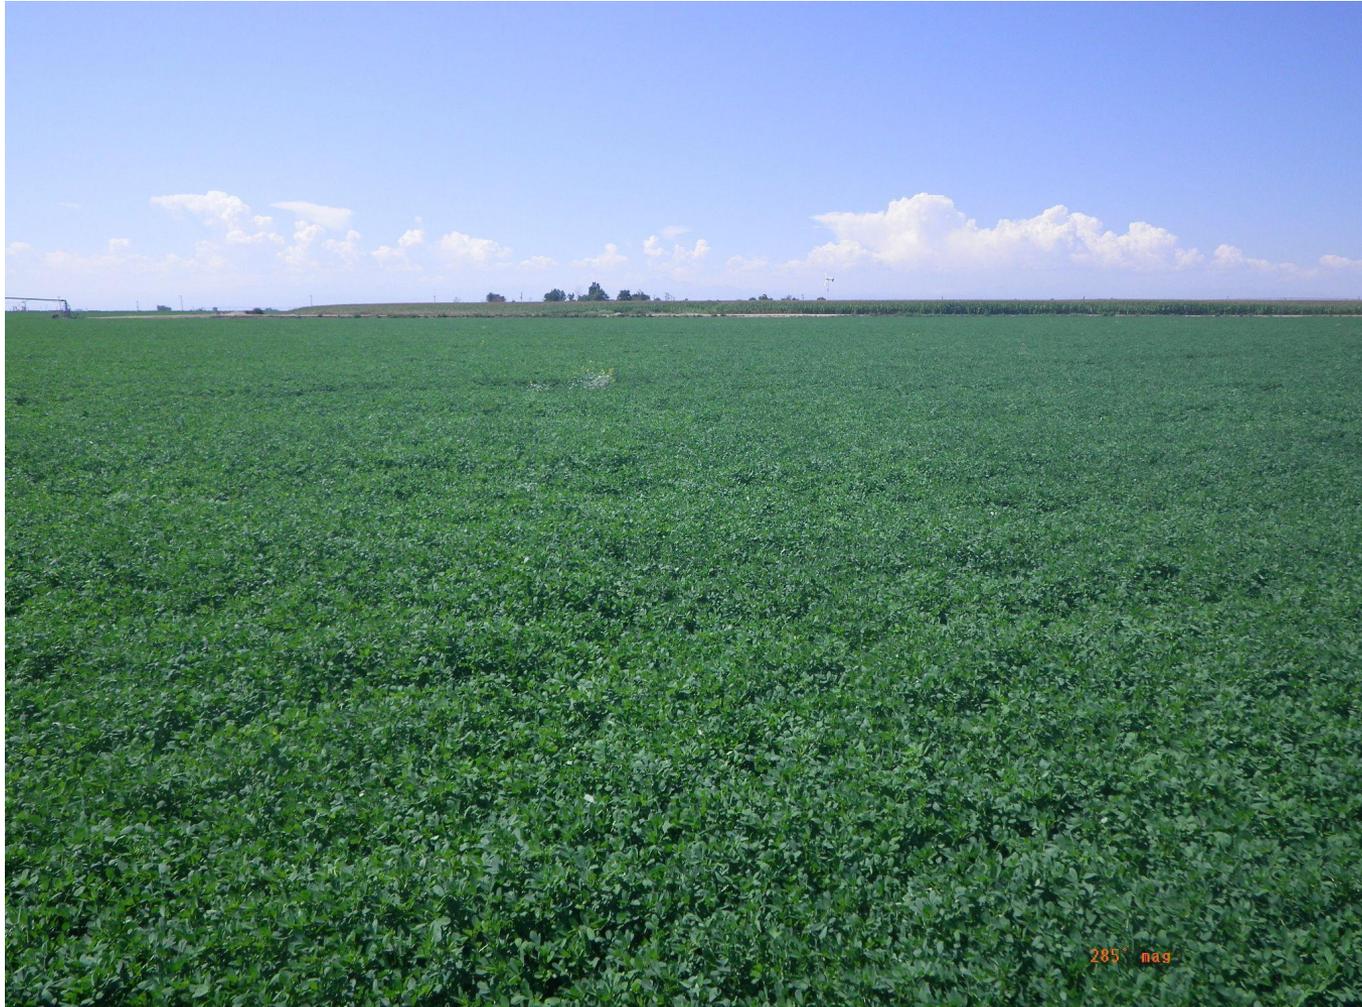
**Photo 2.** Overview photo of the well pad taken at ground level.

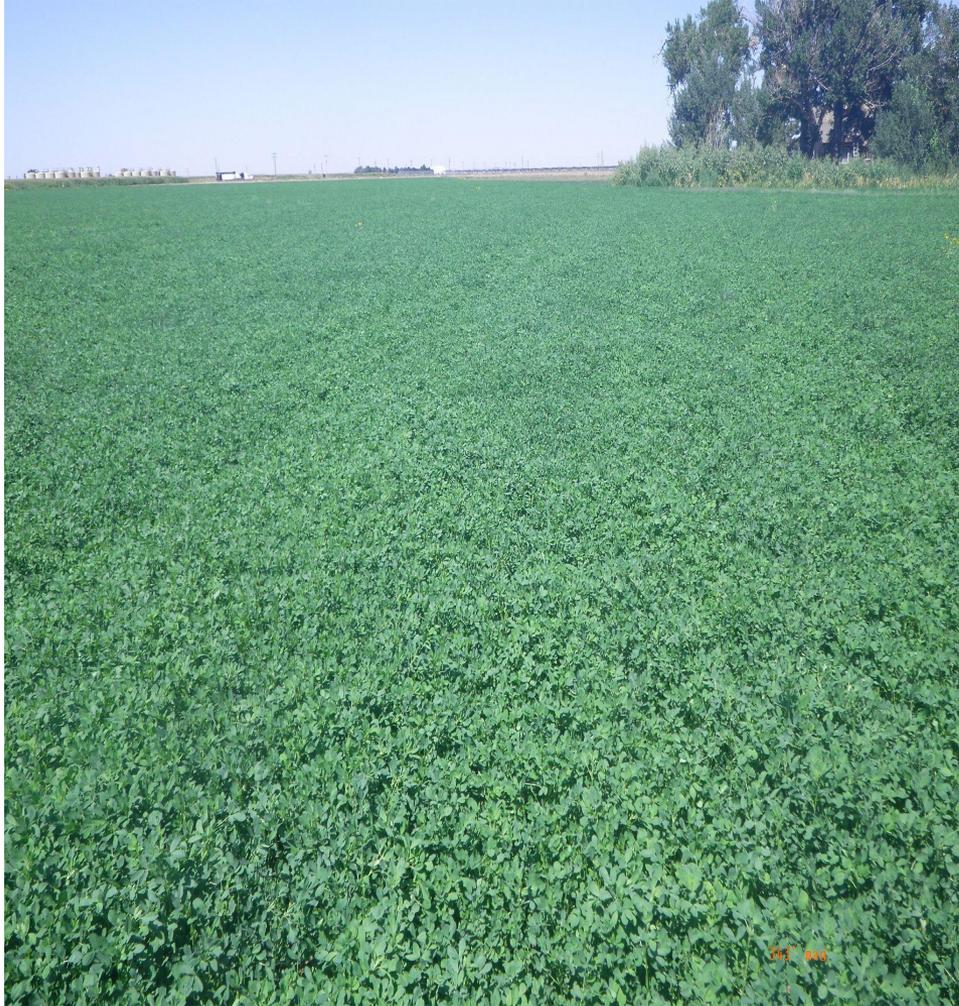
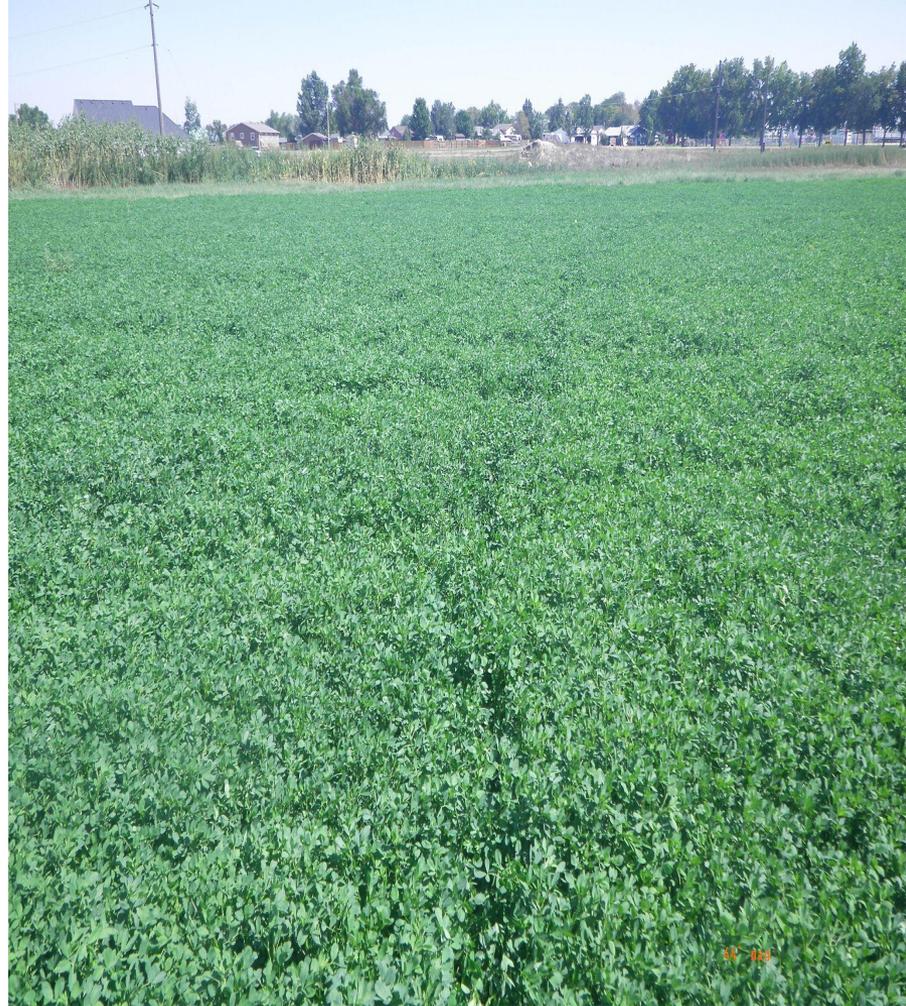
**Photo 3.** Cardinal photos taken from the middle of the well pad. Left photo facing north, right photo facing east.

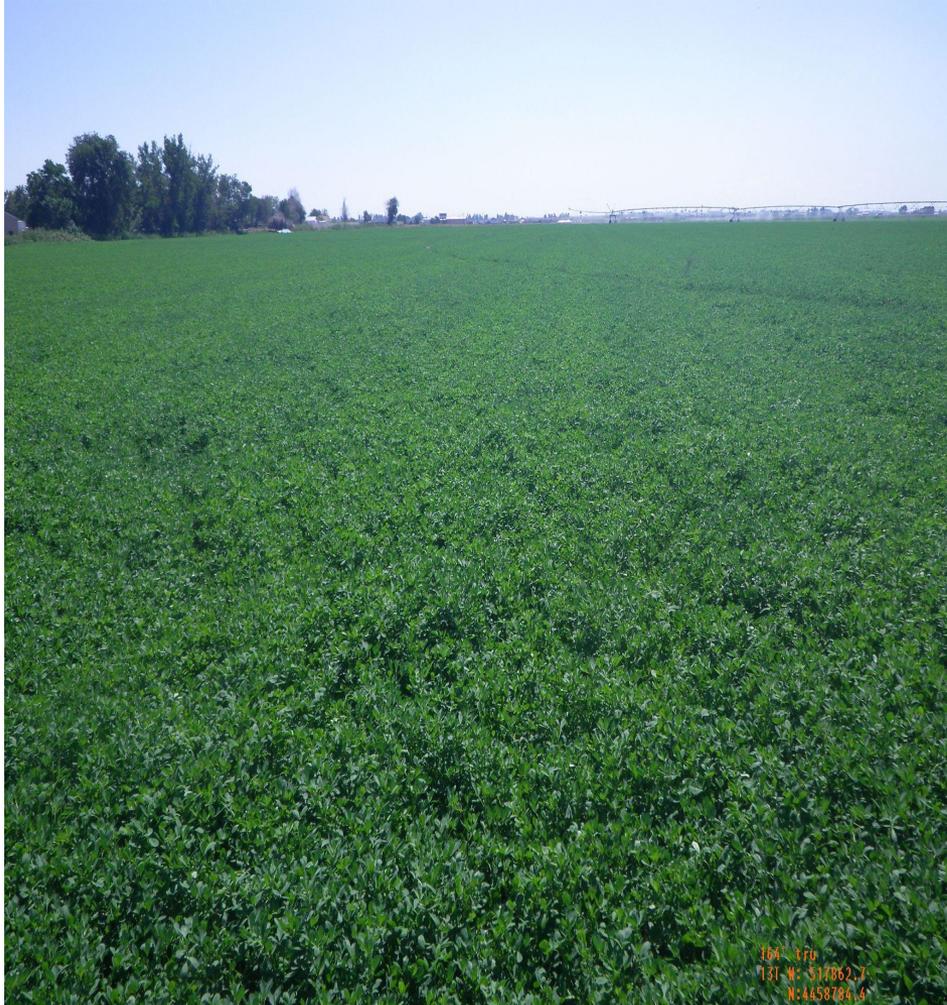
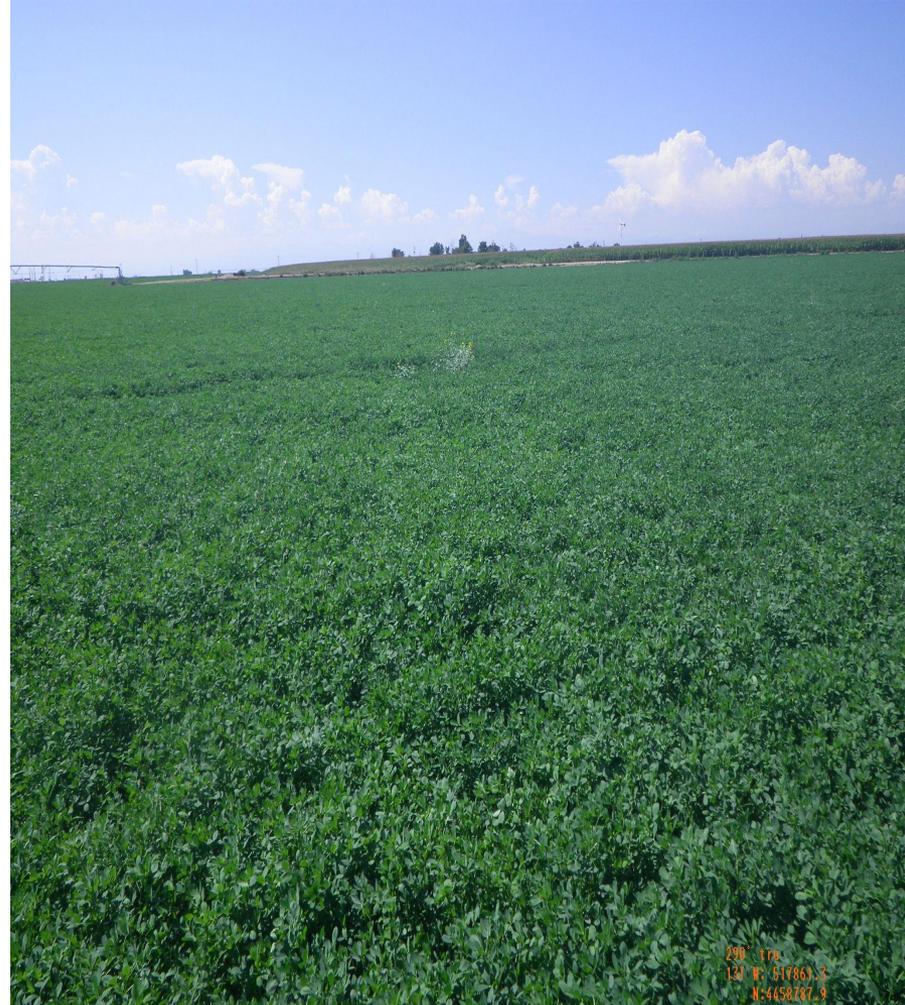
**Photo 4.** Cardinal photos taken from the middle of the well pad. Left photo facing south, right photo facing west. Note: well pad appears consistent with adjacent crop reference area (see photo 5).

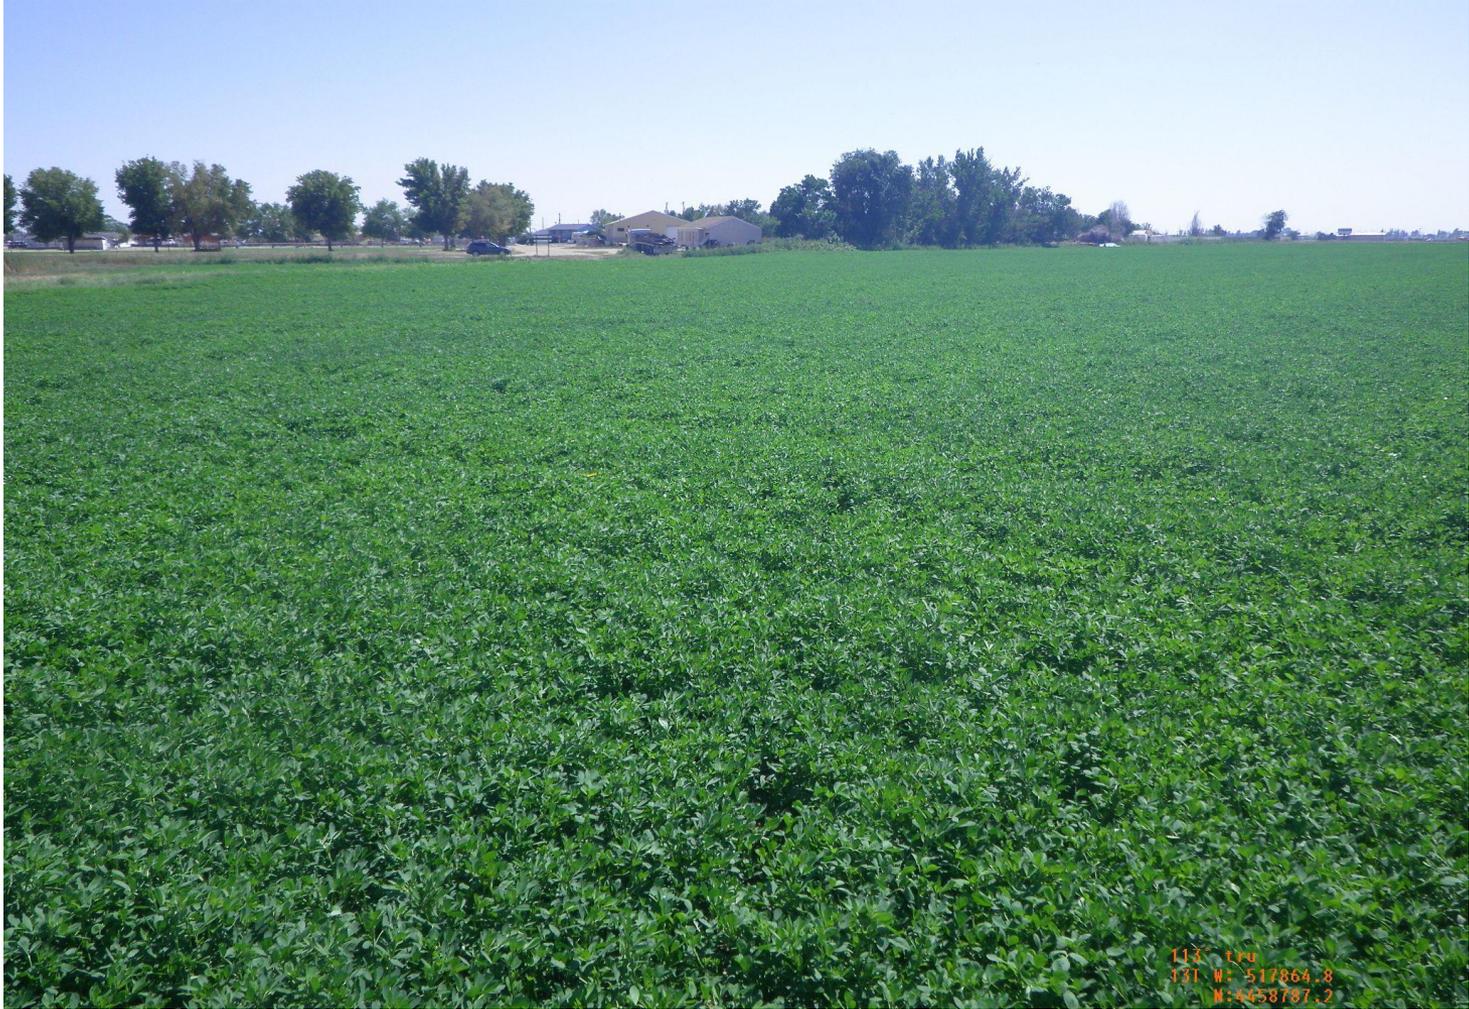
**Photo 5.** Well pad reference area.

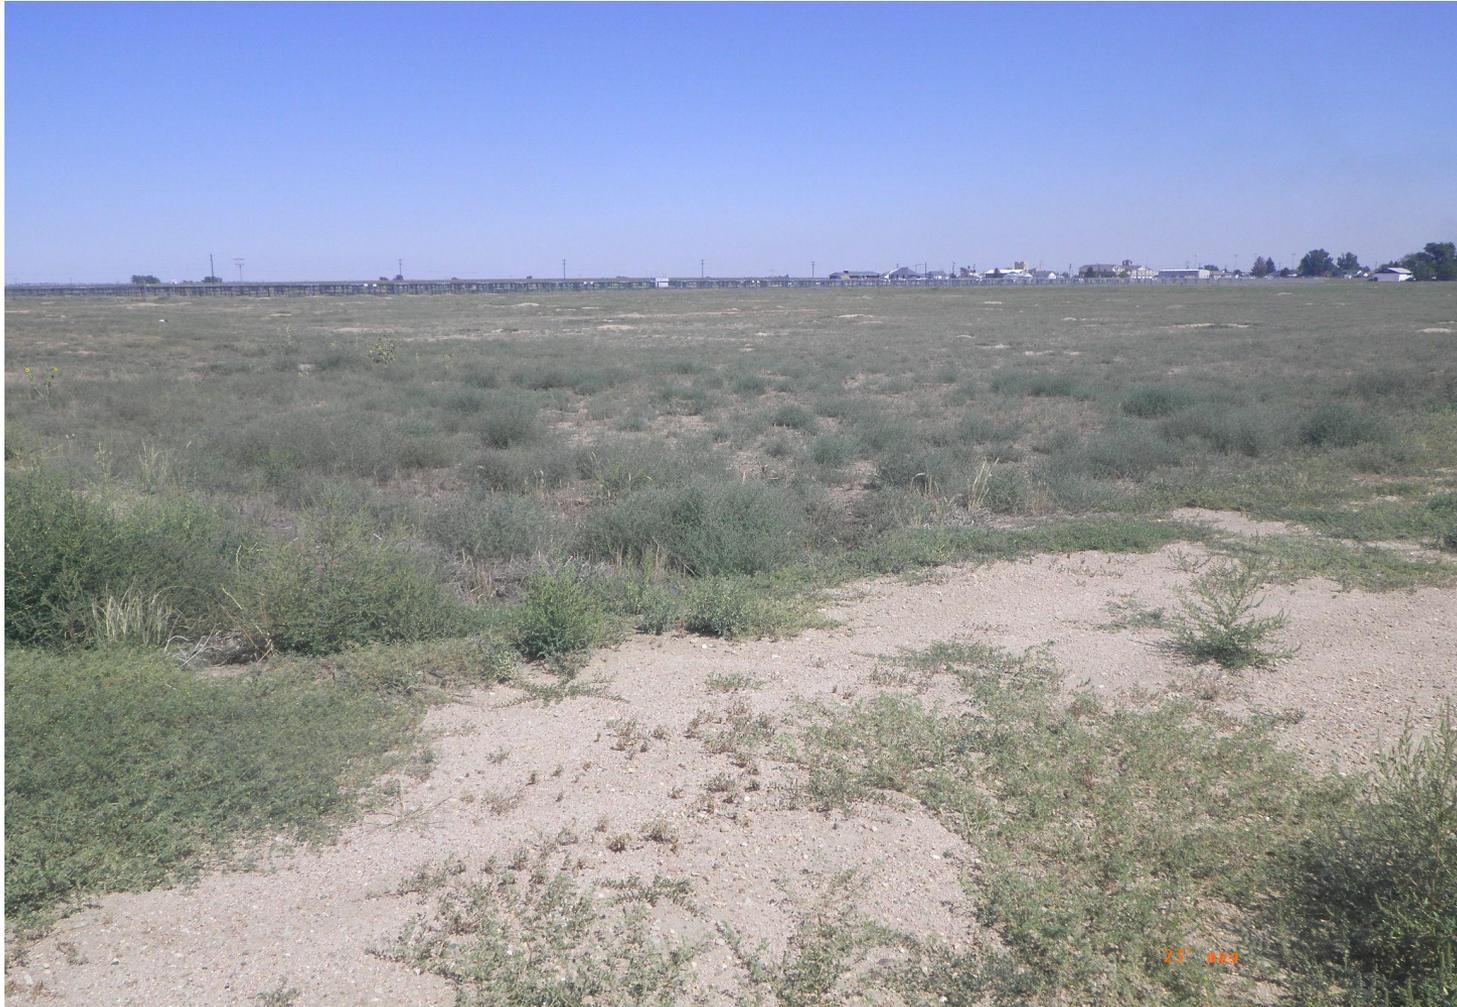
**Photo 6.** Overview photo of the tank battery taken at ground level from the western edge facing northeast. Note: tank battery access point remains with gravel.

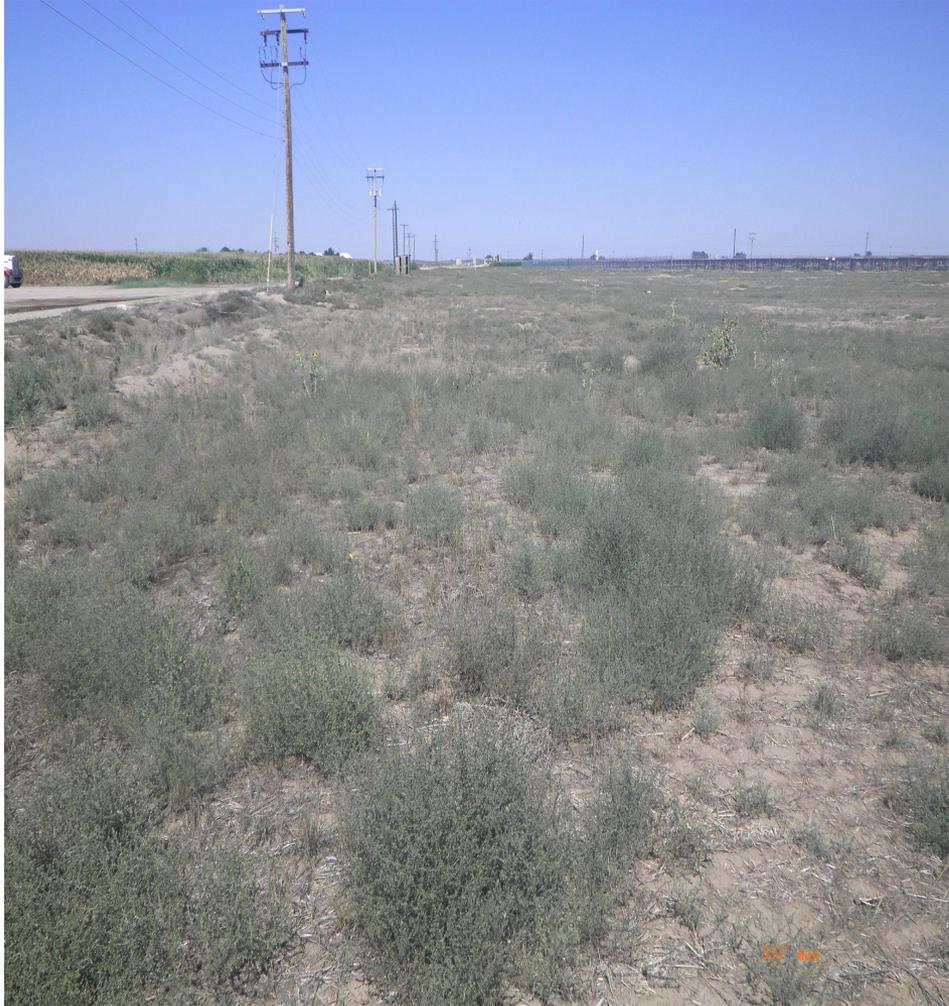
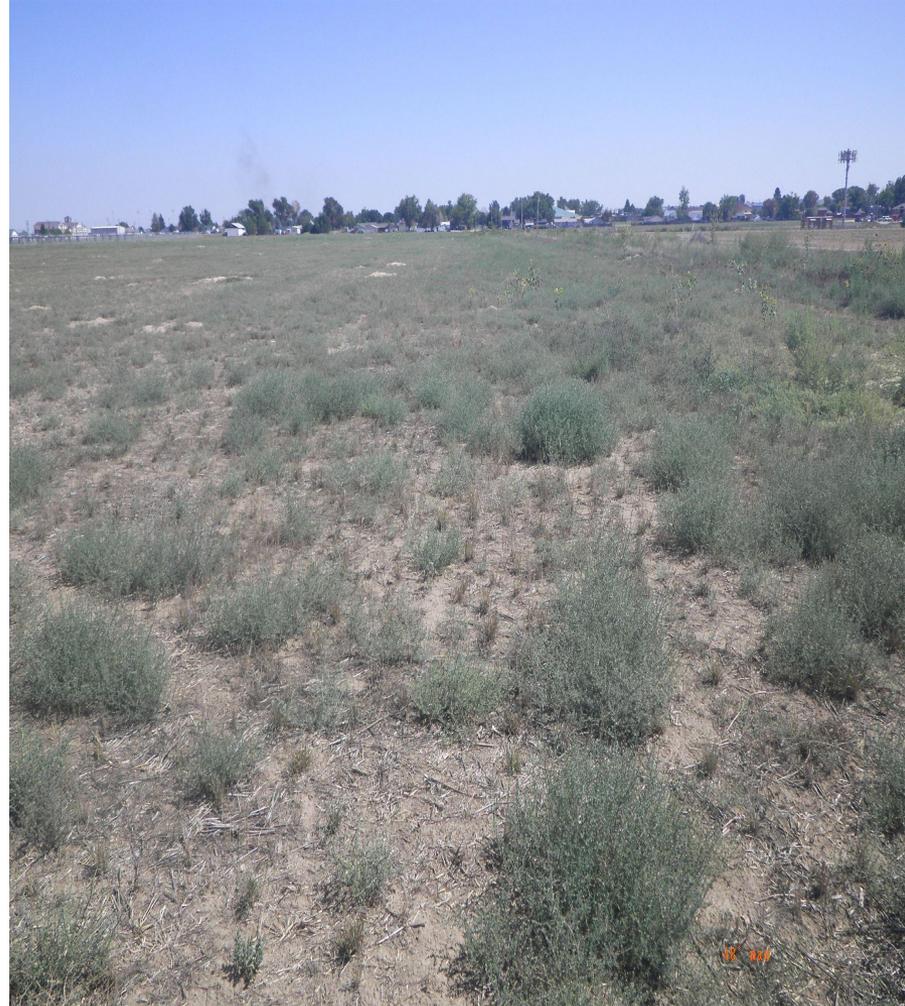
**Photo 7.** Cardinal photos taken from the middle of the tank battery. Left photo facing north, right photo facing east.

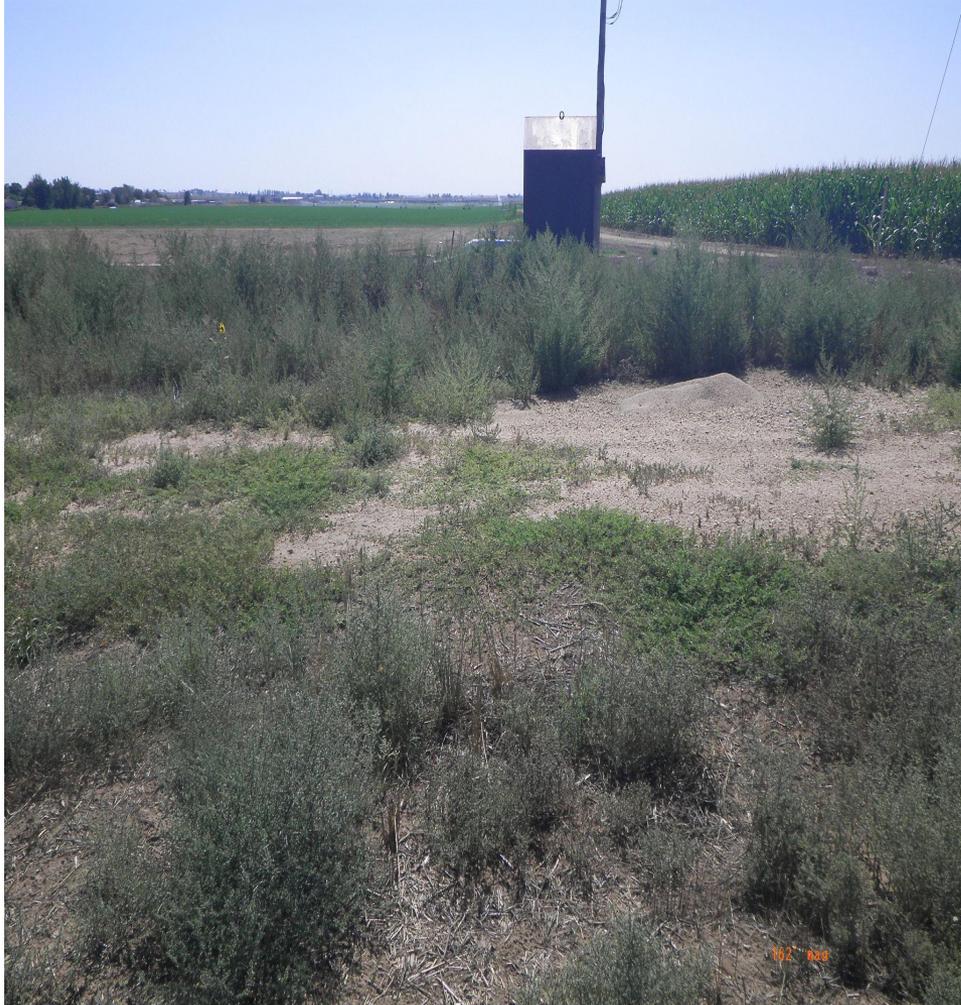
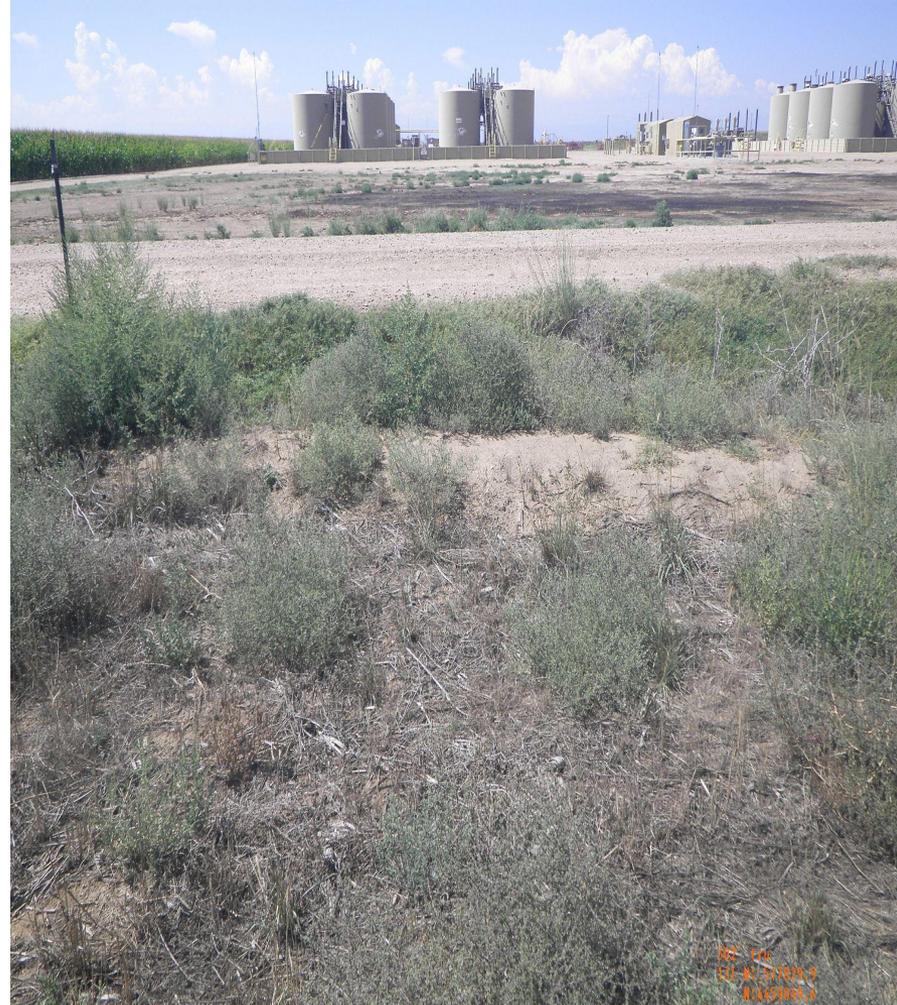
**Photo 8.** Cardinal photos taken from the middle of the tank battery. Left photo facing south, right photo facing west.
