Inspection Photos

API: 071-08606

Operator: EVERGREEN NATURAL RESOURCES

Inspection Date: 12/28/2022

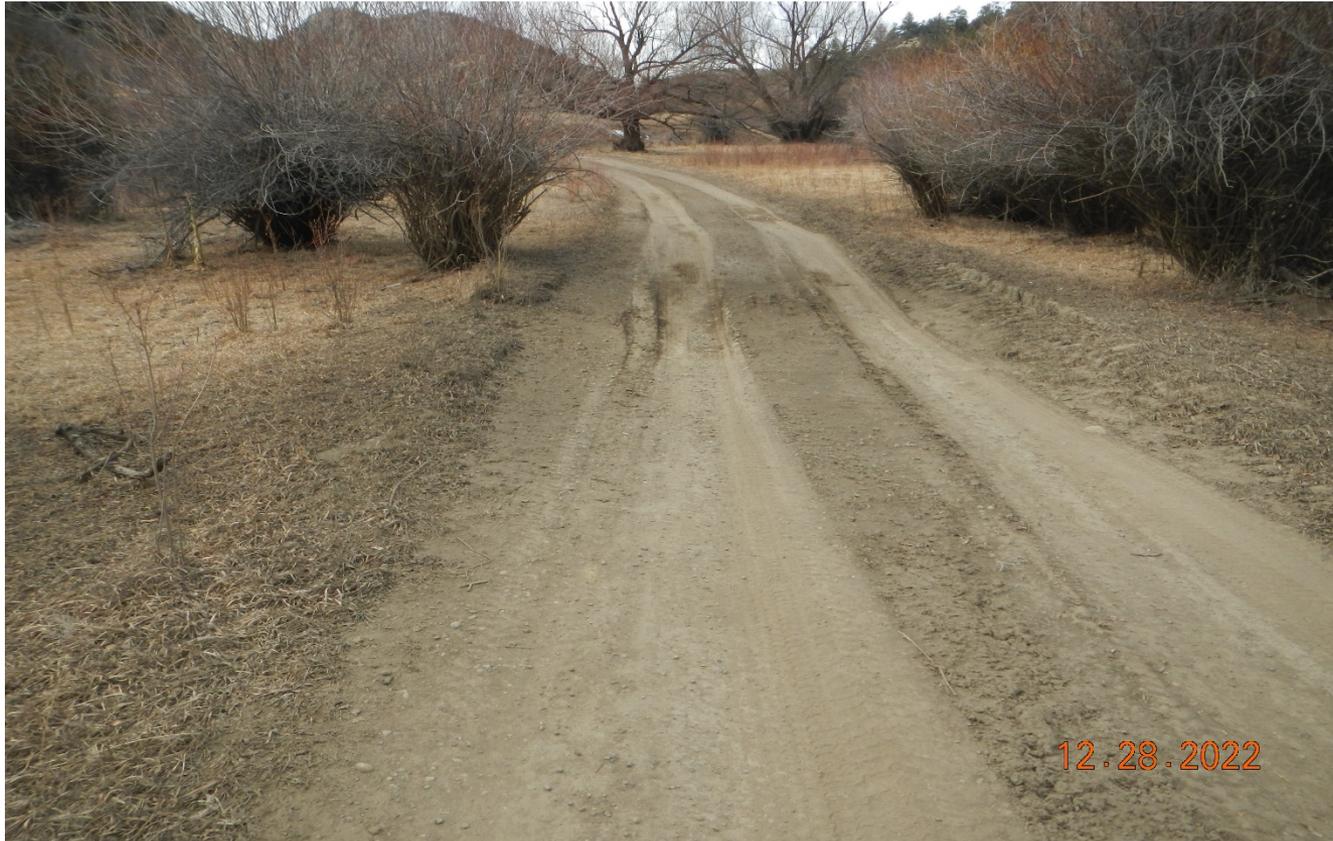
Photo 1. Facing west along the main road in Jaroso Canyon. This low area of the road accumulates the intermittent stream water and needs to be built up and stabilized. Approx. Lat/Long:37.29289,-104.84867.

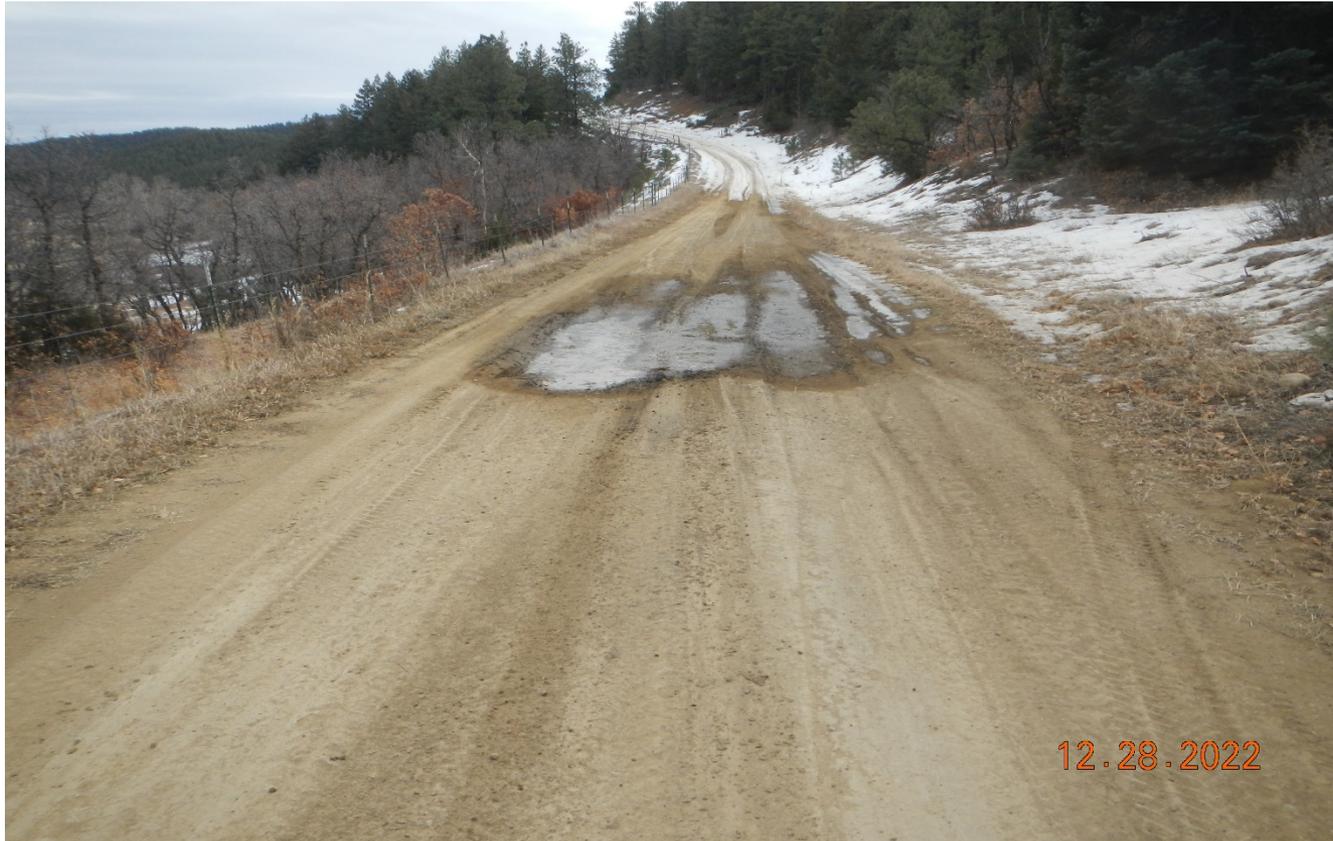
Photo 2. Facing southeast along the road. Stormwater is accumulating on the road and vehicles are driving around this area causing widening of the road. Approx. Lat/Long:37.29215,-104.84876.

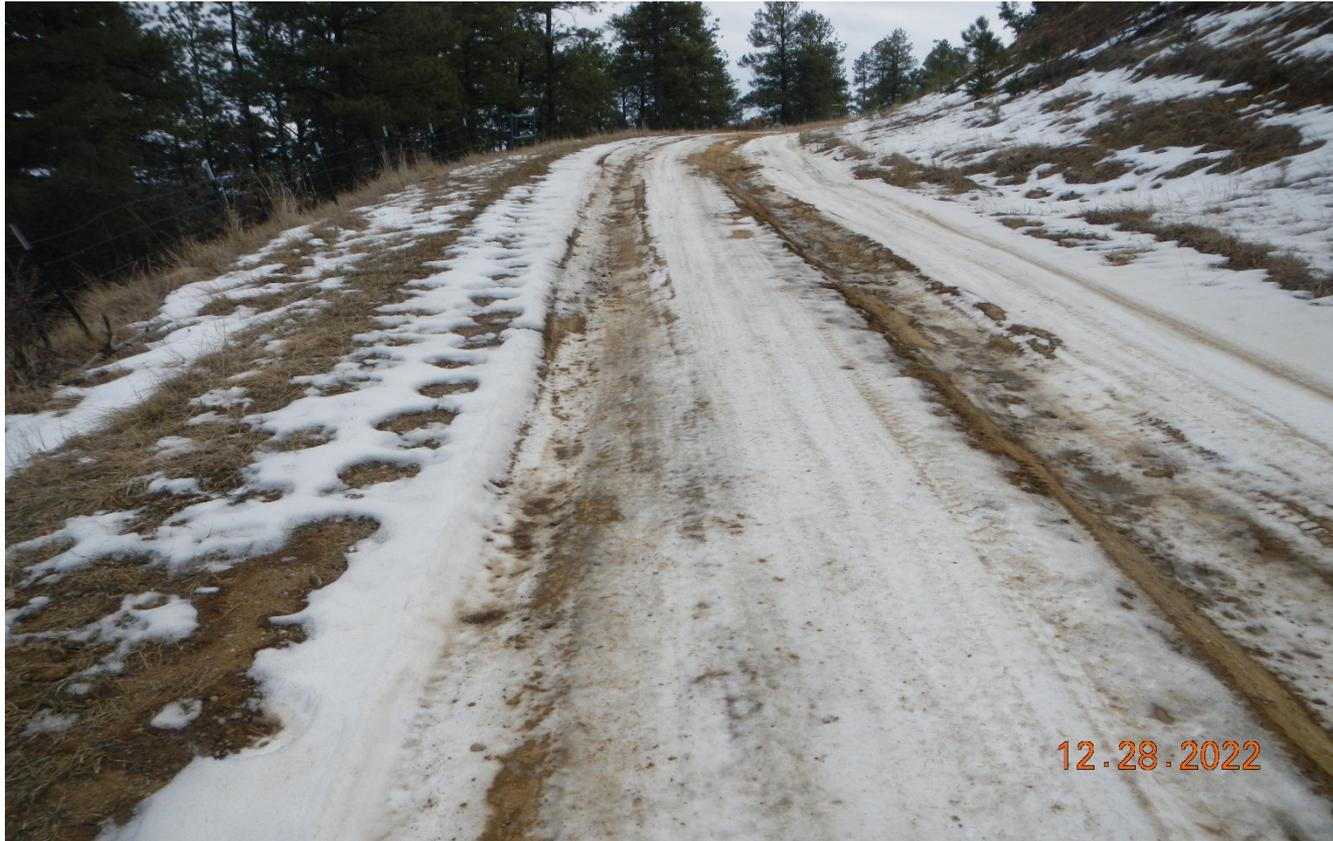
Photo 3. Further up the road there is vehicle rutting of the road. Soils are frozen so repairs will likely need to be made at a later in the season.

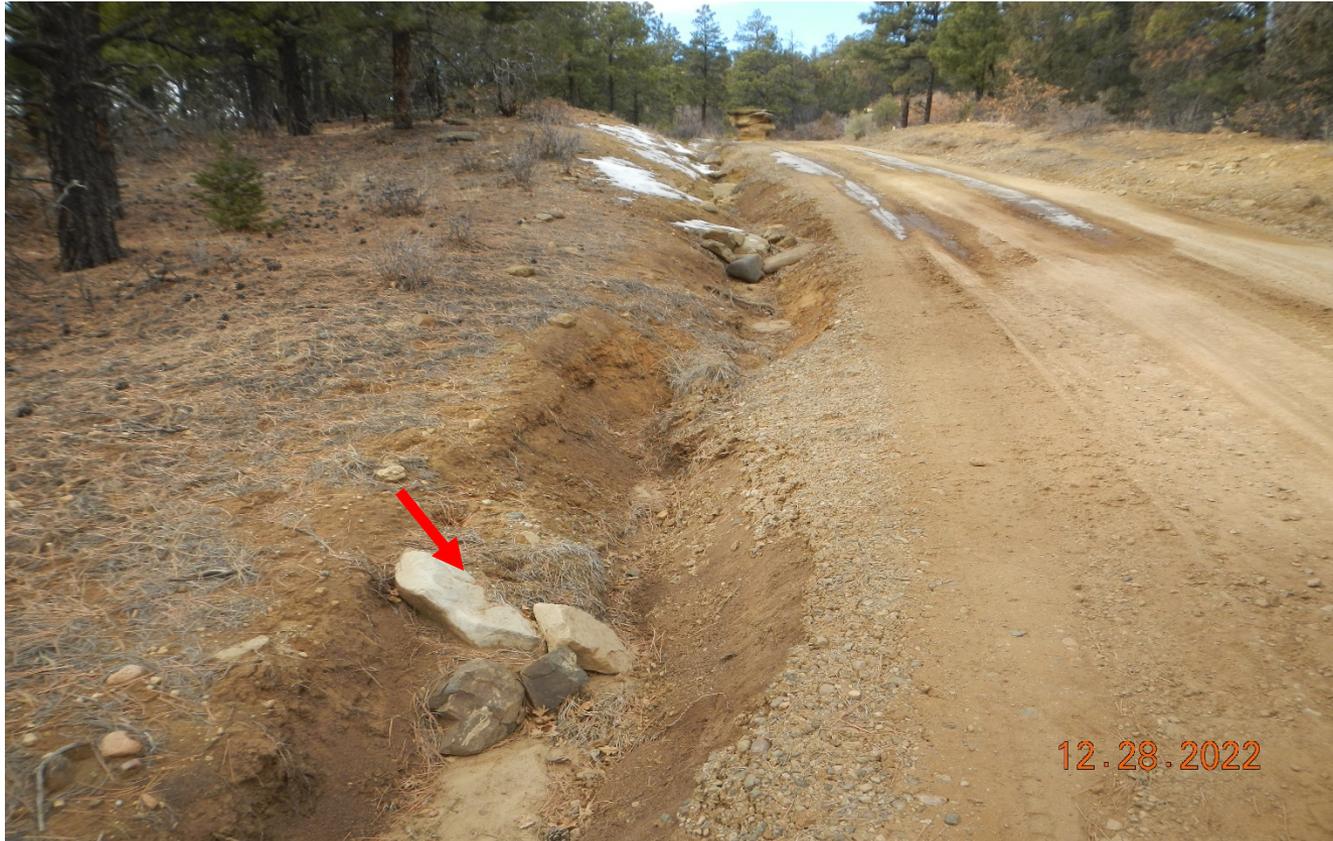
Photo 4. Facing northwest along the main road. The rock check dams are in need of maintenance. Lat/Long:37.28628,-104.85538.

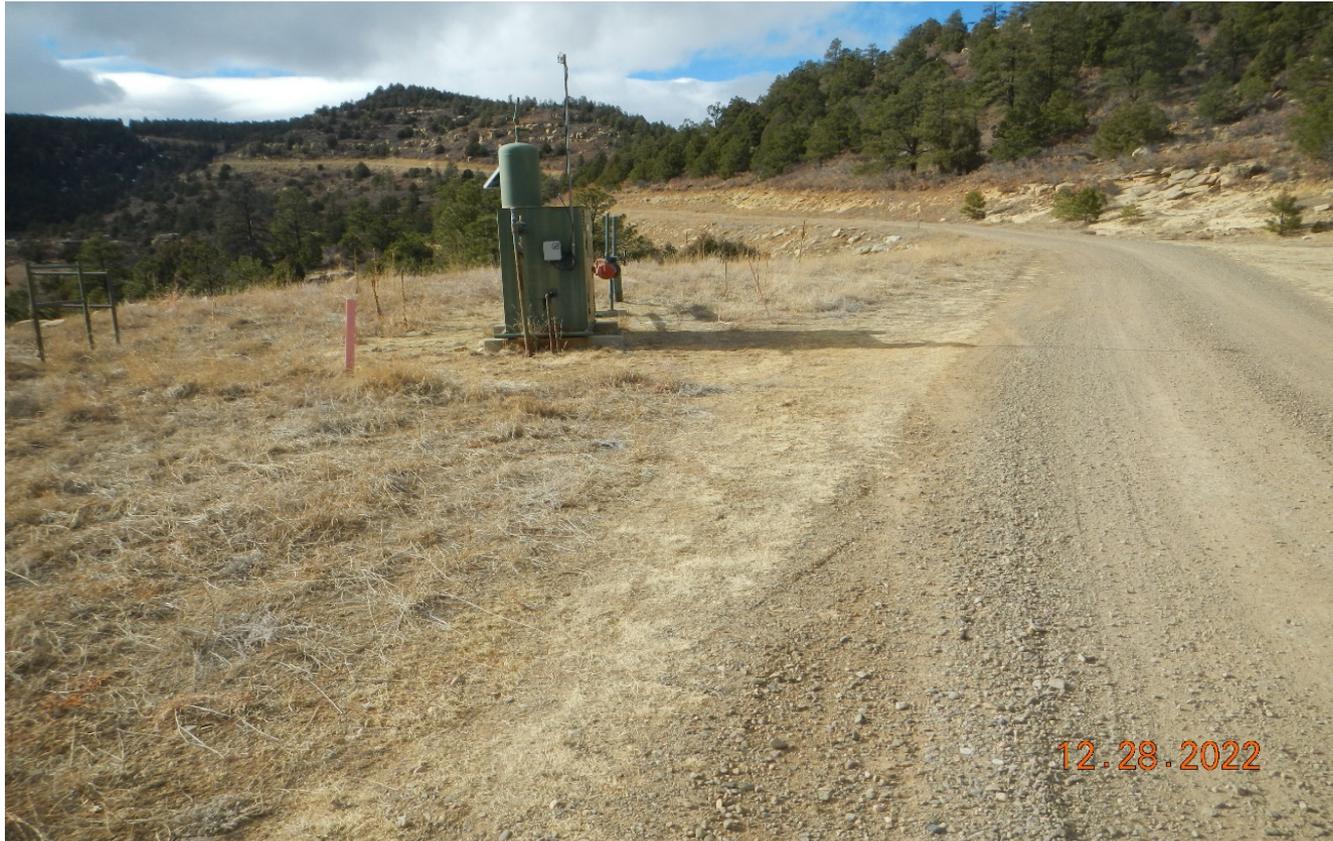
Photo 6. Facing west at the location. There is also culverts further along the road that are filled in with sediment.
