# Site Inspection Report

**Site: CAMENISCH 1SX NEW RELEASE**  
01/03/2023

SITE/LOCATION	DATE	TIME	INSPECTOR
CAMENISCH 1SX NEW RELEASE	01/03/2023	12:56 PM	COGCC Representative
Comments			
Work Activity Notes			
Changes since previous inspection?	No	Drive by inspection	No
Actively being worked?	No		
Fieldwork Oversight Performed?	No	Oversight Type	
Were Oversight Samples Collected?	No	Sample Details

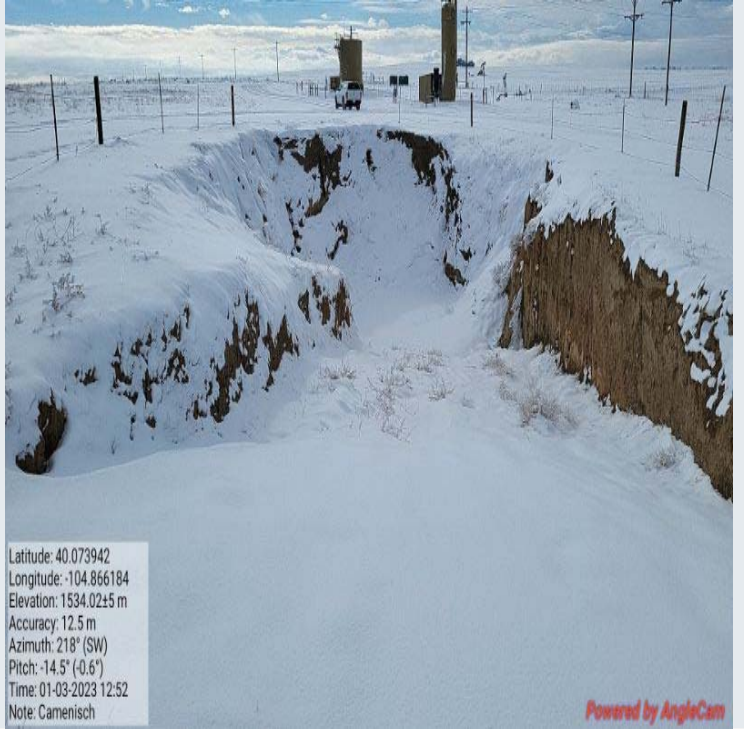
Remediation Activity Checklist	
	Photo
<b>Question:</b> Open excavation(s)? Note: Approximate size(s) (Length x Width x Depth, ft) <b>Response:</b> Yes <b>Notes:</b> 52'x125'x20'

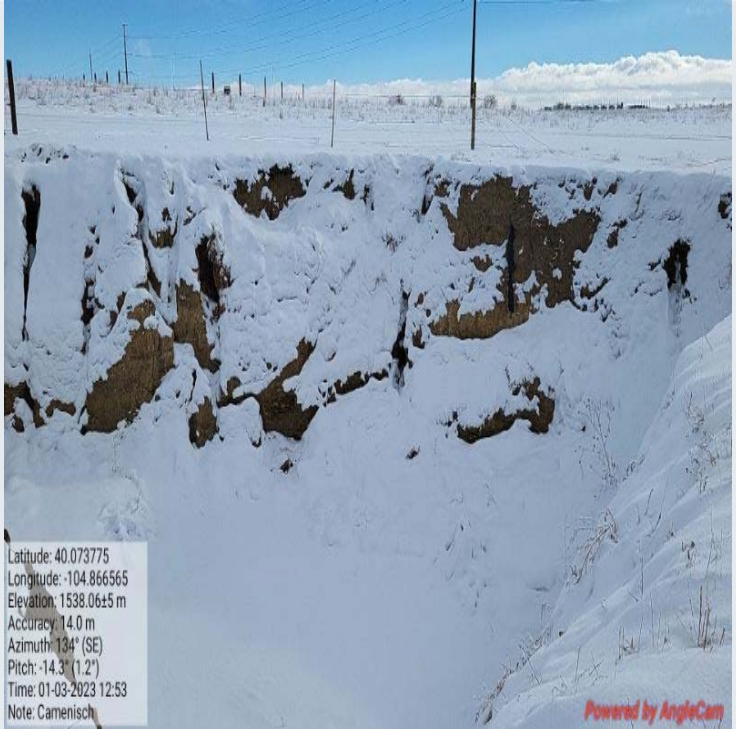
Photo
<b>Question:</b> Groundwater present within excavation? Note: Depth to water below grade surface (ft), free product/sheen <b>Response:</b> No <b>Notes:</b> Snow-covered bottom.

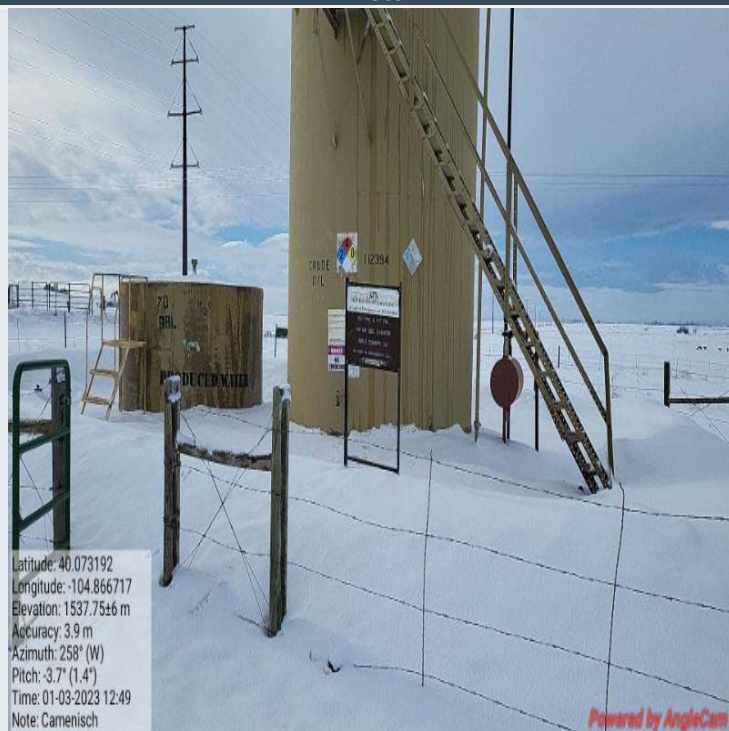
**Question:** Emergency signage in compliance with 605.g.?  
**Note:** Location of signage - Location entrance, Tank Battery, Wellhead(s).

**Response:** Yes

**Notes:** Tank Battery.

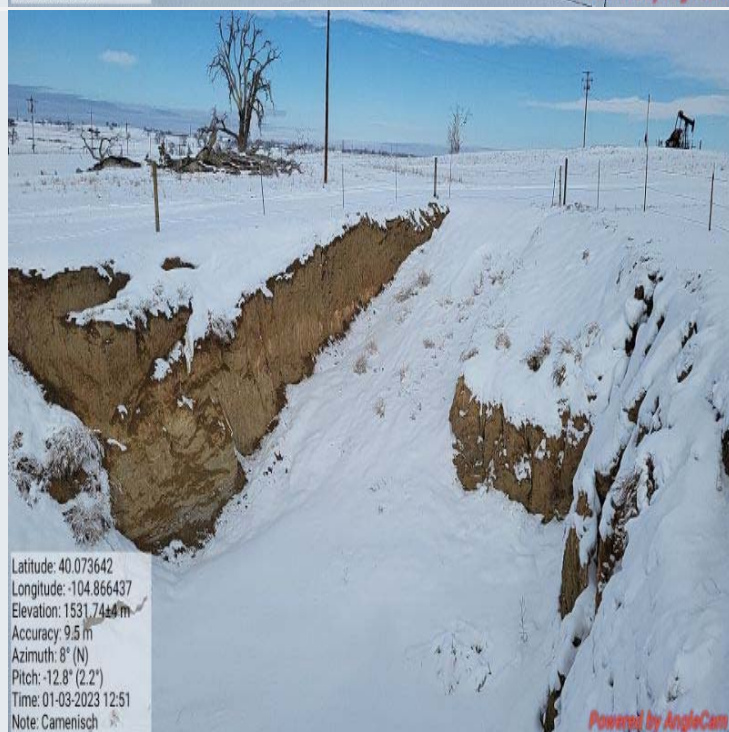
**Question:** Ground surface appears clean (no evidence of new equipment leaks, oil leaks, spills, or releases)?

**Response:** Yes

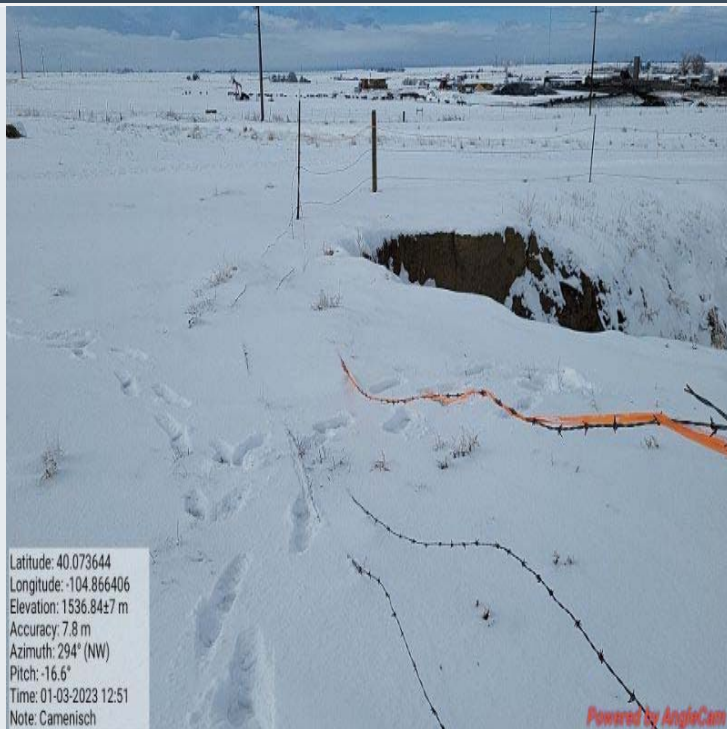
**Question:** Is fencing adequate/appropriate for site and well(s) and maintained?

**Response:** No

**Notes:** Fencing is down on the south side.

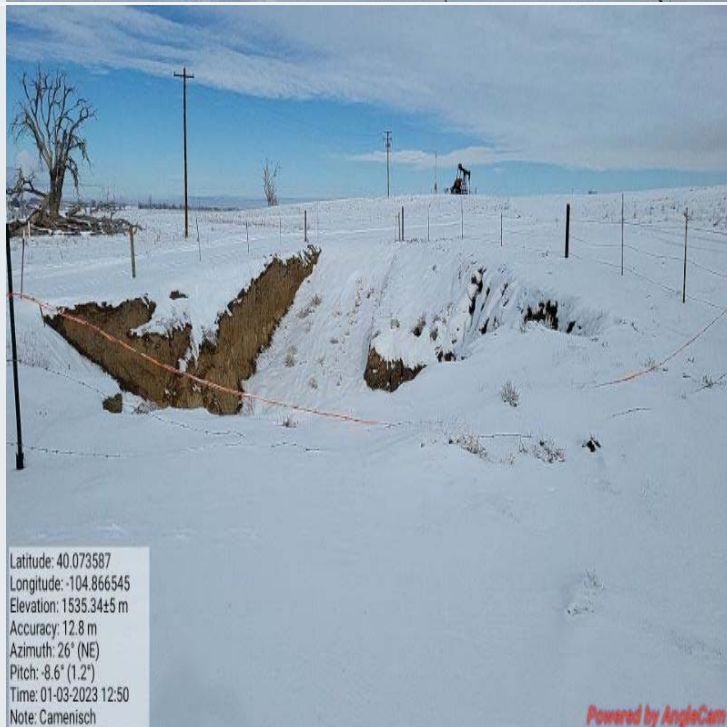
**Question:** Is fencing adequate/appropriate for site and well(s) and maintained?

**Response:** No

**Notes:** Fencing is down on the south side.

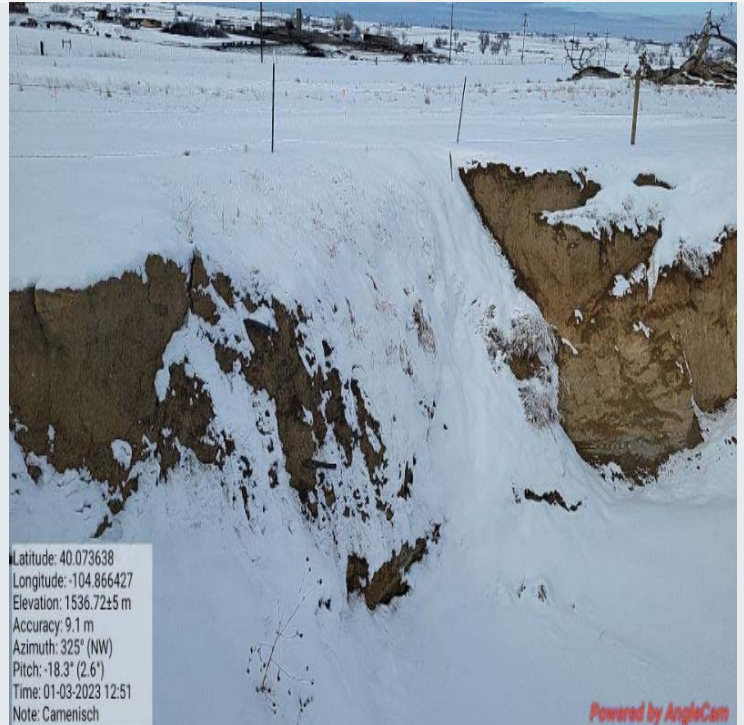
**Question:** Exposed buried/underground flowlines within excavation?

**Response:** Yes

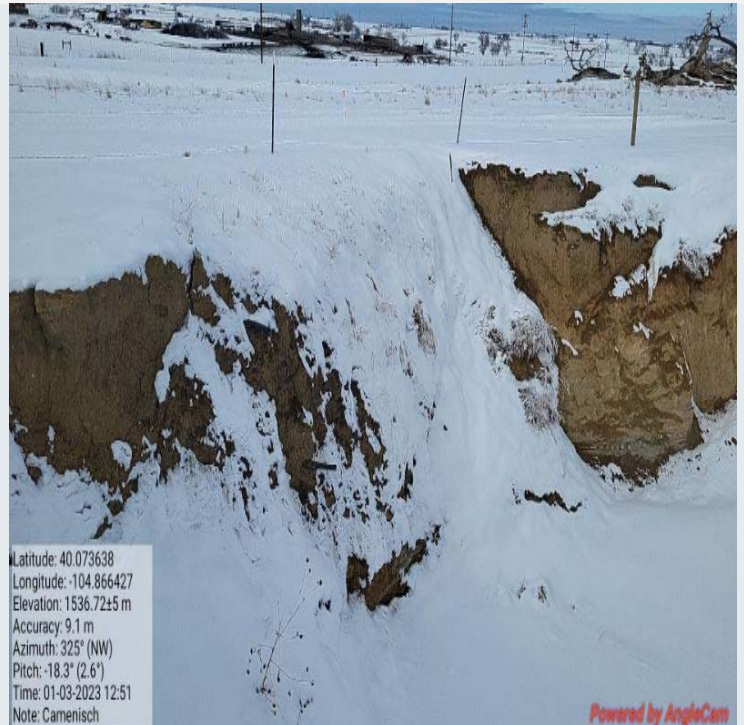
**Question:** If flowlines are exposed are they properly capped (bullnose plug, etc.)?

**Response:** Yes

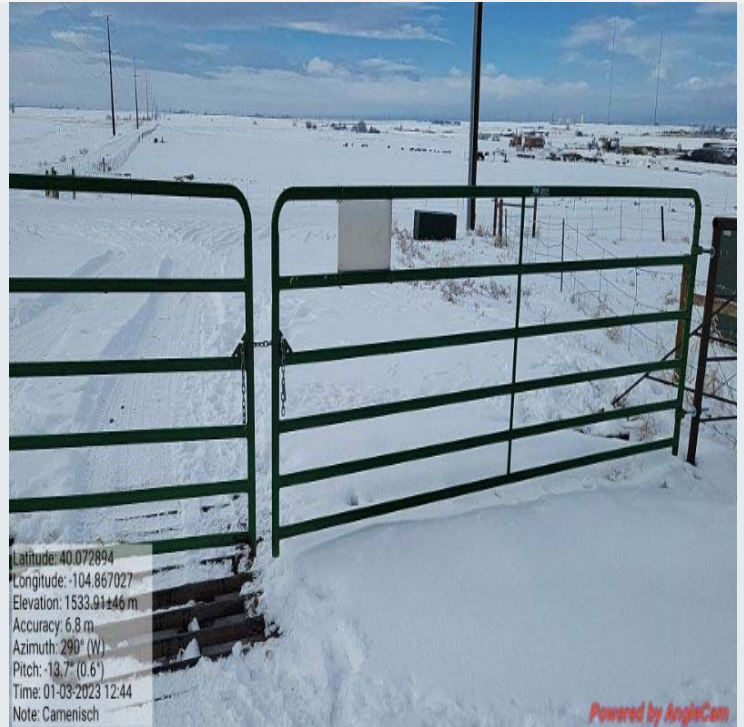
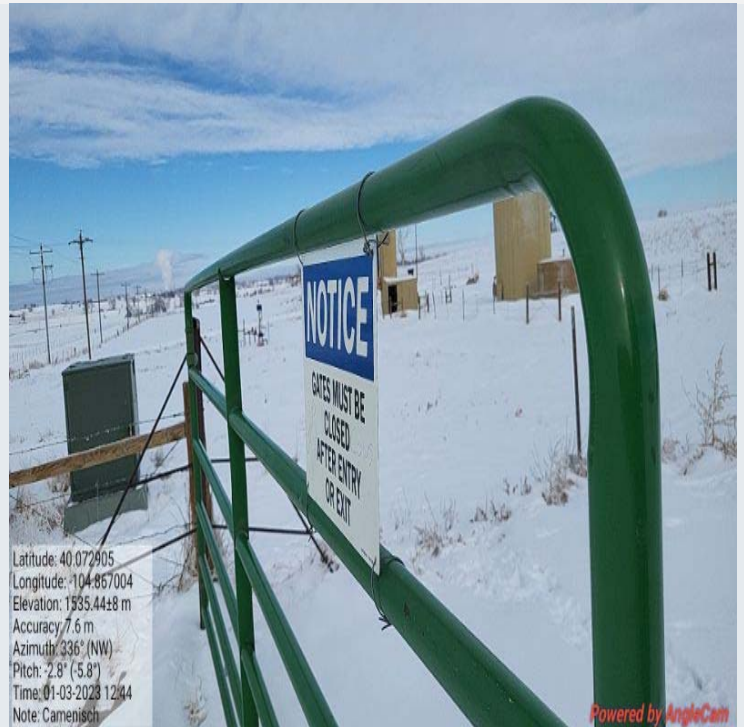
**Question:** Site is protected from vehicular traffic (properly fenced, gated or barricaded)?

**Response:** Yes

**Notes:** Gated entrance.

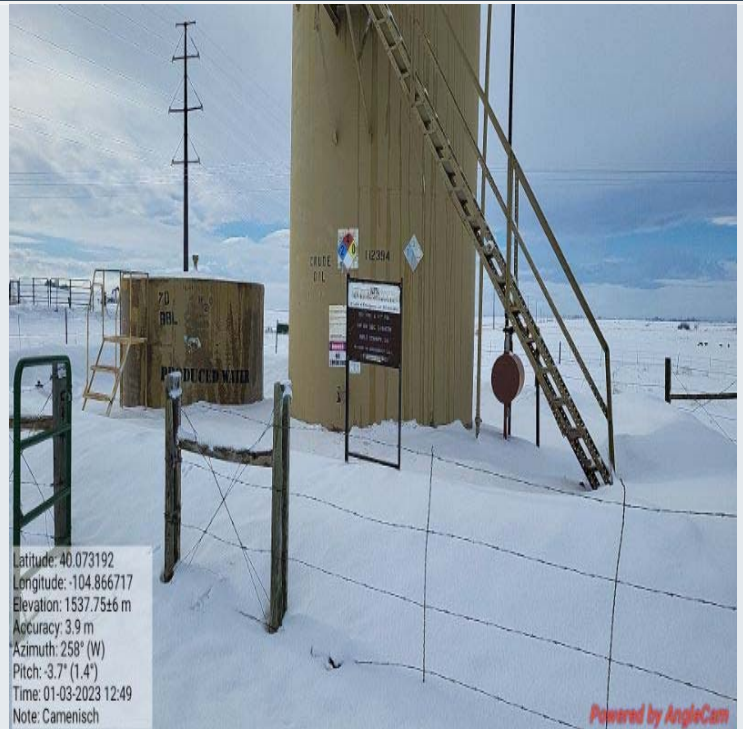
**Question:** Is earthen berm secondary containment present and in good condition (compacted, complete, no evidence of erosion, animal burrowing, etc.)?

**Response:** Yes

**Notes:** Around tanks and separator.

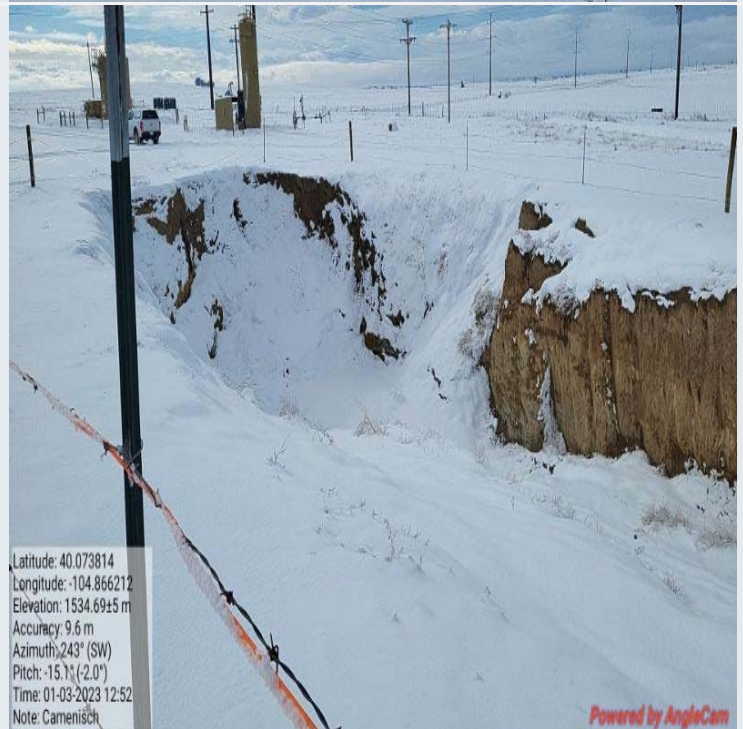
**Question:** Is work being conducted in a minimal footprint?

**Note:** Any property/crop damage

**Response:** Yes

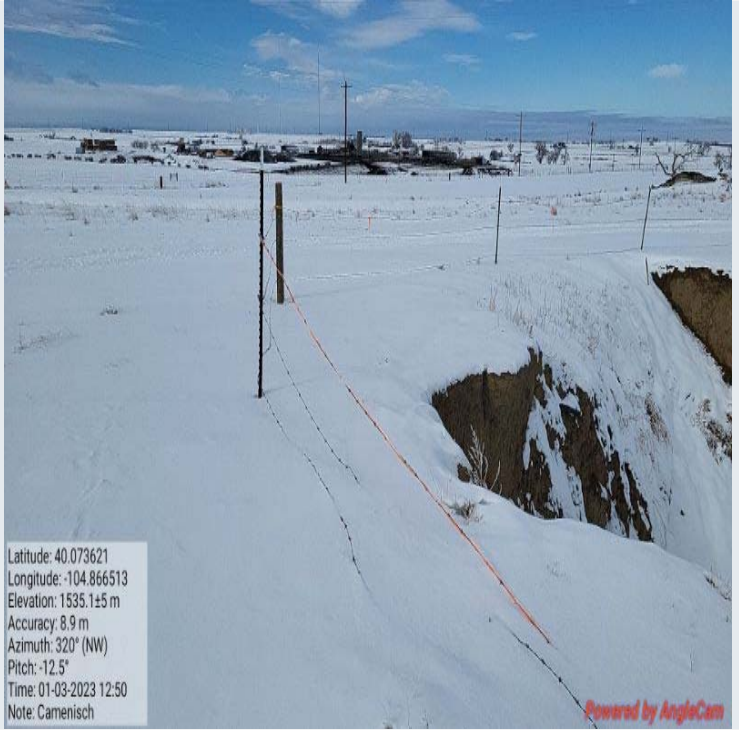
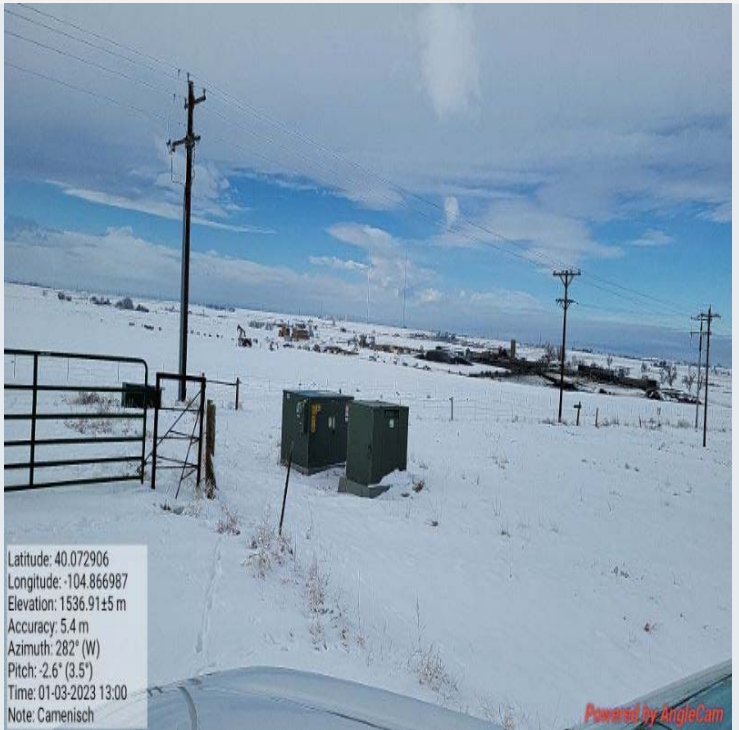
Site Condition Checklist	
	Photo
<p><b>Question:</b> Is location adjacent to any Potential Receptors? Note: Livestock, surface water, occupied structure, adjacent land use, etc. <b>Response:</b> Yes <b>Notes:</b> Livestock across street.</p>

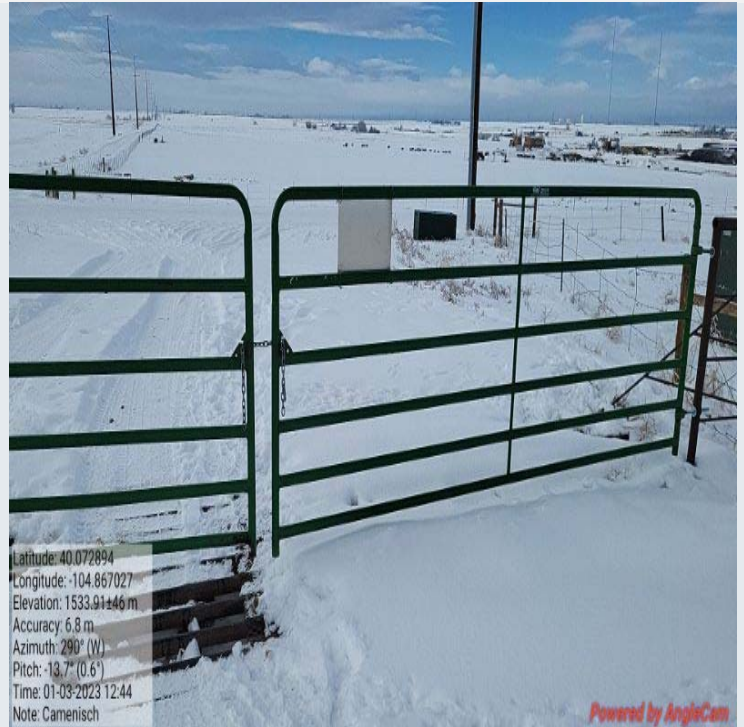
**Question:** Evidence of pollutants being discharged off-site?

**Response:** No

**Notes:** Dirt road

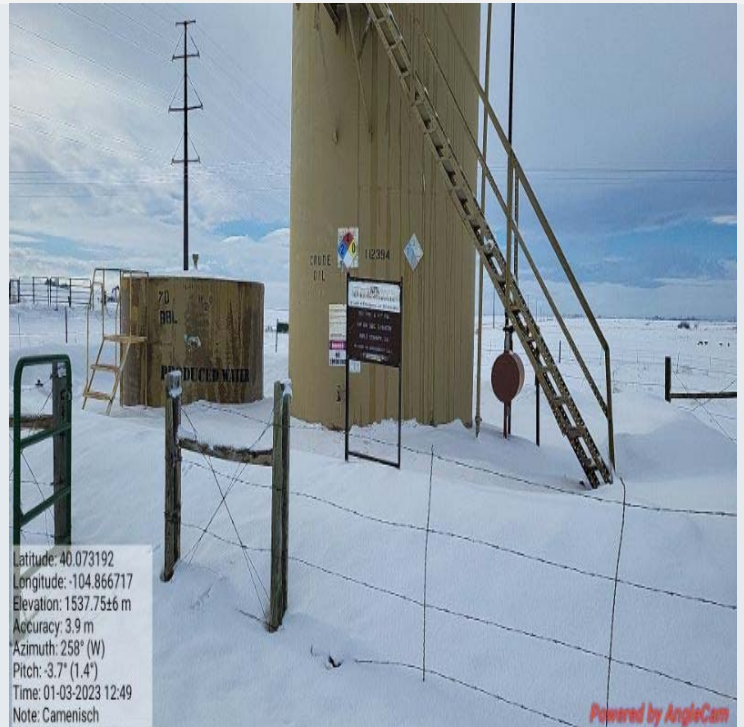
**Question:** All stormwater erosion control measures and BMPs are present and in good/working condition?

**Response:** Yes

**Notes:** Earthen berm around tanks.

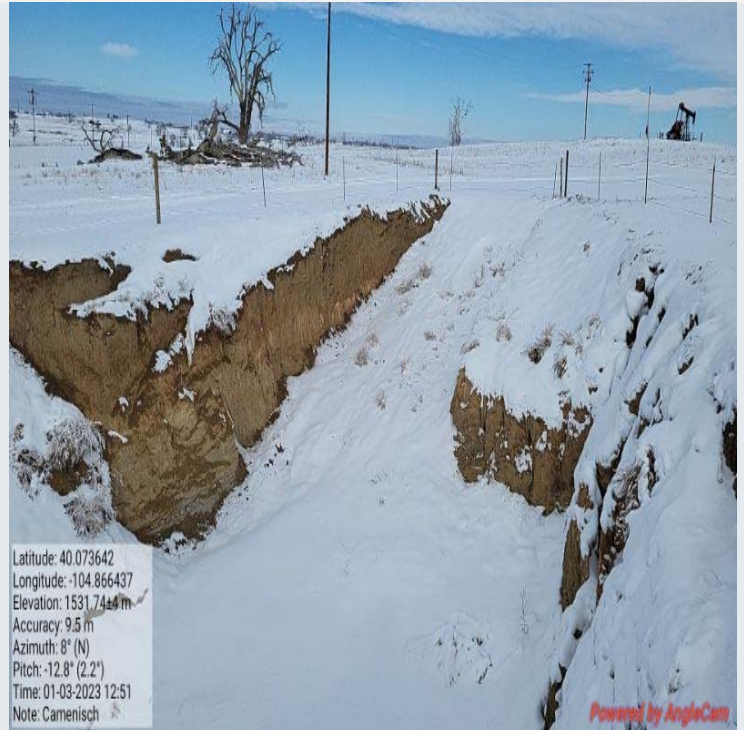
**Question:** Site free of unused equipment, weeds, debris/trash?

**Response:** Yes
