Final Reclamation and Stormwater Inspection

Date: 12/28/2022

Operator: CHAMPLIN PETROLEUM COMPANY
(15550)/ ANADARKO E&P ONSHORE LLC (2800)

Location ID: 454039

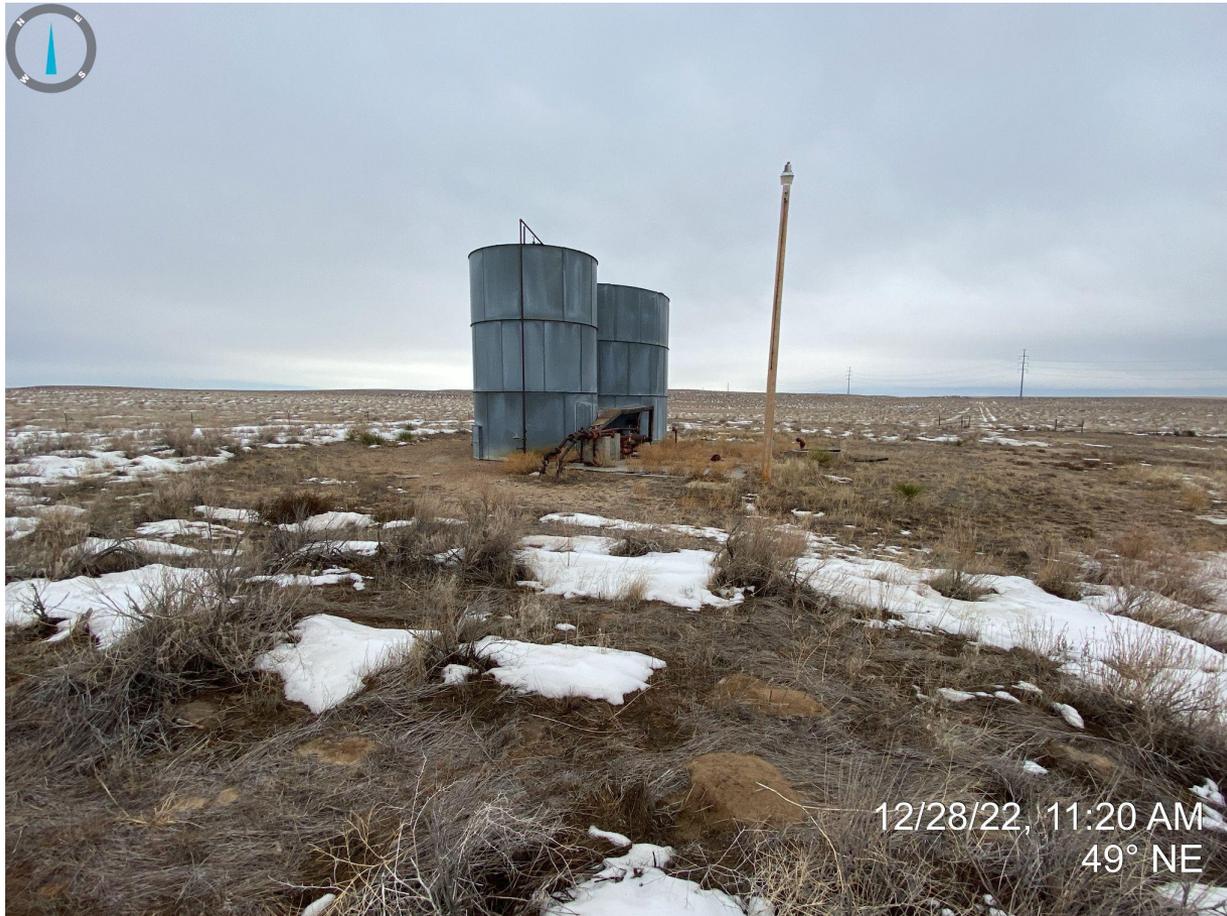
Photo 1. Facing northeast from the western portion of the location. Water plant pictured.

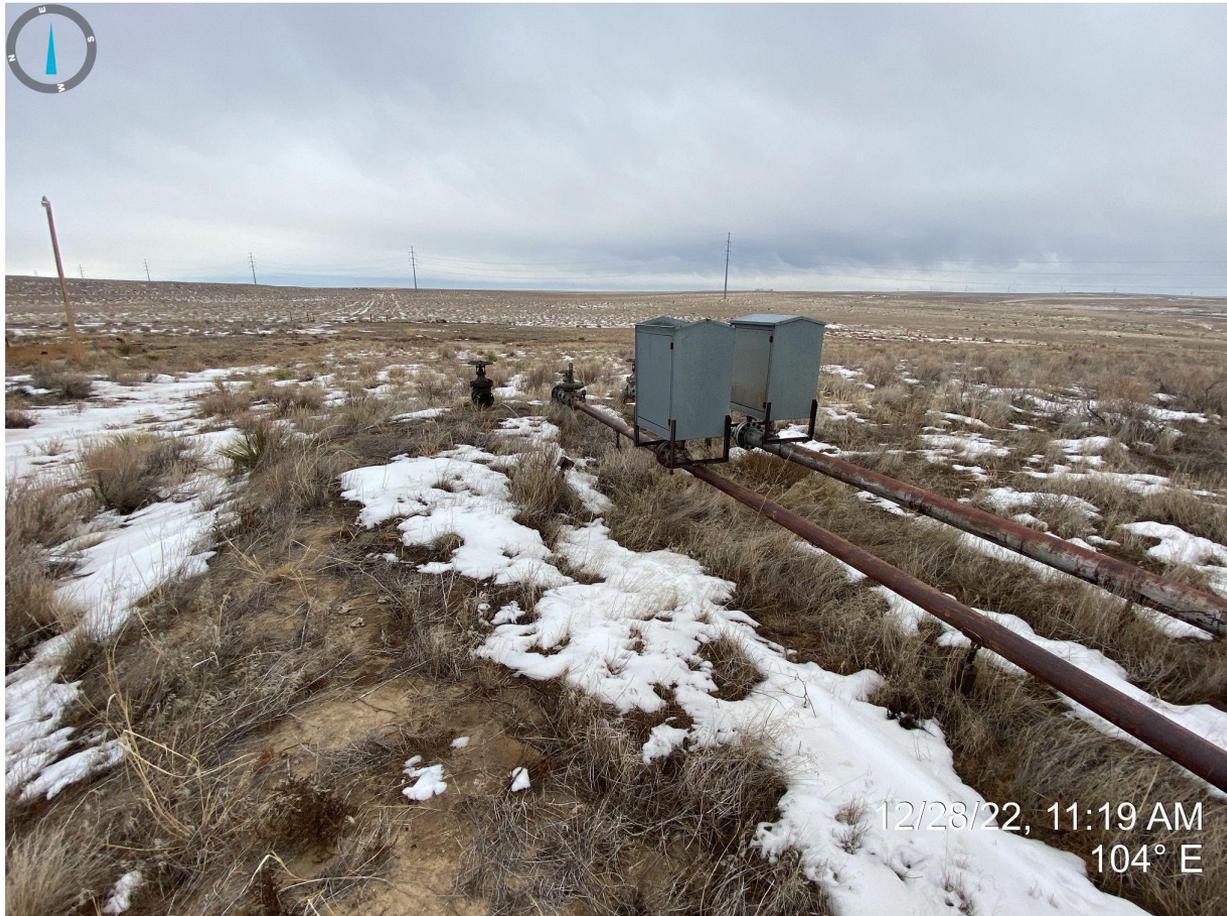
Photo 2. Facing east from the western portion of the location. Flowlines pictured.

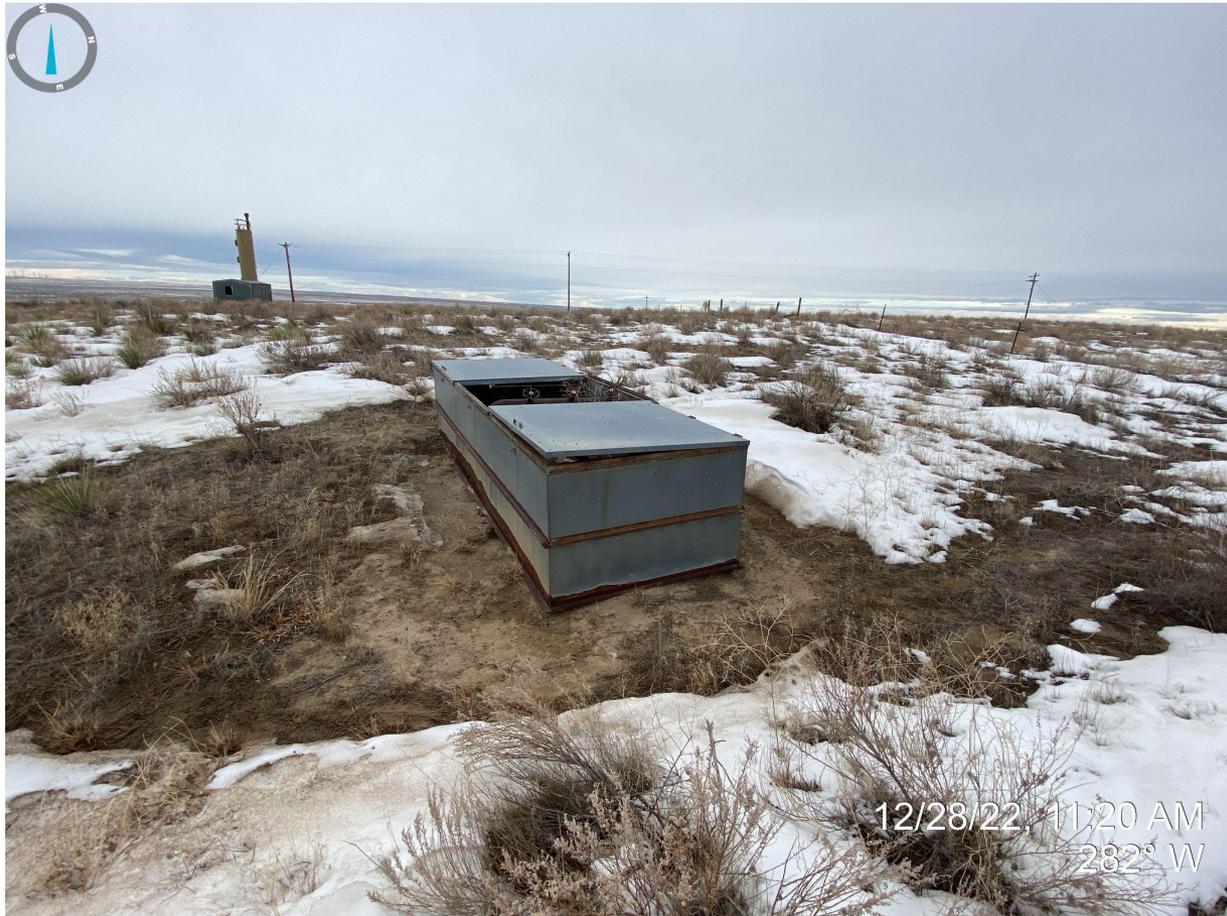
Photo 3. Facing west from the western portion of the location. Valve box pictured.

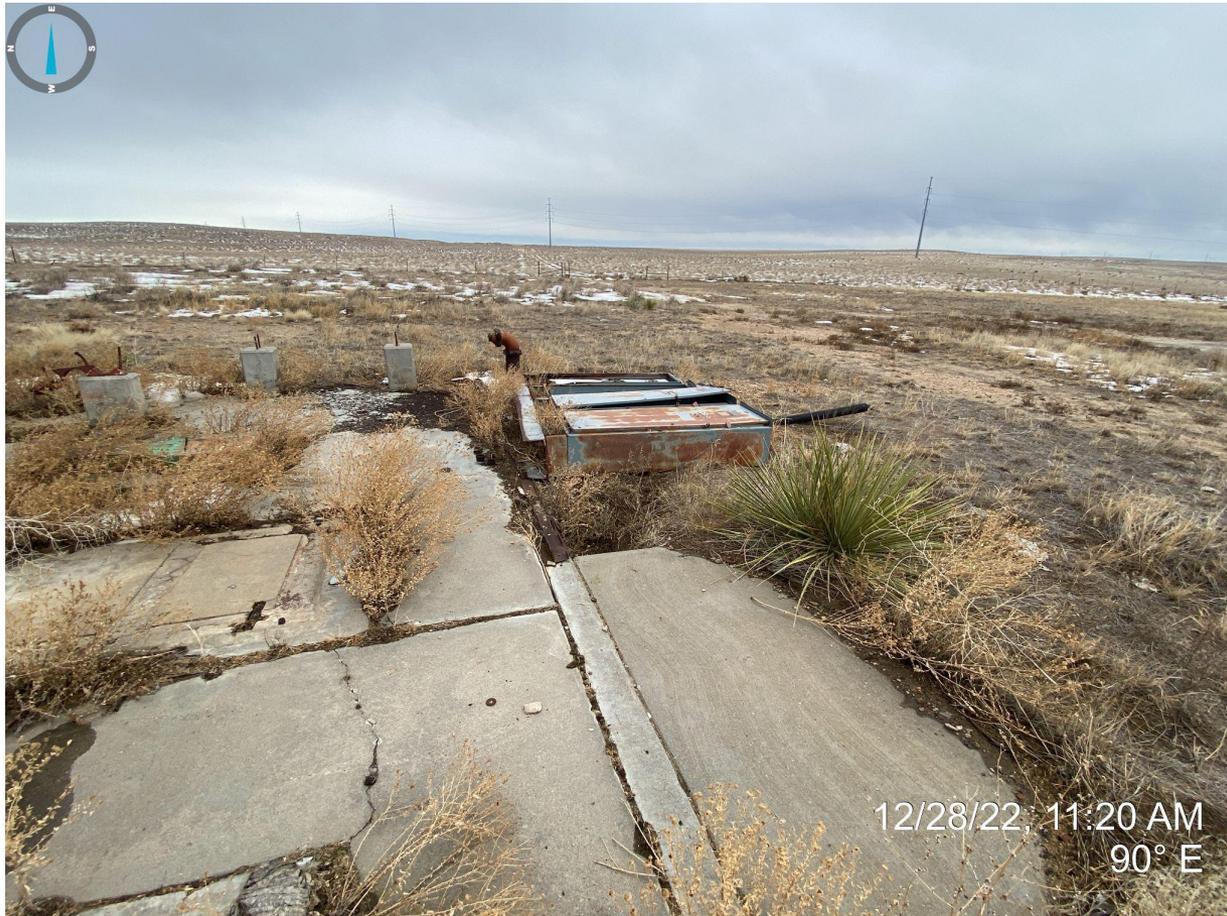
Photo 4. Facing east from the water plant. Foundation and all equipment will need to be removed.

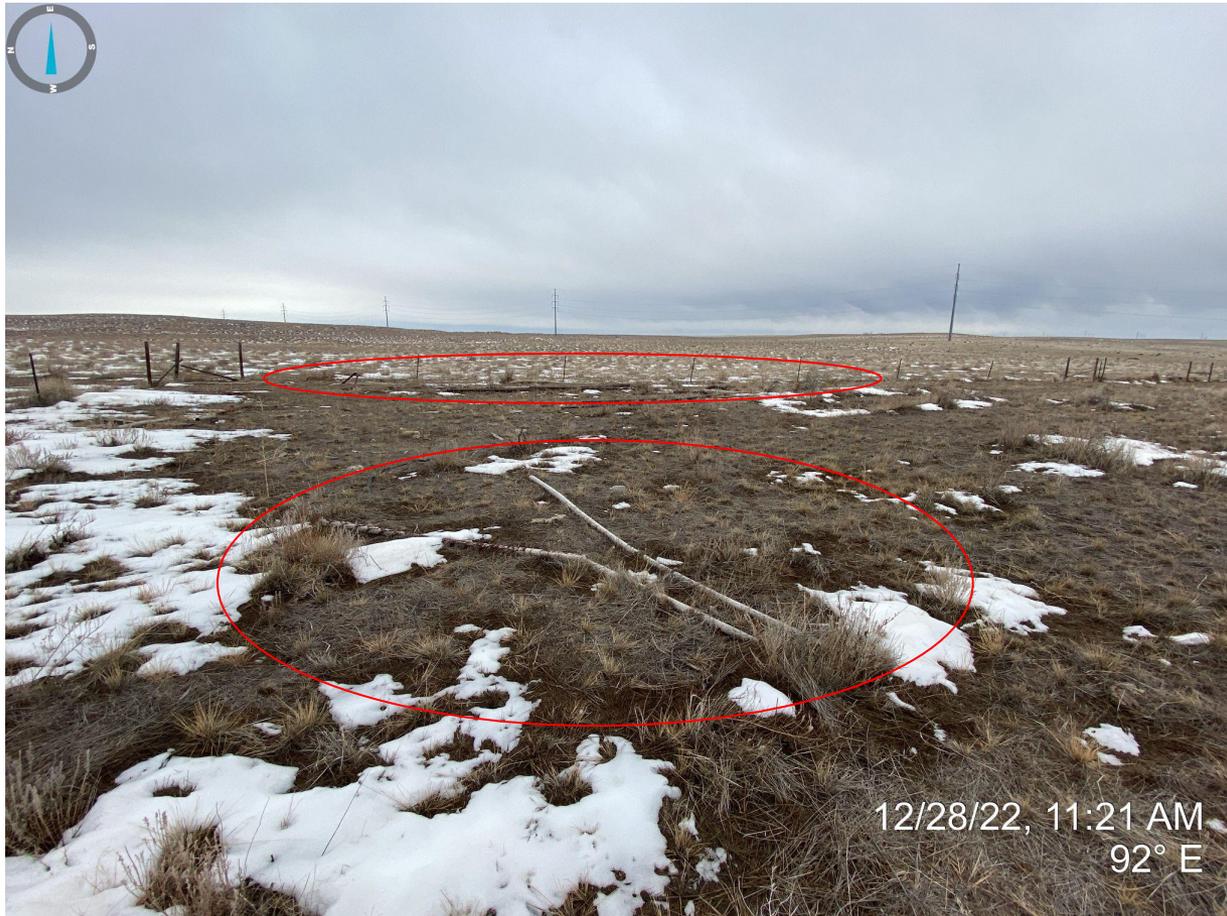
Photo 5. Facing east from the eastern portion of the location. Various fiberglass and steel pipe observed.
