Construction and Stormwater Inspection

Date: 01/09/2023

Operator: ST CROIX OPERATING INC - 81490

Inspection Photos
Location Name: Alice Seedorf #1
Location ID: 474453

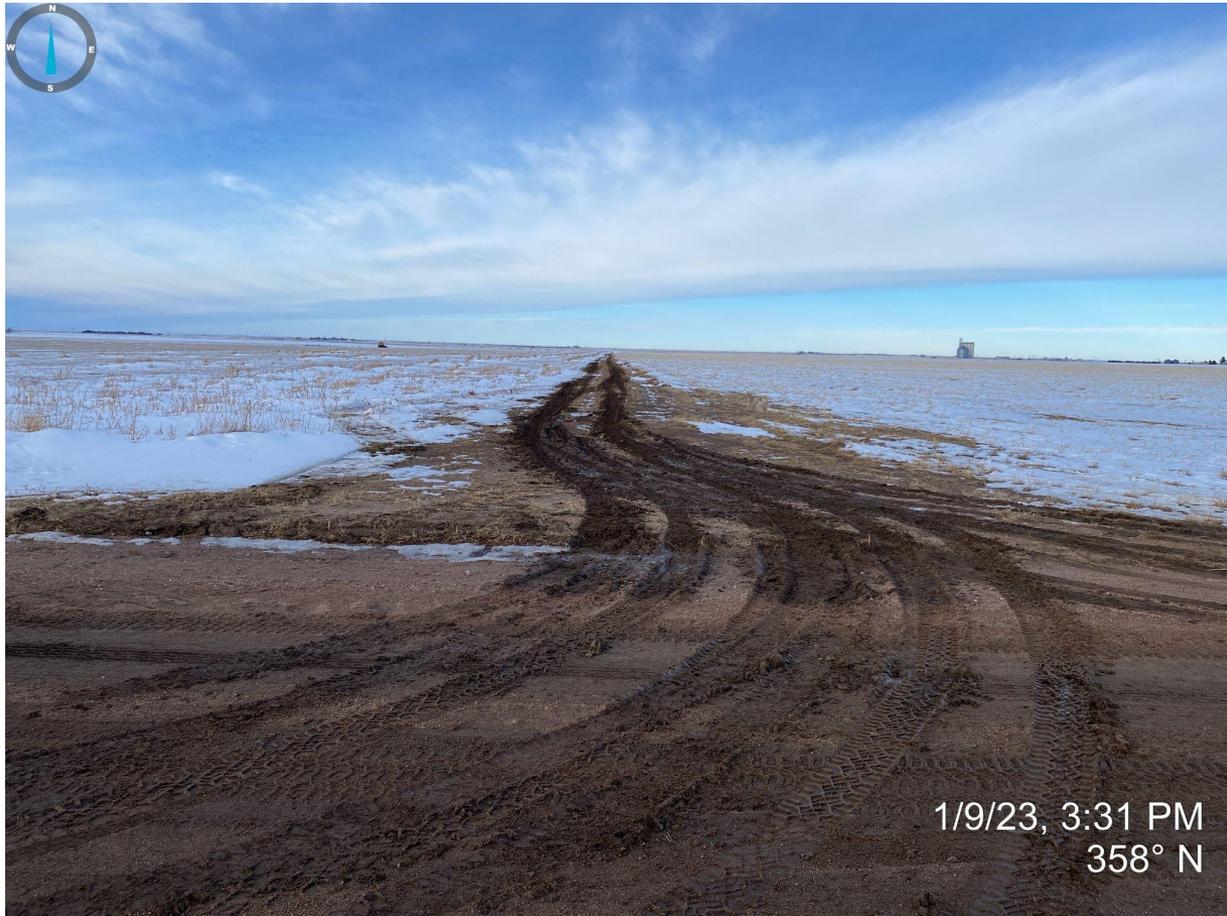
Photo 1. Facing north from CR 38. The access road being used appears to be different from the access road map document (#402267065) attached to the Form 2A. Operator shall update the map figure and attach it to the location file. Additionally, during this inspection, a Form 2A and location sign were not posted and will need to be installed. See Photo 5 for additional information.

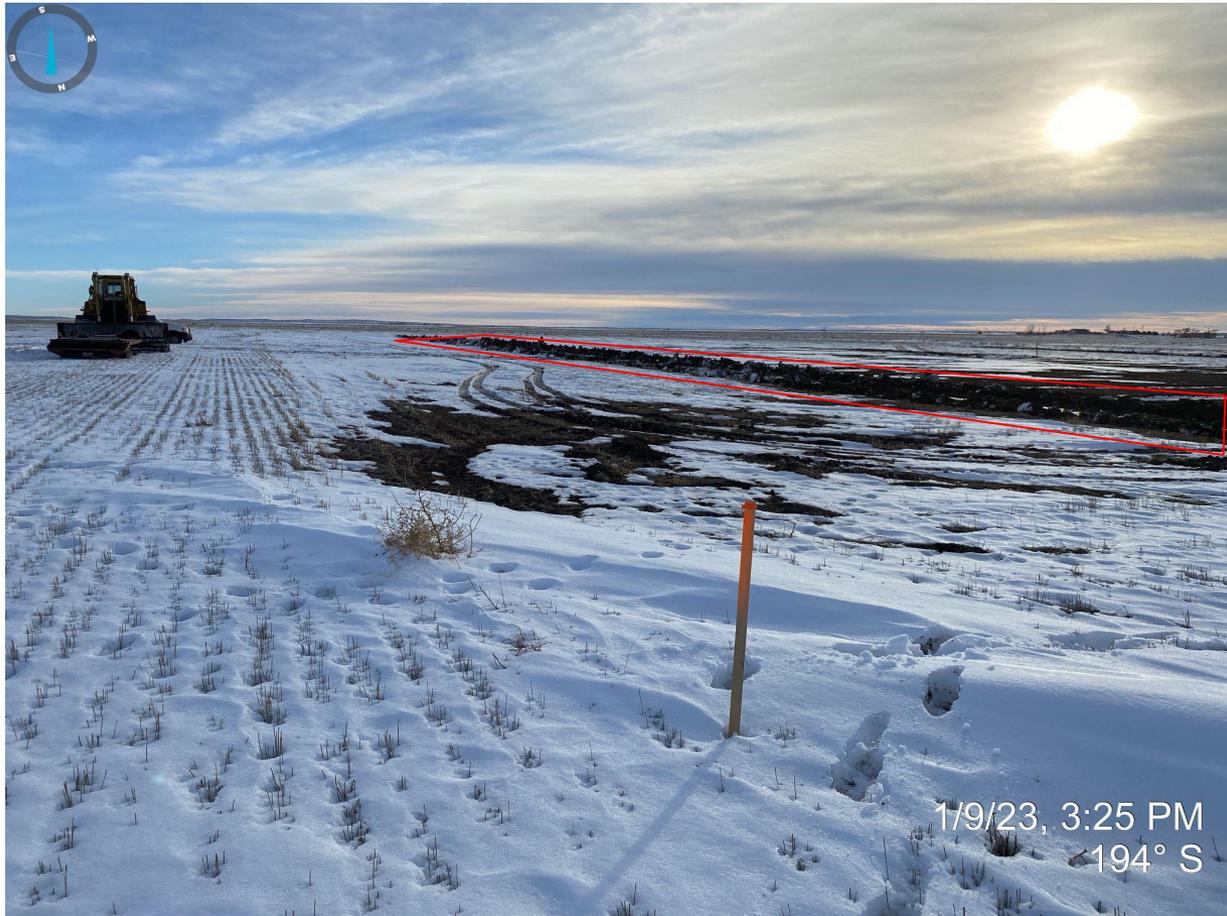
Photo 2. Taken from the northeast corner of the disturbance area, facing south. Photo illustrates heavy machinery has been brought to location and recent soil disturbance was evident, outlined in red. A follow-up inspection will be performed in the future to document topsoil salvage operations.

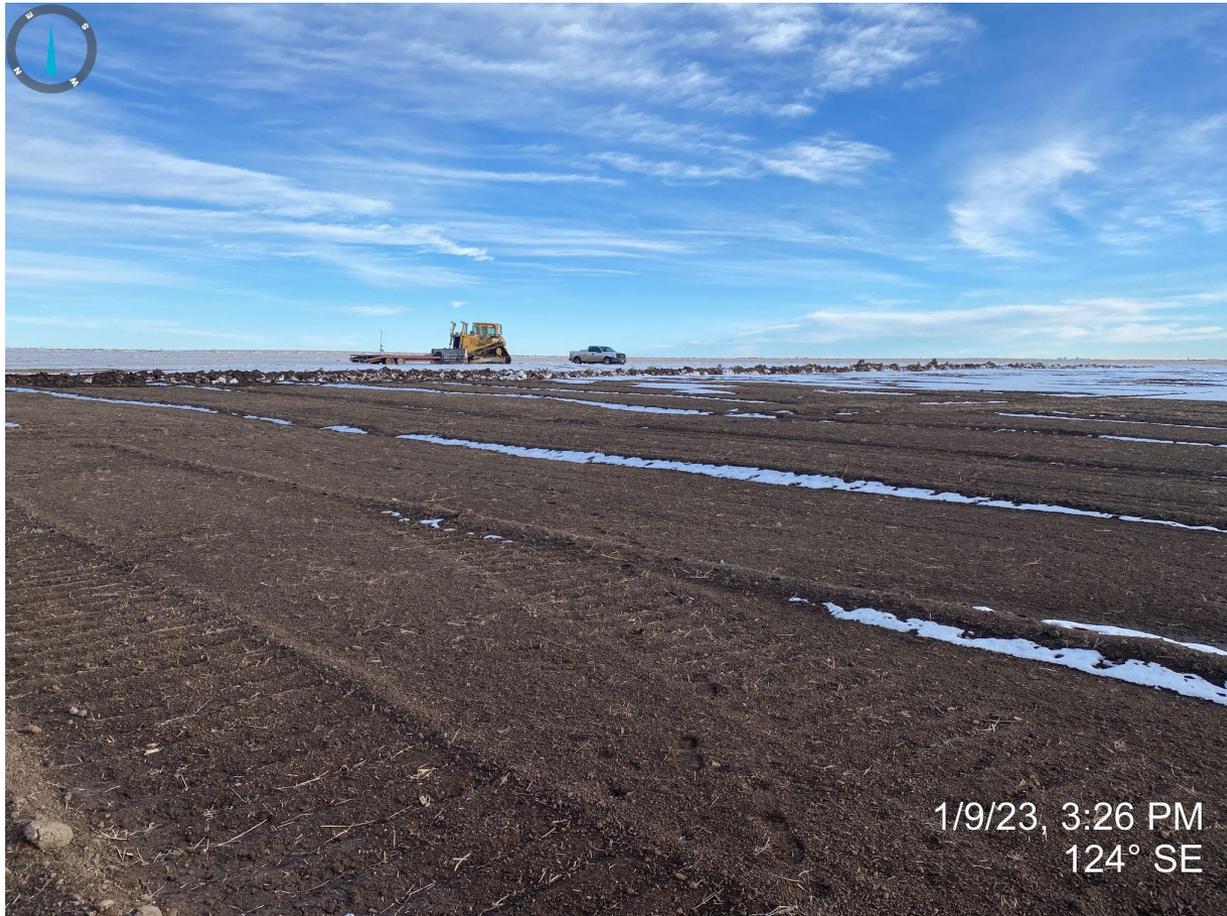
Photo 3. Facing southeast from the center, northern portion of the location. See comments in Photo 2.

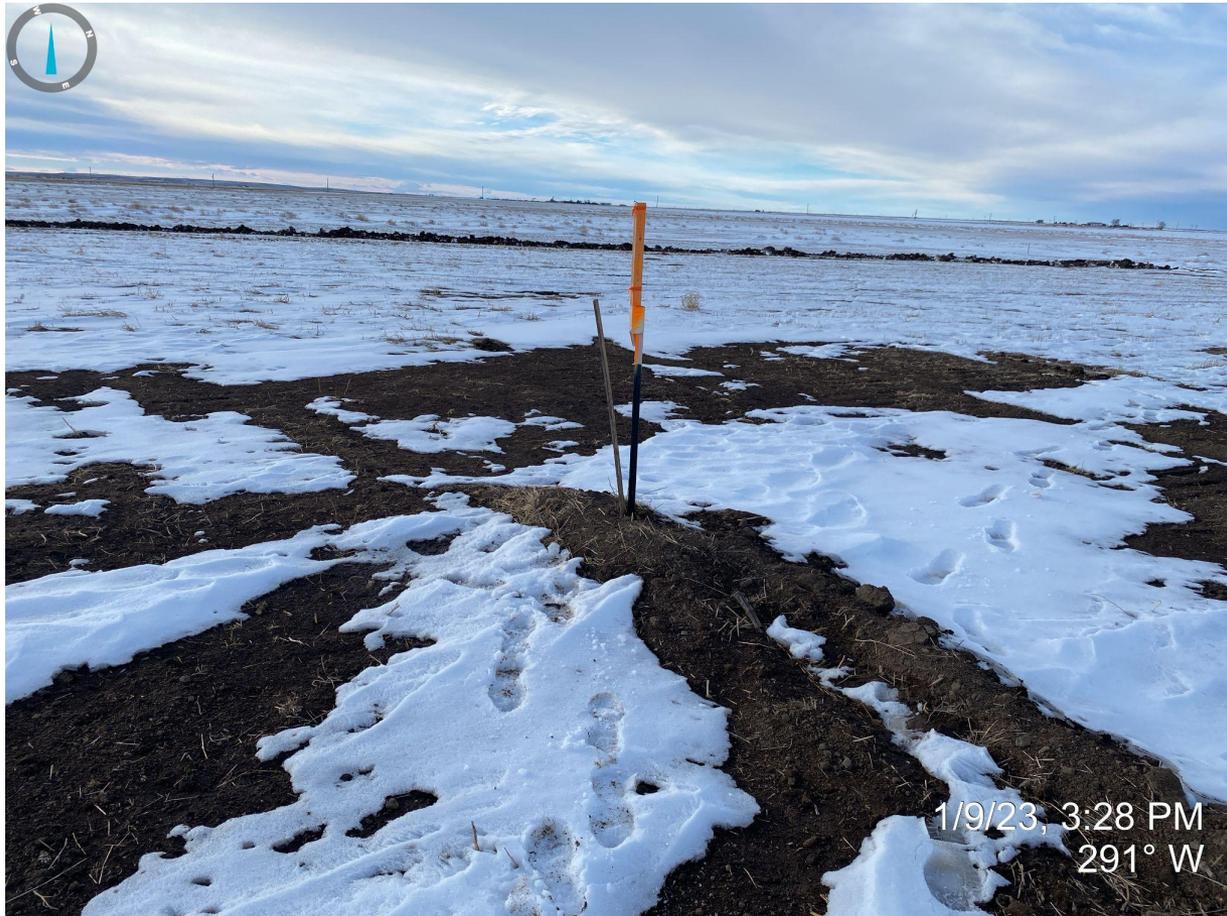
Photo 4. Facing west at the proposed well location.

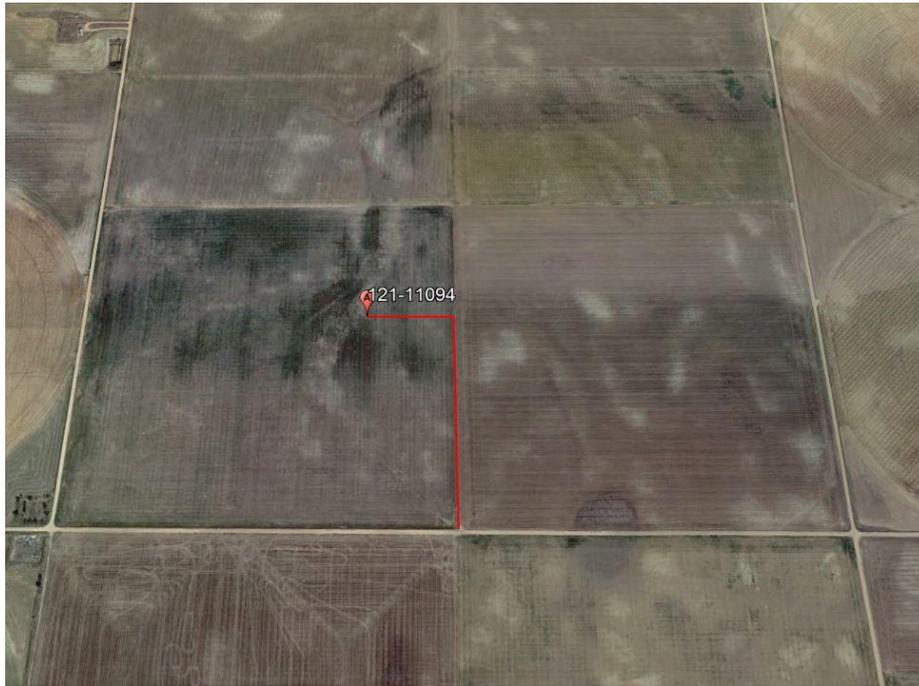
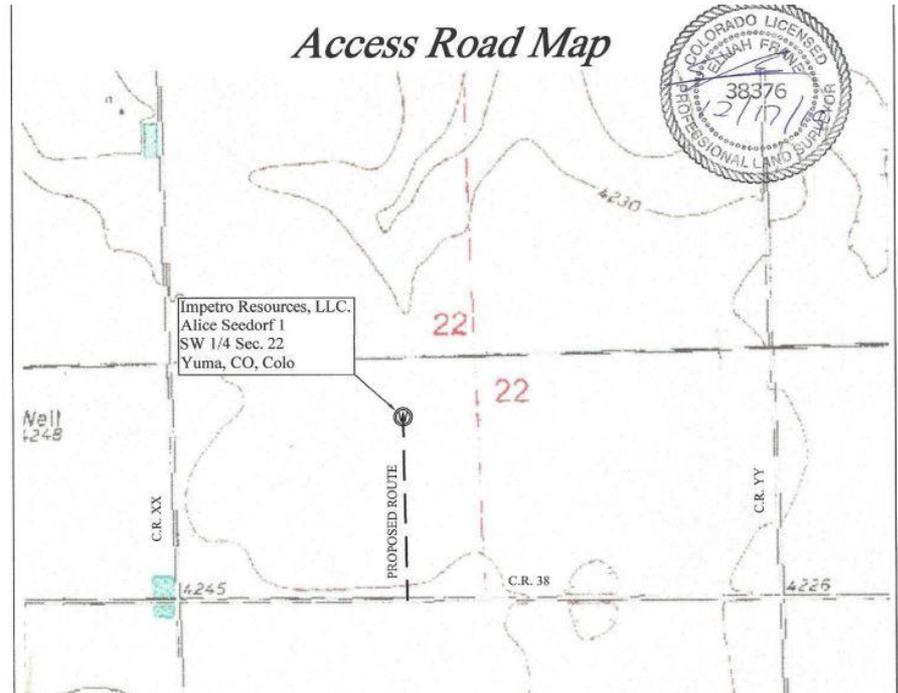
Photo 5. Photo on the left illustrates the access road currently being used, illustrated by the red line, between the SW and SE ¼ section line of section 22. The photo on the right is the access road map (Doc #402267065) and suggests the access road is proposed on the eastern half of the SW ¼ of section 22. Operator shall update the map to reflect the actual access road being used.
