## Final Reclamation Completion Notice – Reclamation Overview

<b>COGCC Location Name (ID)</b>	SECORA-633S68W/21SENE (308892)
<b>Operator Location Name</b>	Secora 1 Well Pad
<b>COGCC Operator Name (ID)</b>	XTO Energy Inc. (100264)
<b>Legal Description</b>	SWNE Sec. 21 T33S-R68W
<b>Geographic Coordinates (WGS84)</b>	37.159490 / -104.993060
<b>County</b>	Las Animas County, Colorado

XTO Energy Inc.  
Secora 1 Well Pad (05-071-08776)  
Date Completed – 09/06/2022

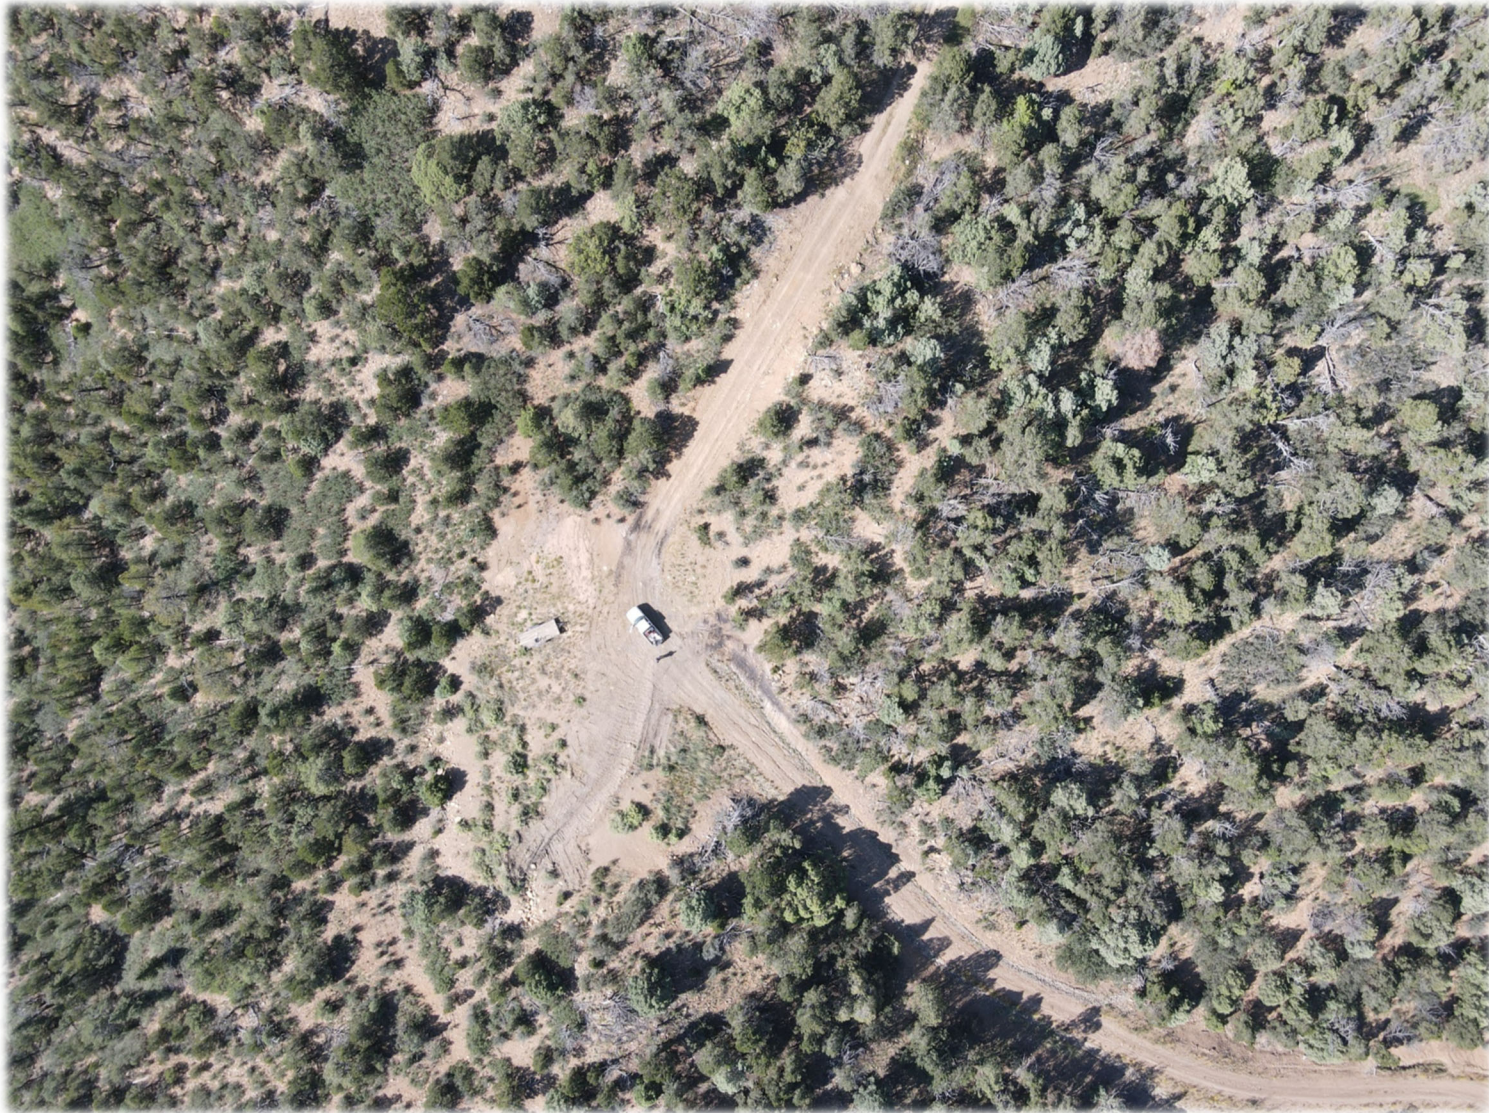
Photo Point A: Disturbance Overview

During the September 6, 2022, site assessment, recent surface disturbing activities caused by the landowner were observed. The reclaim had been redisturbed by heavy equipment, vegetation stripped from the surface, and the area highly compacted. A small drainage feature was created through the center of the reclaim draining to a previously armored outfall on the southwest corner of the Location. No other major site degradation concerns were noted and installed control measures appeared to be functioning as designed. Where not redisturbed by surface owner activities, vegetation composition within the Reclaim appeared comparable to Reference. Undesirable species were underrepresented in the Reclaim, and it appears the 80% threshold required in COGCC Rule 1004.d has been achieved in areas outside of the recent redisturbance.

No maintenance is recommended for this location at this time as undesirable and noxious weed species were under-represented on the Reclaim and vegetation establishment is uniform and comparable to Reference, where not redisturbed by the surface owner. Based on the results of the survey, it appears that reclamation as defined by COGCC rules has been achieved and vegetation cover has been established that reflects surrounding conditions with a total plant cover of at least 80% of the Reference. Submittal of a Form 4 (Sundry Notice) is recommended to document successful completion of final reclamation, notify the COGCC that the site is ready for final reclamation inspection, and request XTO's release from financial assurance for this location.
