SITE-SPECIFIC QUALITY ASSURANCE & QUALITY CONTROL AUDIT

PERMIT CLOSURE REPORT – DESIGNATION LAND USE CHANGE

Location ID - 319611

Location Name – HAAS-66N67W 15NESE

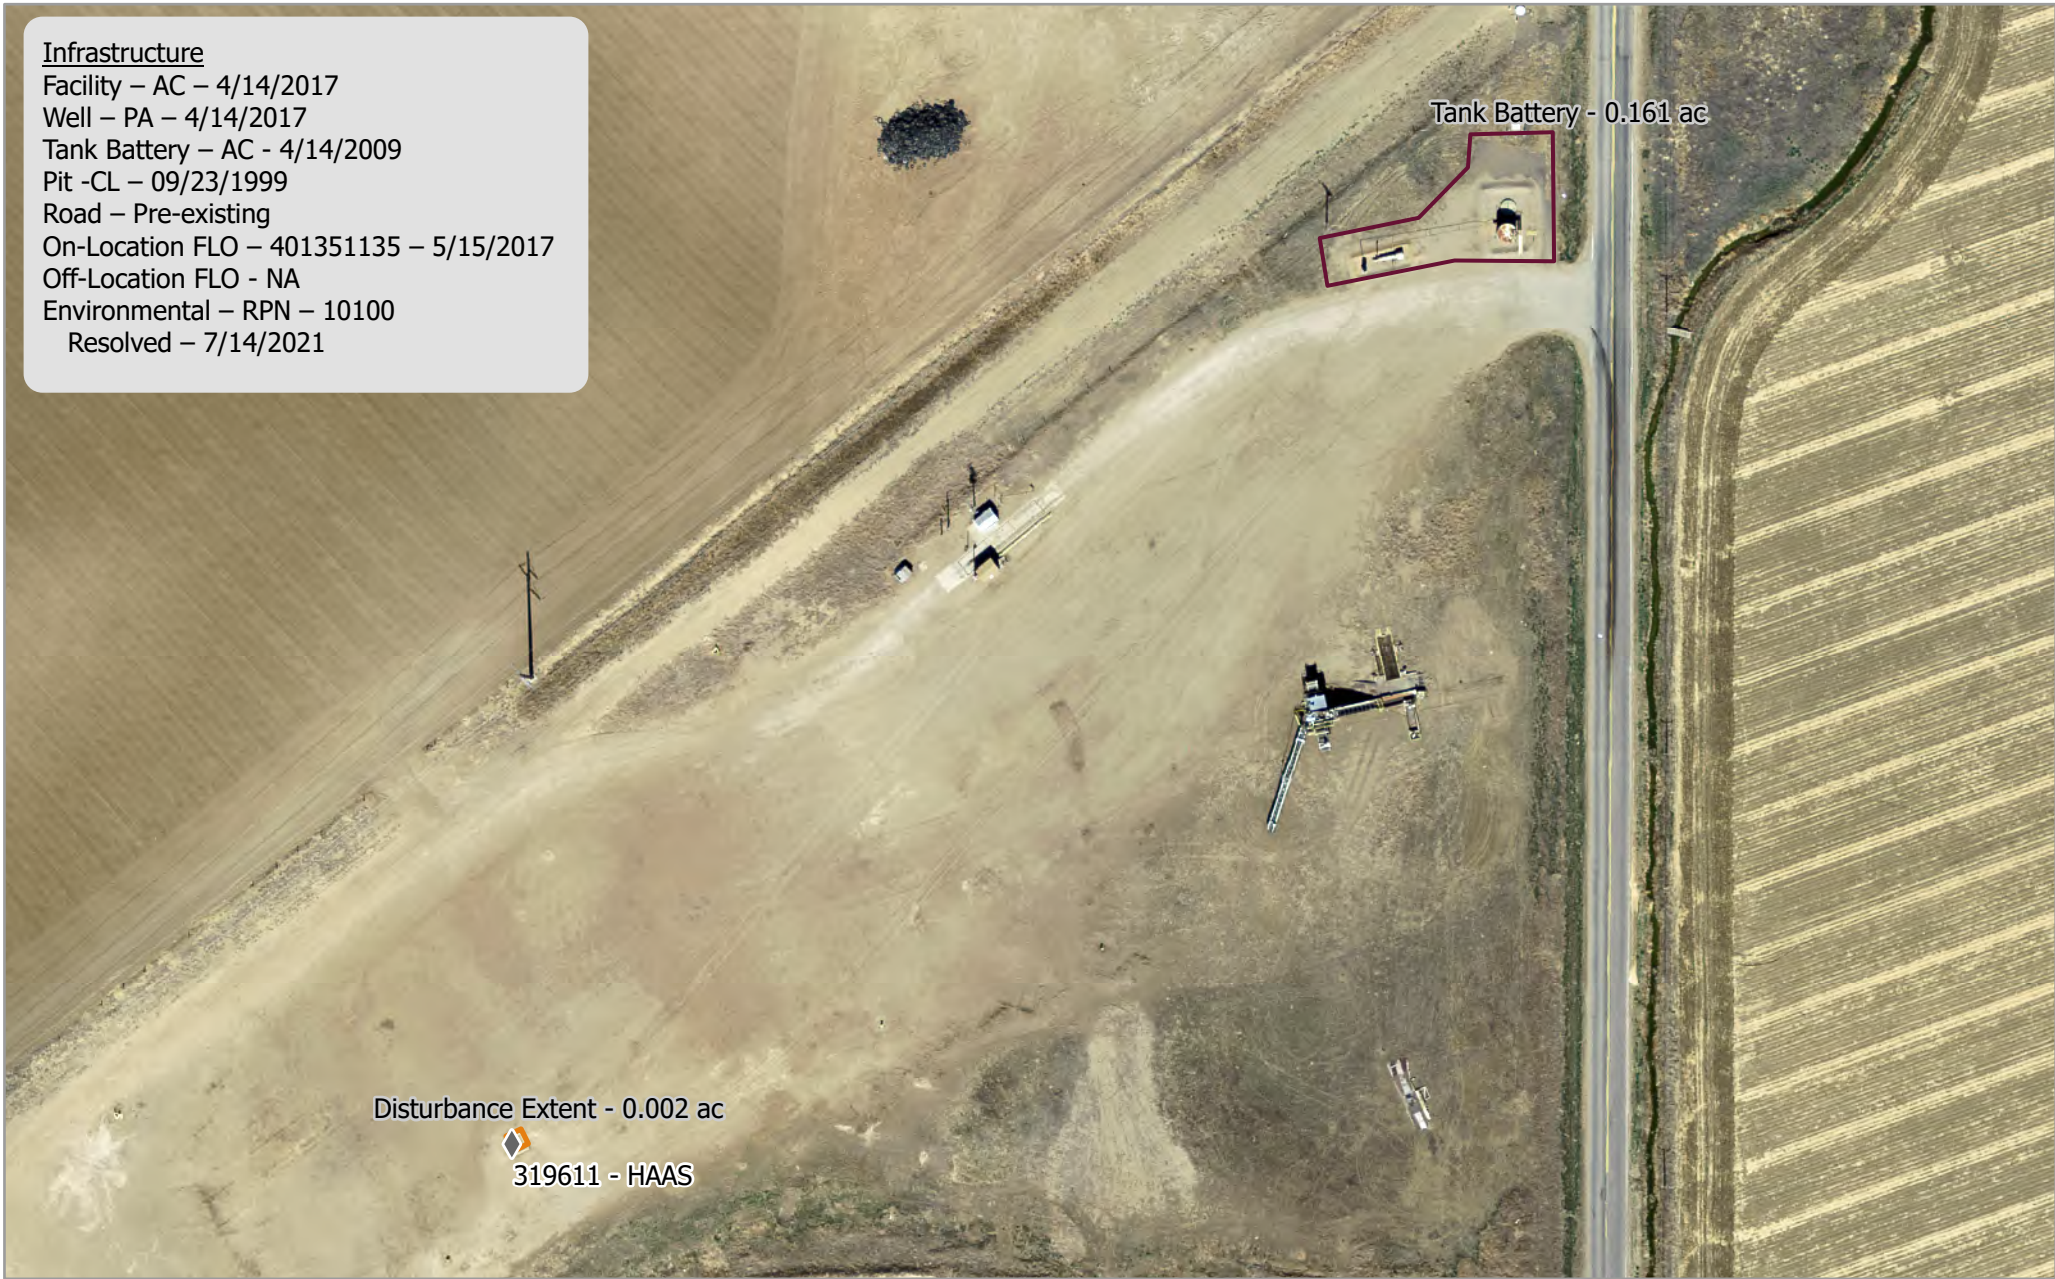
CIV - 319611- HAAS
Map Extent - DRCOG 2012

Overall Disturbance: 0.16 Acres
Scale: 1:1,400

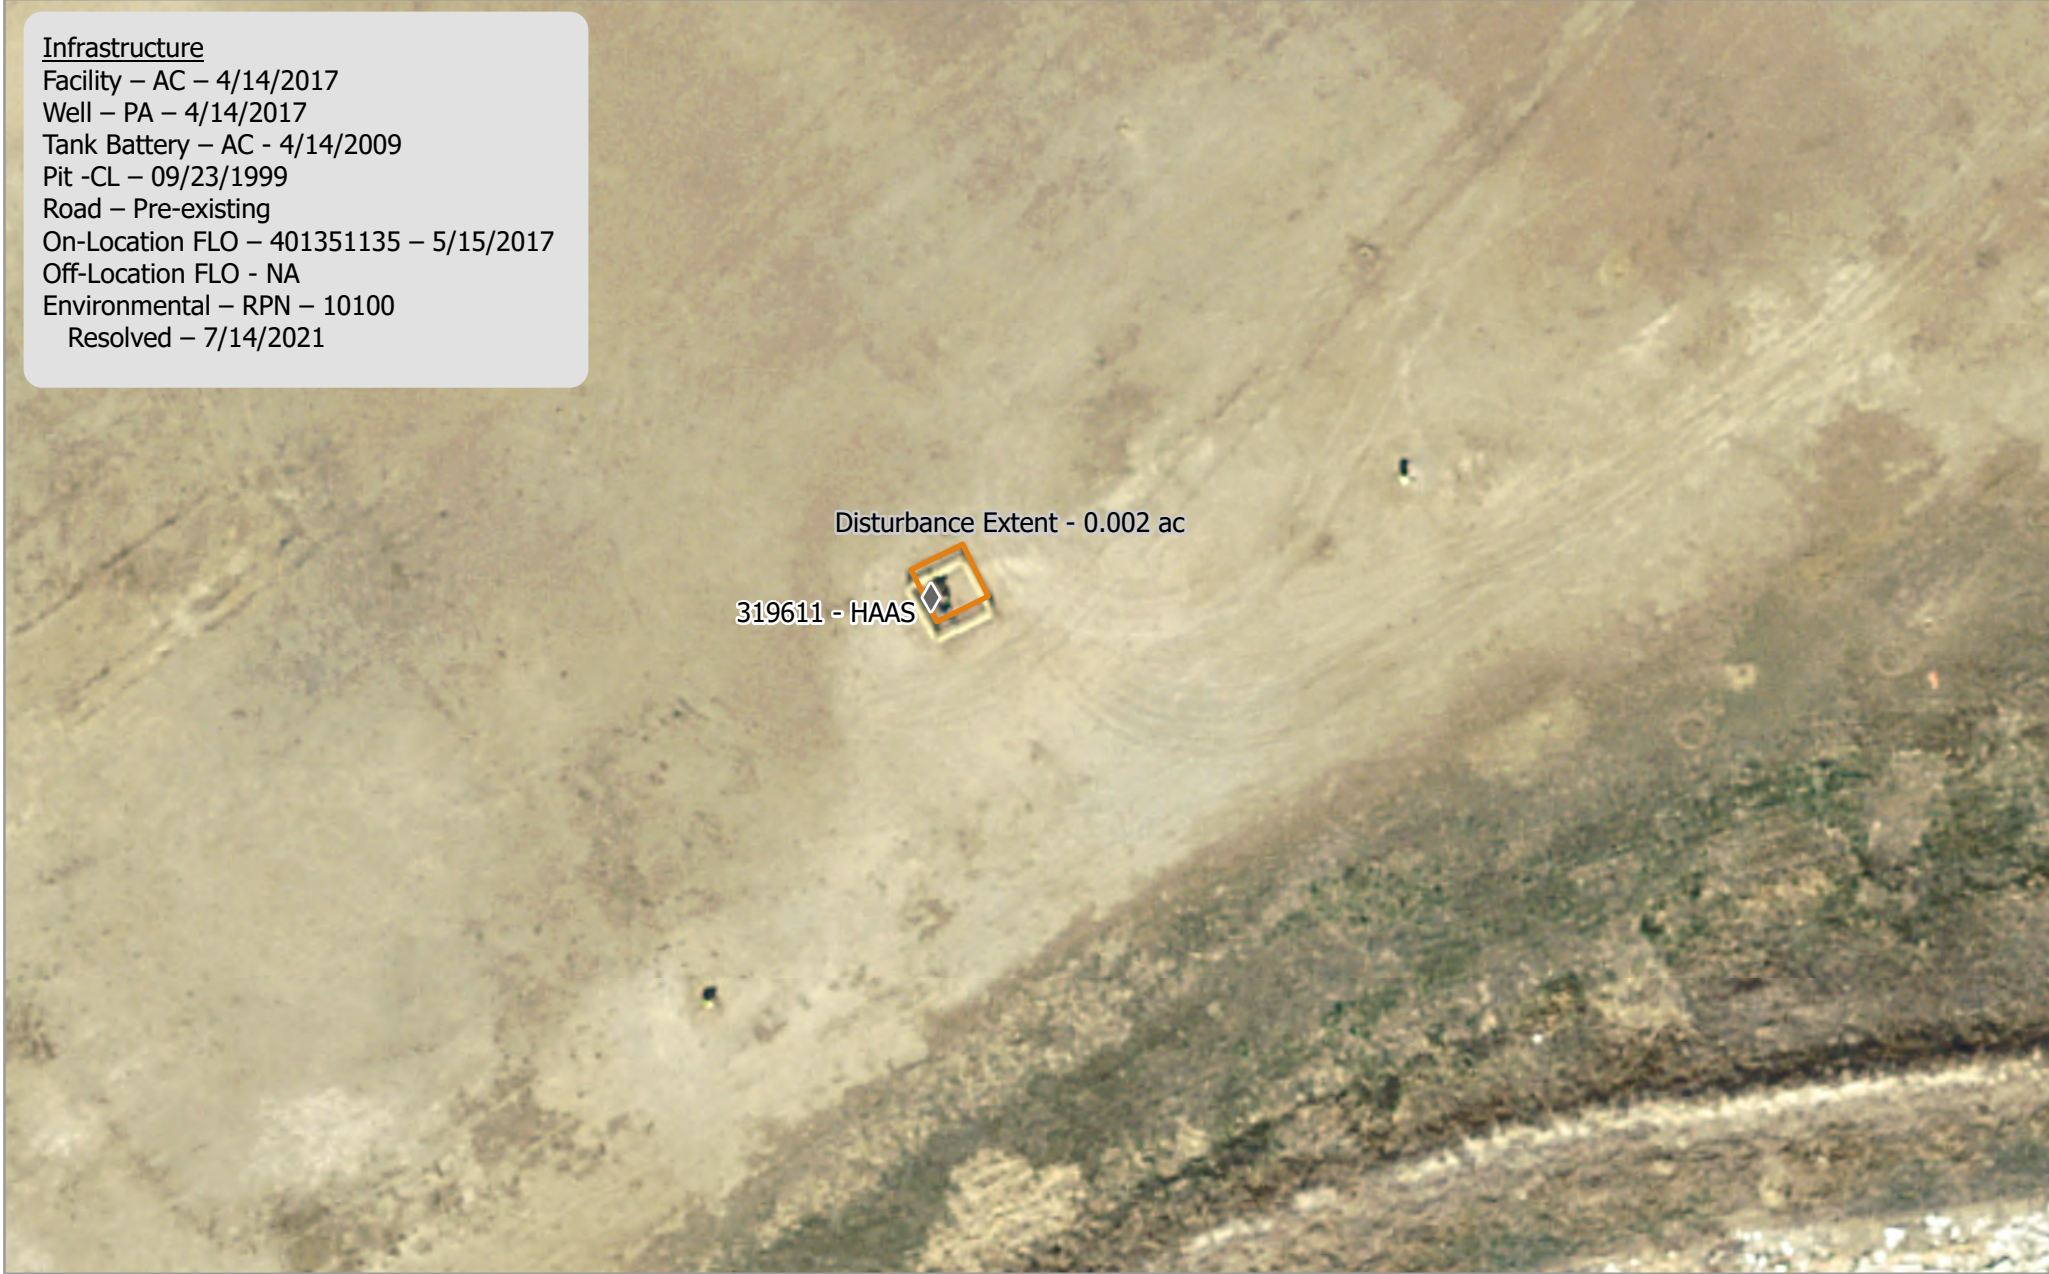
CIV - 319611- HAAS
Map Extent - DRCOG 2012

Disturbance Extent - 0.002 ac

Overall Disturbance:
0.16 Acres
Scale: 1:400

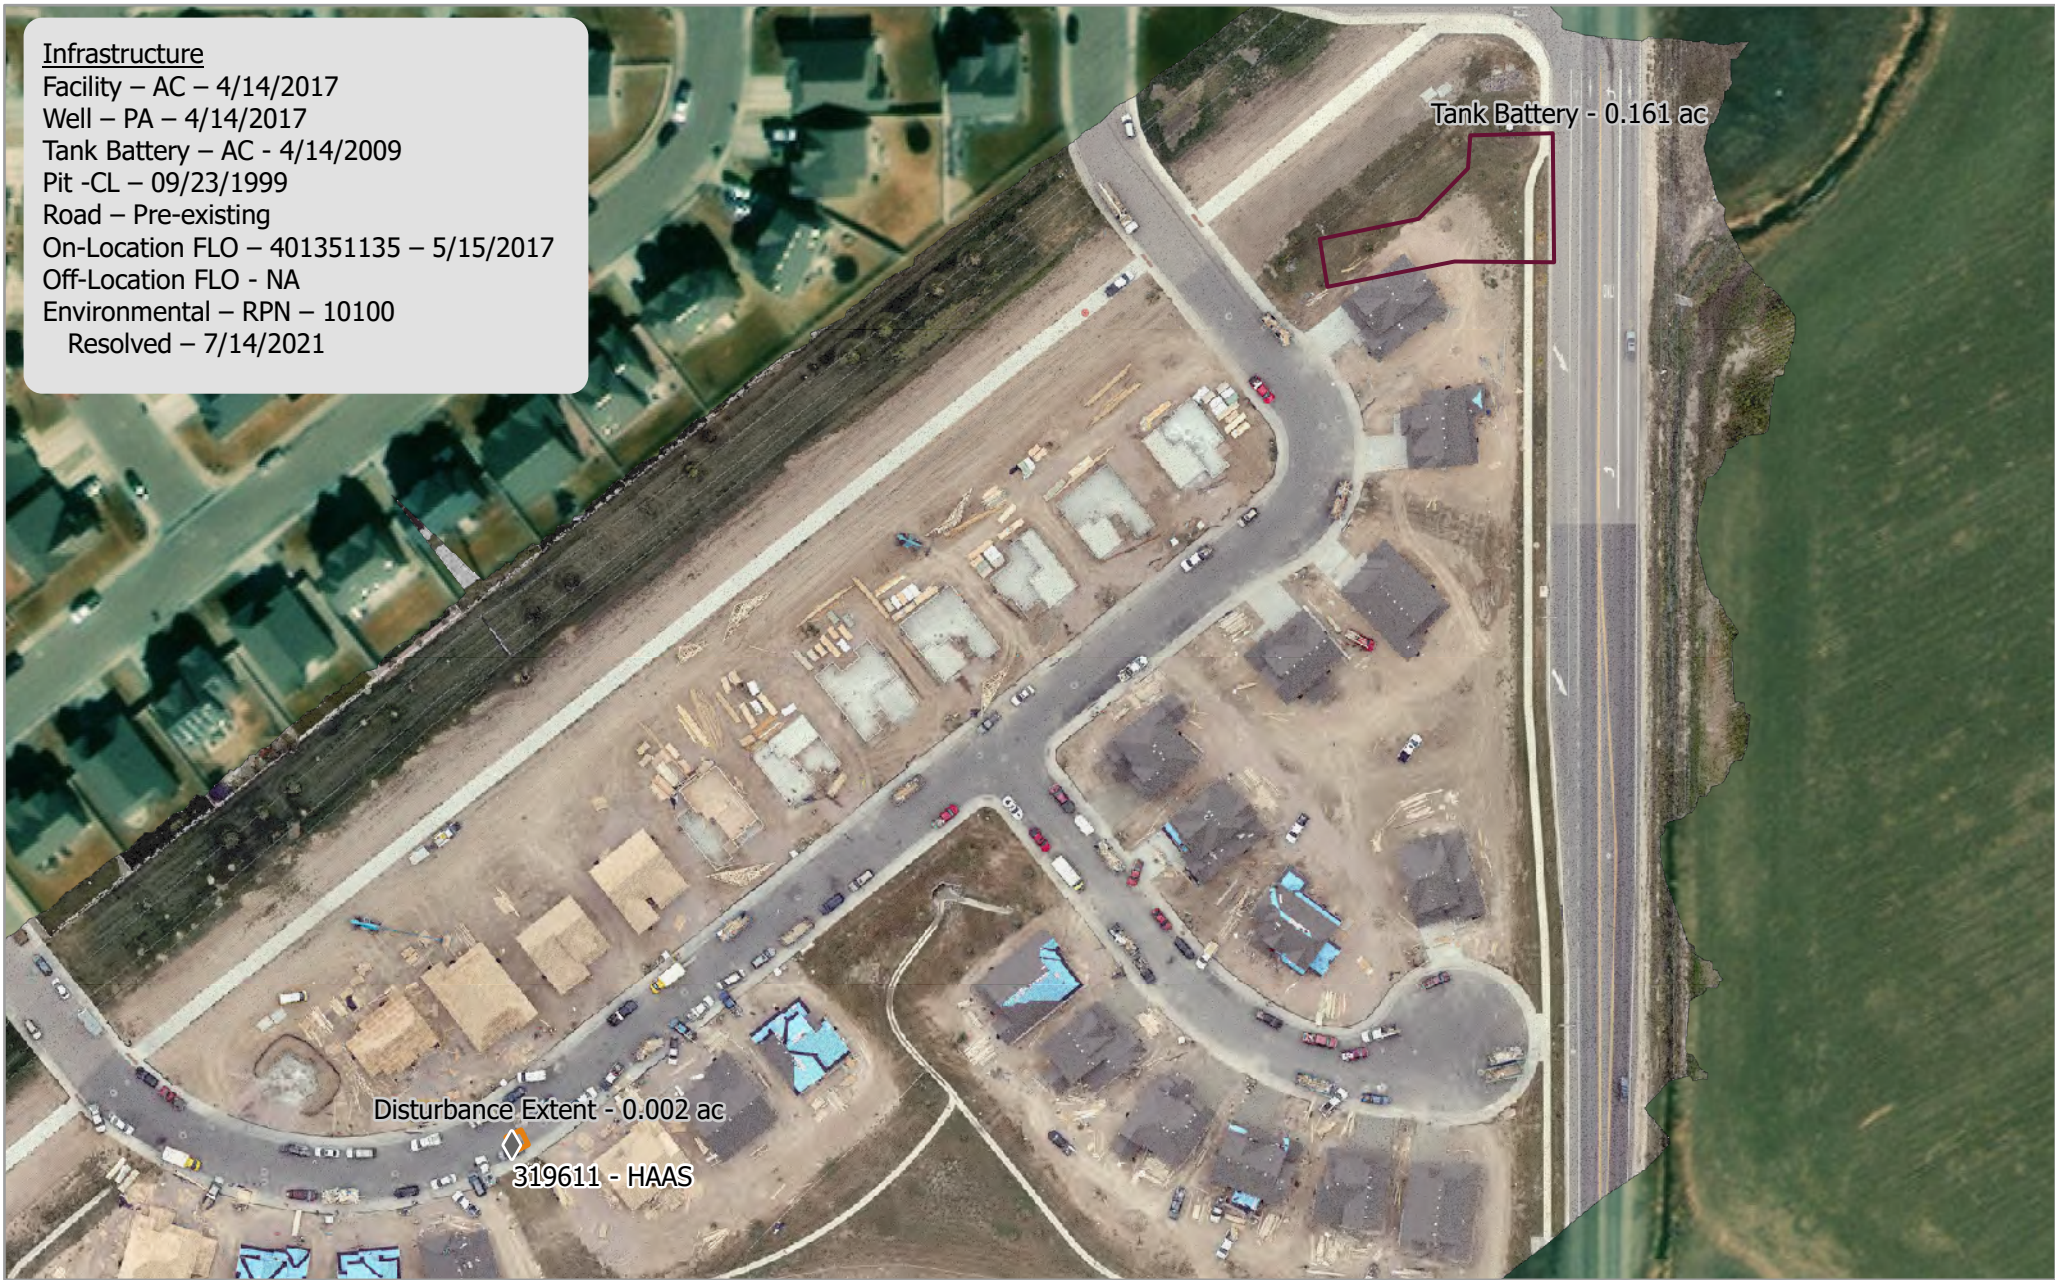
**CIV - 319611- HAAS
Map Extent - Overview**

Overall Disturbance:
0.16 Acres
Scale: 1:1,400

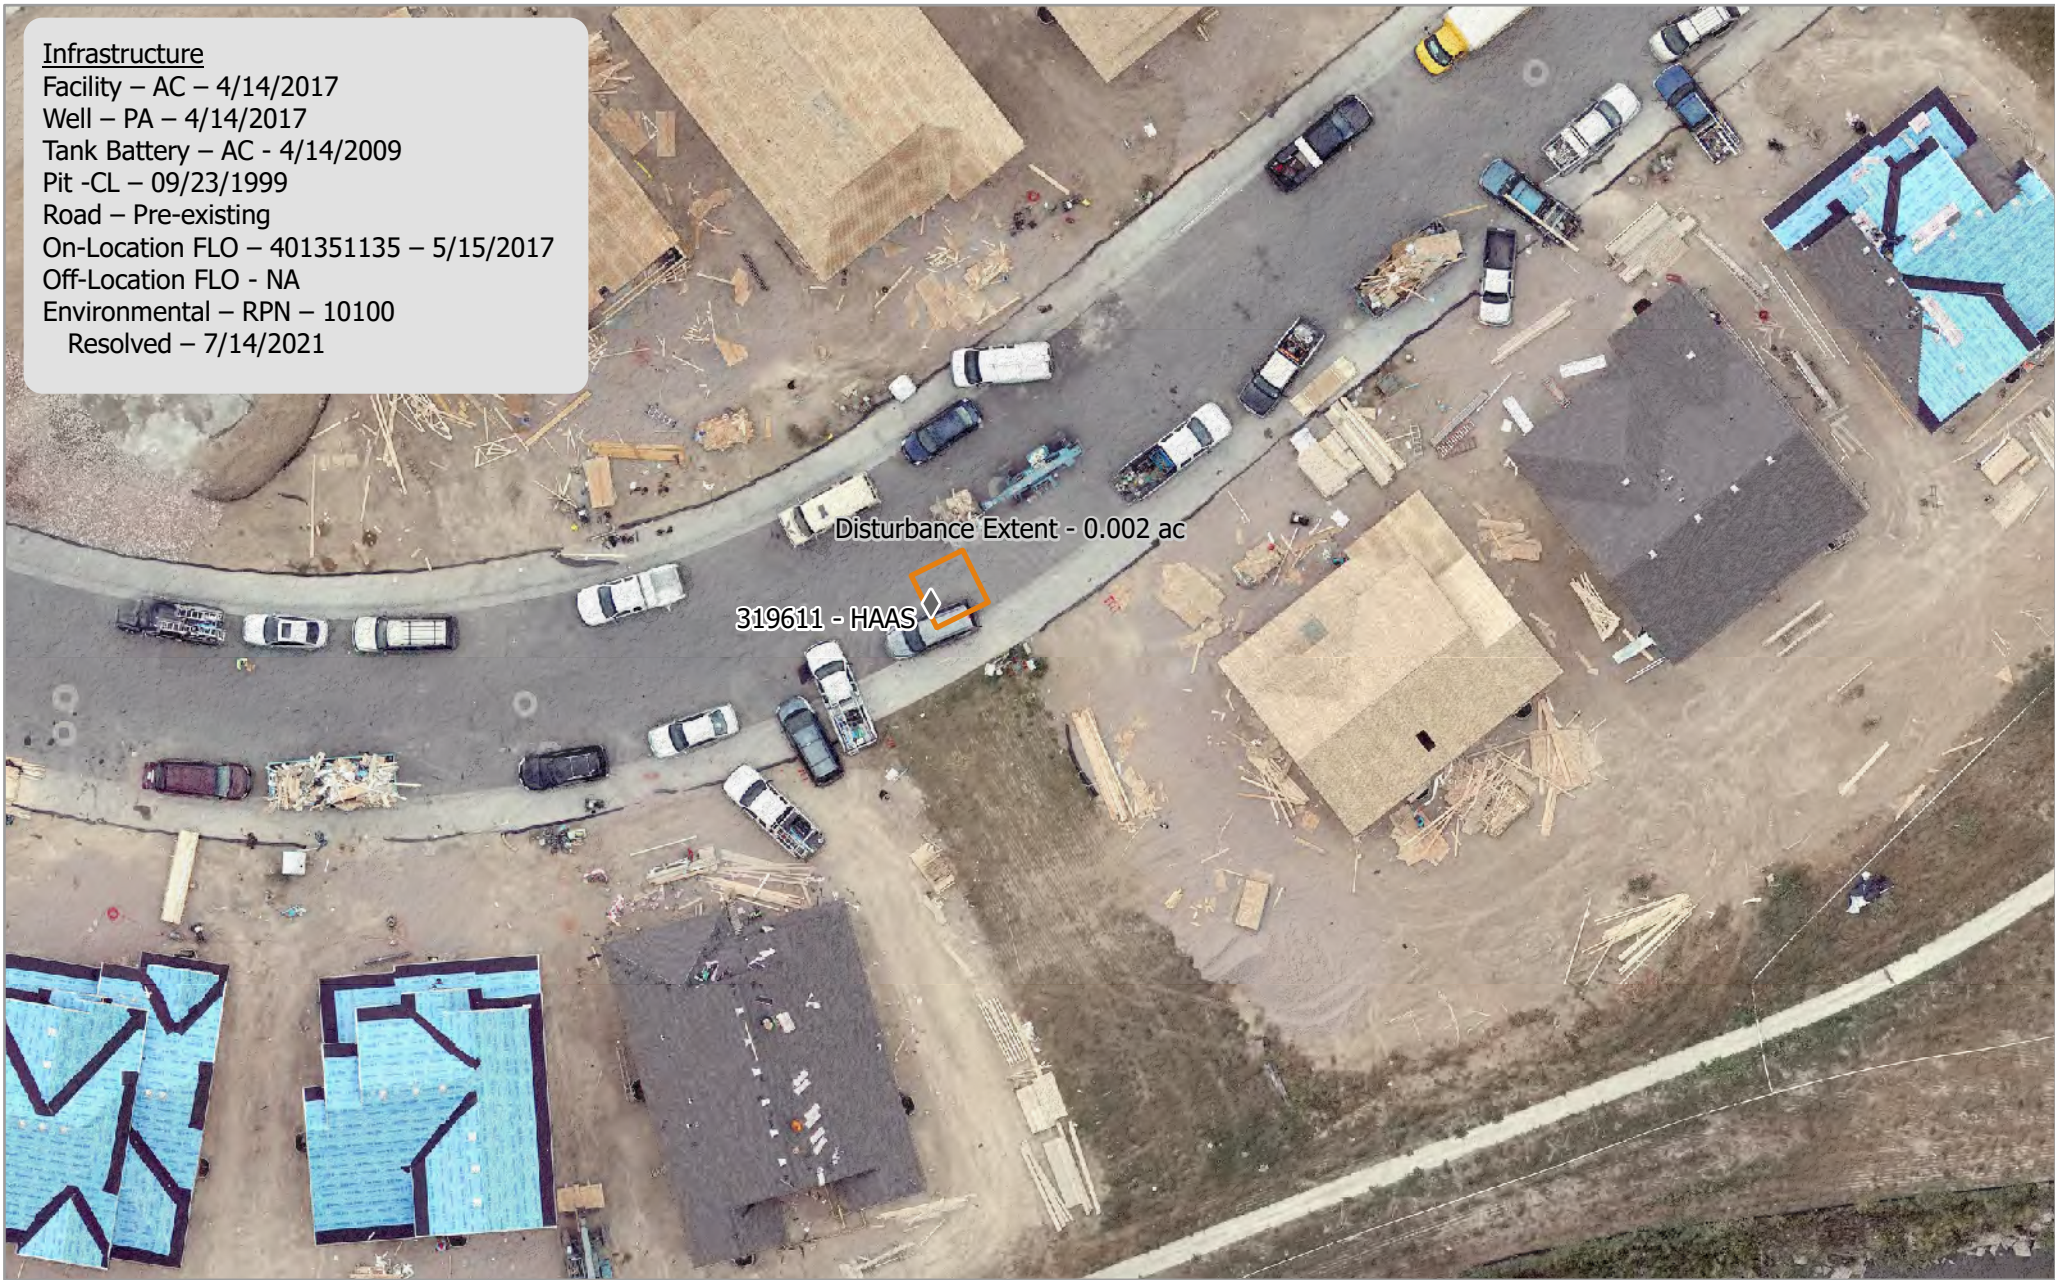
**CIV - 319611- HAAS
Map Extent - Overview**

Overall Disturbance:
0.16 Acres
Scale: 1:400
