SITE-SPECIFIC QUALITY ASSURANCE & QUALITY CONTROL AUDIT

PERMIT CLOSURE REPORT – DESIGNATION LAND USE CHANGE

Location ID - 327723

Location Name – HALEY-62N68W22NESE

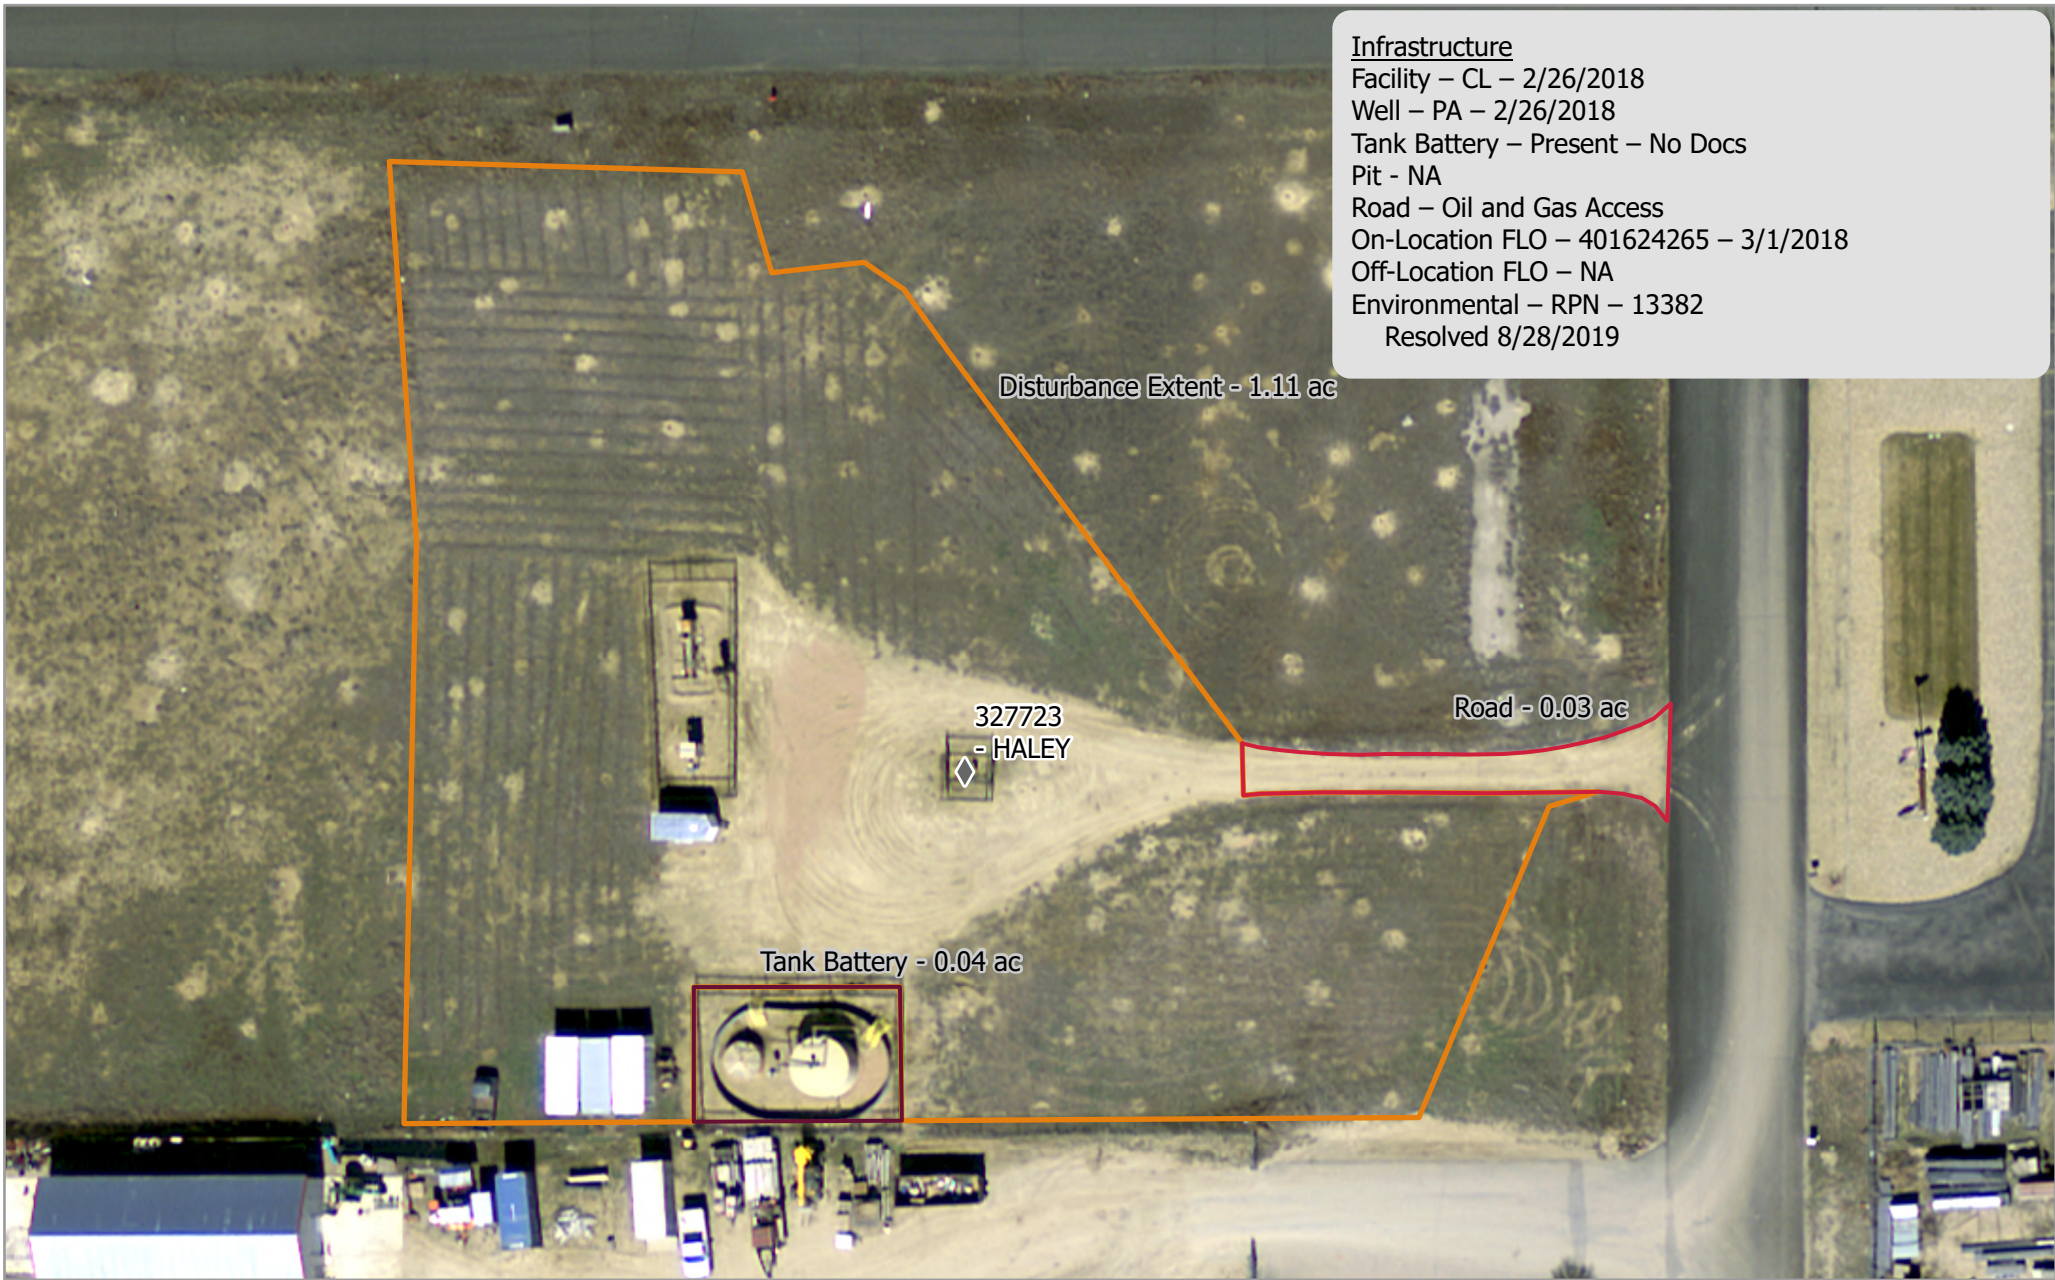
CIV - 327723- HALEY Map Extent - DRCOG 2014

Facility – CL – 2/26/2018
Well – PA – 2/26/2018
Tank Battery – Present – No Docs
Pit - NA
Road – Oil and Gas Access
On-Location FLO – 401624265 – 3/1/2018
Off-Location FLO – NA
Environmental – RPN – 13382
Resolved 8/28/2019

Overall Disturbance:
1.19 Acres
Scale: 1:600

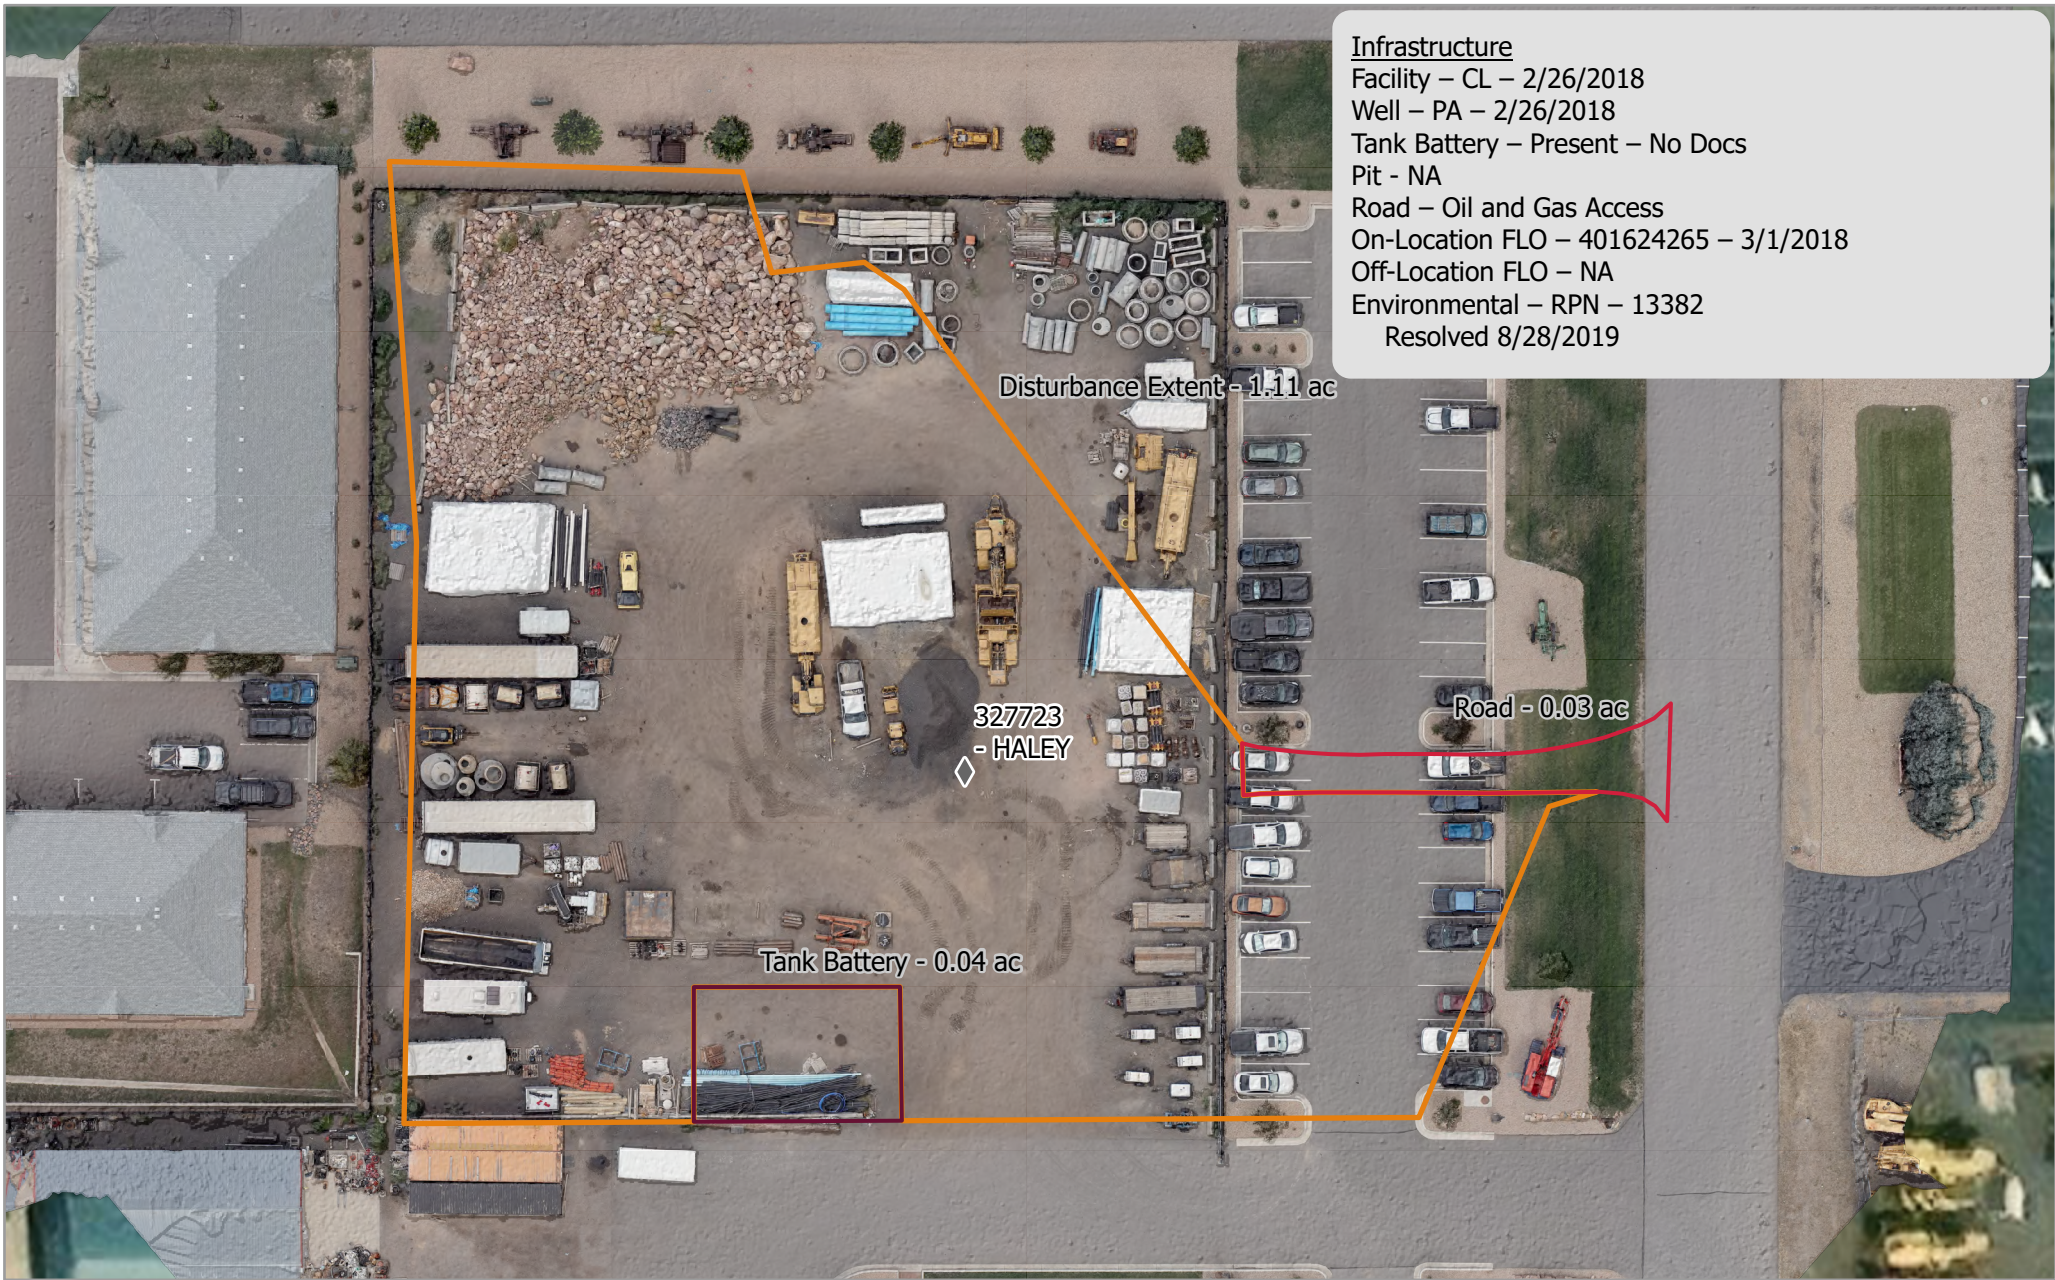
CIV - 327723- HALEY
Map Extent - Overview

Overall Disturbance:
1.19 Acres
Scale: 1:600
