Inspection Photos

API: 009-06504

Operator: MURFIN DRILLING COMPANY INC

Inspection Date: 1/10/2023

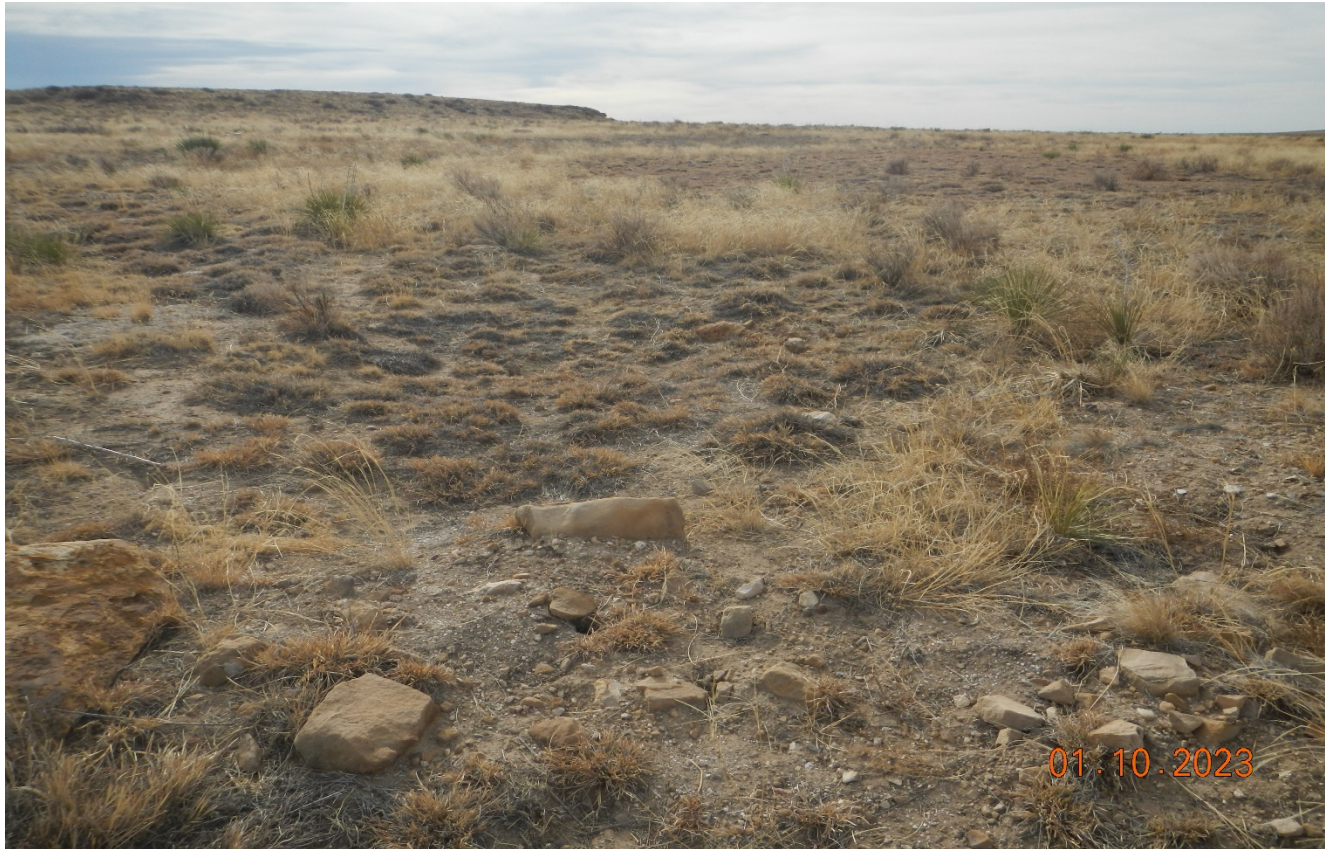
Photo 1. Facing south toward the location. Perennial vegetation has established throughout the location.

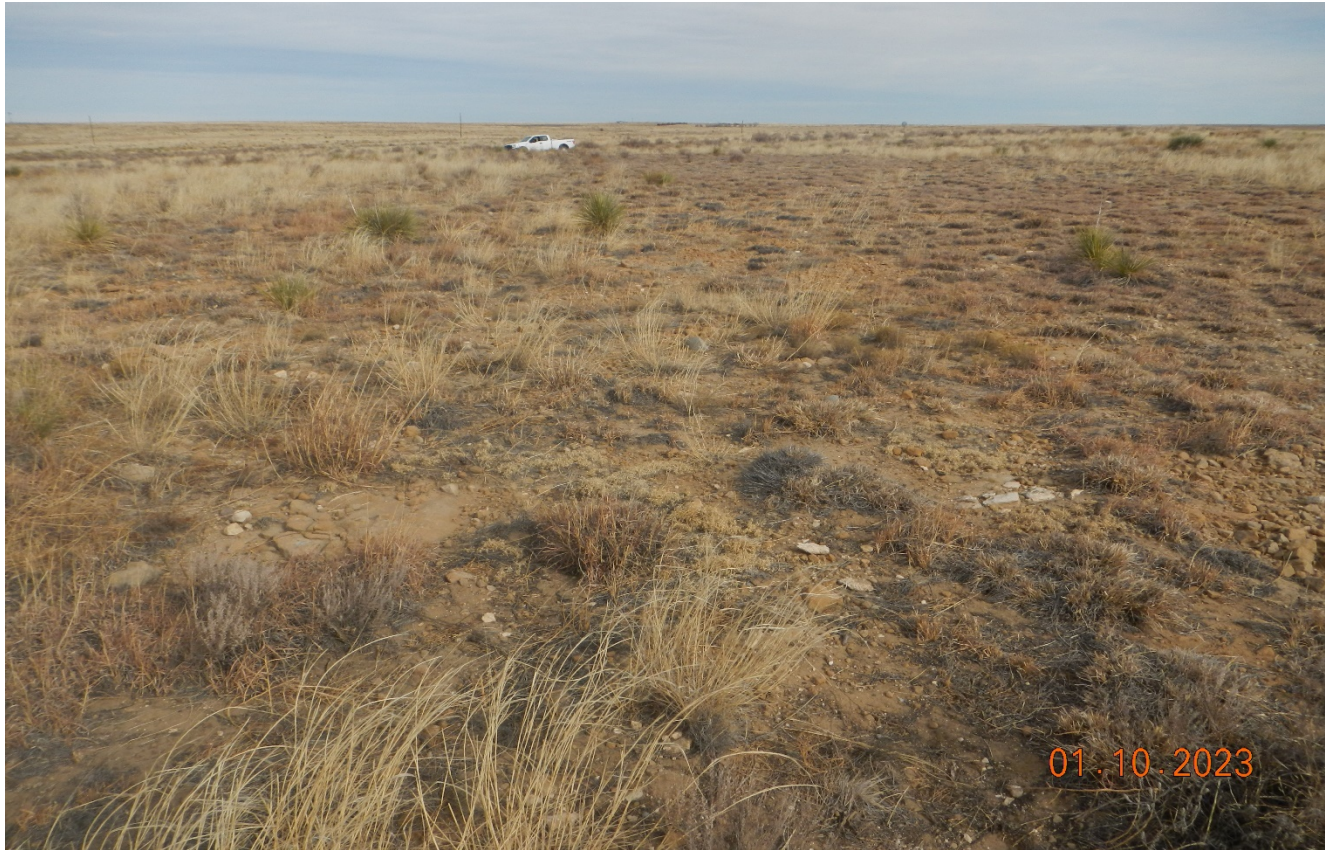
Photo 2. Facing north toward the location. Perennial vegetation has established throughout the location.

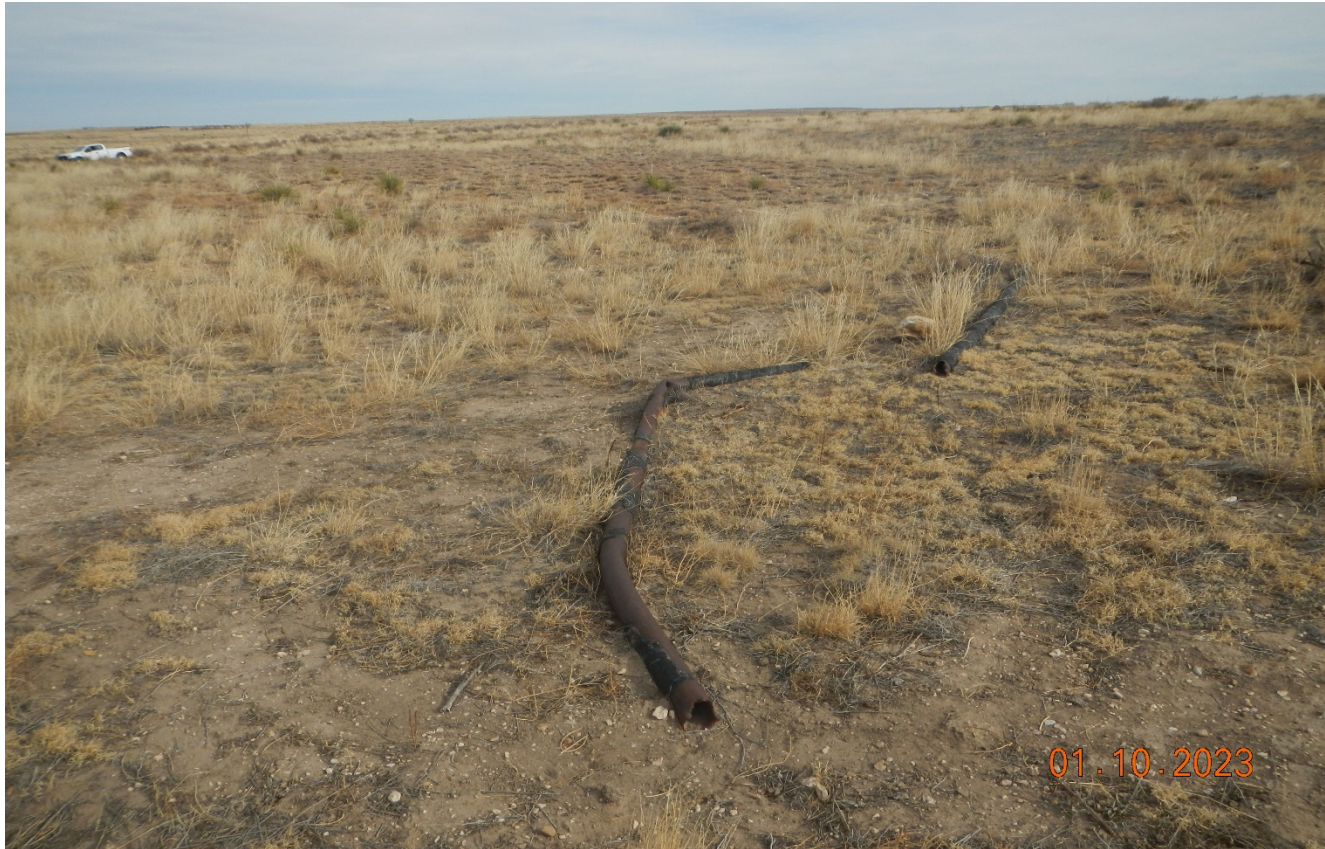
Photo 3. There are pieces of pipe that remain at south side of the location that need to be removed.
