Inspection Photos

Loc ID: 321098

Operator: INVESTMENT EQUIPMENT LLC

Inspection Date: 1/10/2023

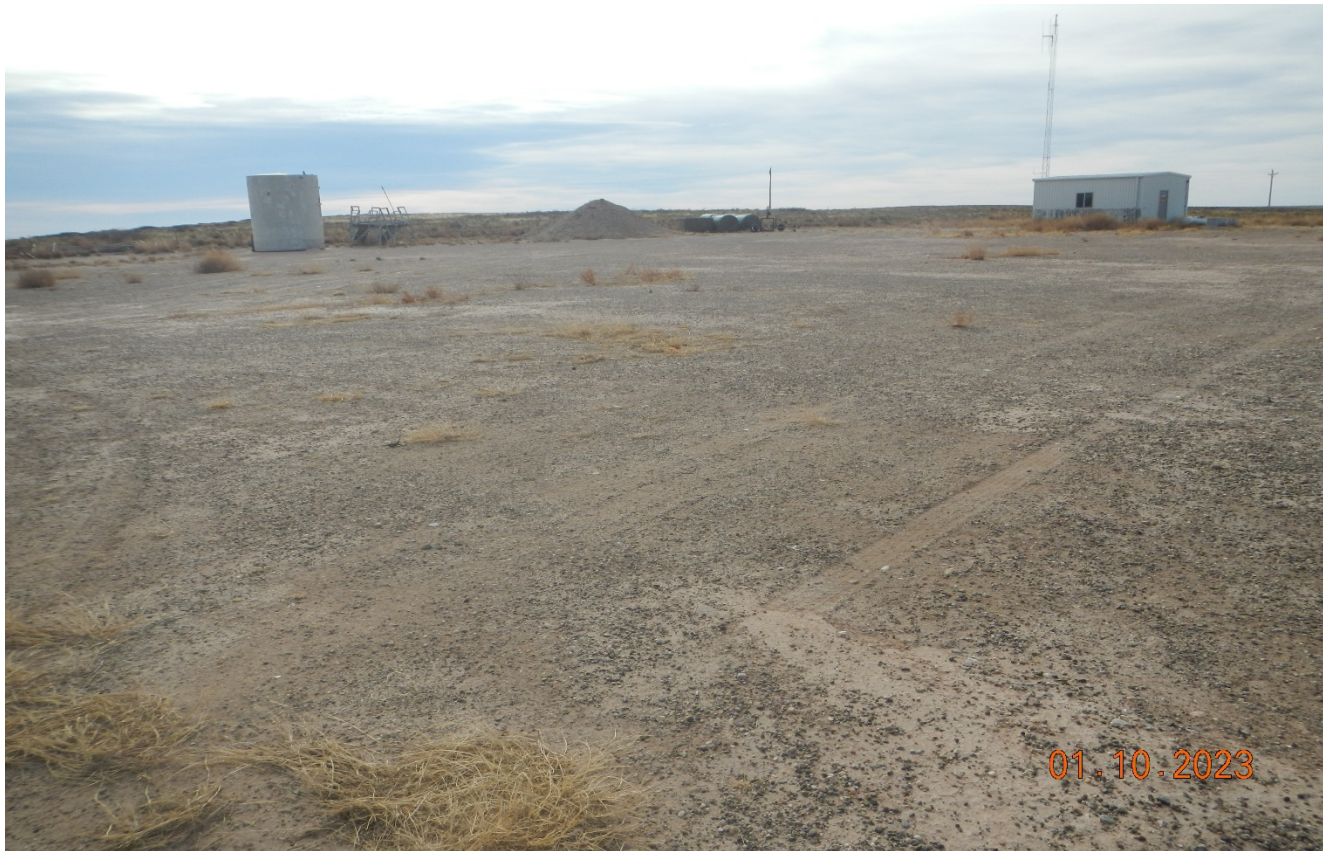
Photo 1. Facing southwest toward the abandoned facility and well site which is approximately 3 acres in size.

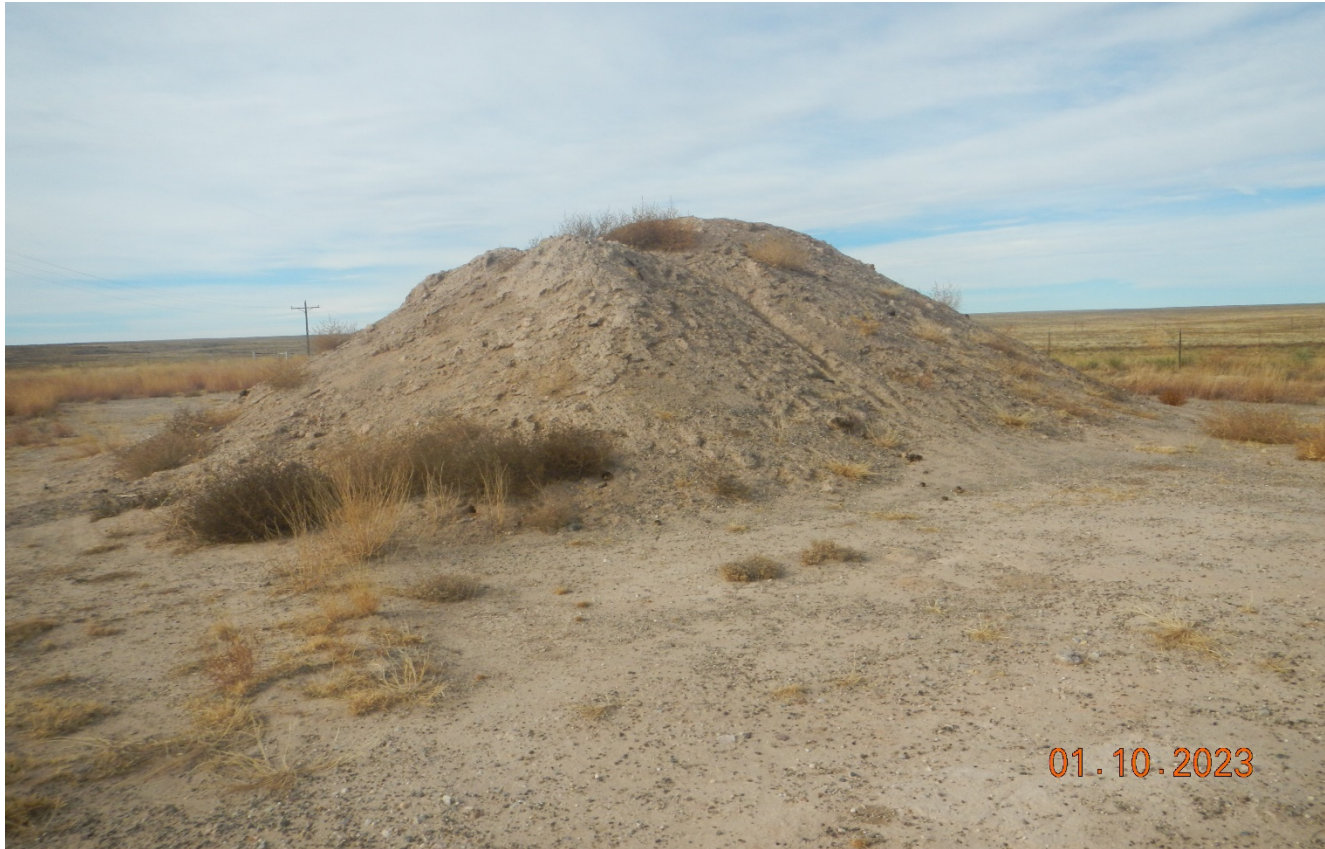
Photo 2. There is a soil material pile that remains at the north side of the location.

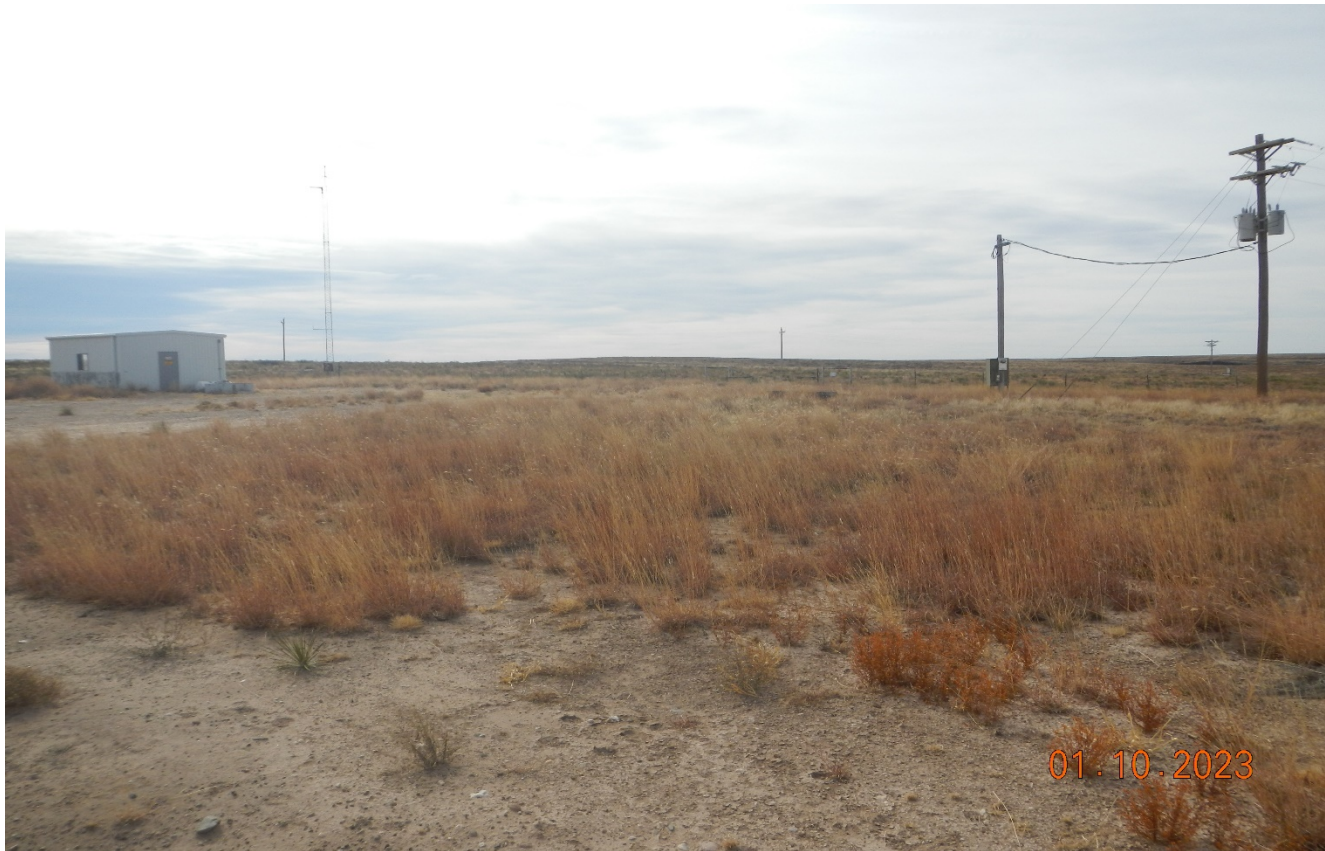
Photo 3. The electric powerline utilities have not been removed.

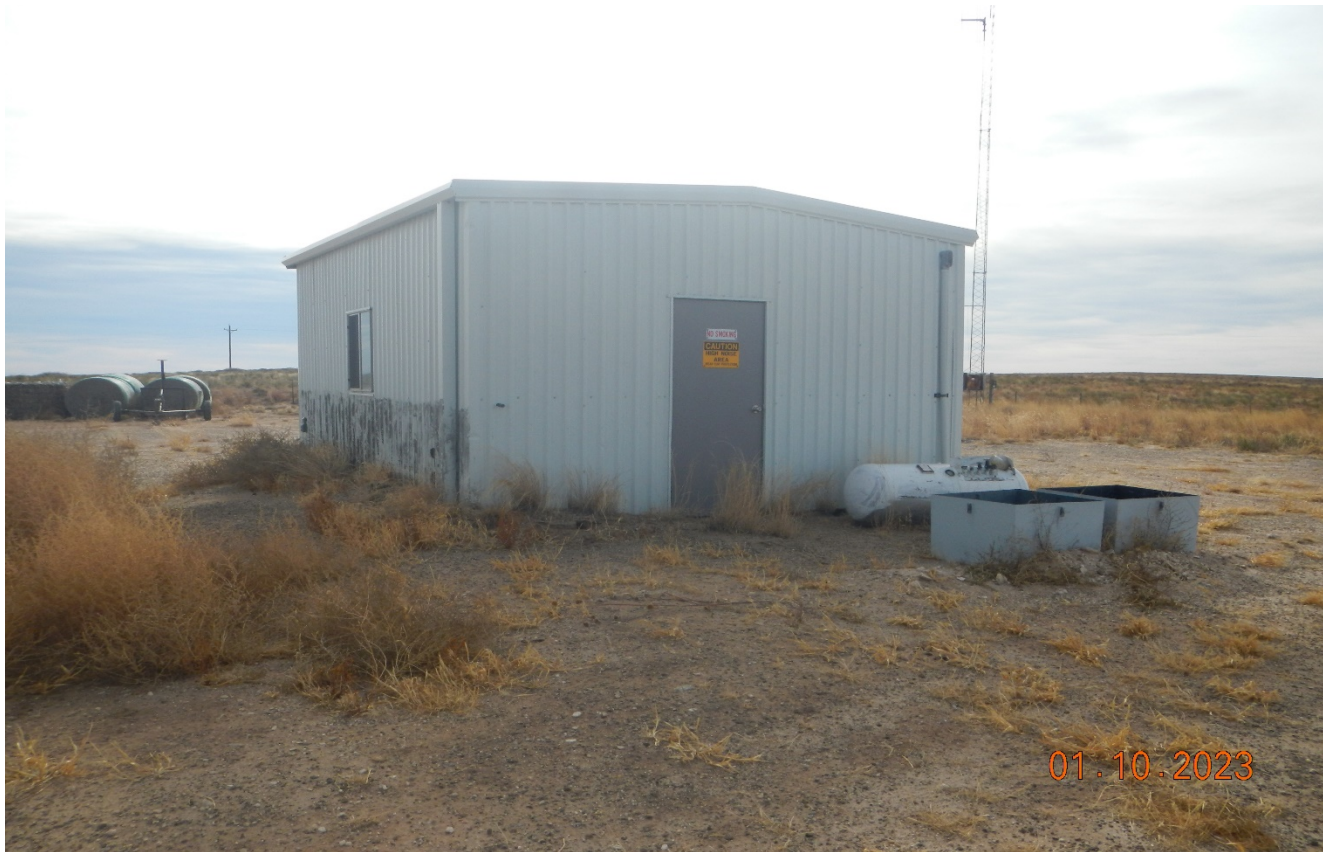
Photo 4. There is a metal shed that remains at the west side of the location.

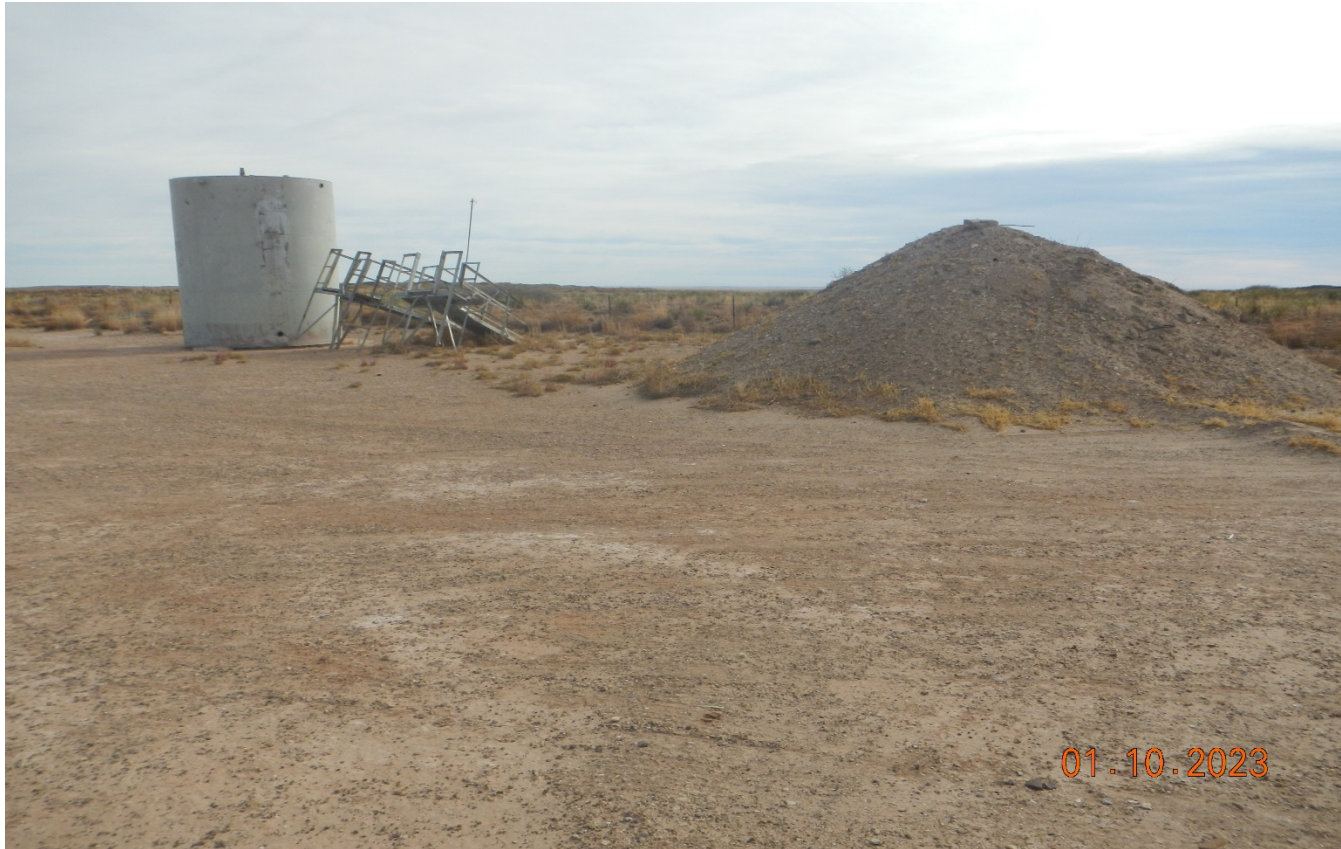
Photo 5. Another soil material pile that remains at the south side of the location. There is a steel tank that remains.

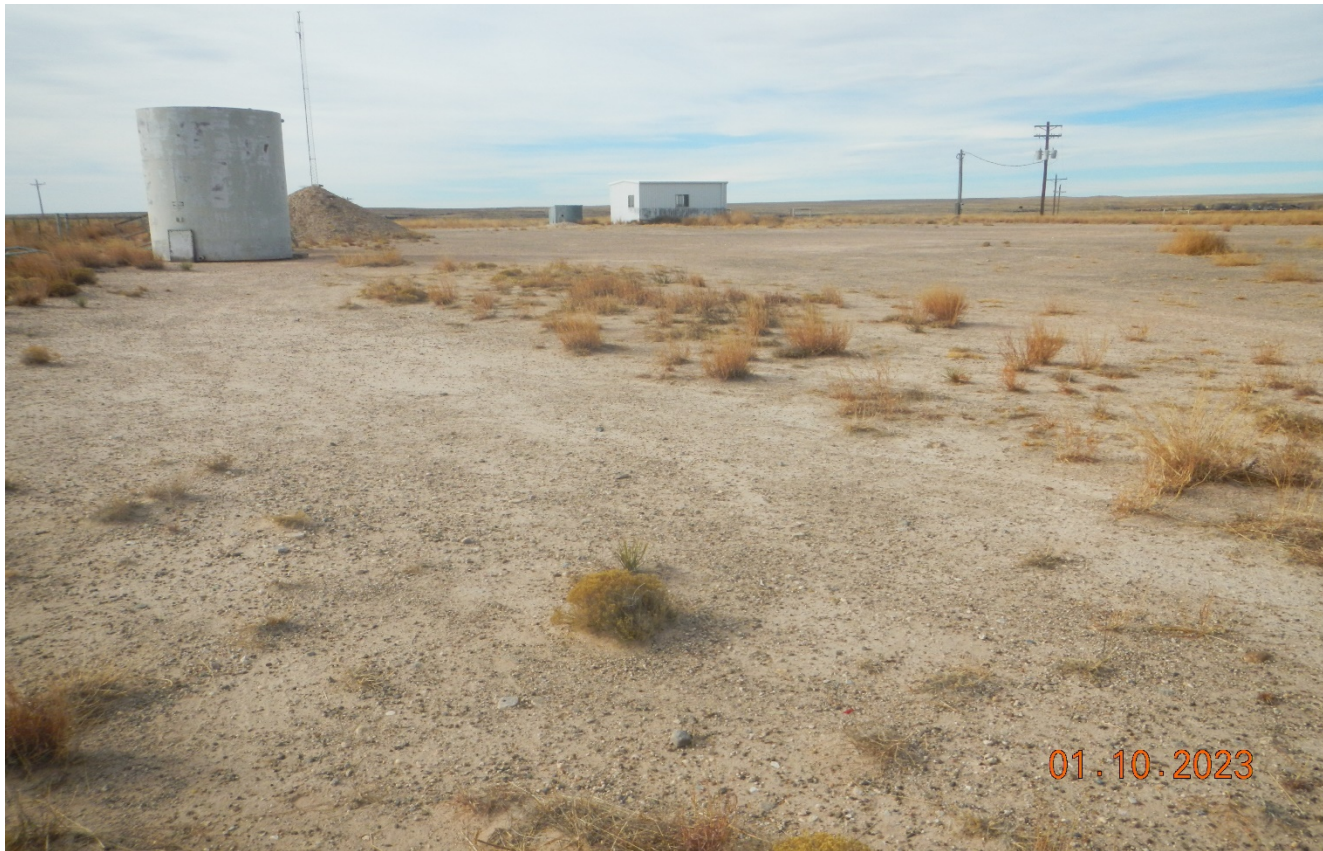
Photo 6. East side of the location facing southwest.

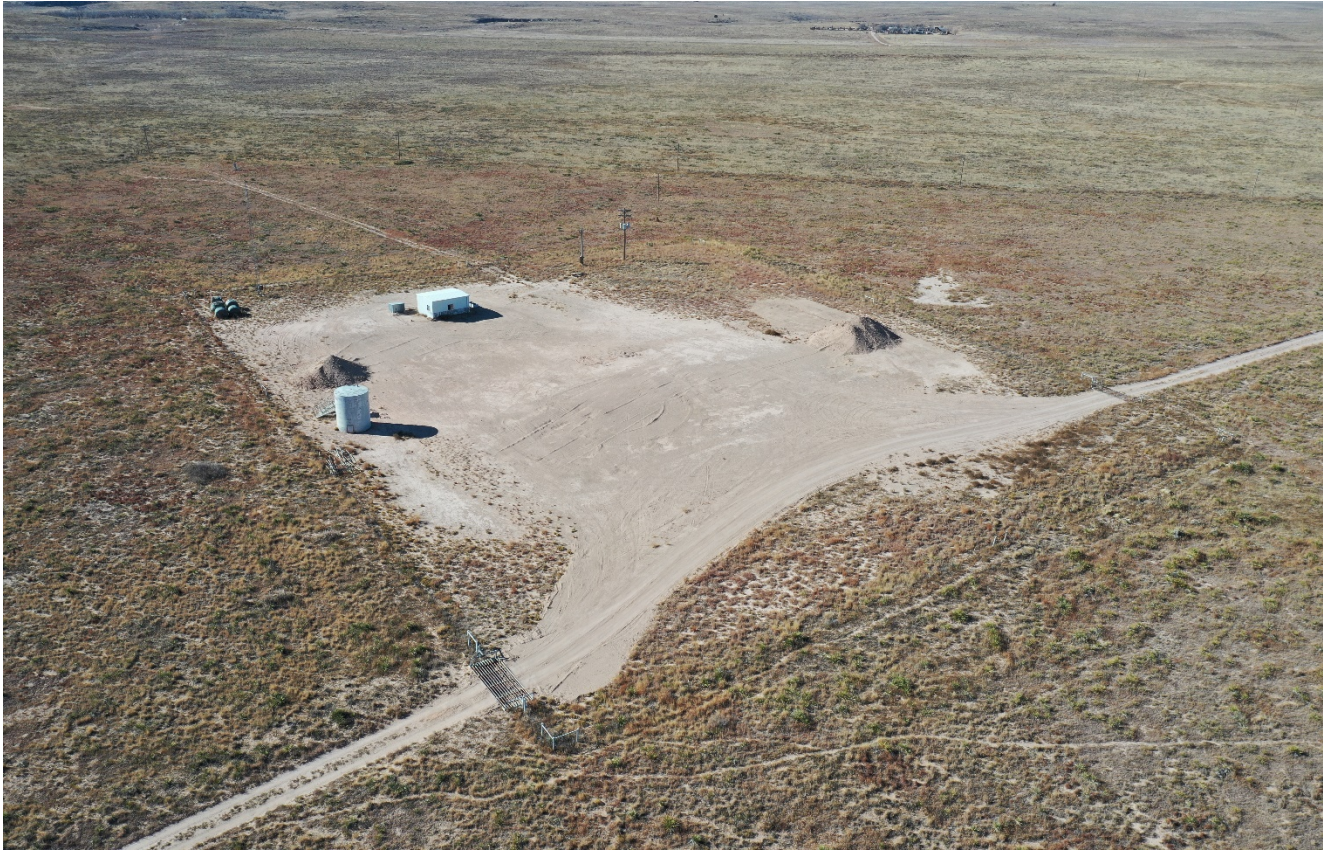
Photo 7. Drone aerial photo facing west toward the [TANNER SEC REC UNIT #501](#) well site and production facility. The abandoned facility and well site has not been reclaimed and equipment remains. This image was taken during previous inspection.
