Inspection Photos

API: 009-06439

Operator: INVESTMENT EQUIPMENT LLC

Inspection Date: 1/10/2023

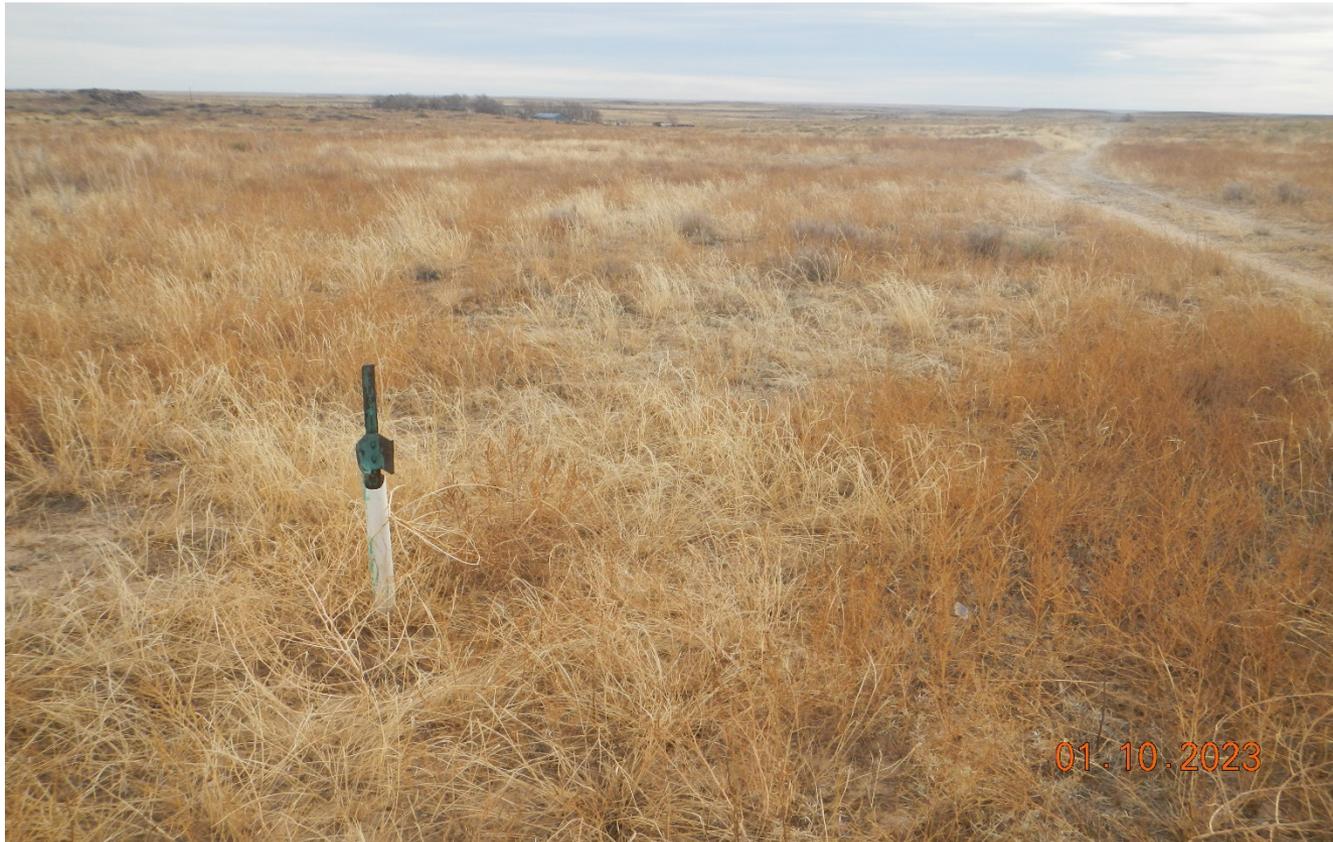
Photo 1. Facing southeast toward the location. There is a white pvc pipe extending out of the ground at the north side of the location..

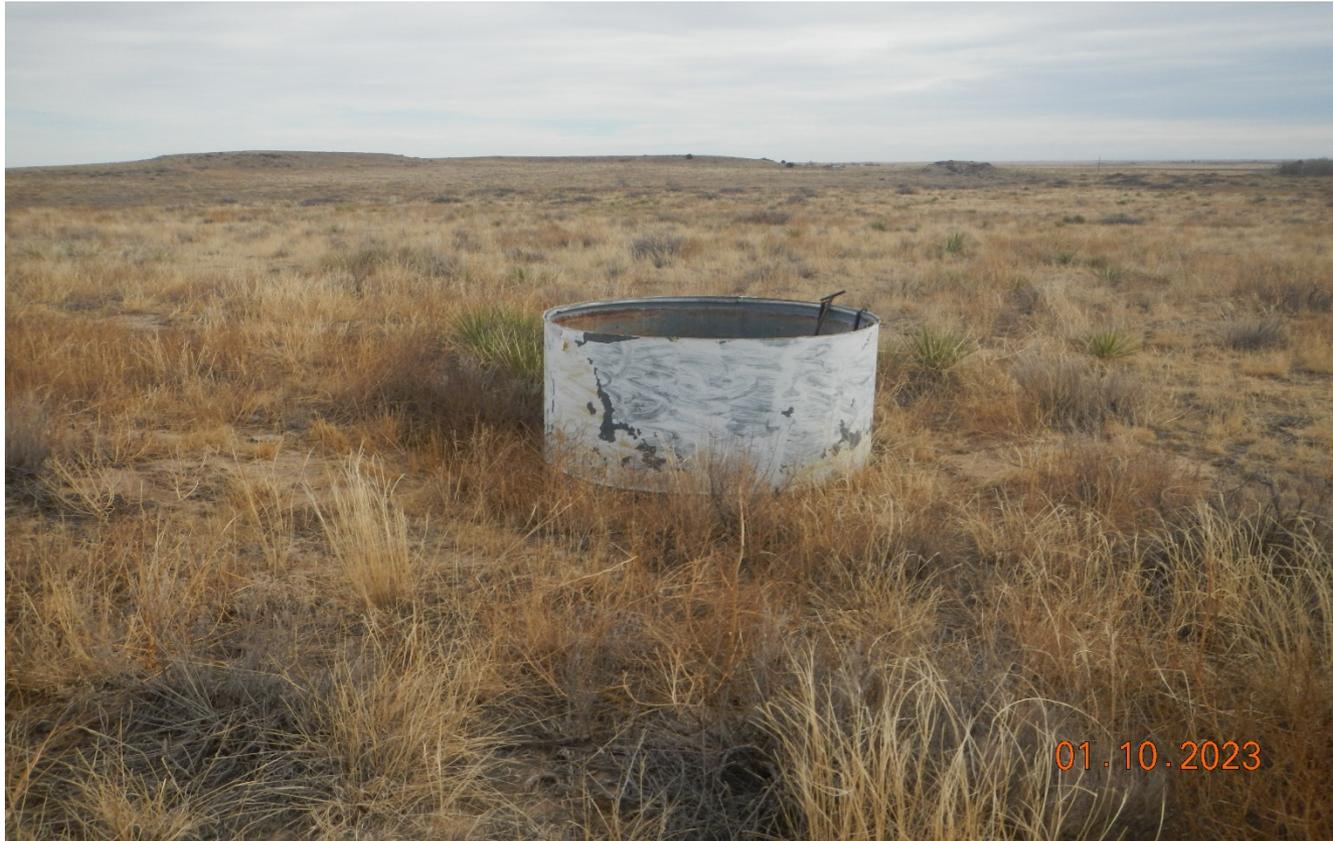
Photo 2. Facing northeast near the location. There is cellar with pipeline valves northeast of the location that may have been associated with the well.

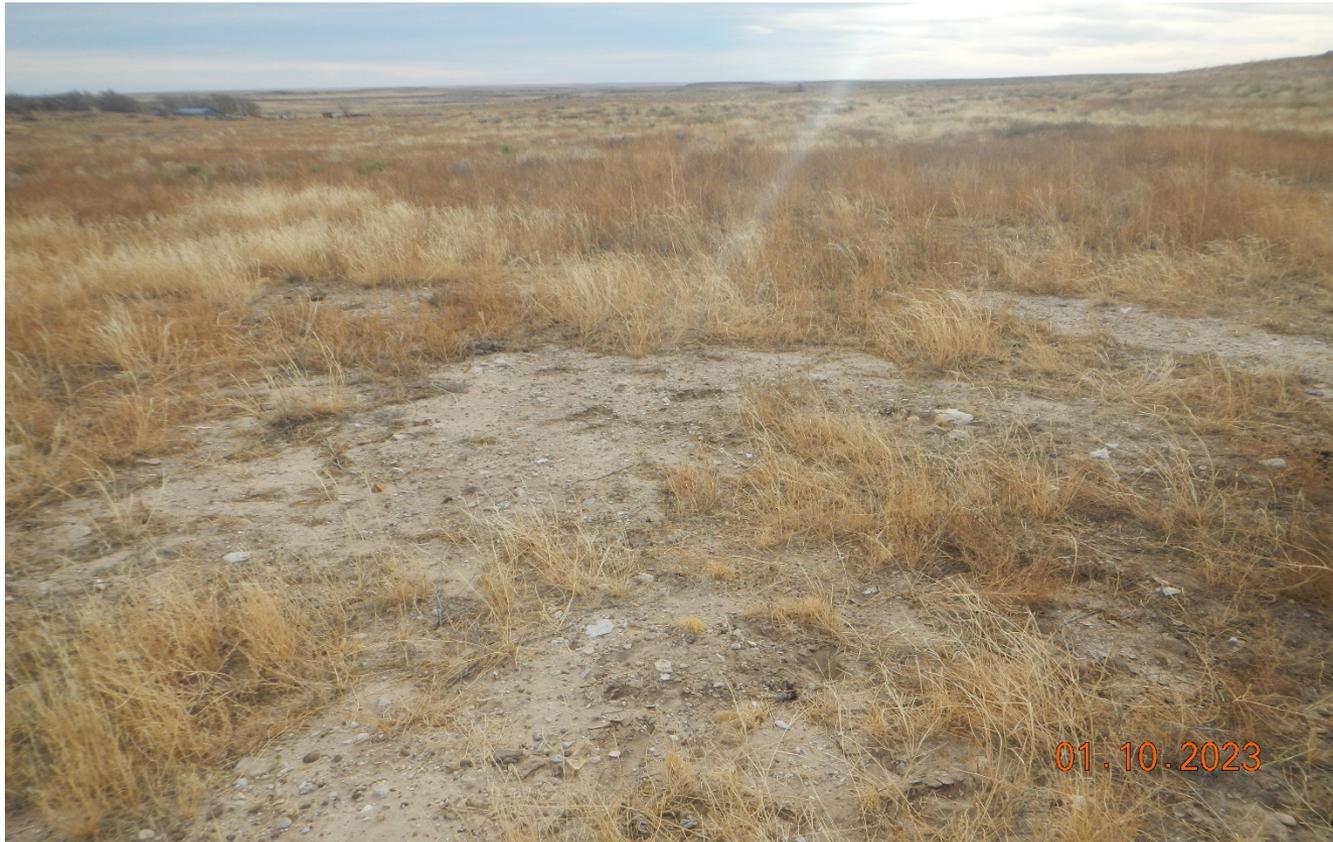
Photo 3. Facing south at the location. The location has not been reclaimed.

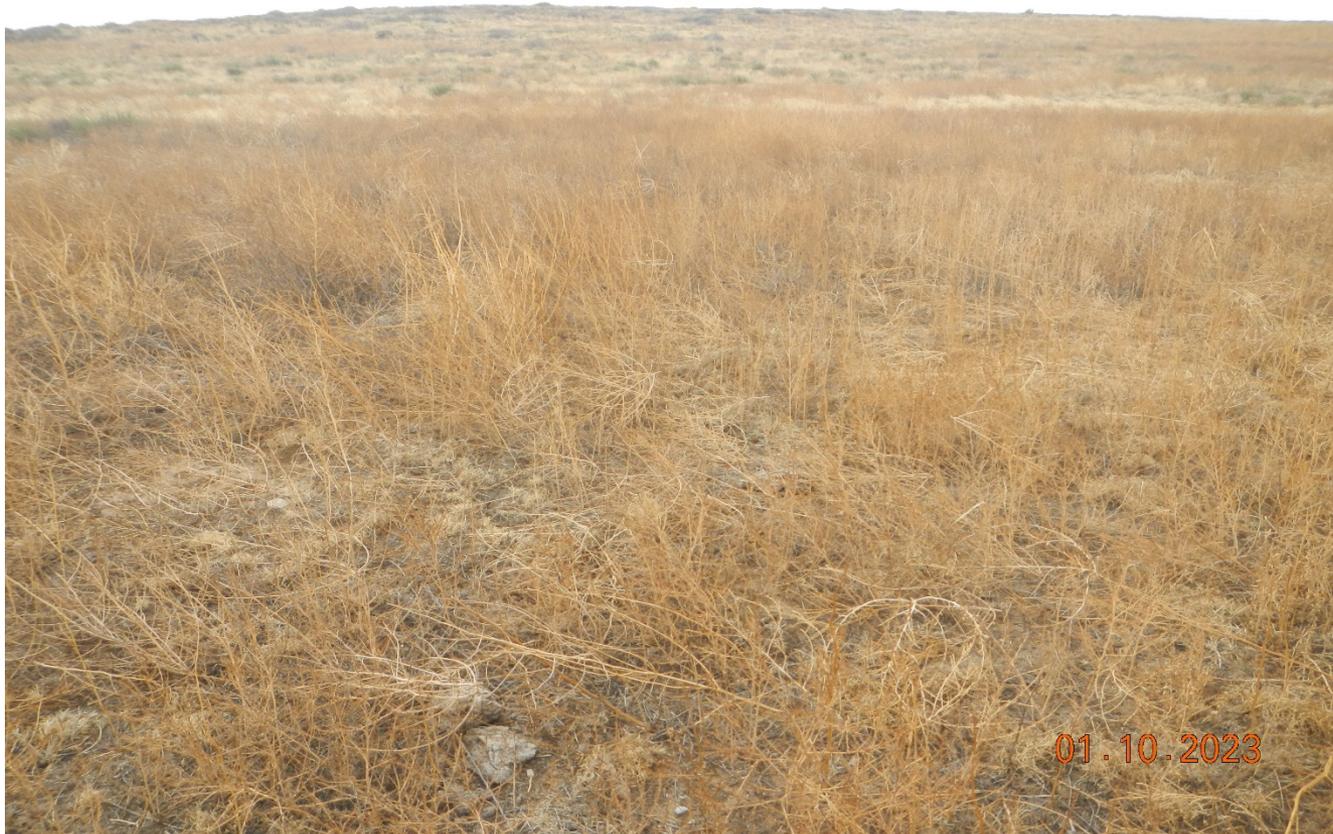
Photo 4. Facing west at the south side of the location. This area consists mostly of undesirable weeds (Russian thistle, Kochia).

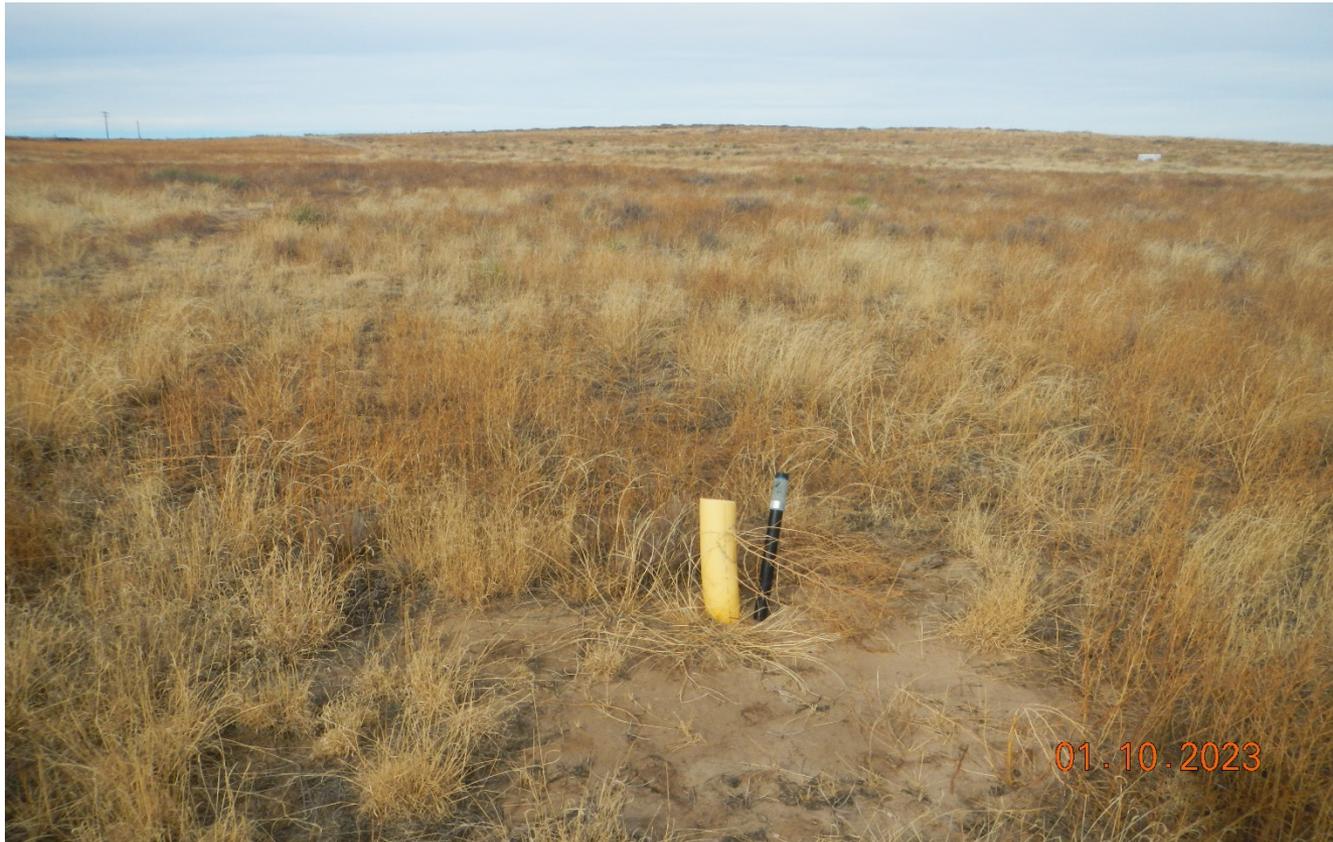
Photo 5. There is a plastic pipe sticking out of the ground approx. 200' southeast of the location.

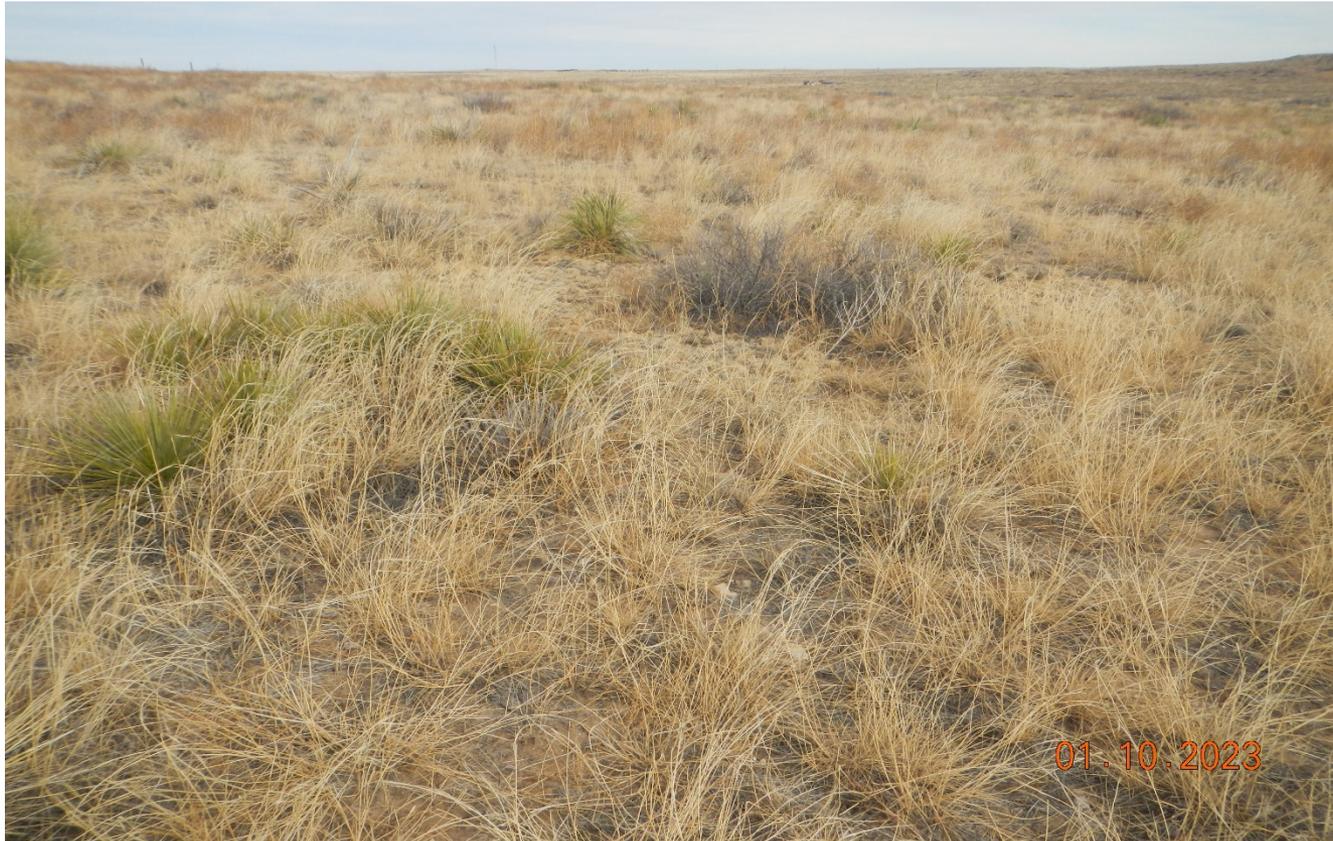
Photo 6. Facing toward the surrounding undisturbed reference area which consists of Blue grama, Sand dropseed, Prairie threeawn, among other native species.
