Inspection Photos

API: 009-06498

Operator: INVESTMENT EQUIPMENT LLC

Inspection Date: 1/10/2023

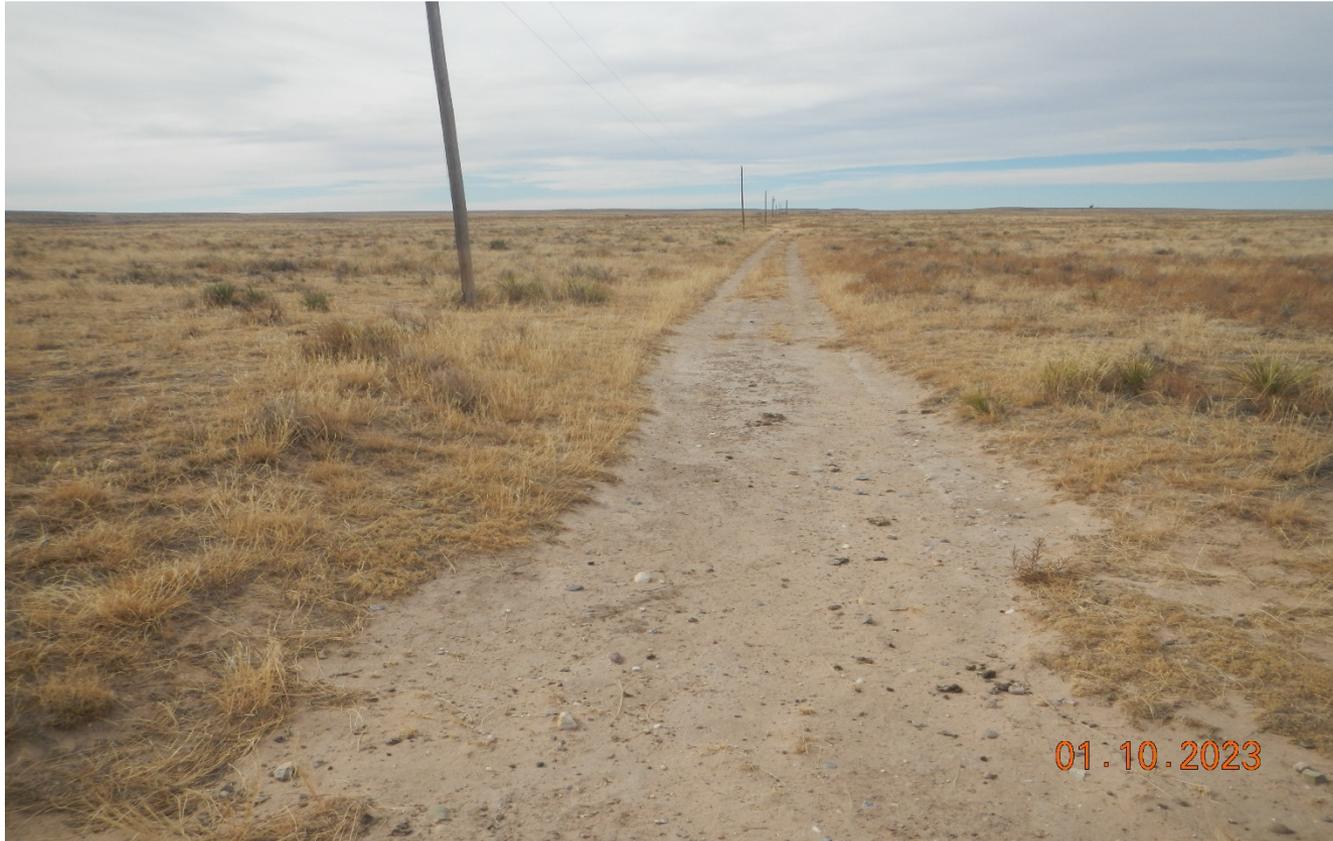
Photo 1. Facing west toward the access road which has not been reclaimed.

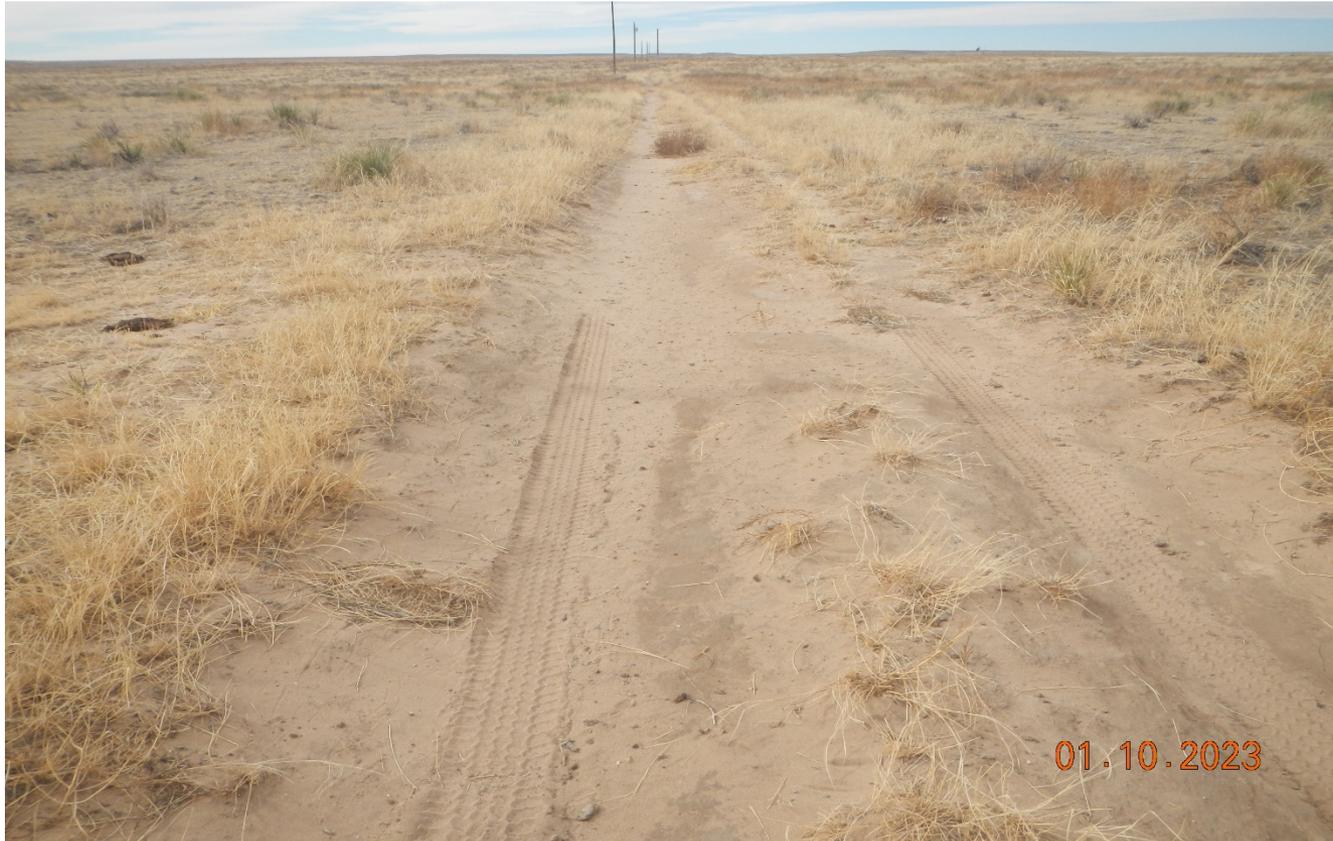
Photo 2. Facing west further along the access road which has not been reclaimed.

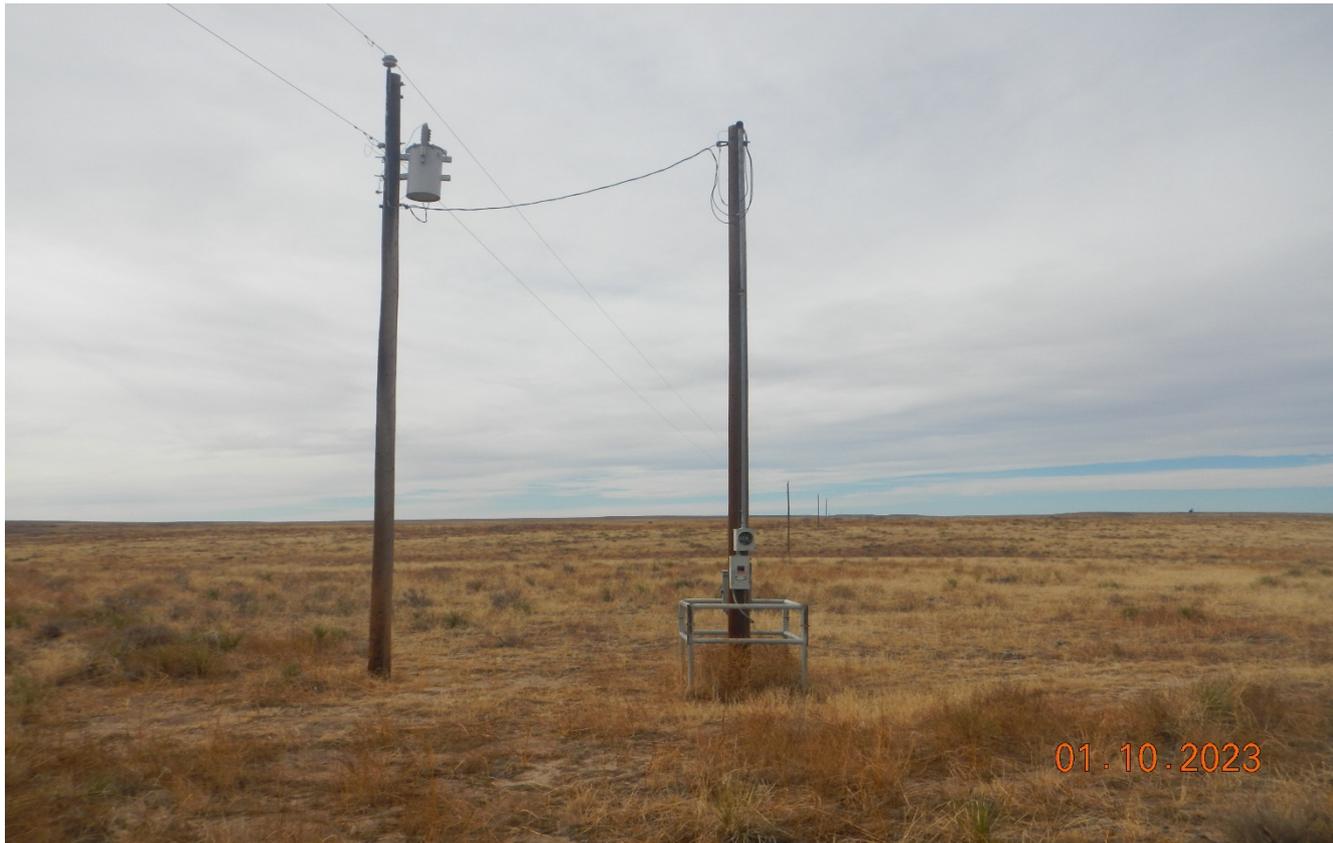
Photo 3. The electric pole servicing the former will needs to be removed.

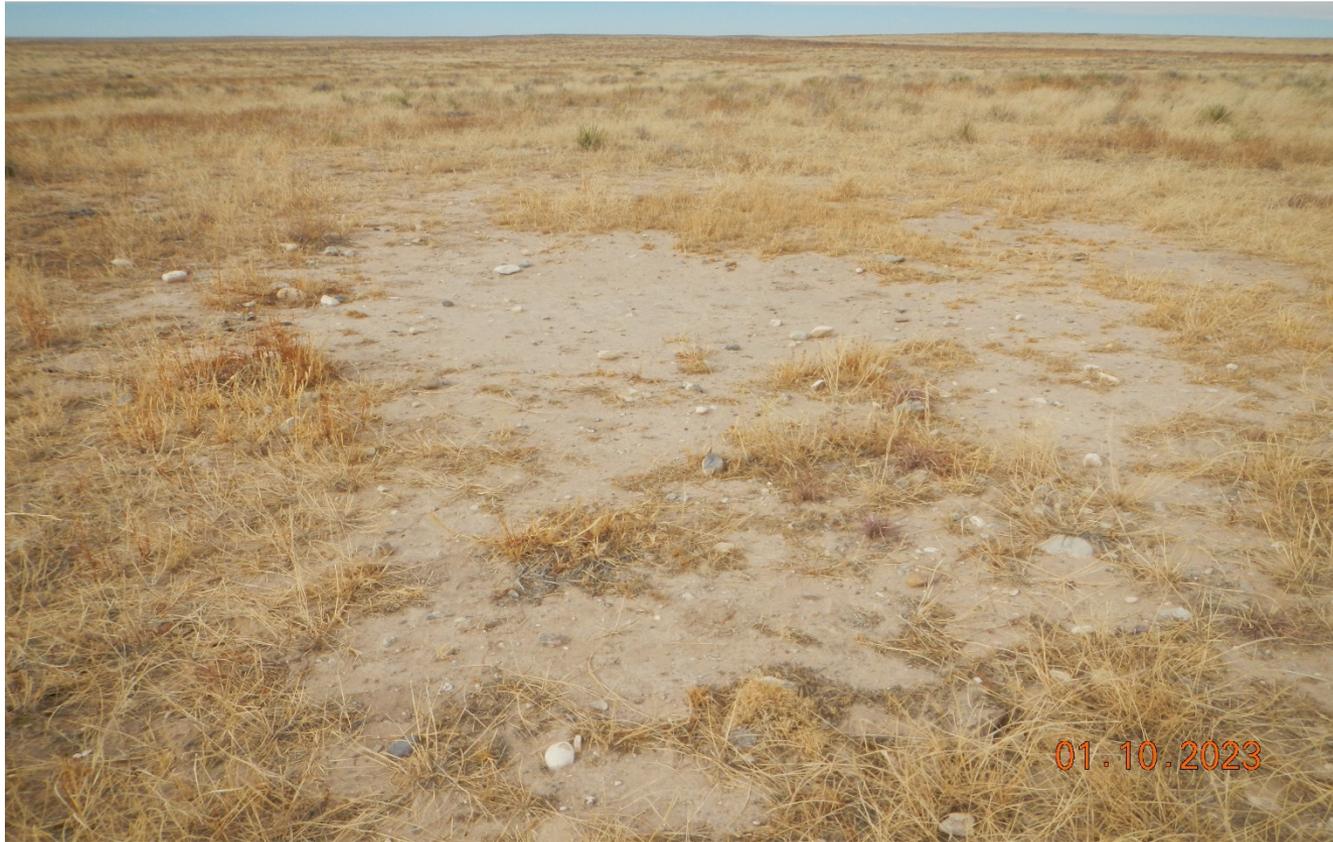
Photo 4. Facing northwest at the location. This area approx. 15x15ft. Where the well was located has not re-established vegetation. Other areas of the location have established a uniform vegetation cover.
