Inspection Photos

API: 009-06464

Operator: INVESTMENT EQUIPMENT LLC

Inspection Date: 1/10/2023

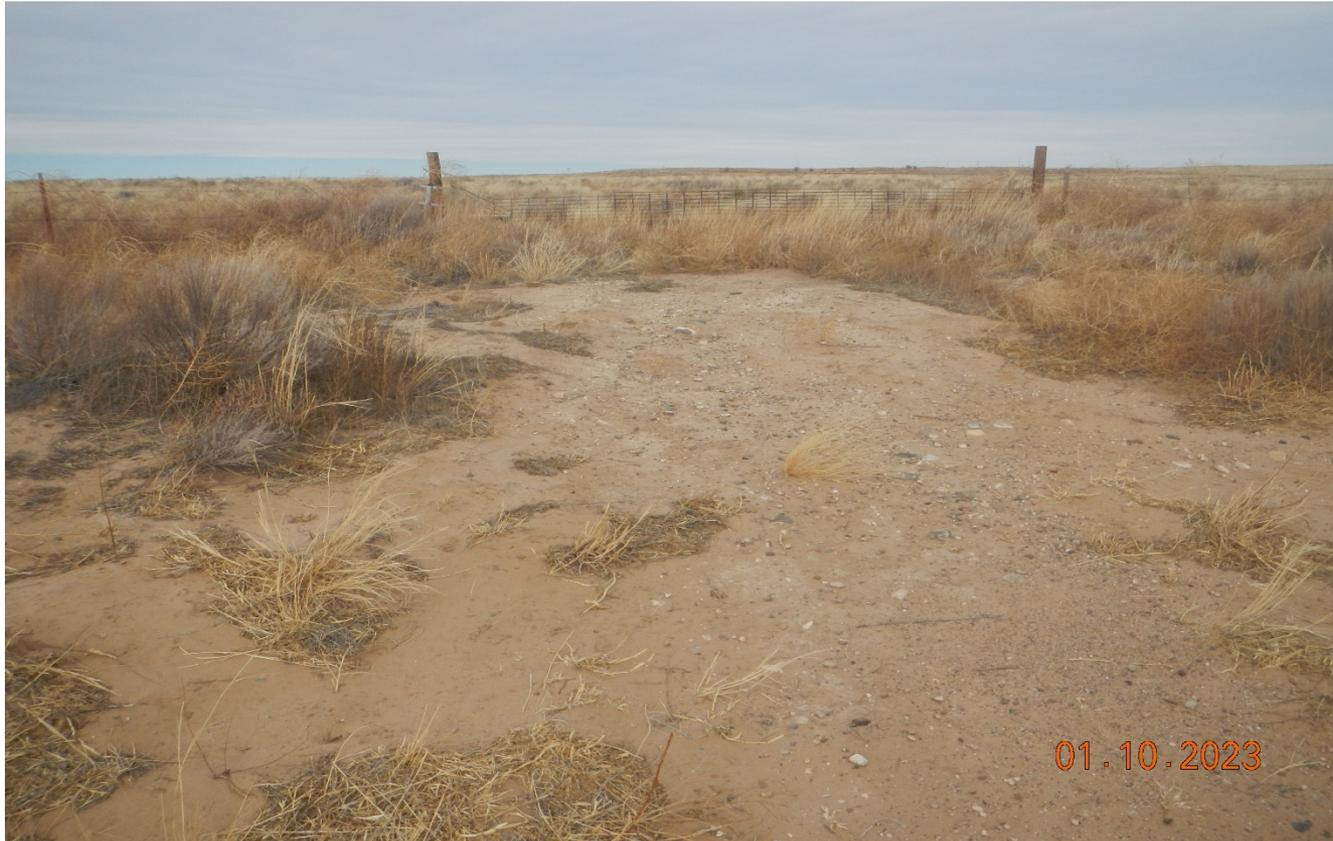
Photo 1. Facing north at the beginning of the access road which has not been reclaimed and the cattle guard remains.

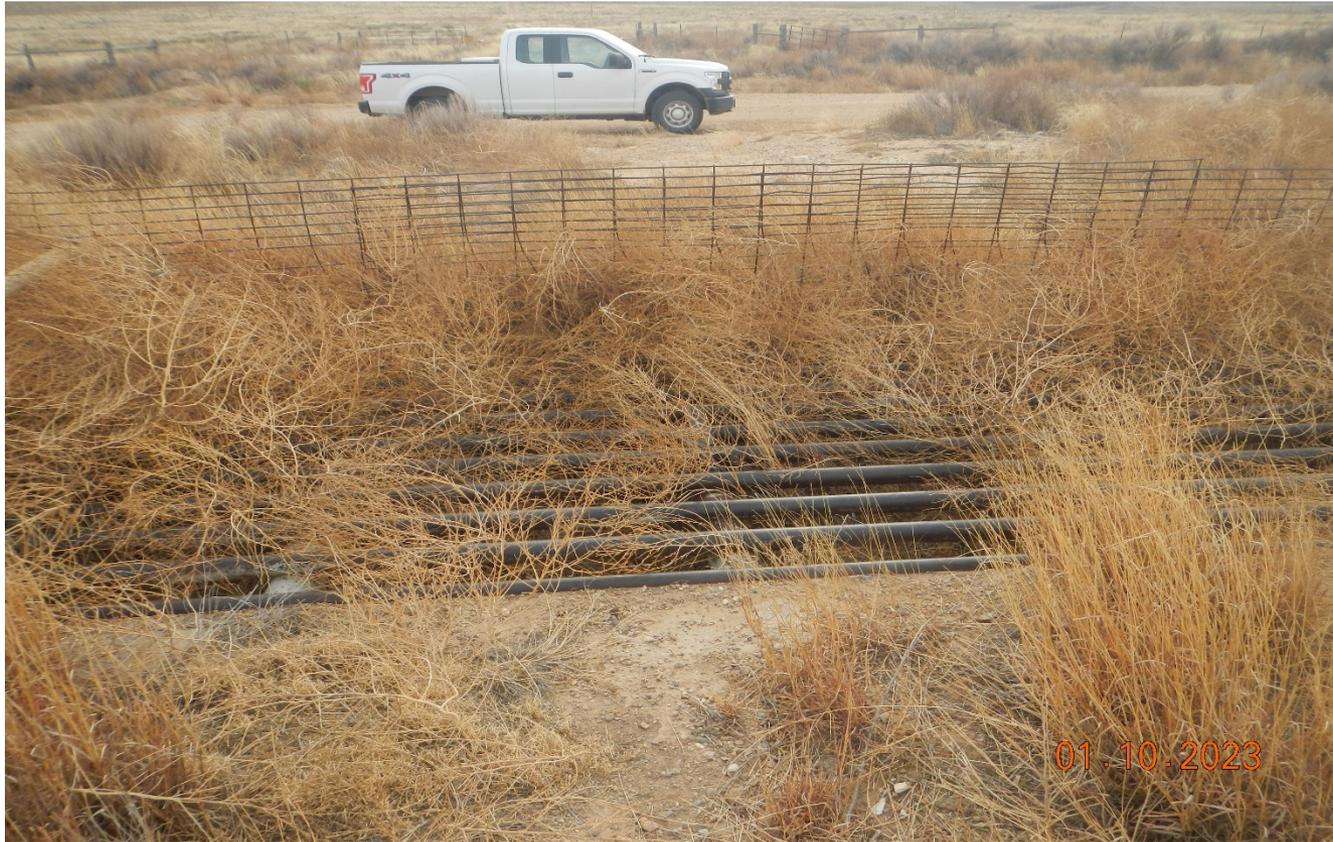
Photo 2. The cattleguard needs to be removed and fence put back to original position.

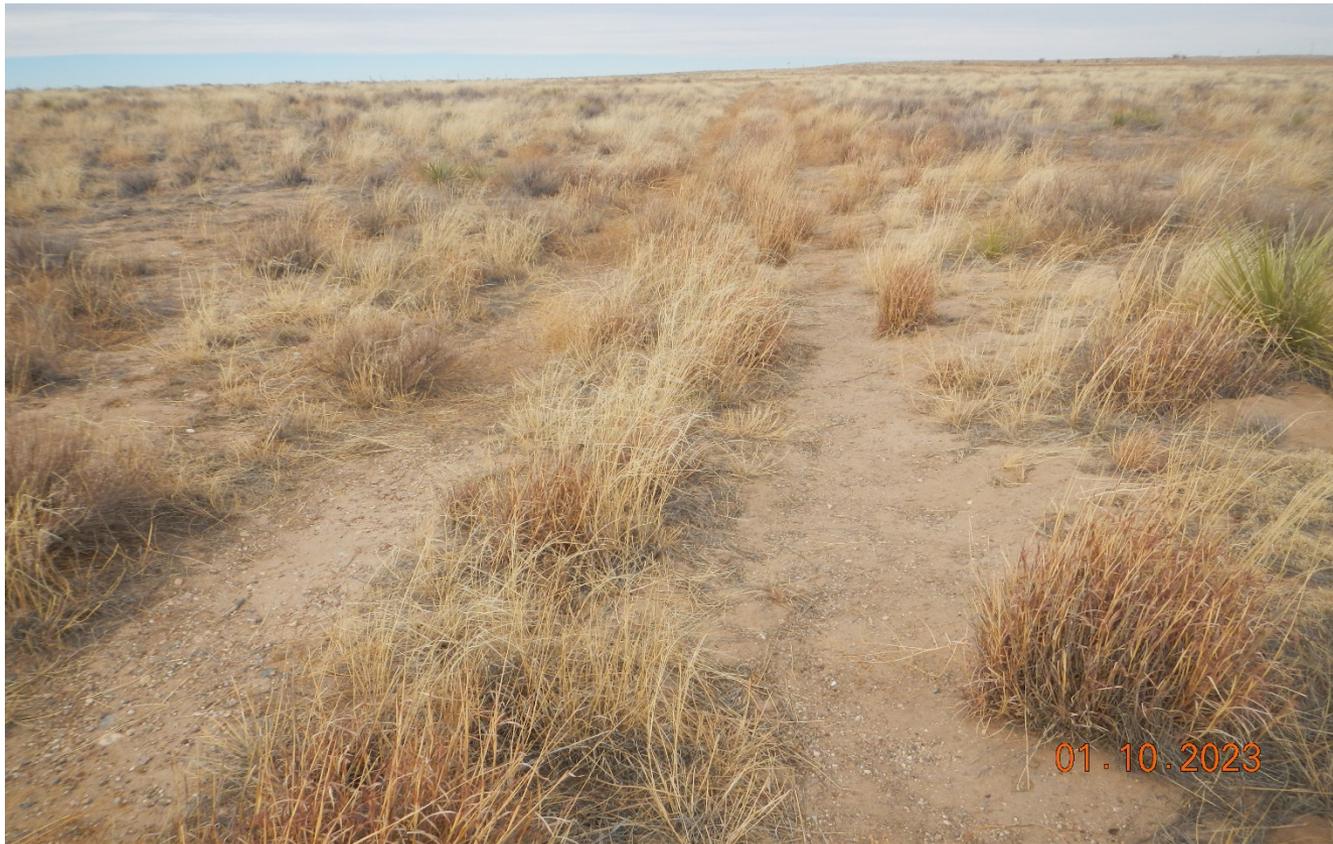
Photo 3. Facing north along the former access road.

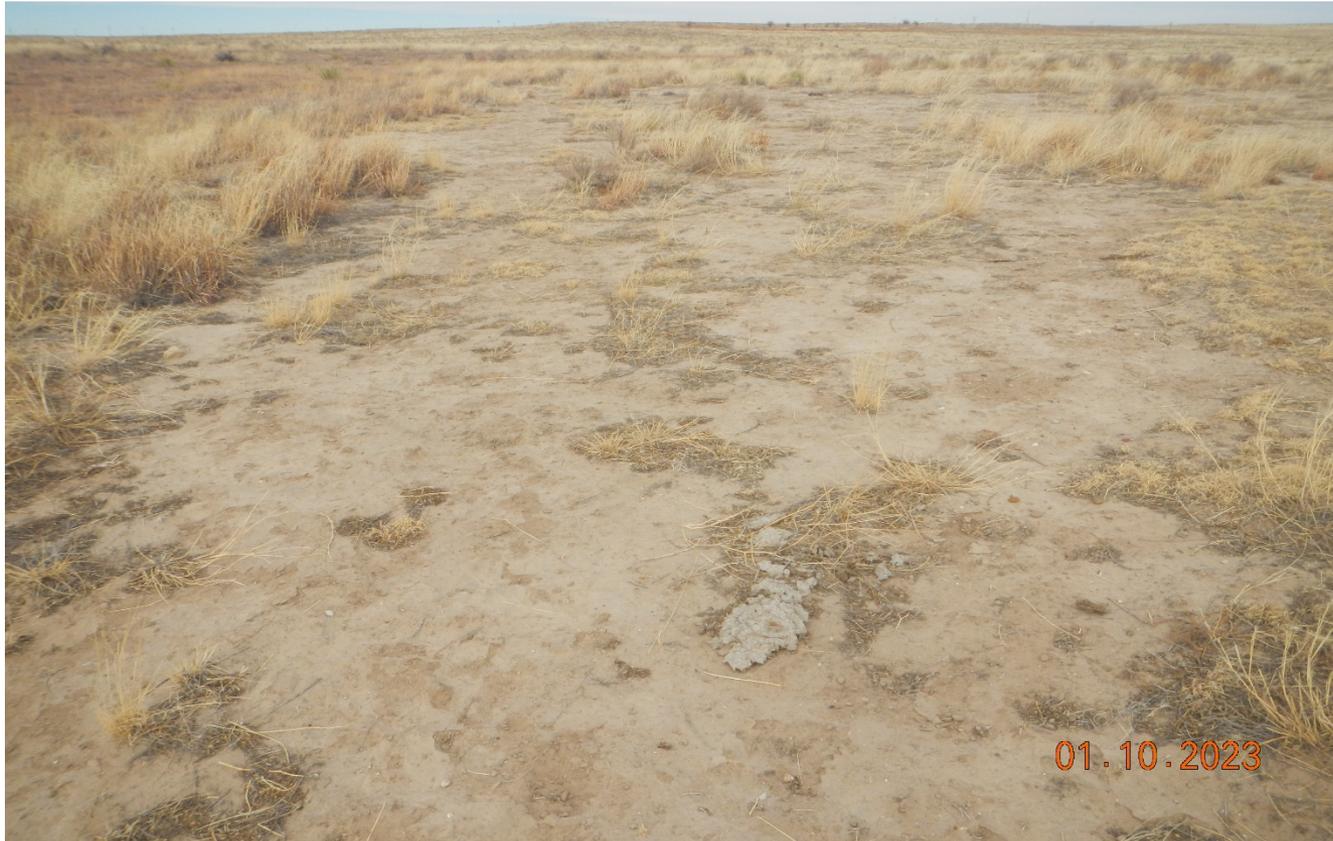
Photo 4. Facing north at the location. There are areas of sparse vegetation and soils seem to be compacted.

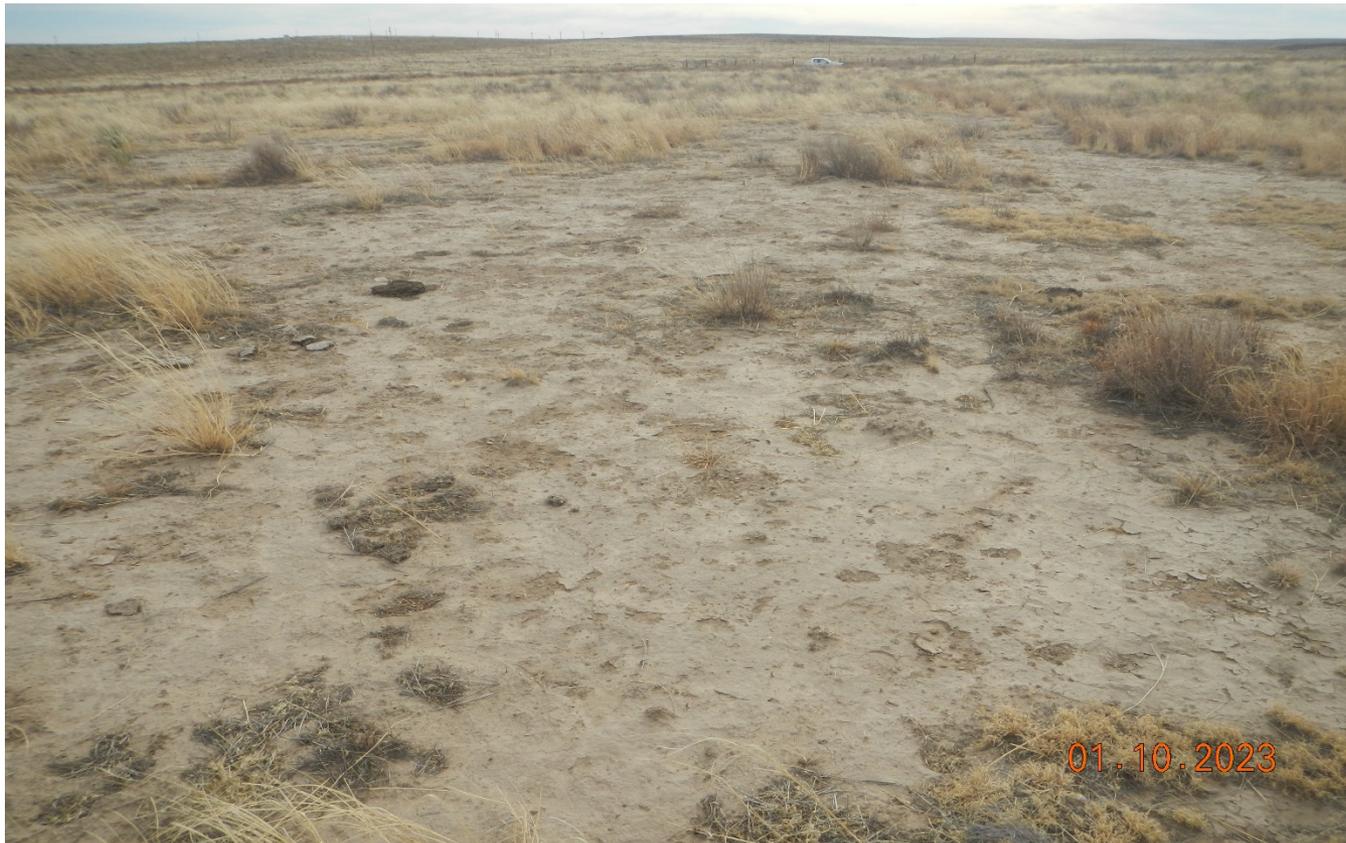
Photo 5. Facing south at the location. There are areas of sparse vegetation and soils seem to be compacted.

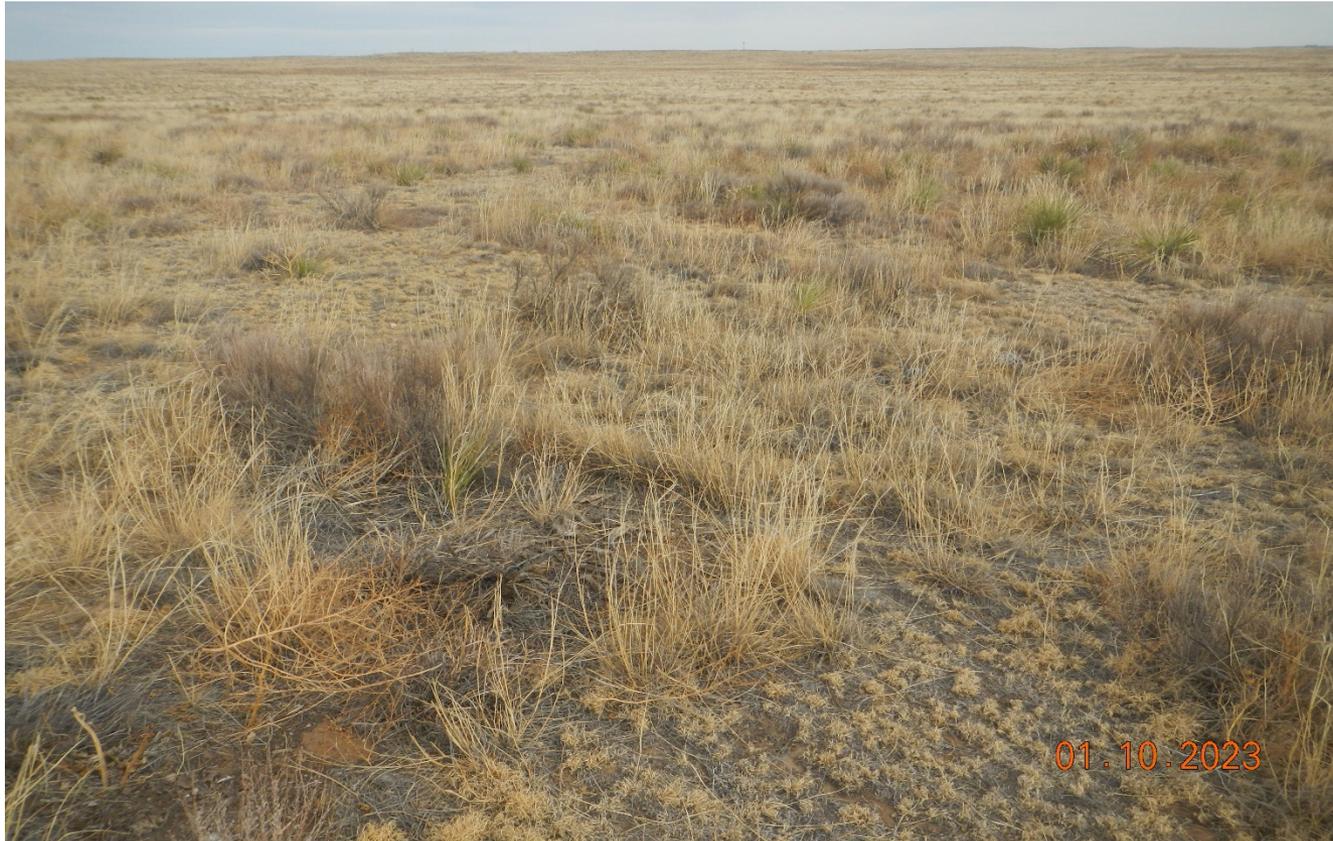
Photo 6. Facing east toward the surrounding undisturbed reference area.
