# Inspection Photos

API: 009-06454

Operator: INVESTMENT EQUIPMENT LLC

Inspection Date: 1/10/2023

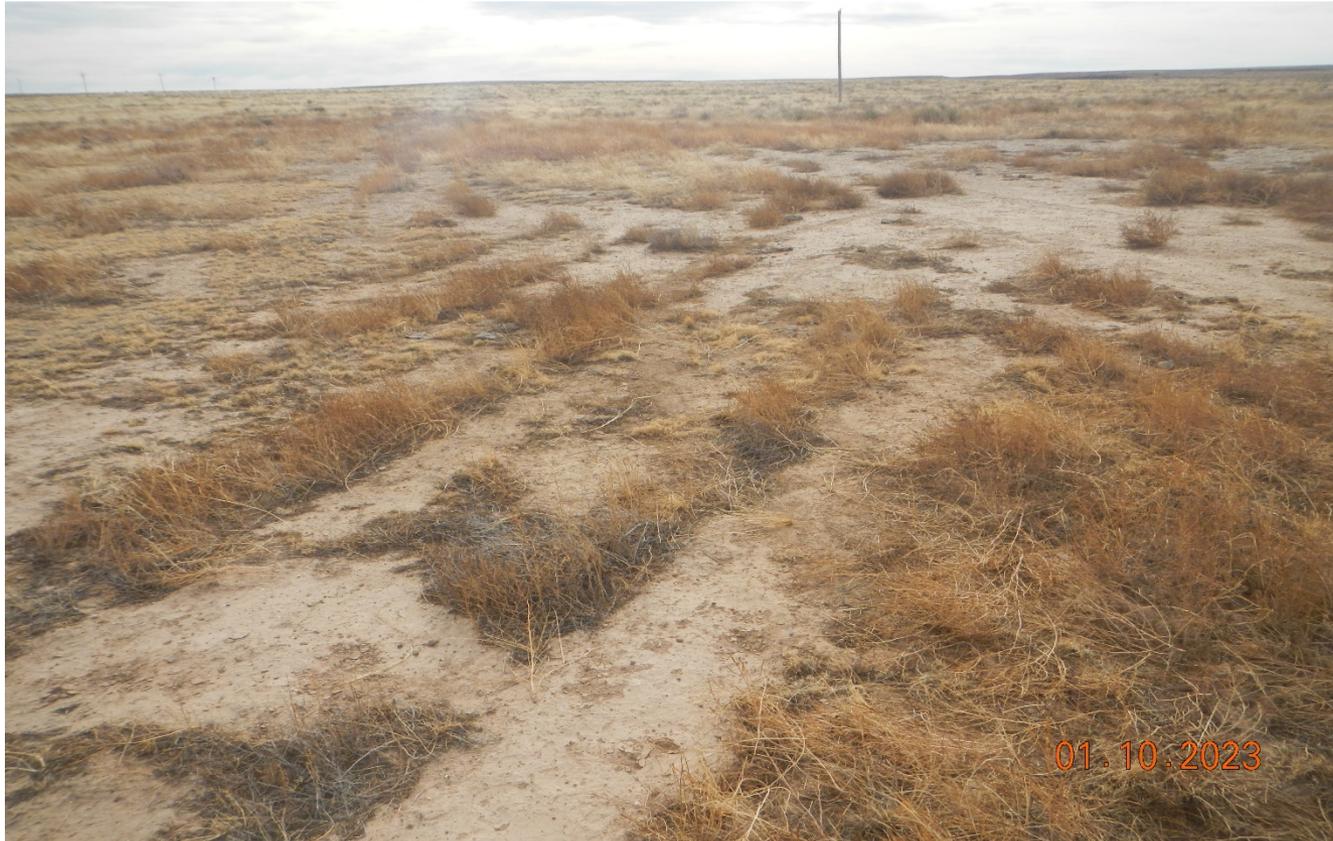
**Photo 1.** Facing southwest at the location. There are areas of sparse vegetation and soils are compacted.

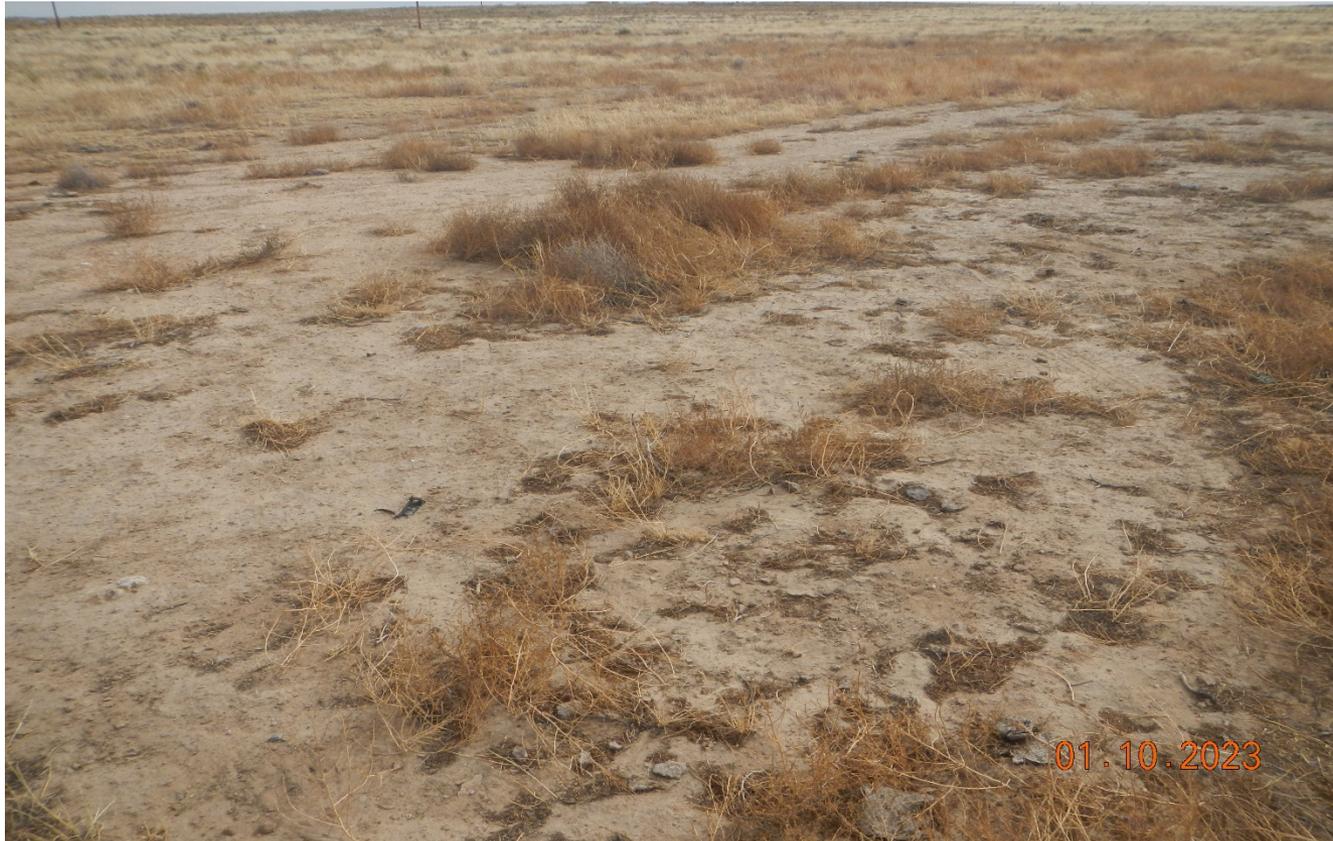
**Photo 2.** Facing southeast at the location. There are areas of sparse vegetation and soils are compacted.

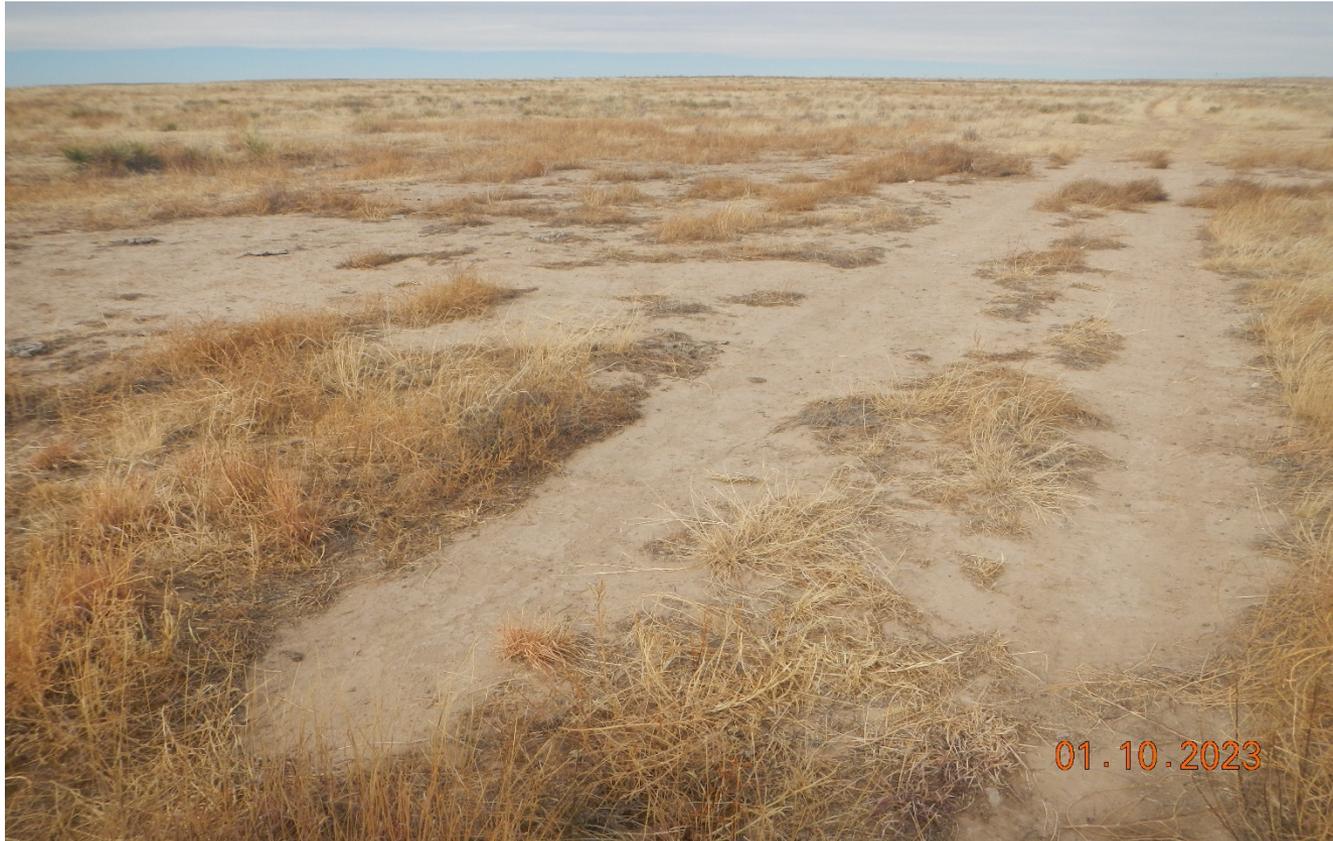
**Photo 3.** Facing back to the northwest at the location. There are areas of sparse vegetation and soils are compacted.

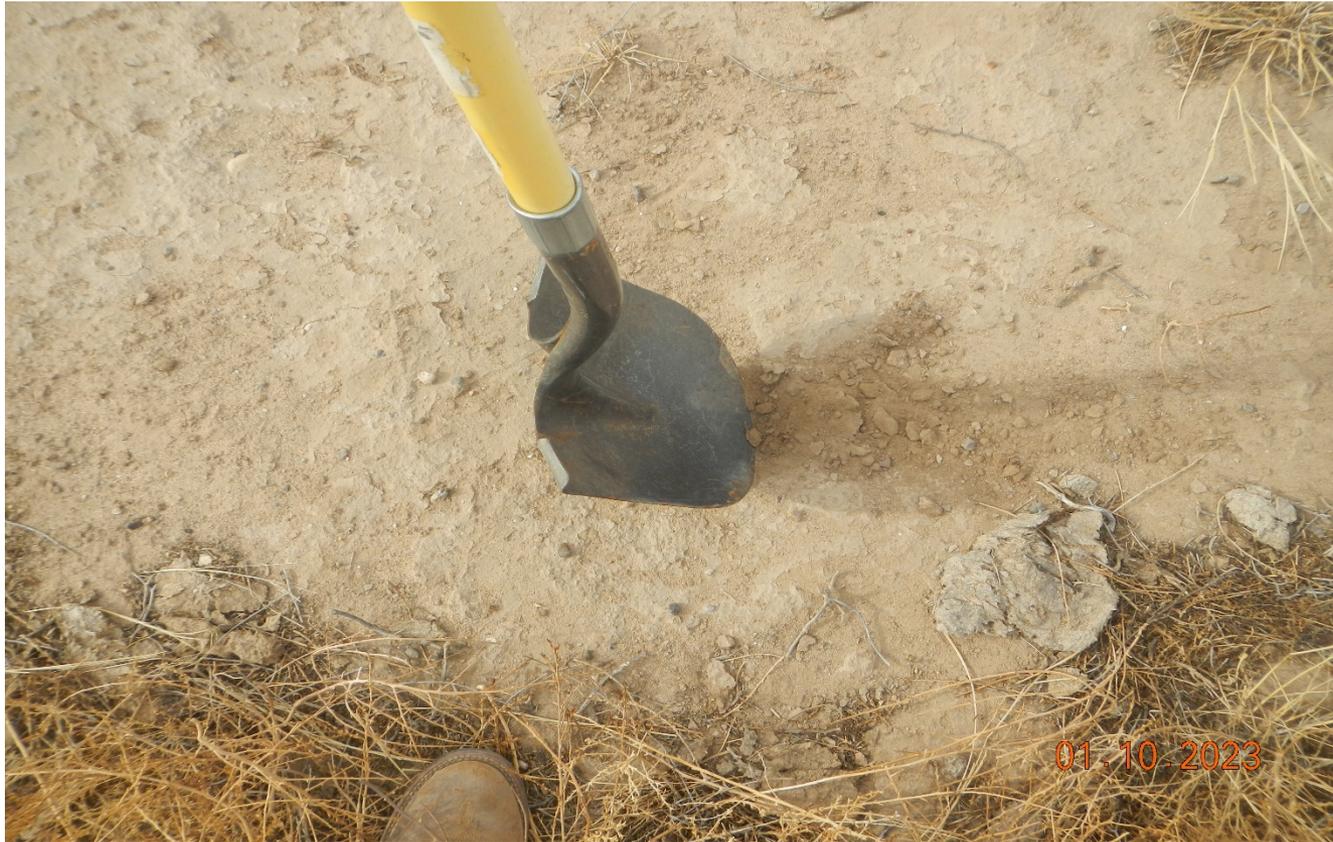
**Photo 4.** The soils were not decompacted. The shovel shown in the photo could not penetrate the soil surface.

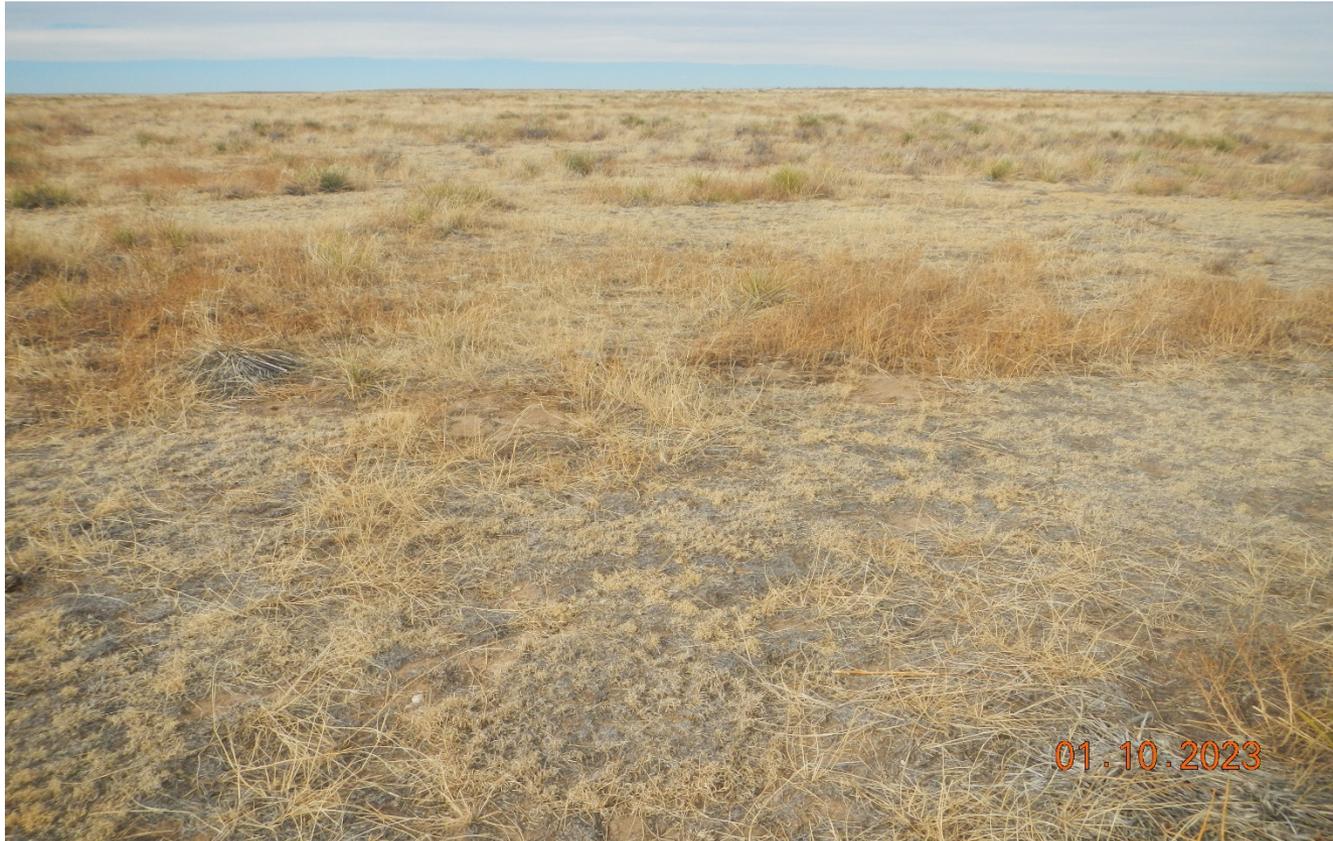
**Photo 5.** Facing northwest toward the surrounding undisturbed reference area.
