Inspection Photos

API: 009-06458

Operator: INVESTMENT EQUIPMENT LLC

Inspection Date: 1/10/2023

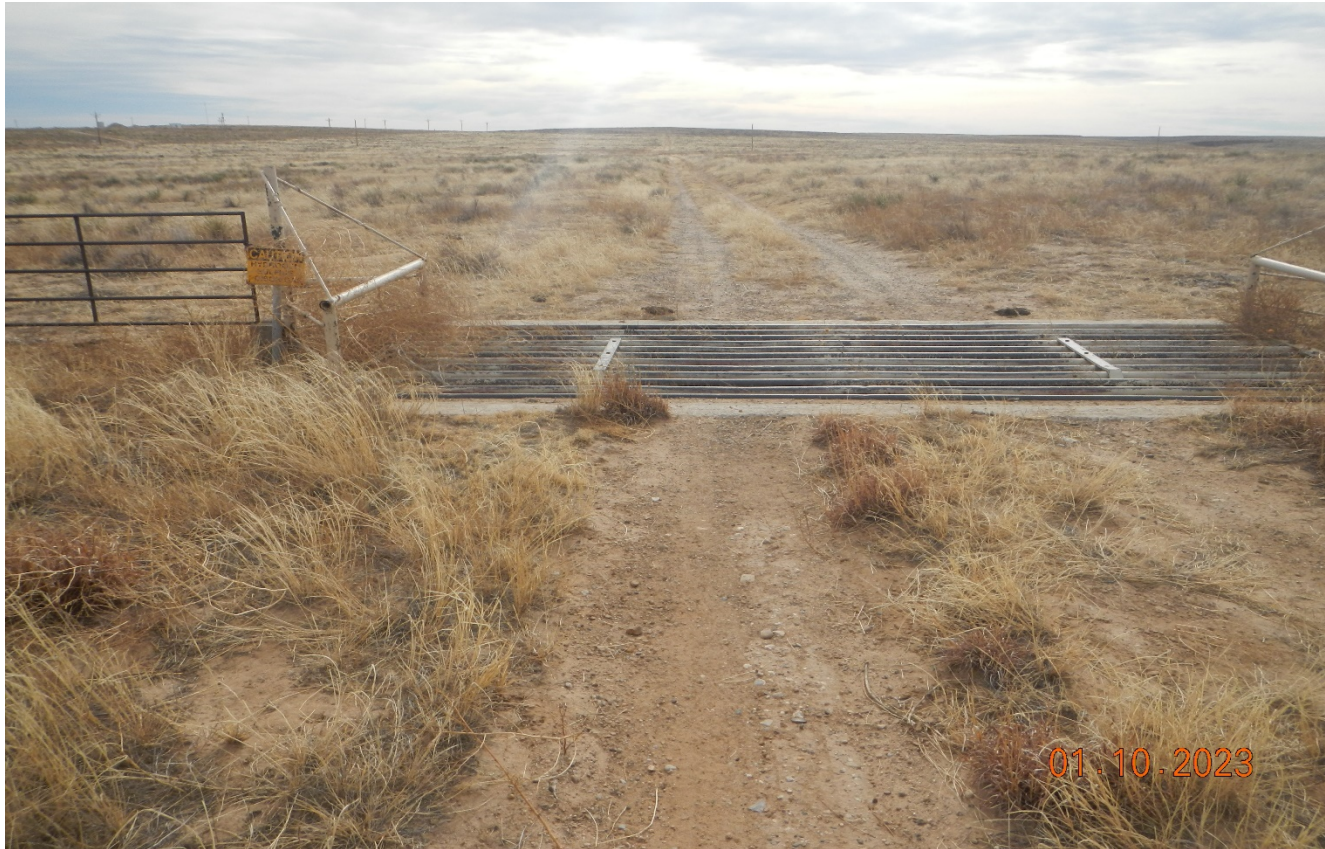
Photo 1. Facing south at the beginning of the access road. The cattle guard has not been removed and the road is not reclaimed.

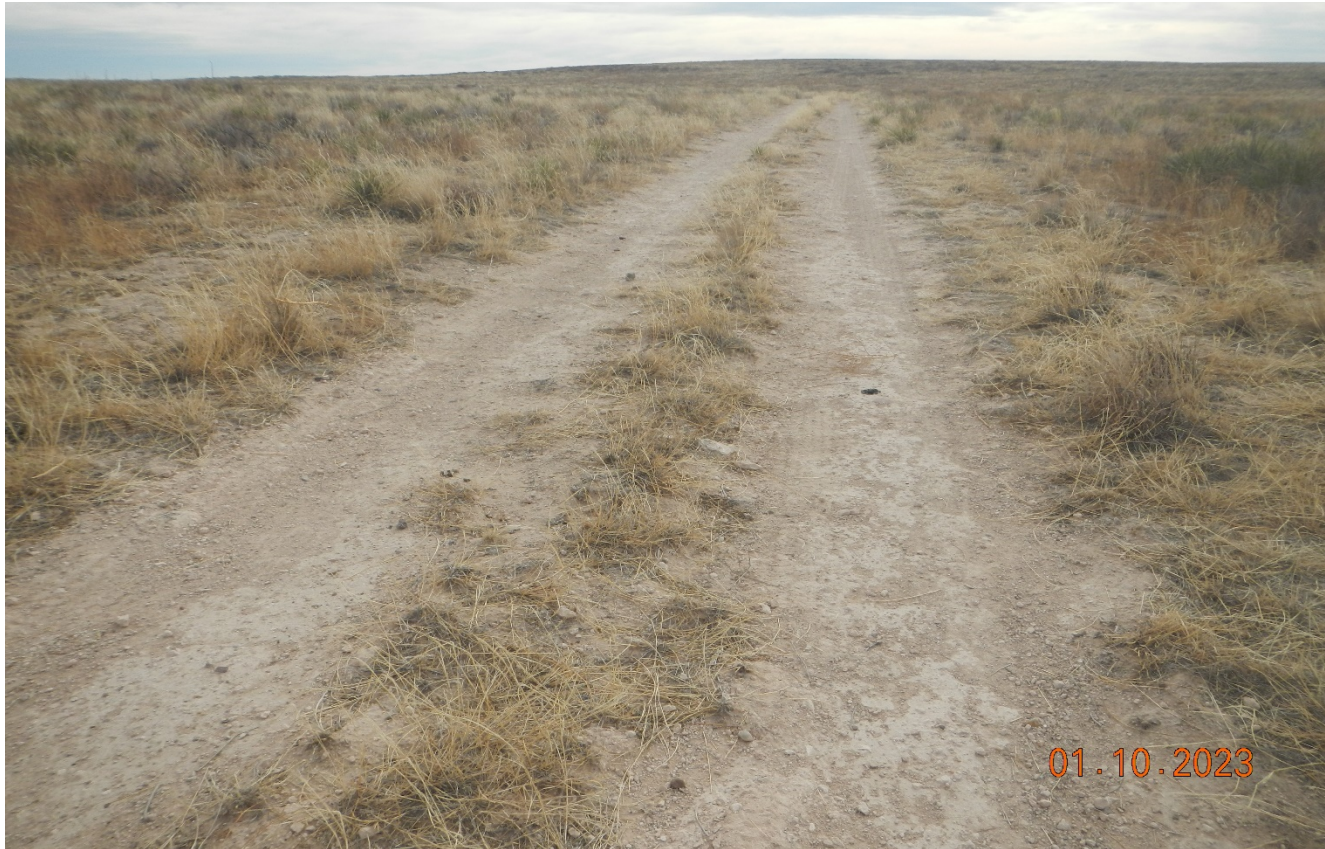
Photo 2. Facing south further along the access road which has not been reclaimed.

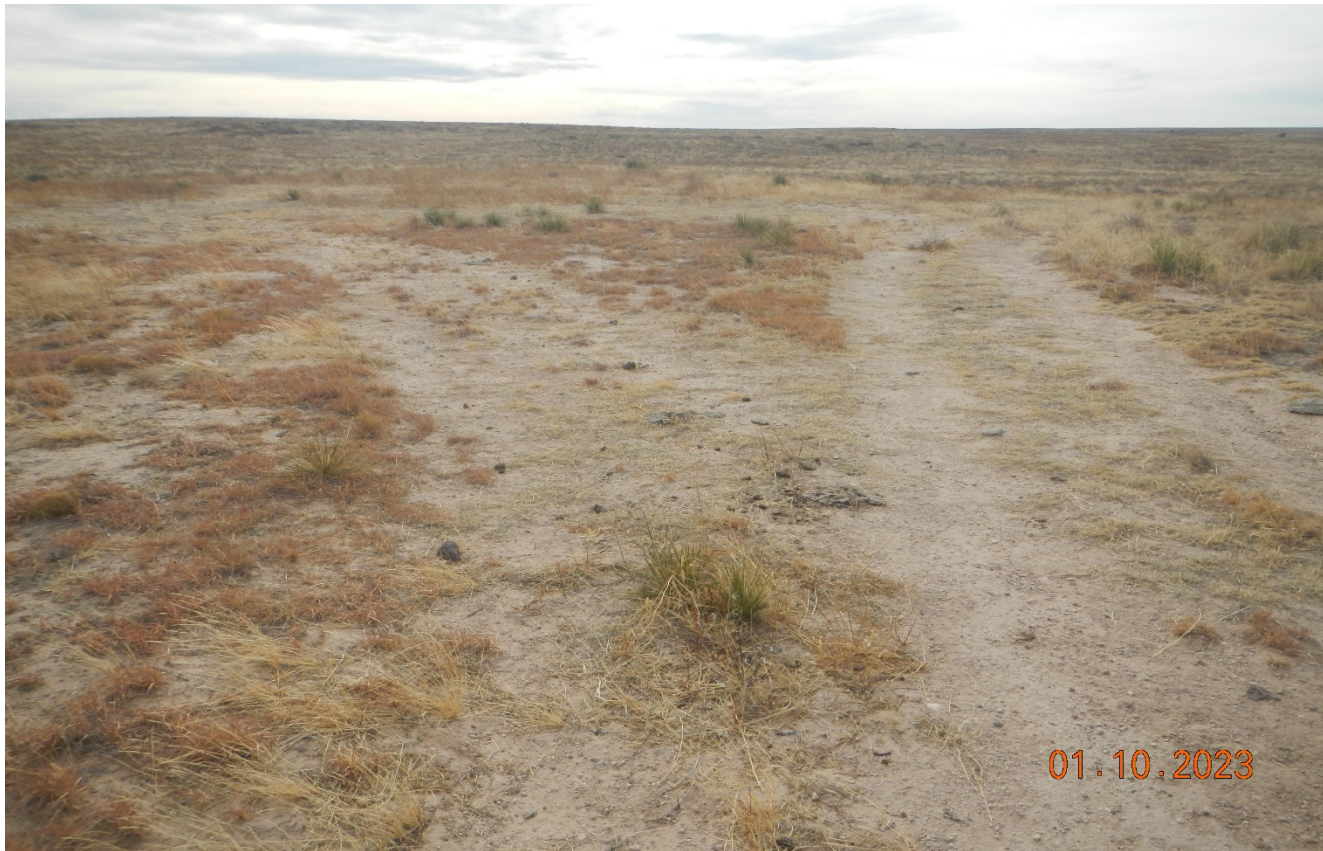
Photo 3. Facing southwest toward the location. There is compacted soil where the two track road remains.

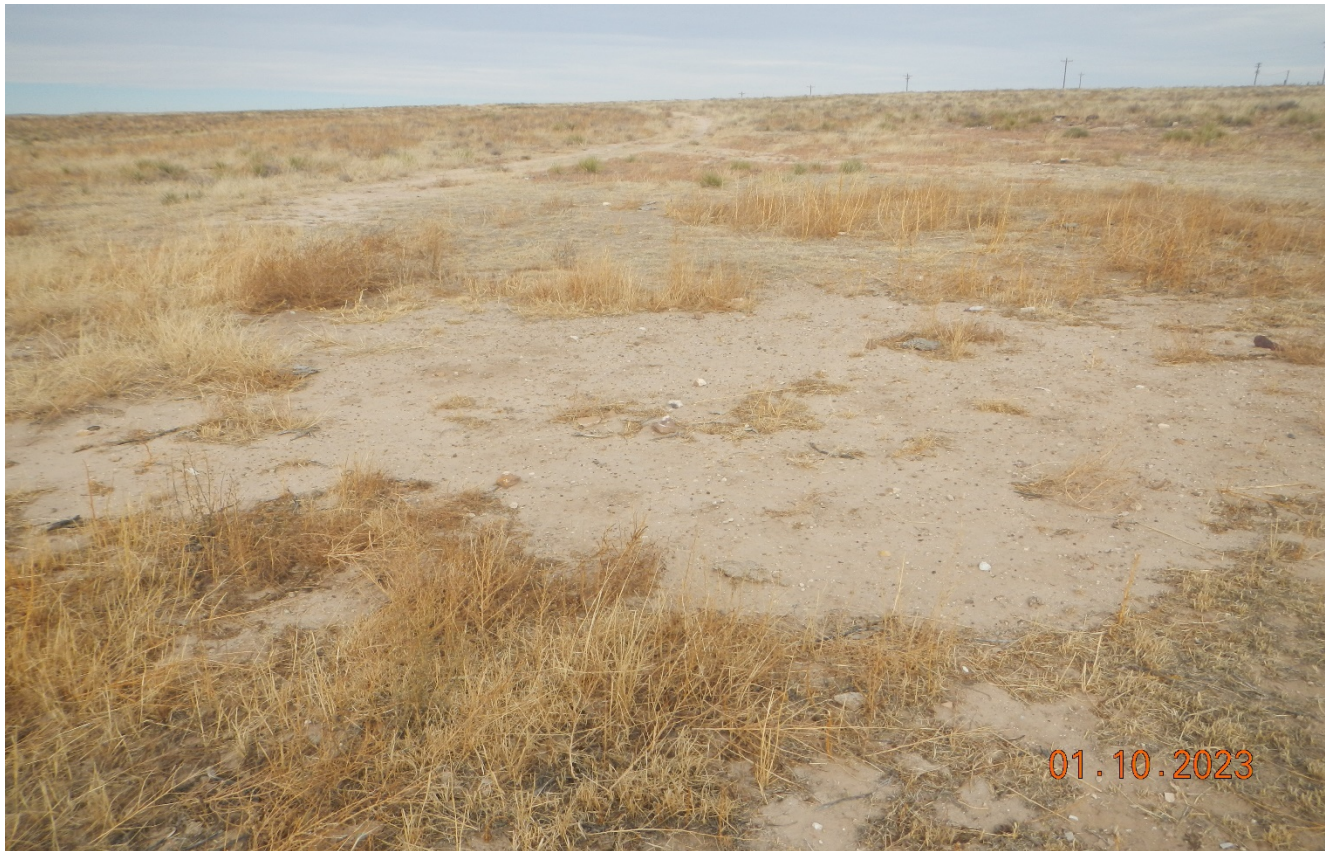
Photo 4. Facing north at the location. This area approx. 15x15ft. Where the well was located has not re-established vegetation.

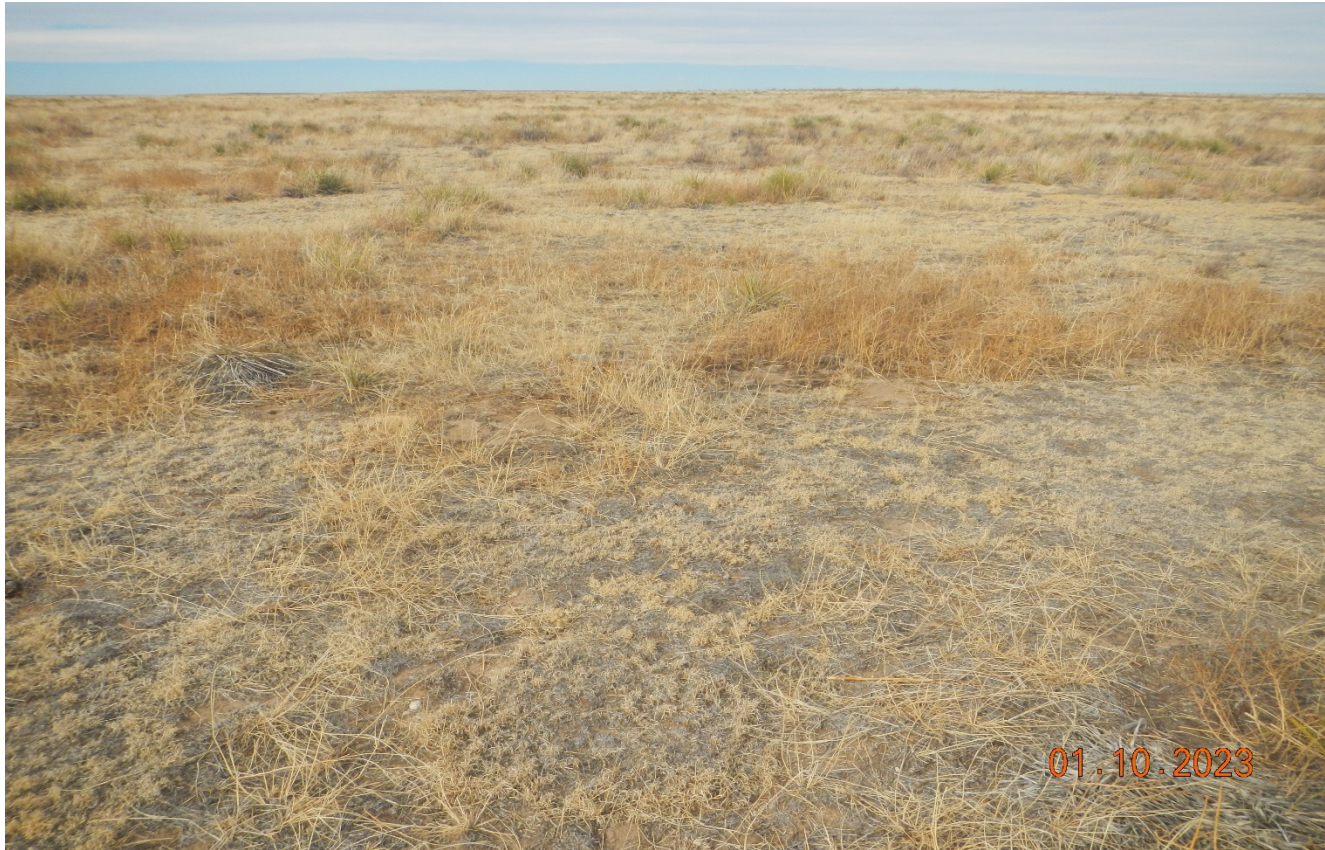
Photo 5. Facing northwest toward the surrounding undisturbed reference area.
