Final Reclamation and Stormwater Inspection

Operator: ST CROIX OPERATING INC - 81490

Location ID: 482780

Inspection Document #: 696105675

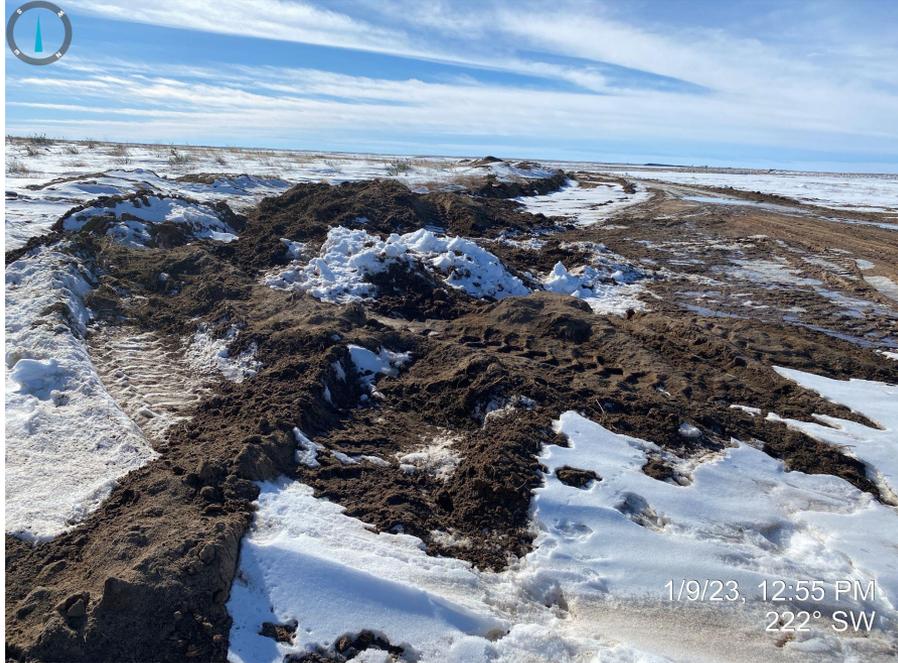
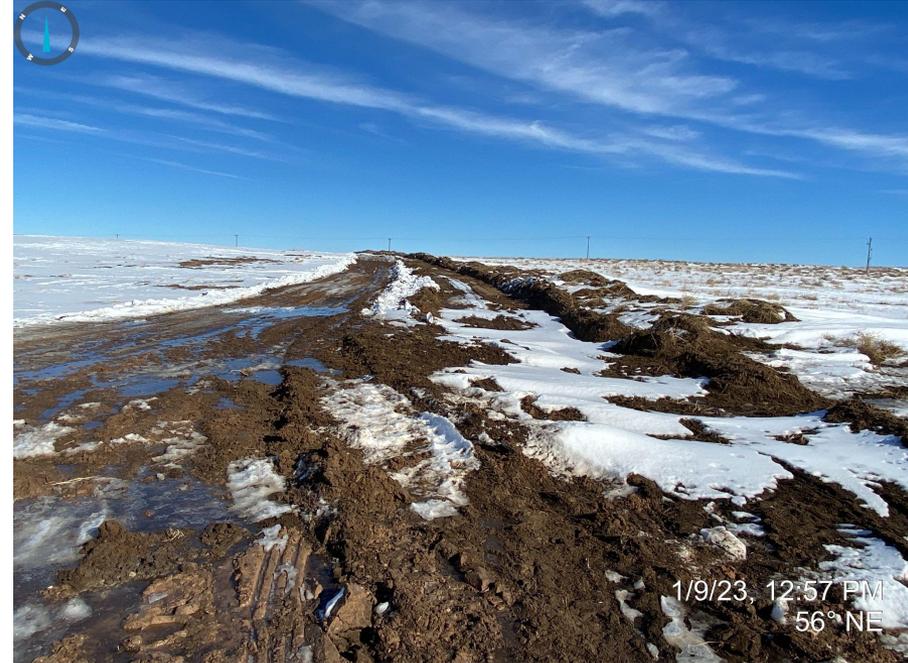
Photos 1 & 2. Facing southwest (photo 1) from the entrance to the location and northeast (photo 2) from the north end of the location. Photos illustrate that topsoil stockpiles are susceptible to wind and water erosion as they're comprised of unconsolidated material that is not stabilized.

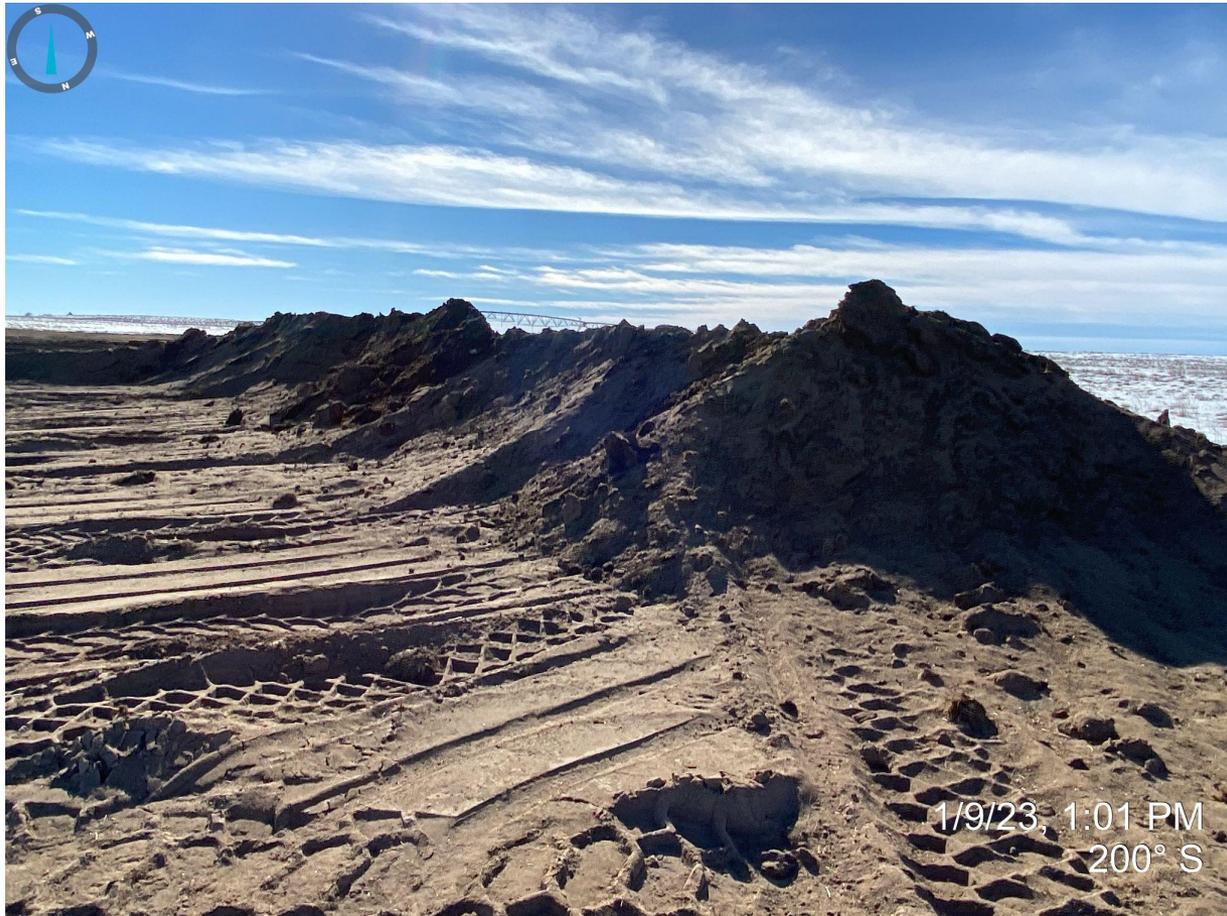
Photo 3. Facing south near one of the topsoil stockpiles on the west end of the location. Photo illustrates this stockpile has not been stabilized with no evidence of temporary equipment tracking and unconsolidated material present. Tires tracks are from a loader grabbing soil from the stockpile and is not considered a temporary BMP.

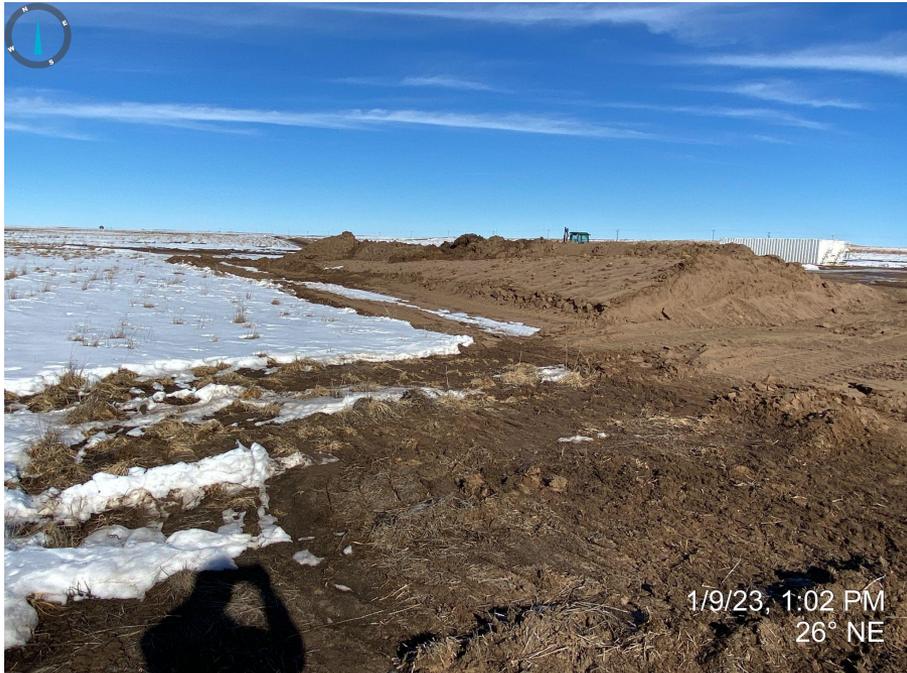
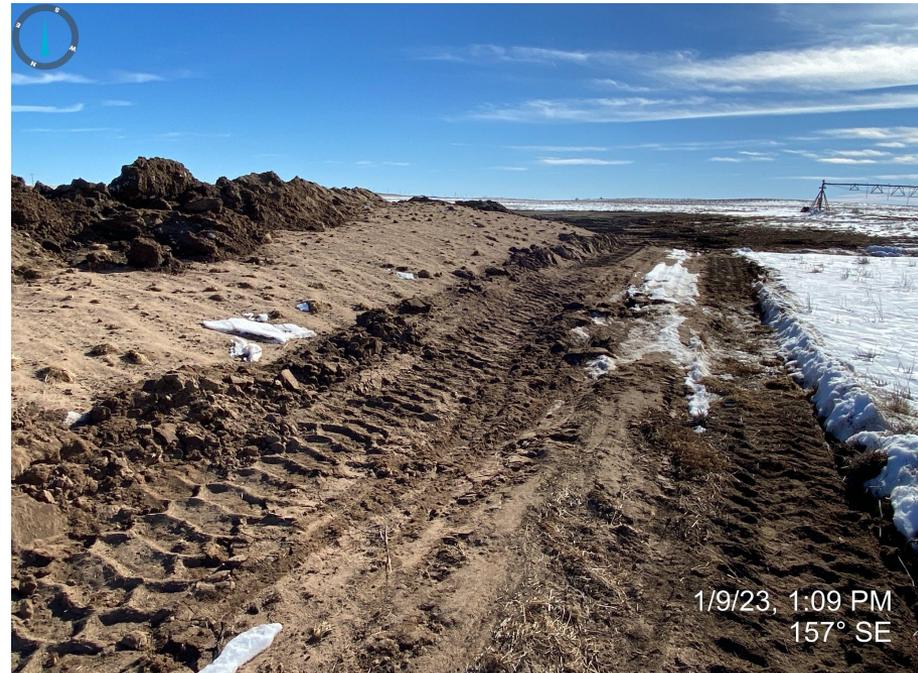
Photos 4 & 5. Facing northeast and southeast from the western topsoil stockpile. See comments in Photo 3. Photos also illustrate no evidence of any stormwater BMP in place to prevent sediment laden stormwater from exiting off location.

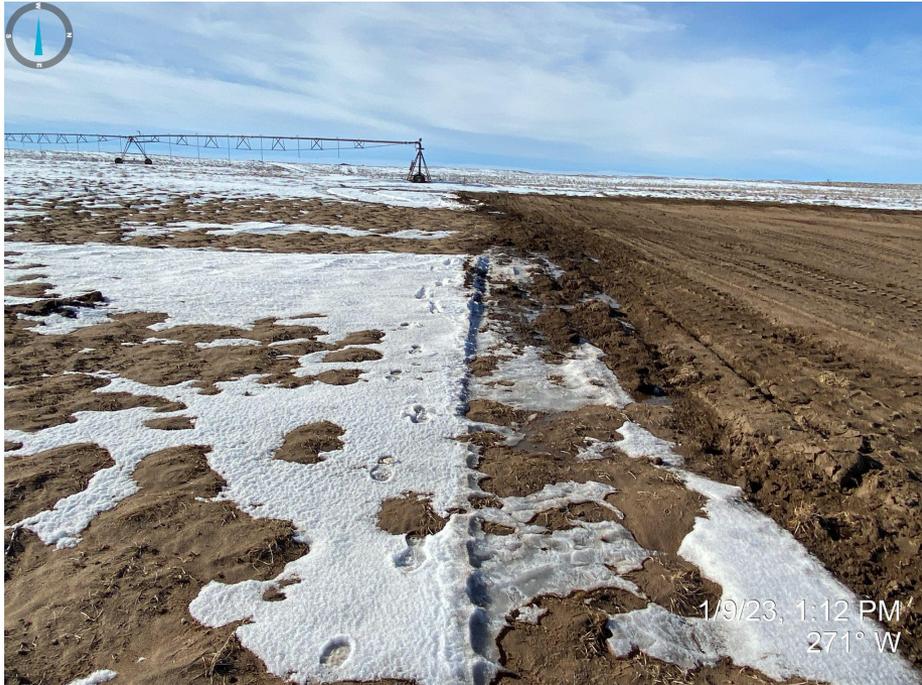
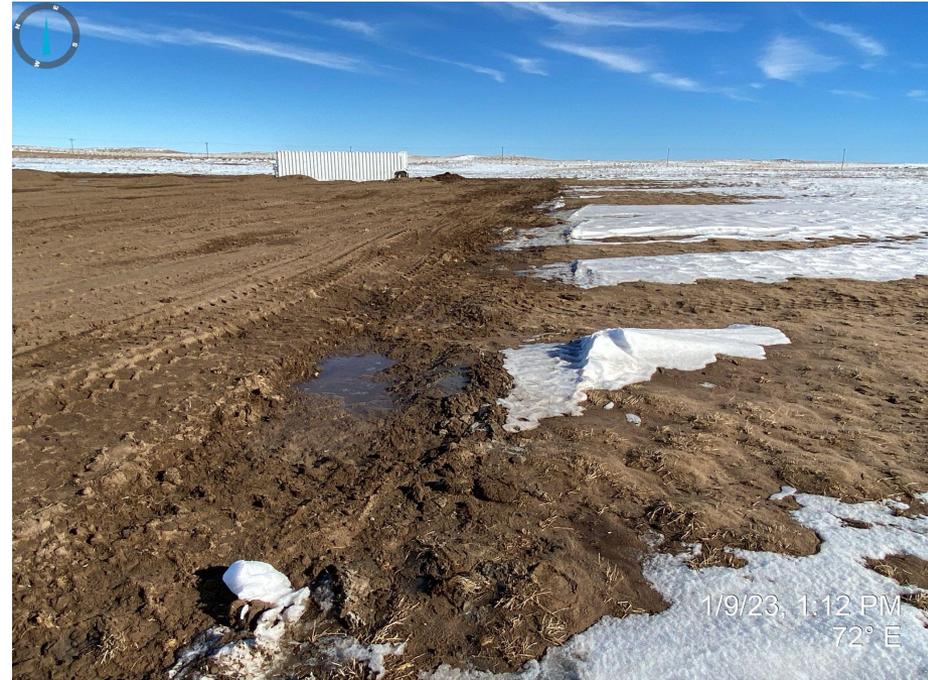
Photos 6 & 7. Facing west and east from the southern portion of the location. Photo illustrates no stormwater control BMPs installed to prevent sediment laden stormwater from exiting off location. Also pictured, this southwest portion of the location was in-process of having the topsoil moved back to its relative position and does not have any controls or BMPs to prevent wind and water erosion.

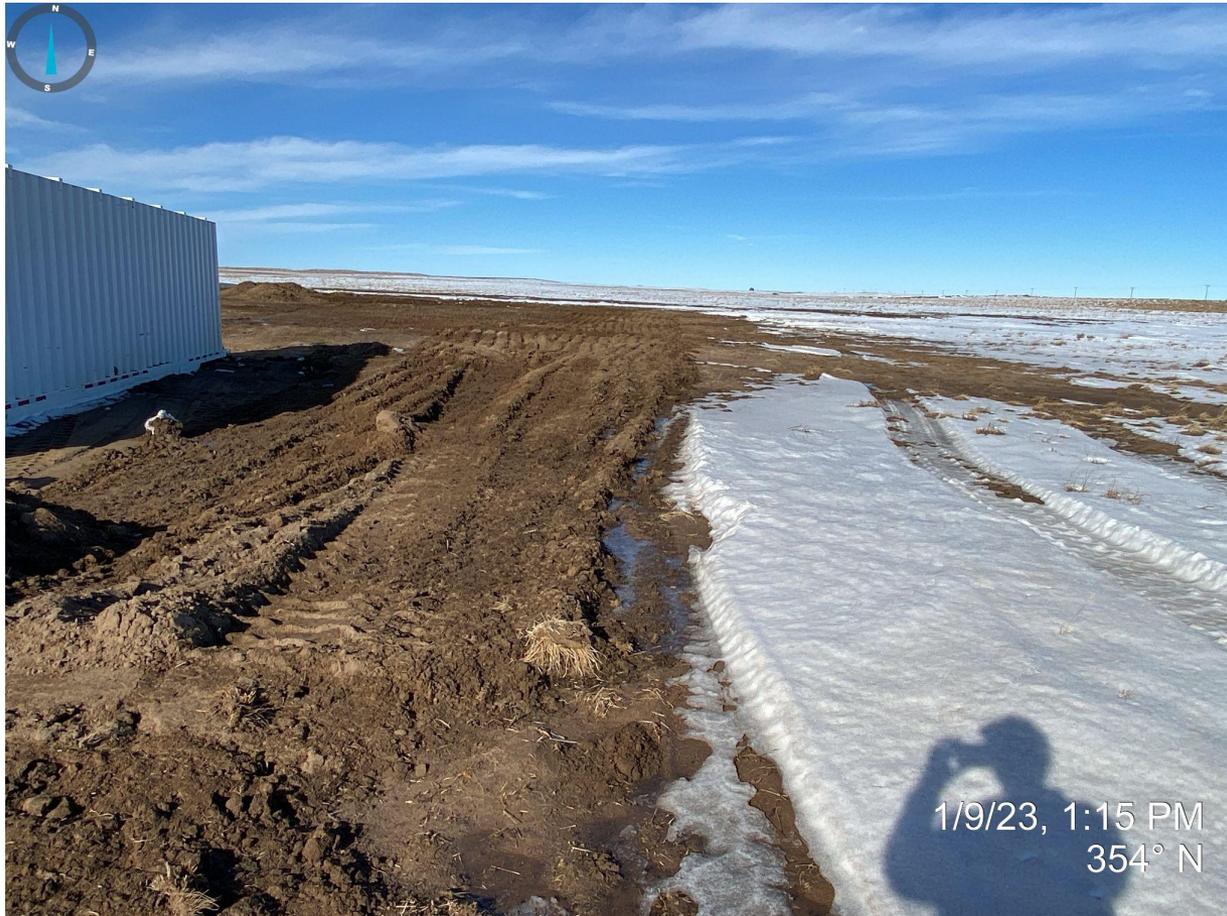
Photo 8. Facing north from the southeast corner of the location. Photo illustrates no stormwater controls/BMPs are installed to prevent sediment laden stormwater from exiting off location. This is the downslope/gradient side of the location. Stormwater controls should be implemented and installed until final reclamation has been achieved.

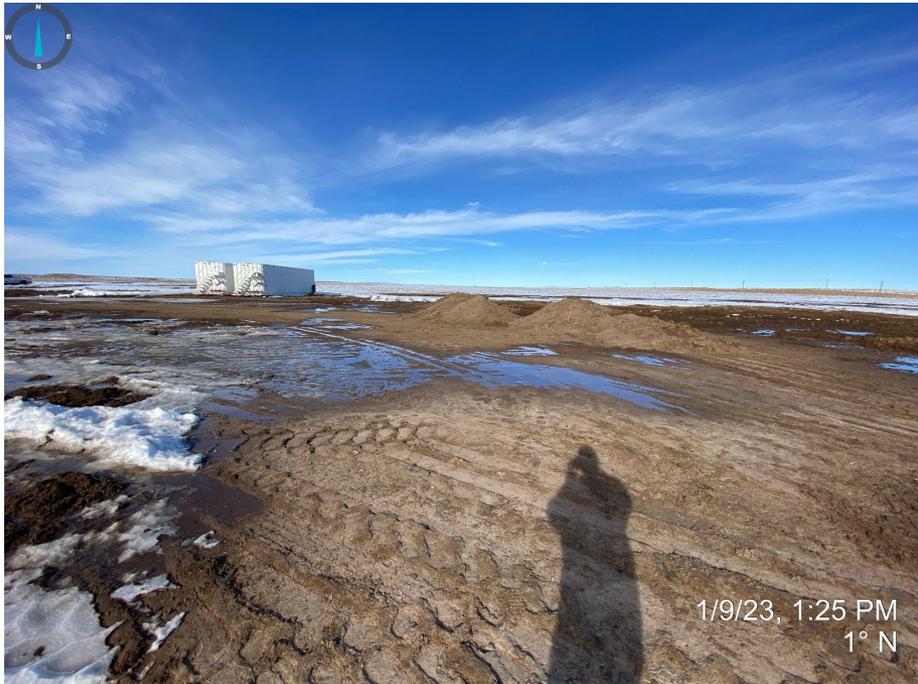
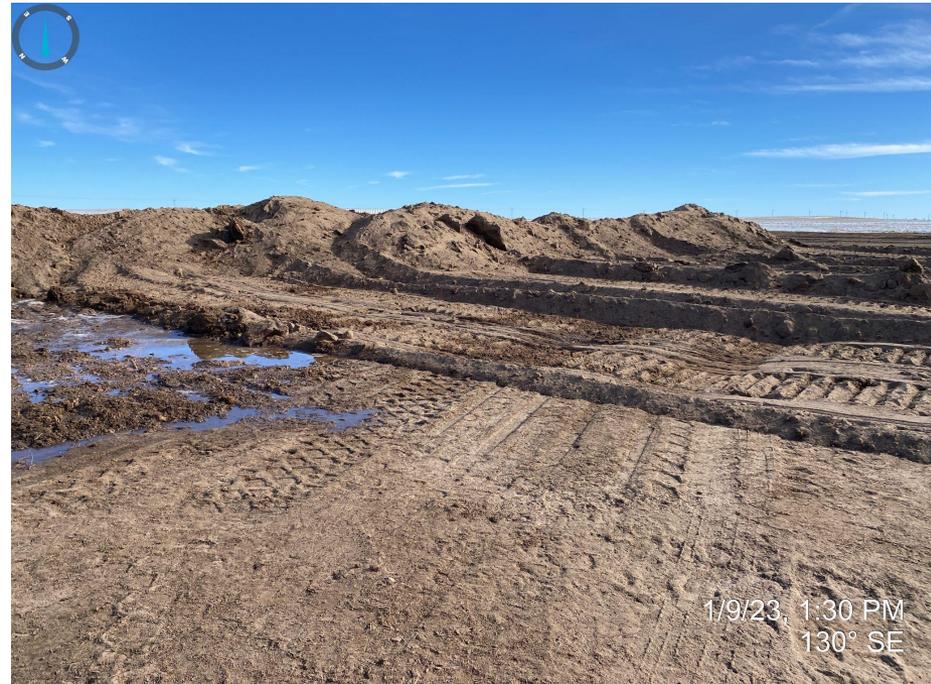
Photos 9 & 10. Facing north and southeast from the center portion of the location. Photos illustrate soil stockpiles not labeled or segregated with corresponding soil layers/horizons and without any protections from wind and water erosion (e.g. no temporary stabilization implemented).

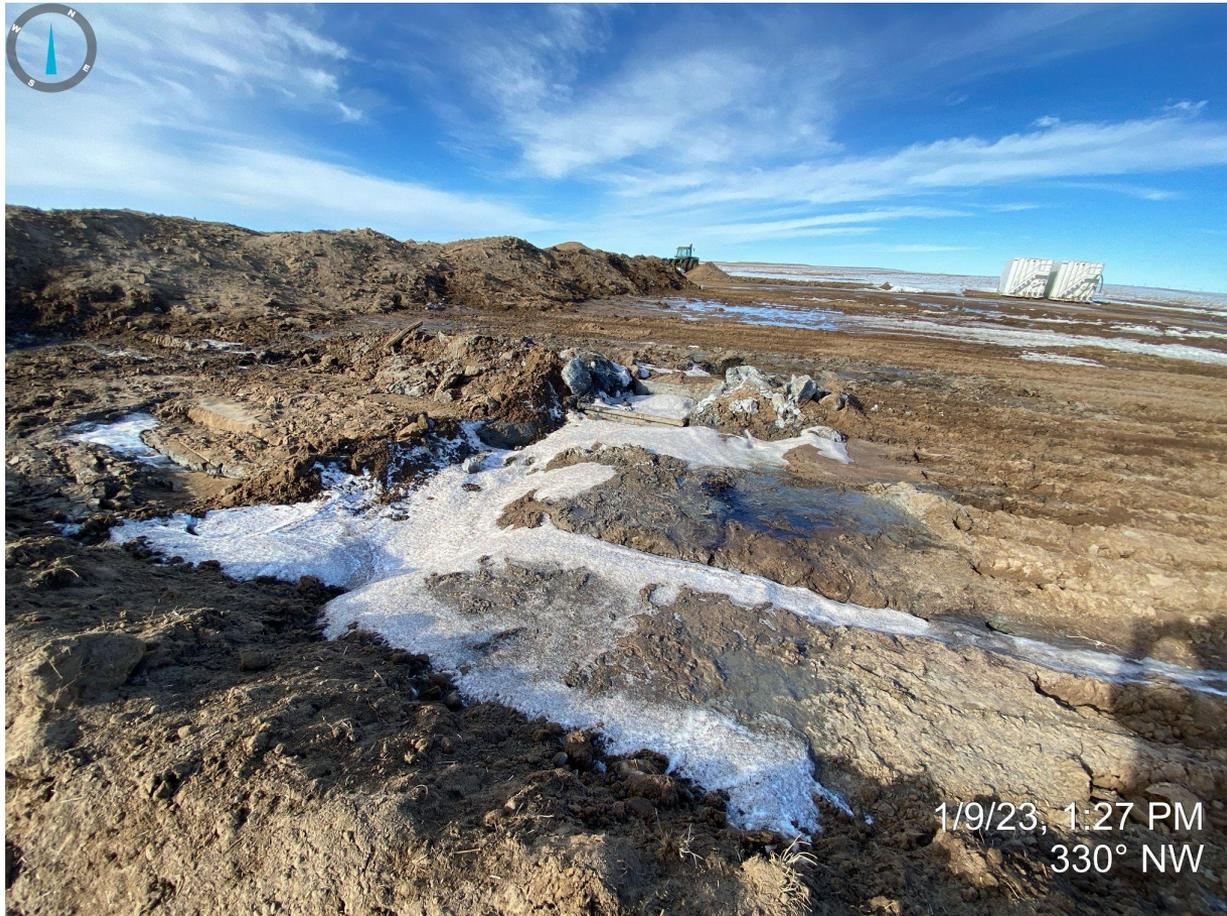
Photo 11. Taken near the center portion of the location. Photo illustrates DA/PA well. Concrete debris will need to be removed prior to final reclamation activities.

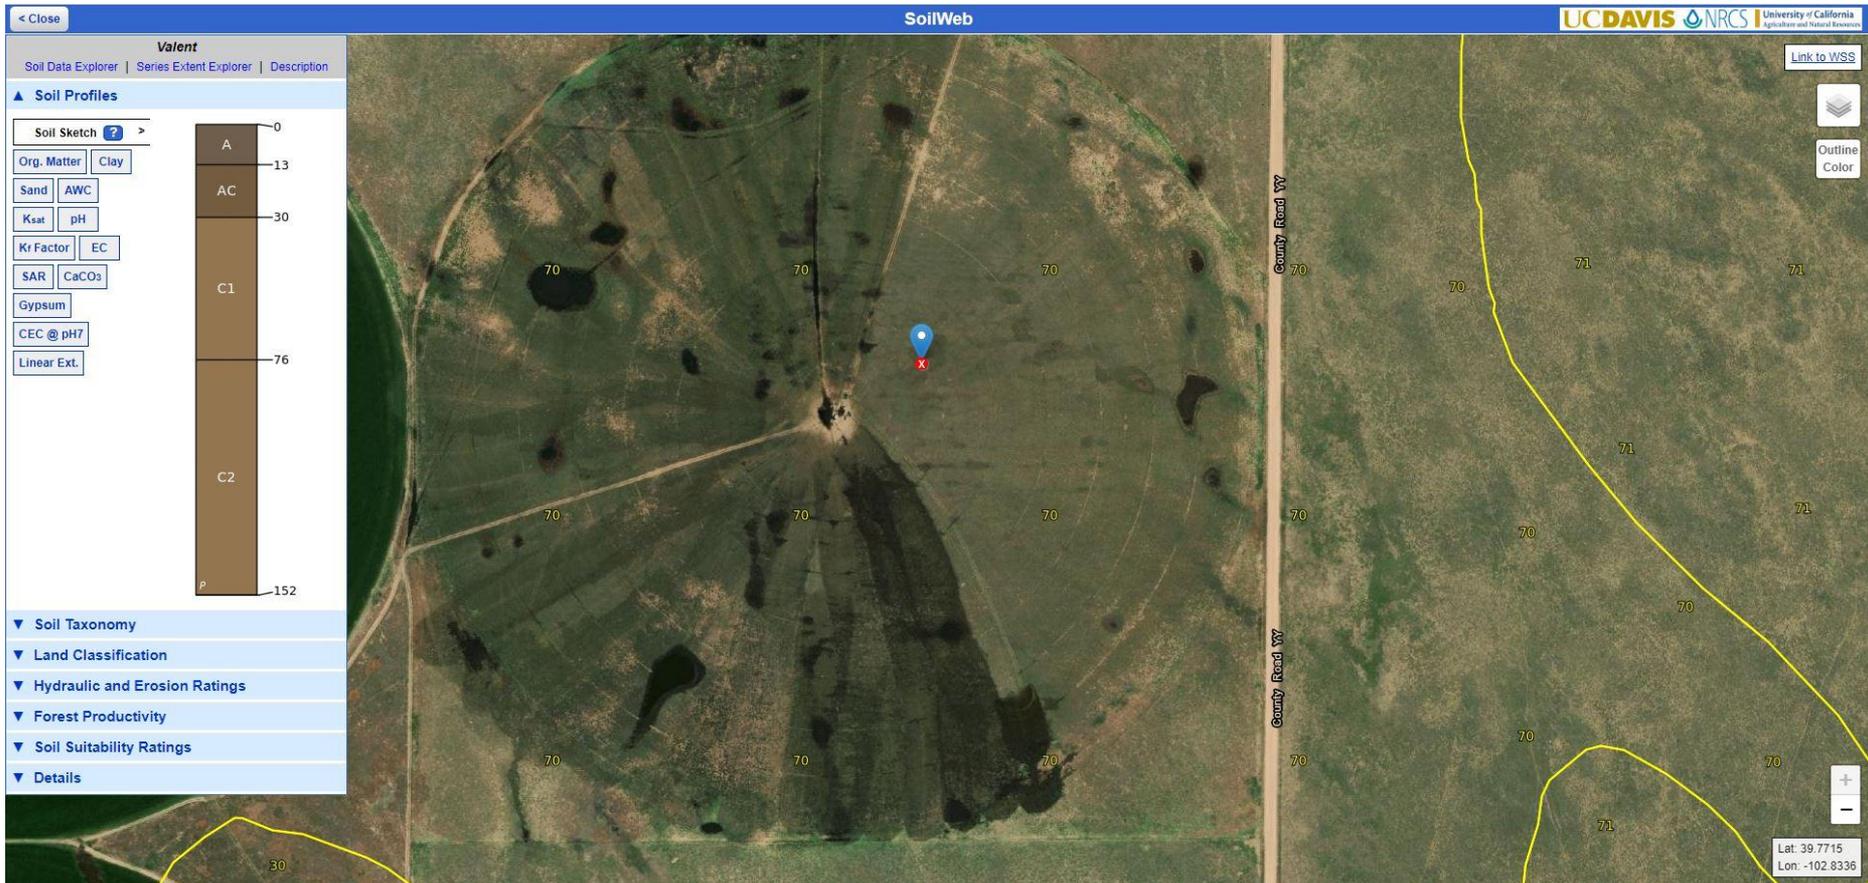
Photo 12. Screen shot from UC Davis Soil Web with the approximate well location plotted as red X/blue marker. Photo illustrates that the Soil Type 70- Valent Sand, A and AC horizon (e.g. topsoil), is approximately 30cm or ~12in. The operator stated that 3,148 cubic yards of topsoil would salvaged from the construction area which equates to approximately 4in of topsoil removed (see next photo). See inspection report for further detail.
