# Construction and Stormwater Inspection

Date: 01/13/2023

Operator: ST CROIX OPERATING INC - 696105679

Location ID: 474453

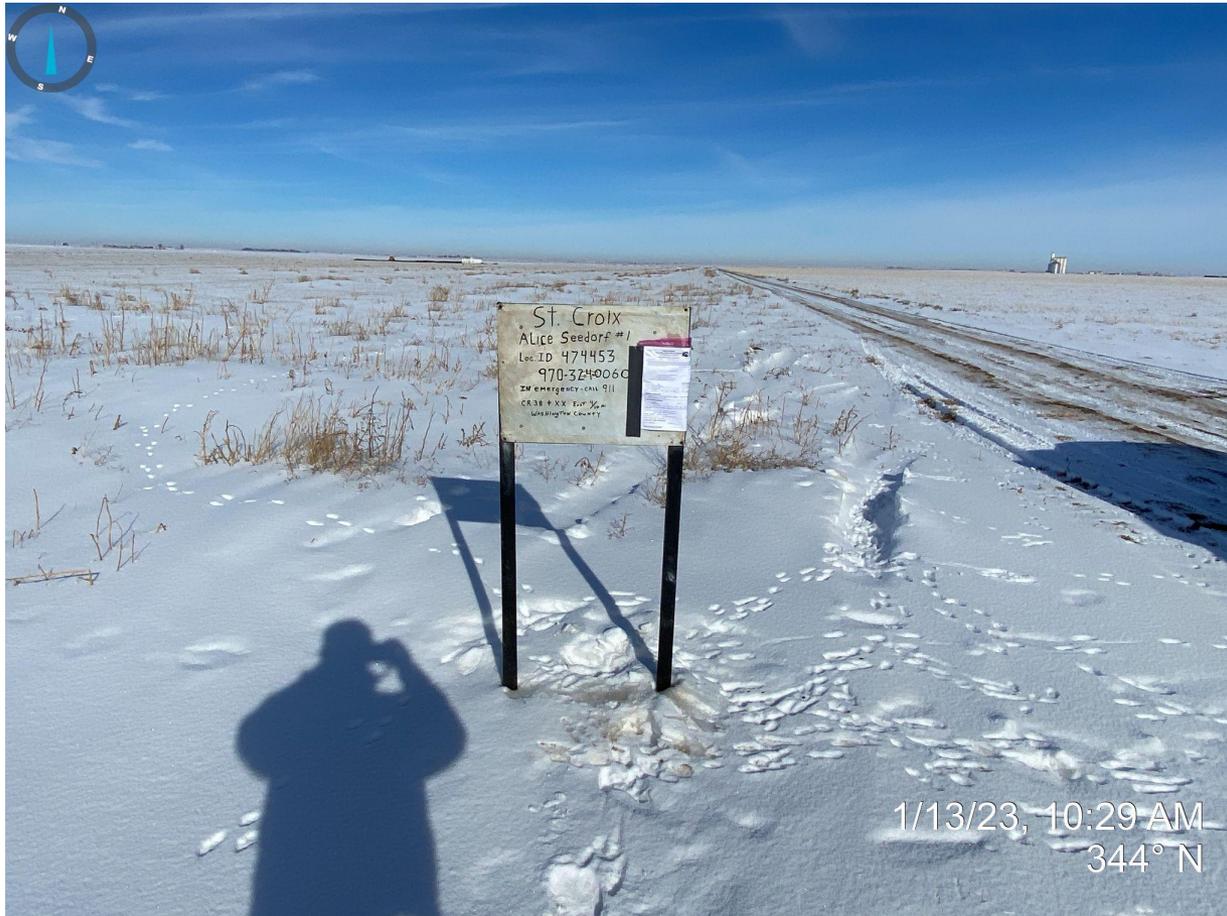
**Photo 1.** Facing north from the location's entrance. Operator resolved previous corrective actions by installing the location sign and attaching their approved Form 2A.

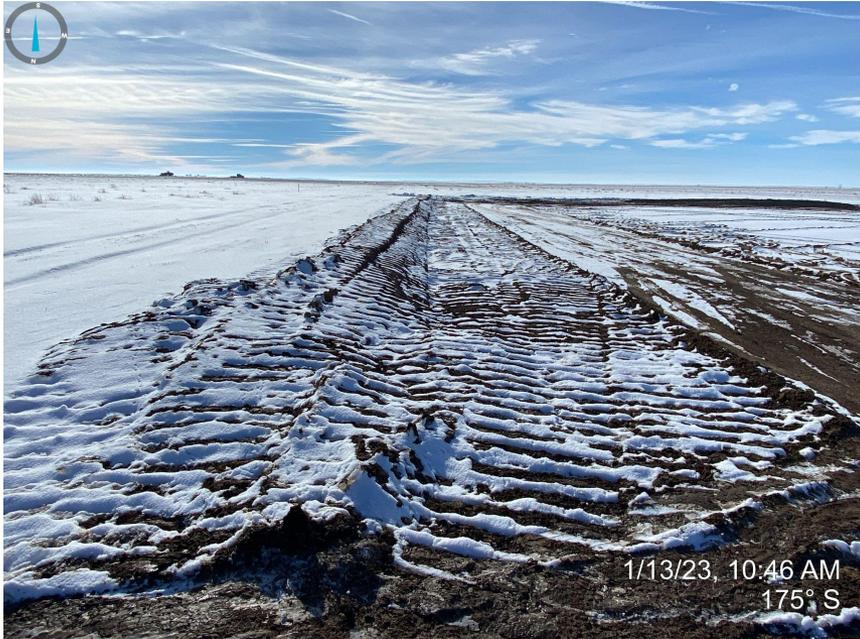
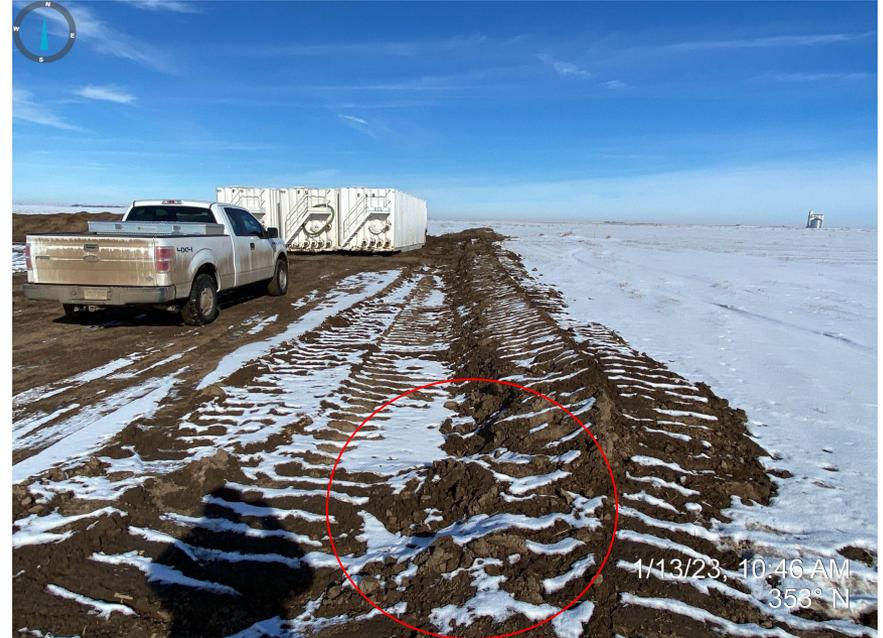
**Photos 2 & 3.** Taken from the entrance of the location, facing south and north. Photos illustrate that a perimeter ditch and berm has been installed and has been temporarily stabilized with equipment tracking. Some areas of the ditch and berm are comprised of unconsolidated material and are susceptible to wind and water erosion, outlined in red. See other photos for additional examples.

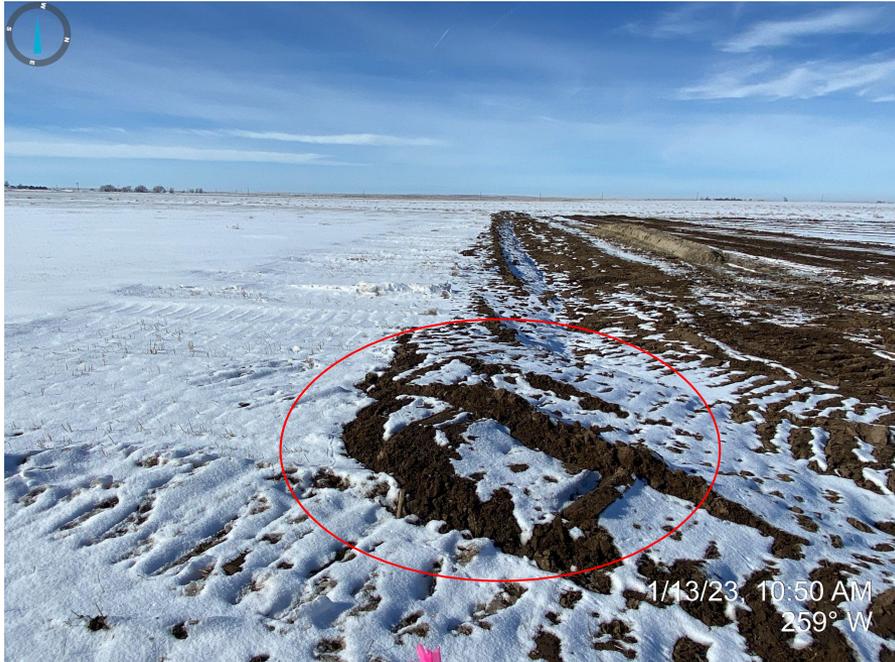
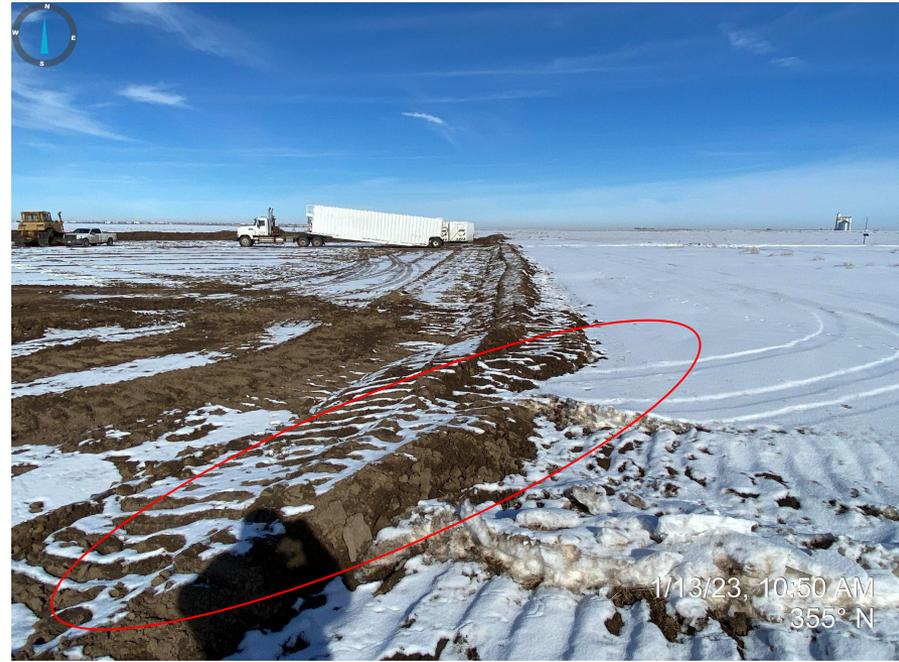
**Photos 4 & 5.** Facing west and north from the southeast corner of the location. See comments in Photos 2 & 3.

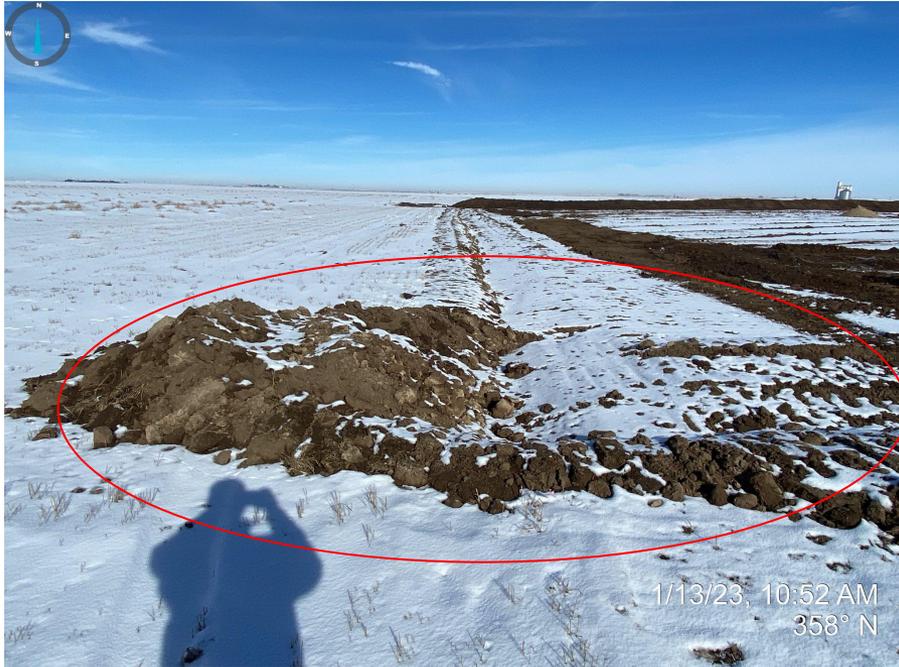
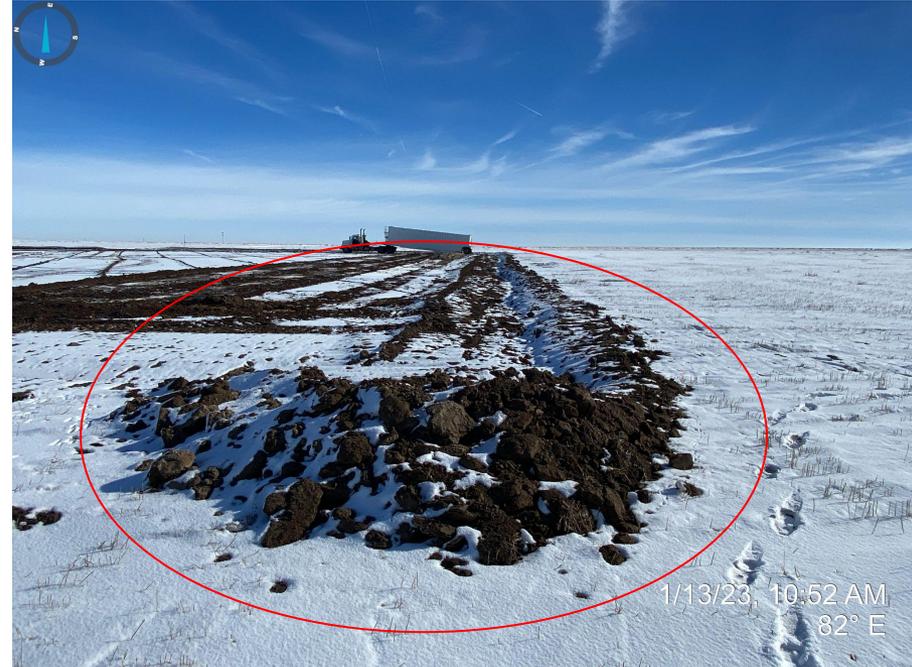
**Photos 6 & 7.** Facing north and east from the southwest corner of the location. See comments in Photos 2 & 3.

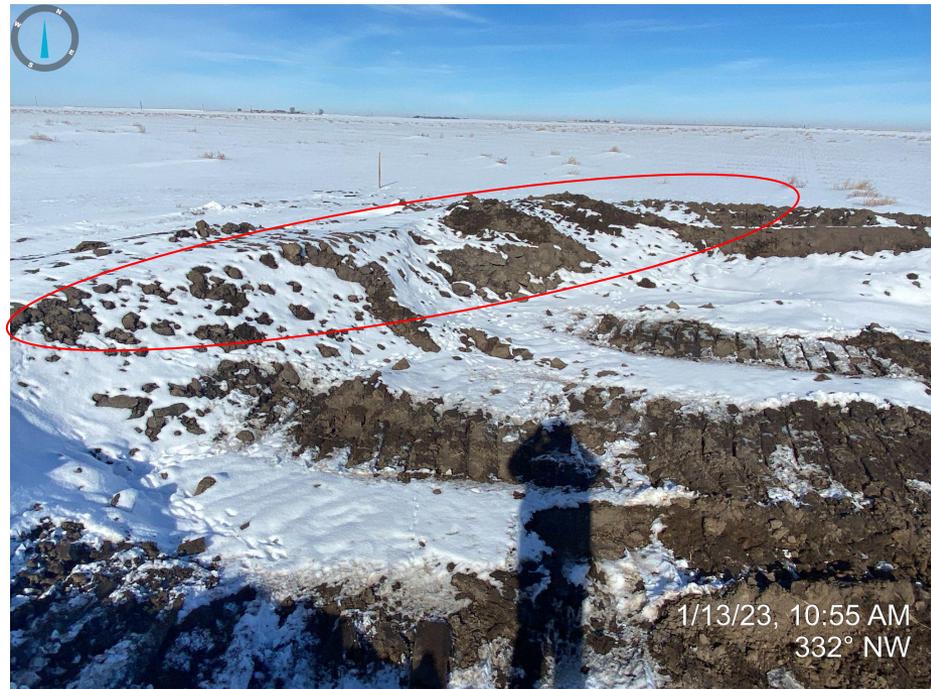
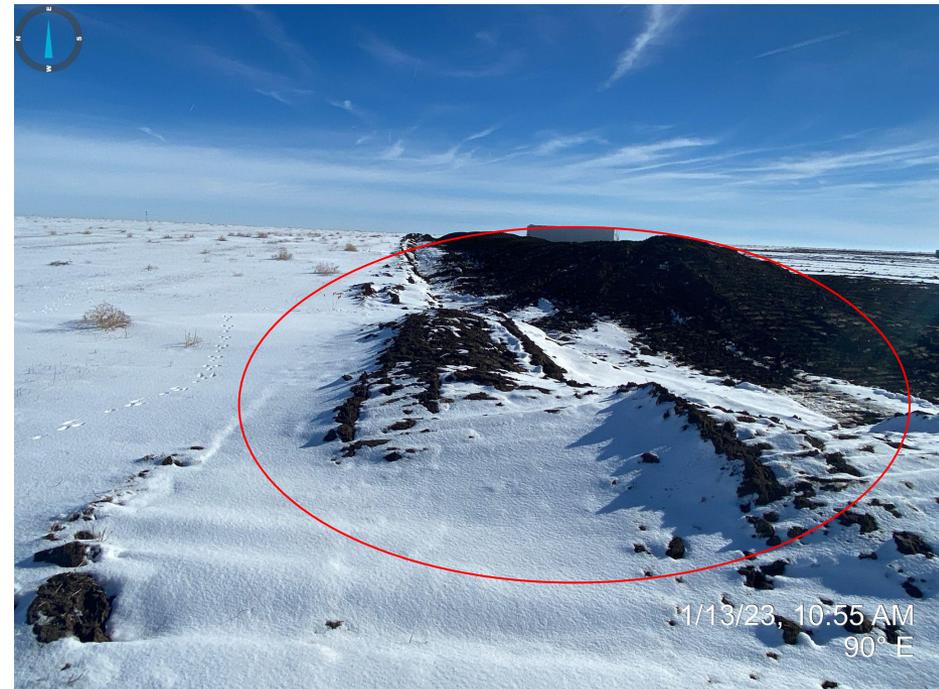
**Photos 8 & 9.** Facing northwest and east from the northwest corner of the location. Photos 8 and 9 illustrates that the sediment trap is comprised of unconsolidated material and is not properly stabilized, examples outlined in red. This is not a properly installed stormwater BMP.

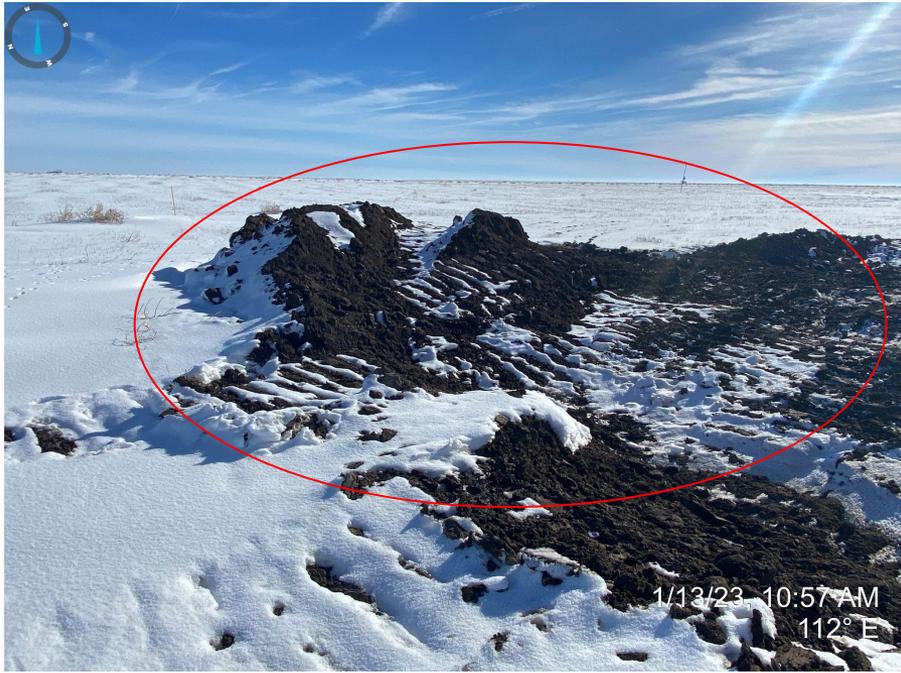
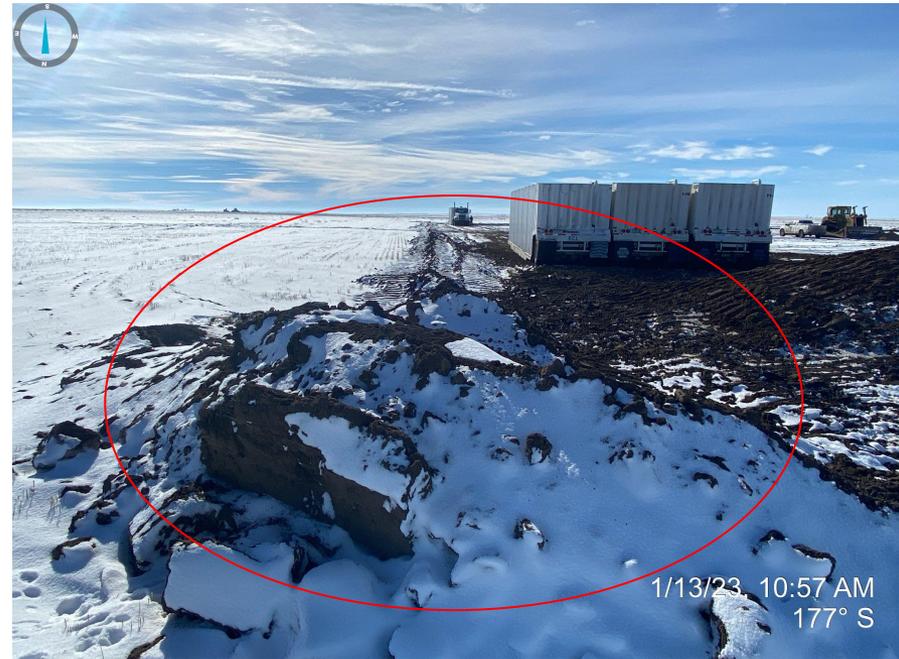
**Photos 10 & 11.** Facing east and south from the northeast corner of the location. See comments in Photos 2 & 3.

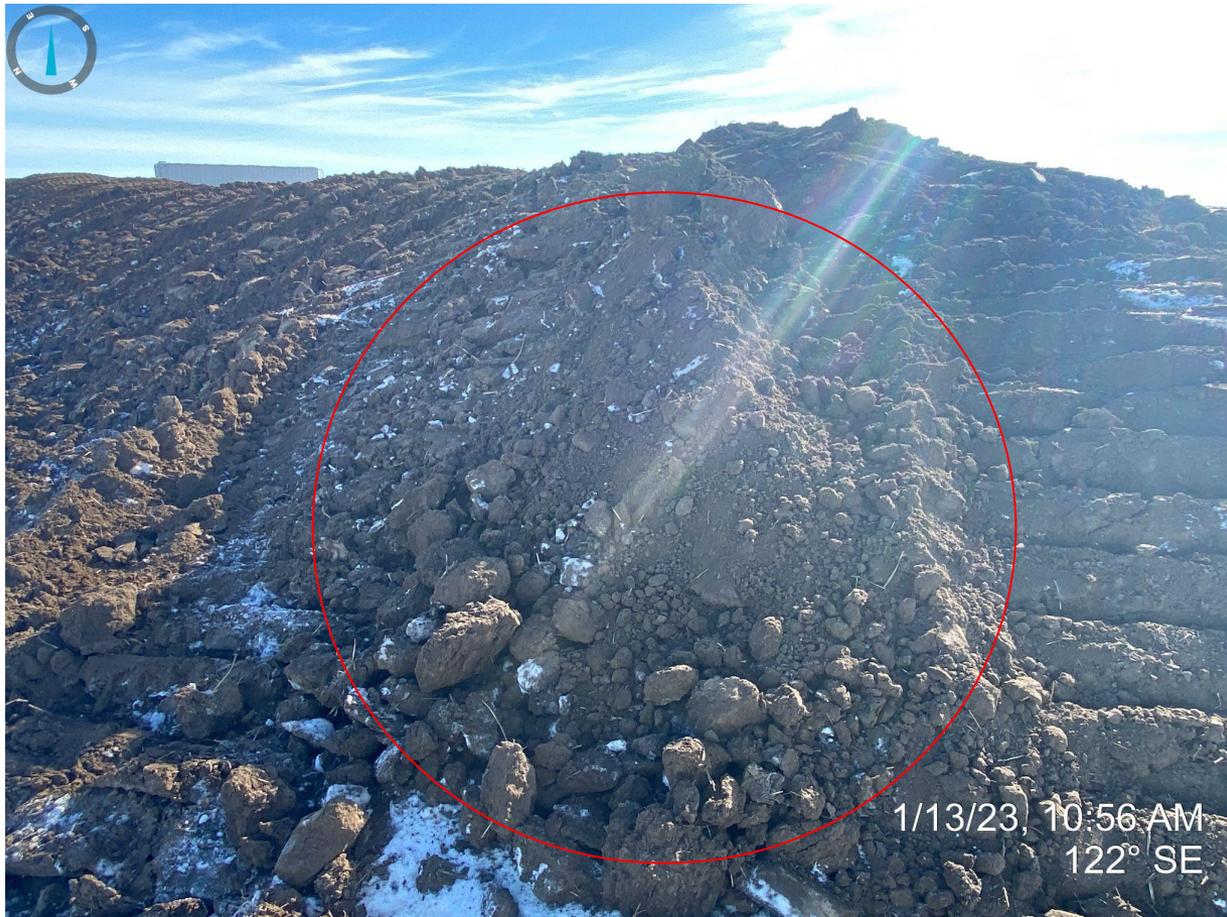
**Photo 12.** Facing southeast and the western end of the topsoil stockpile. Photo illustrates that portions of the stockpile has not been temporarily stabilized as unconsolidated material is evident. As the operator is required to salvage the remaining topsoil still on location, this stockpile will need to be re-stabilized to prevent wind and water erosion.

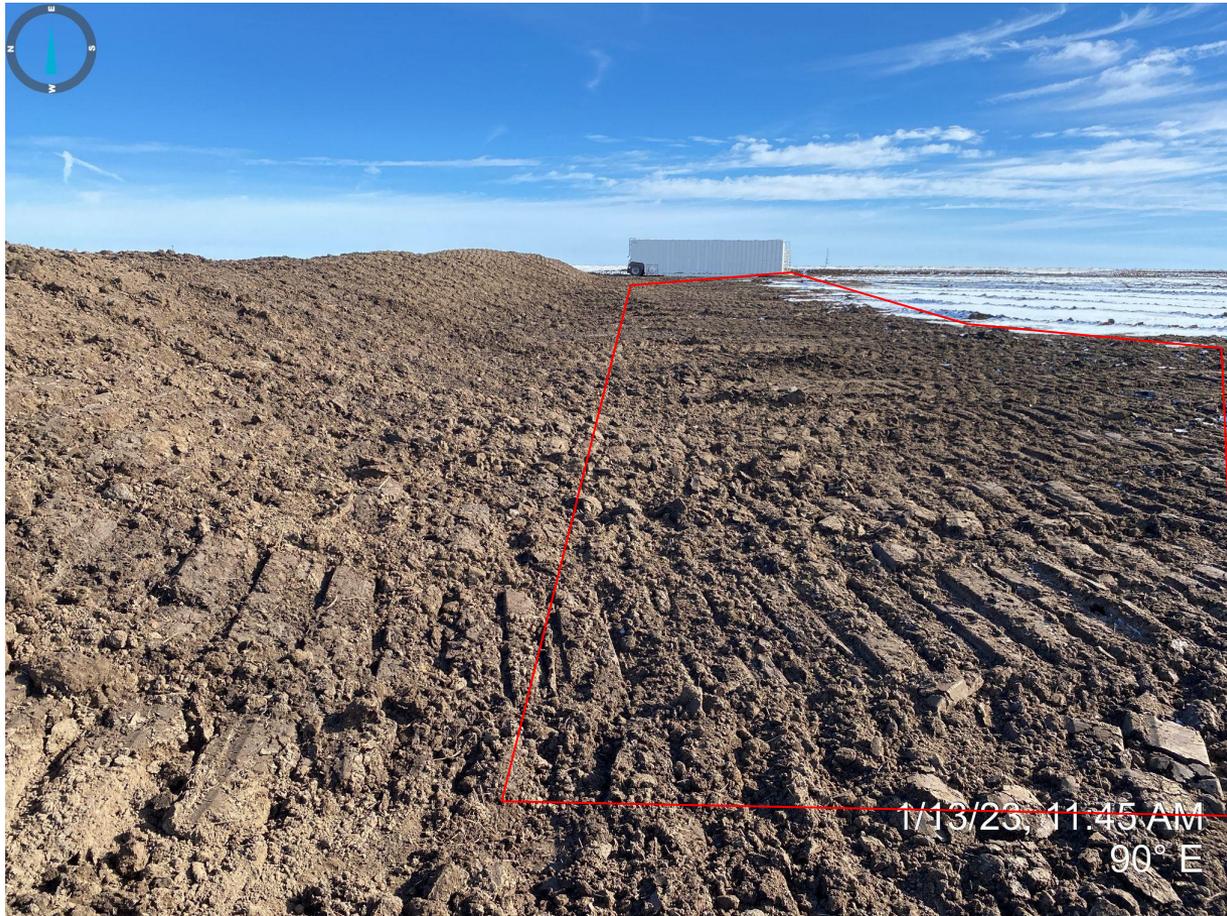
**Photo 13.** Facing east from the western portion of the topsoil stockpile. Photo illustrates that topsoil has been used as fill material and has not been completely segregated from the working pad surface. The red outlined shows the topsoil used as fill material. Snow cover is likely obscuring further evidence of topsoil used as fill material.

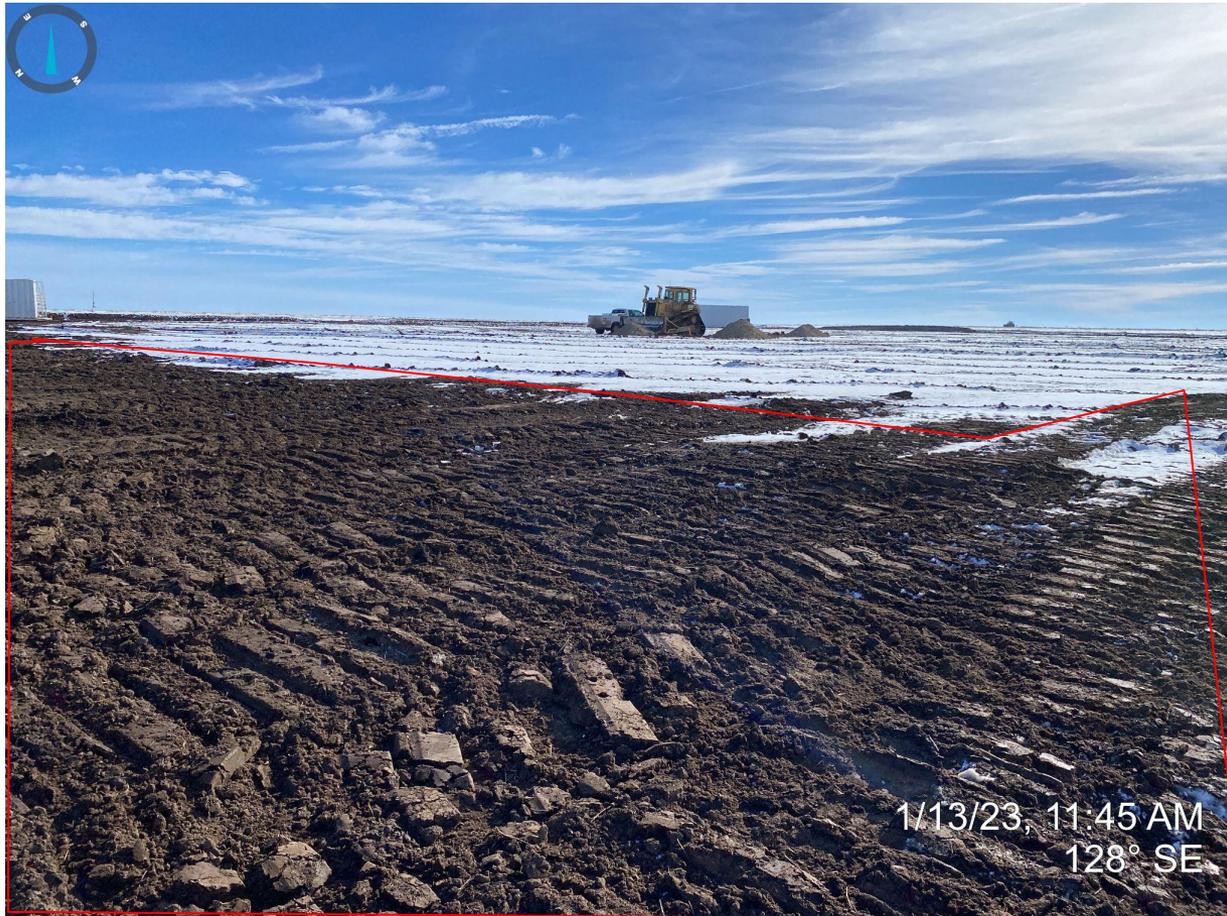
**Photo 14.** Facing southeast from western portion of the topsoil stockpile. See comments in Photo 13.

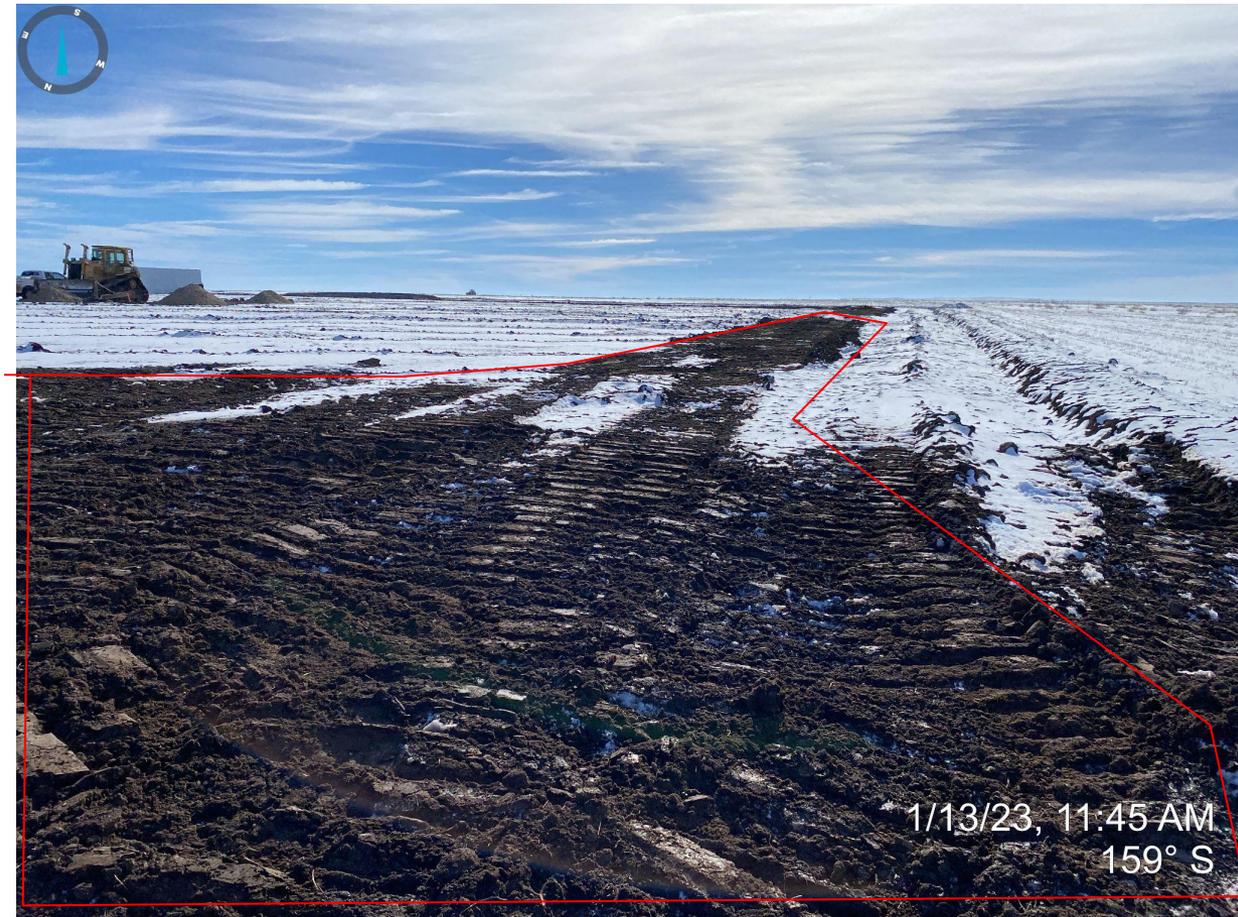
**Photo 15.** Facing south from the western portion of the topsoil stockpile. See comments in Photo 13.

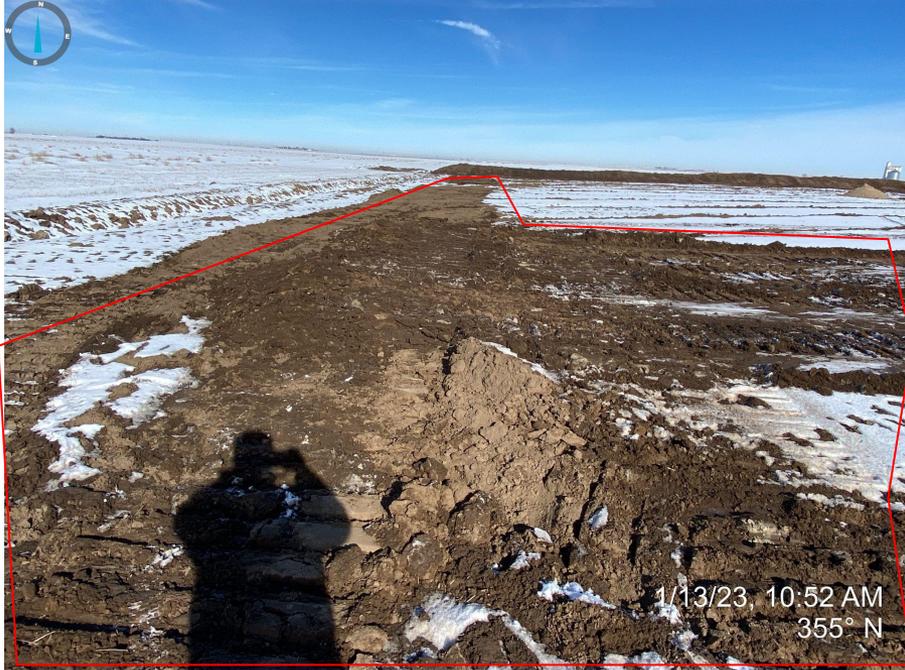
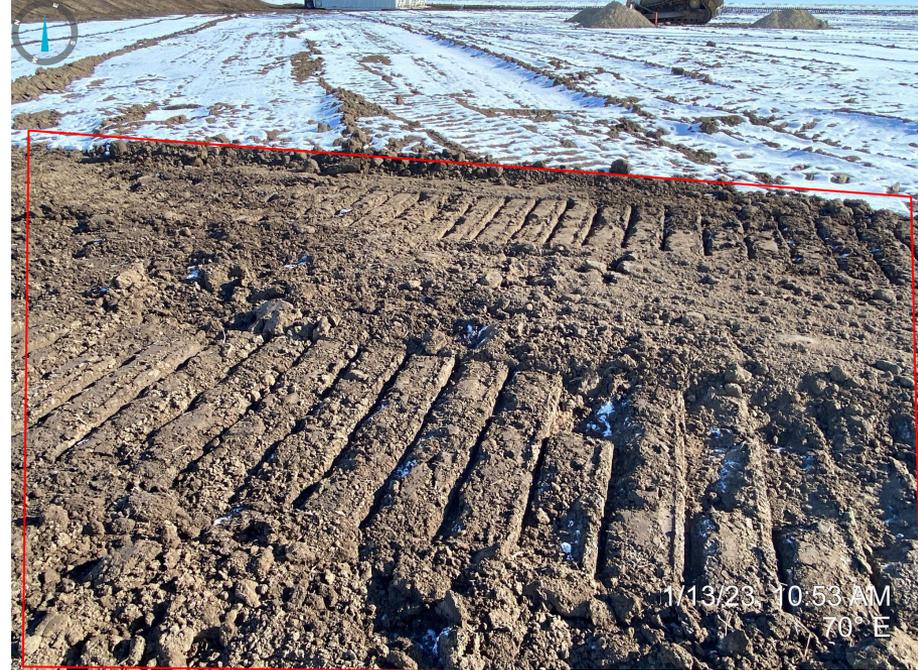
**Photos 16 & 17.** Facing north and east (close-up) from the western, middle portion of the location. See comments in Photo 13.

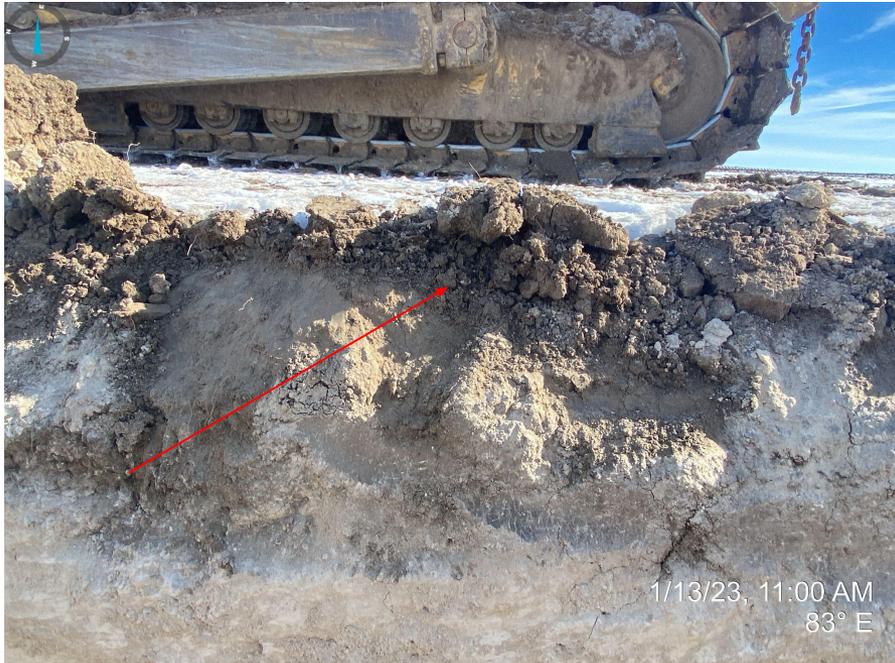
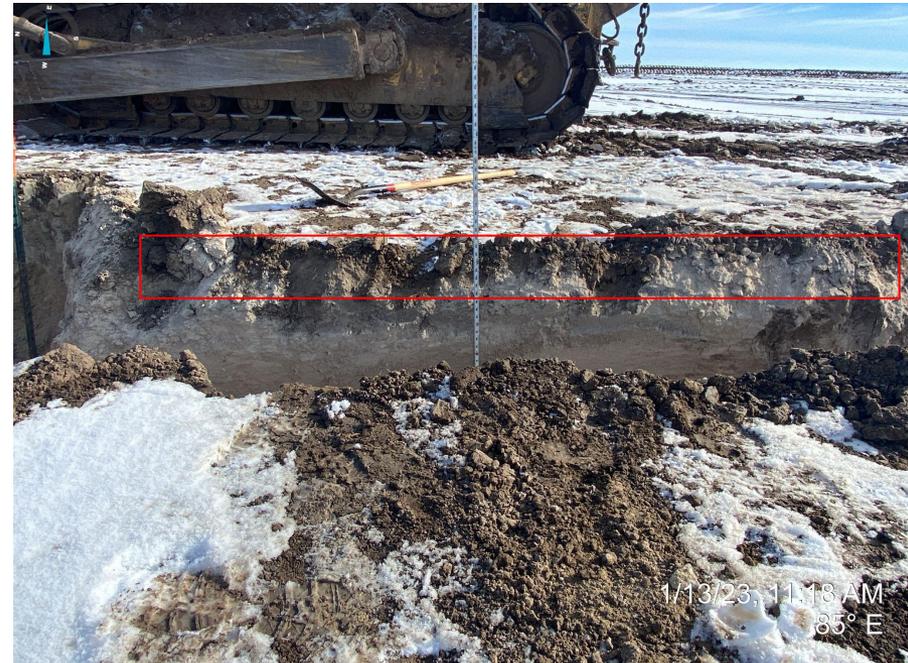
**Photos 18 & 19.** Facing east from the center of the location, near the proposed well location. Photo illustrates that all of the topsoil horizon has not been salvaged (the topsoil varies in depth throughout cross section). Red outlines show evidence of topsoil that has not been salvaged.

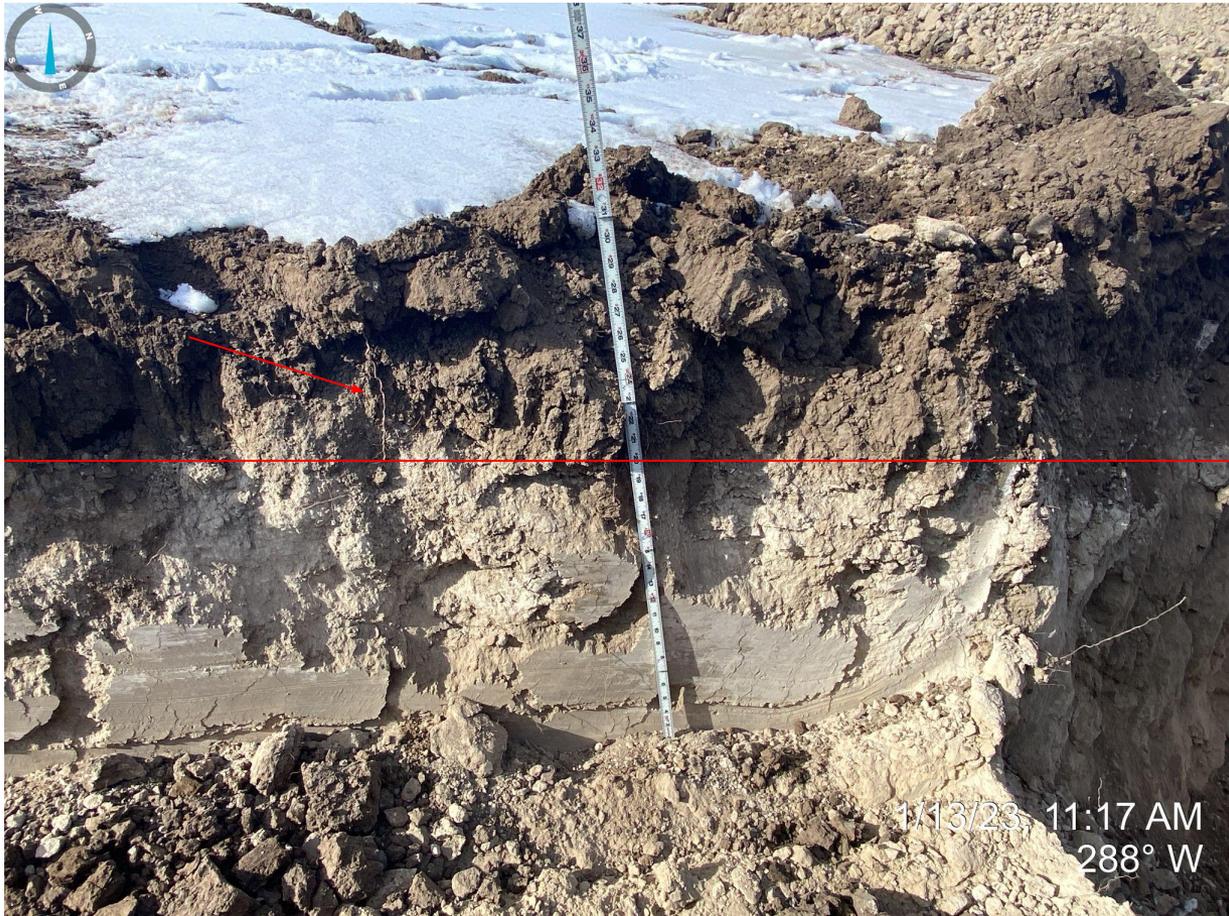
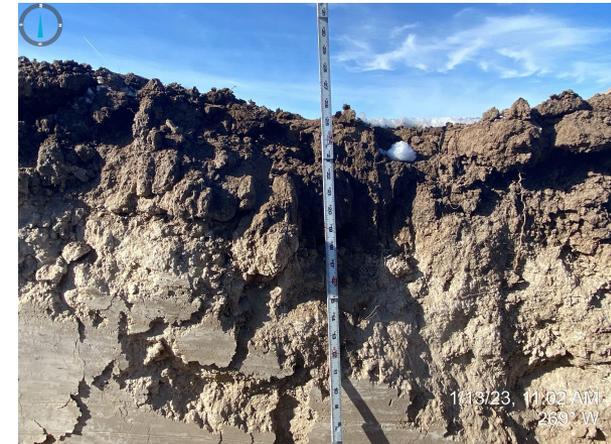
**Photos 20 & 21** . Facing west at the center of the location, near to proposed well location. Photo illustrates that additional topsoil needs to be salvaged as evidenced by presence of organic matter (e.g. roots) and distinct separations of soil horizons, approximated by red line that details changes in color, structure, and texture.
