Inspection Photos

Location Name: CAERUS PICEANCE LLC HILL-67S92W /16SWNW

Location ID: 334915

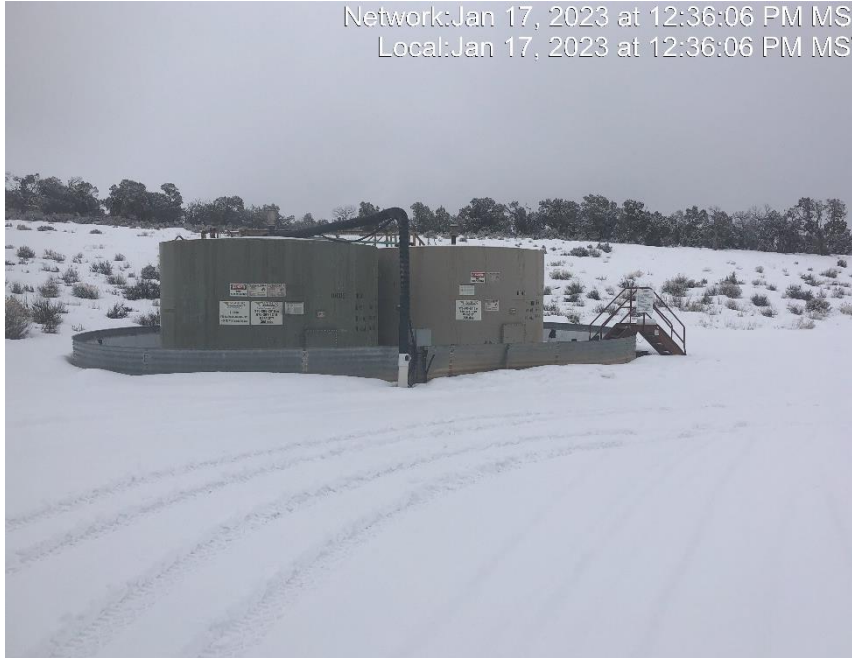
Photo #8800 From entrance to location.

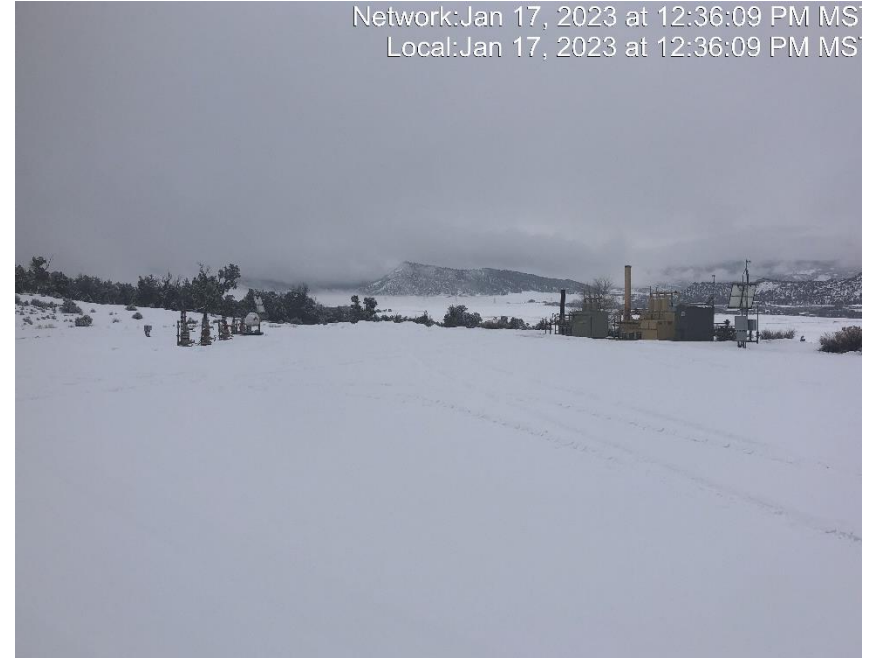
Photo #8801 From entrance to location

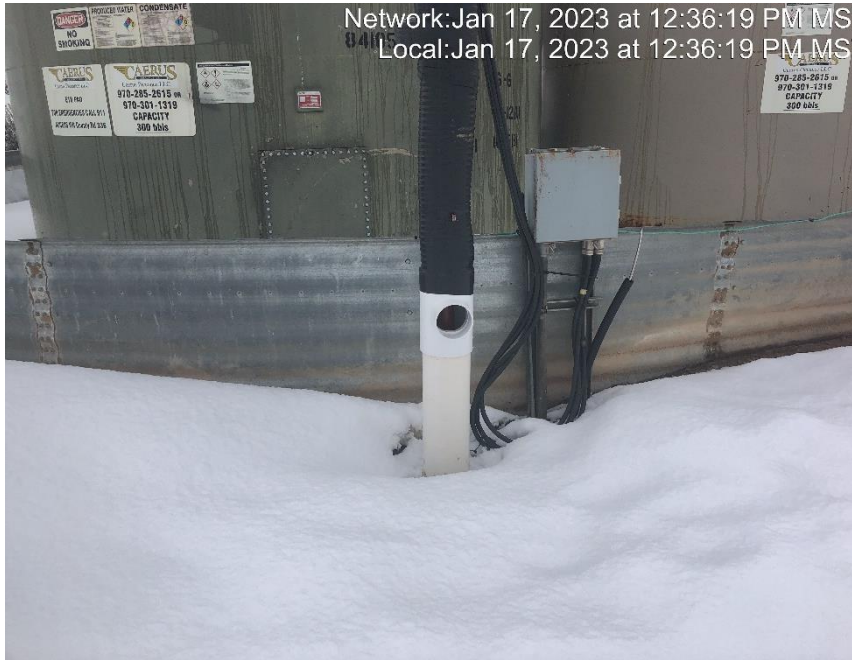
Photo #8802 Flowline heating insulation open ended.
