Construction and Stormwater Inspection

Date: 01/17/2023

Operator: ST CROIX OPERATING INC - 81490

Location ID: 474453

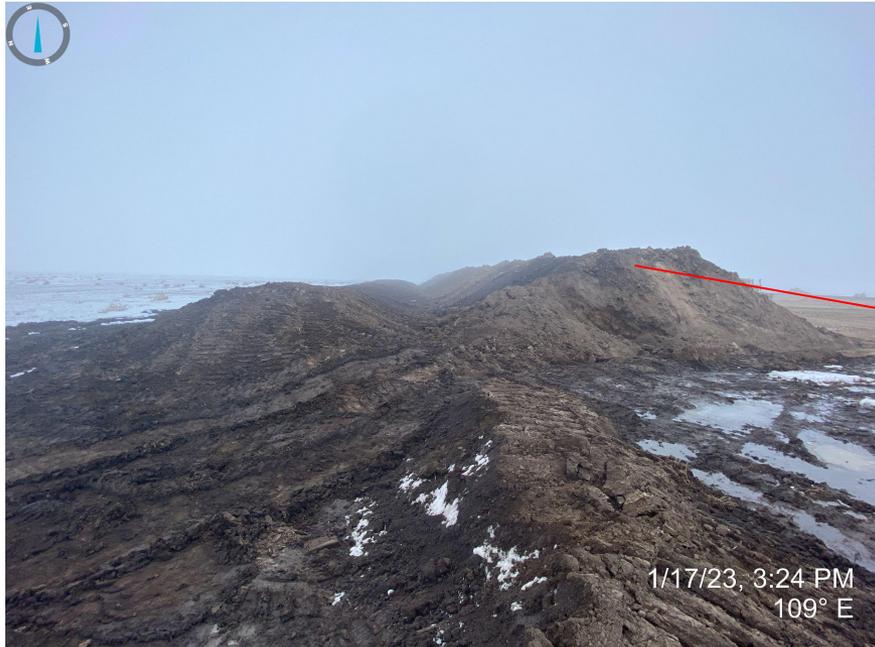
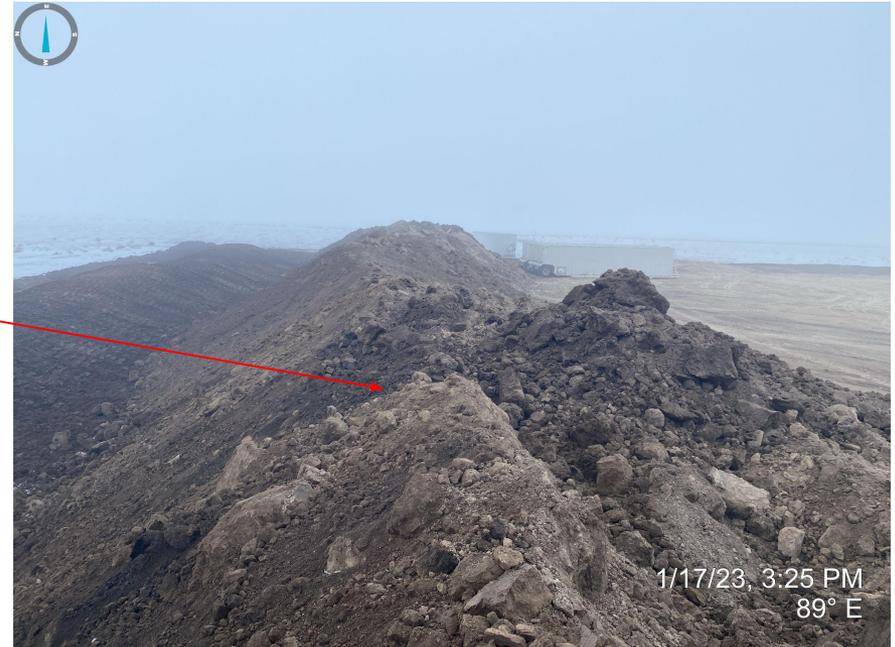
Photos 1 & 2. Facing east from the sediment trap (photo 1) and on top of topsoil stockpile (photo 2). The recently salvaged topsoil stockpile has been removed from the location and placed at the northern portion of the location. The new topsoil stockpile requires stabilization to prevent wind and water erosion.

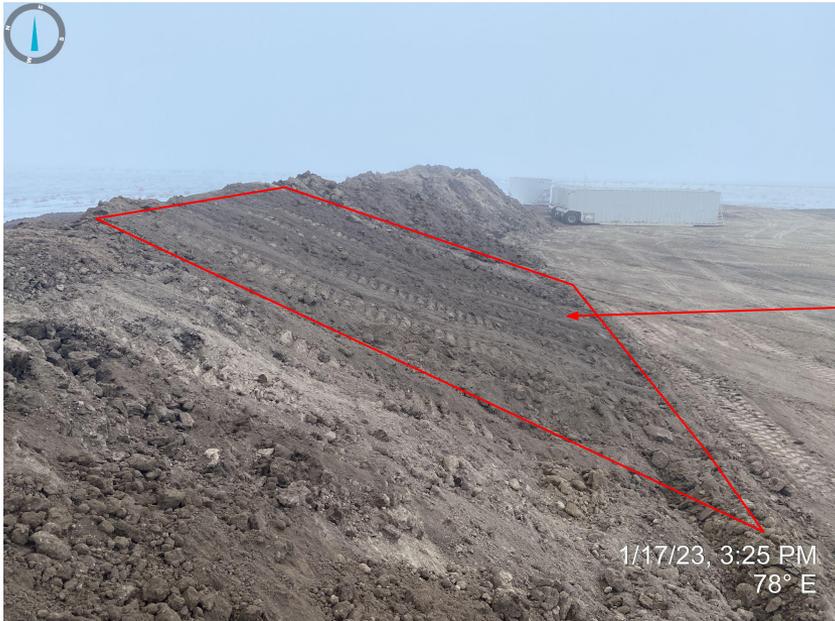
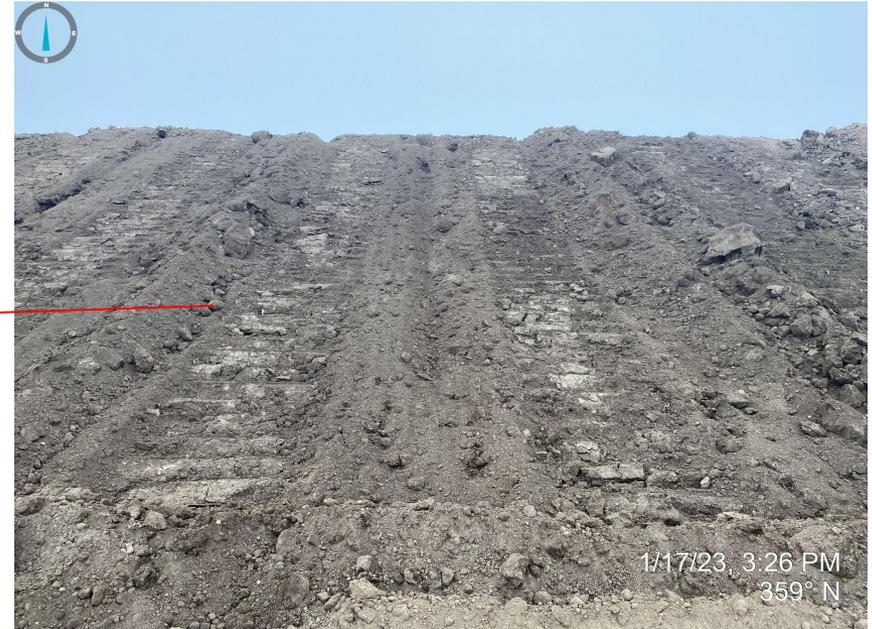
Photos 3 & 4. Facing east from the southern portion of the topsoil stockpile (photo 3) and north from the middle of the stockpile (photo 4). Photo illustrates that some temporary stabilization efforts have occurred with evidence of equipment tracking. The entire stockpile will need to be protected from wind and water erosion.

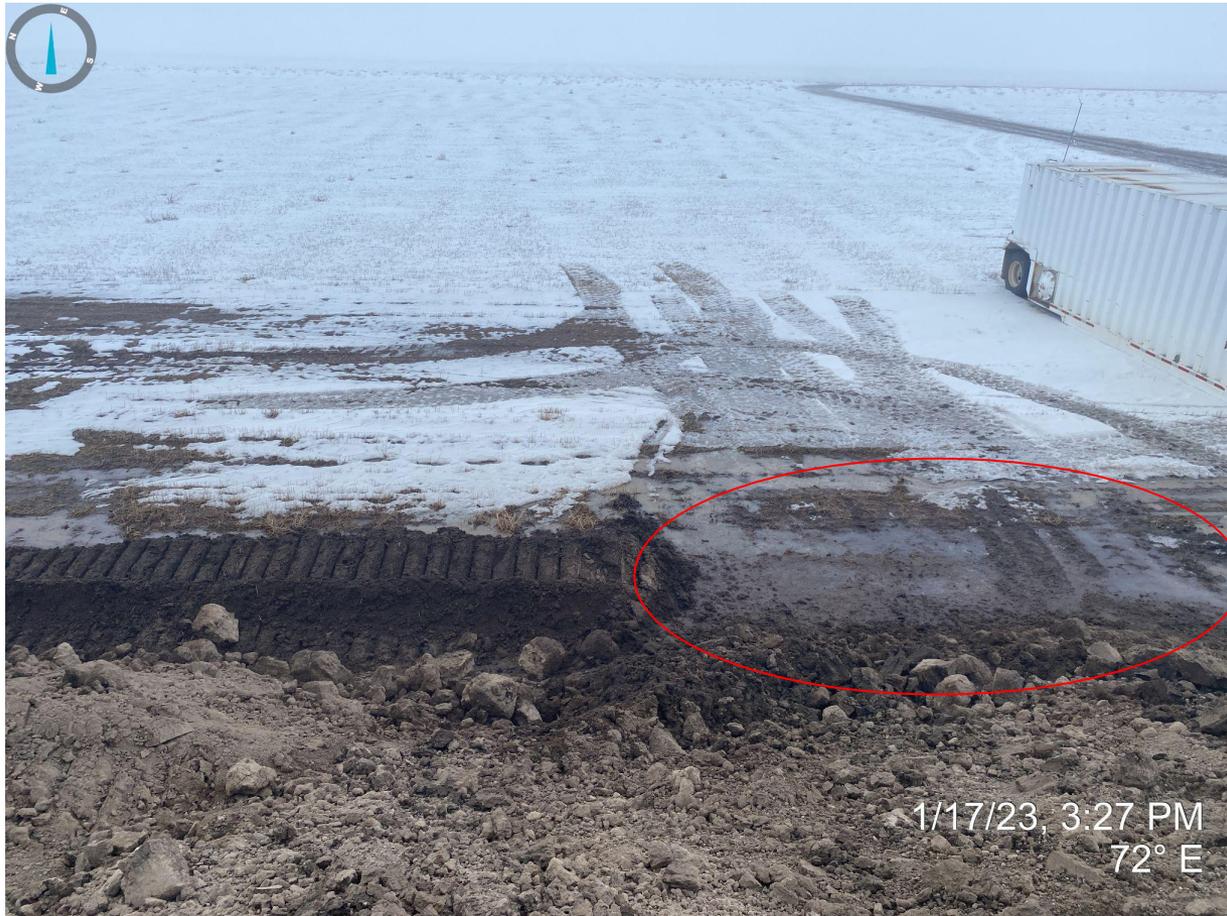
Photo 5. Facing east from the top of the new topsoil stockpile. Photo illustrates (red outline) that part of the perimeter berm has been uninstalled and will need to be re-installed to prevent sediment laden stormwater from exiting off location.

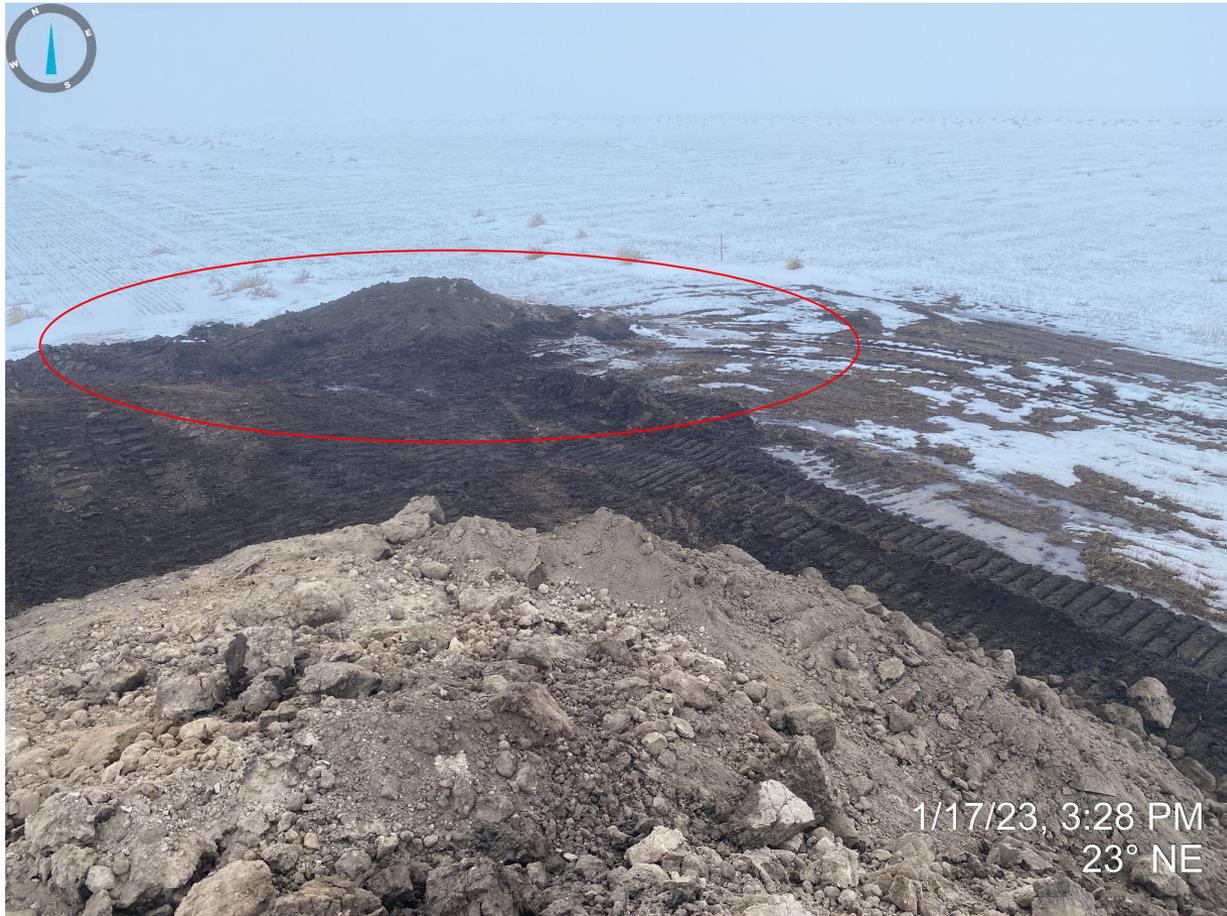
Photo 6. Facing northeast towards the northeast corner of the location. Photo illustrates that portions of the perimeter berm/BMP are comprised of unconsolidated material and not properly stabilized.

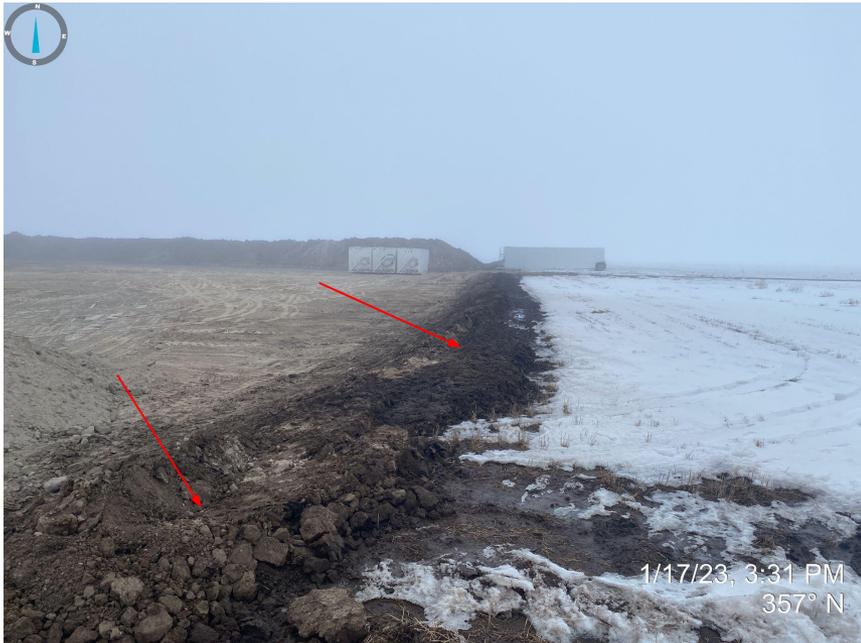
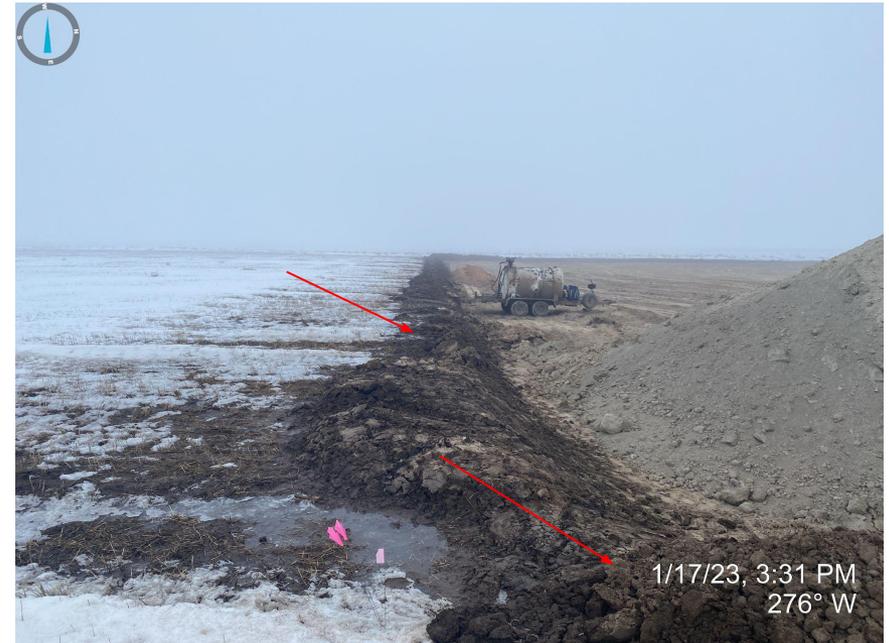
Photos 7 & 8. Facing north (photo 7) and west (photo 8) from the southeast corner of the location. Photo illustrates that portions of the perimeter berm/BMP are comprised of unconsolidated material and not properly stabilized.

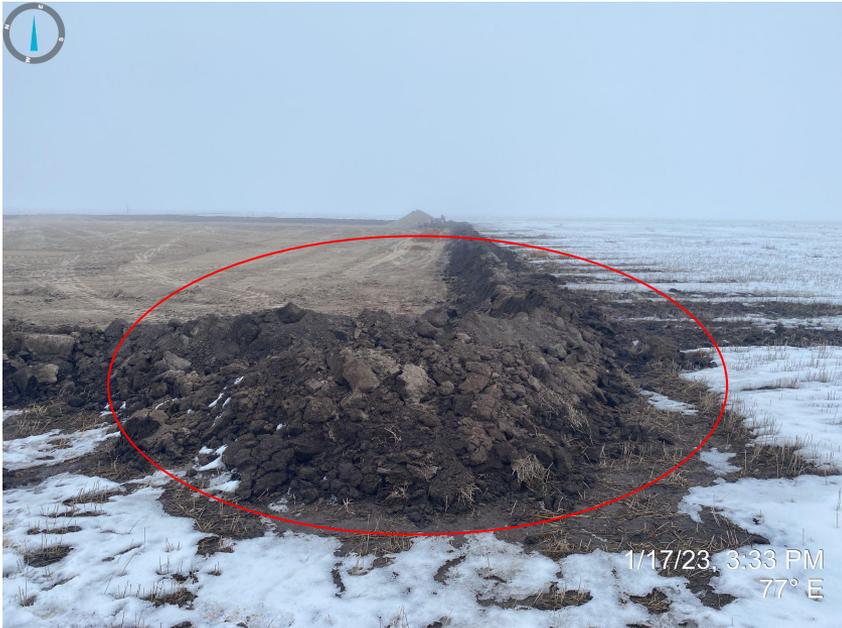
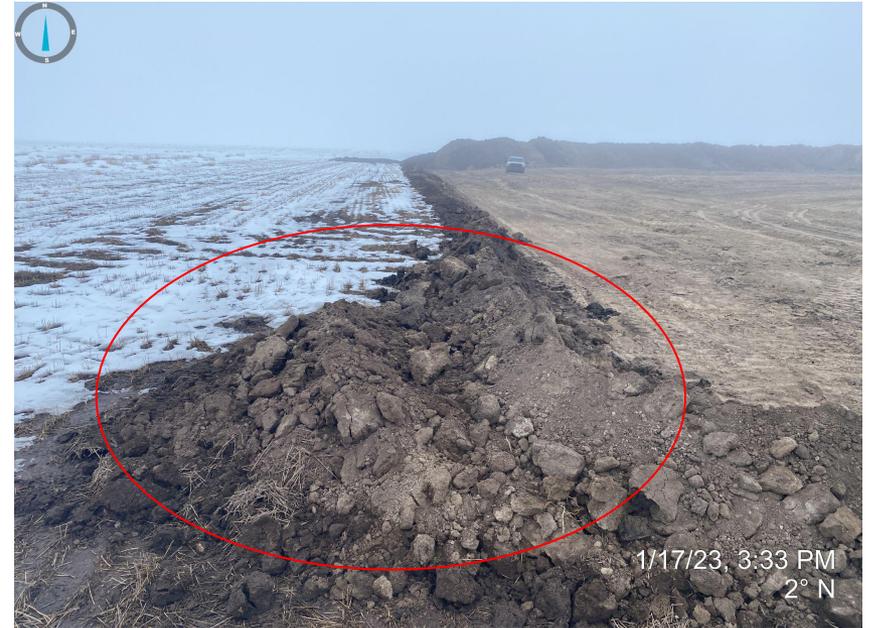
Photos 9 & 10. Facing east (photo 9) and north (photo 10) from the southwestern portion of the location. Photo illustrates that portions of the perimeter berm/BMP are comprised of unconsolidated material and not properly stabilized.

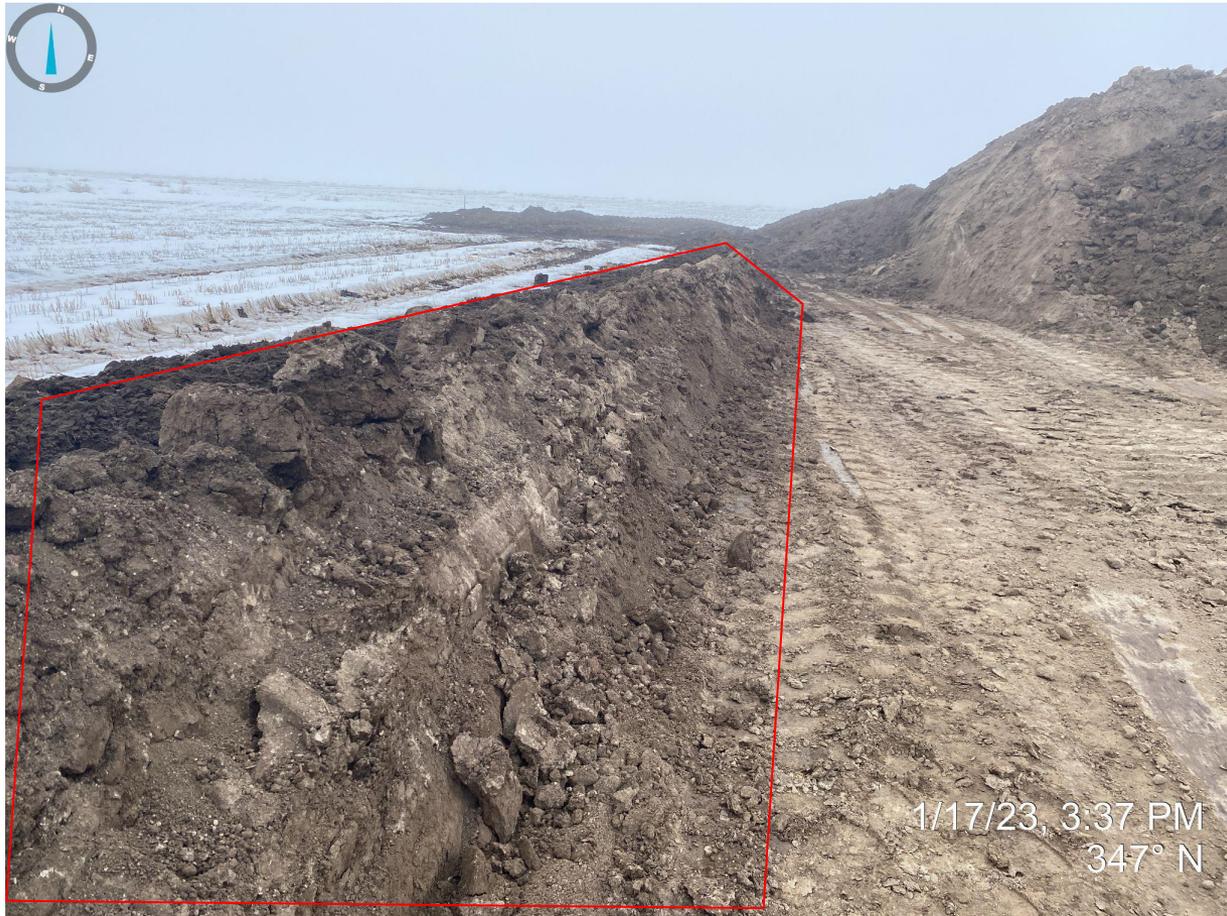
Photo 11. Facing north near the northwest corner of the location. Photo illustrates that portions of the perimeter berm/BMP are comprised of unconsolidated material and not properly stabilized.

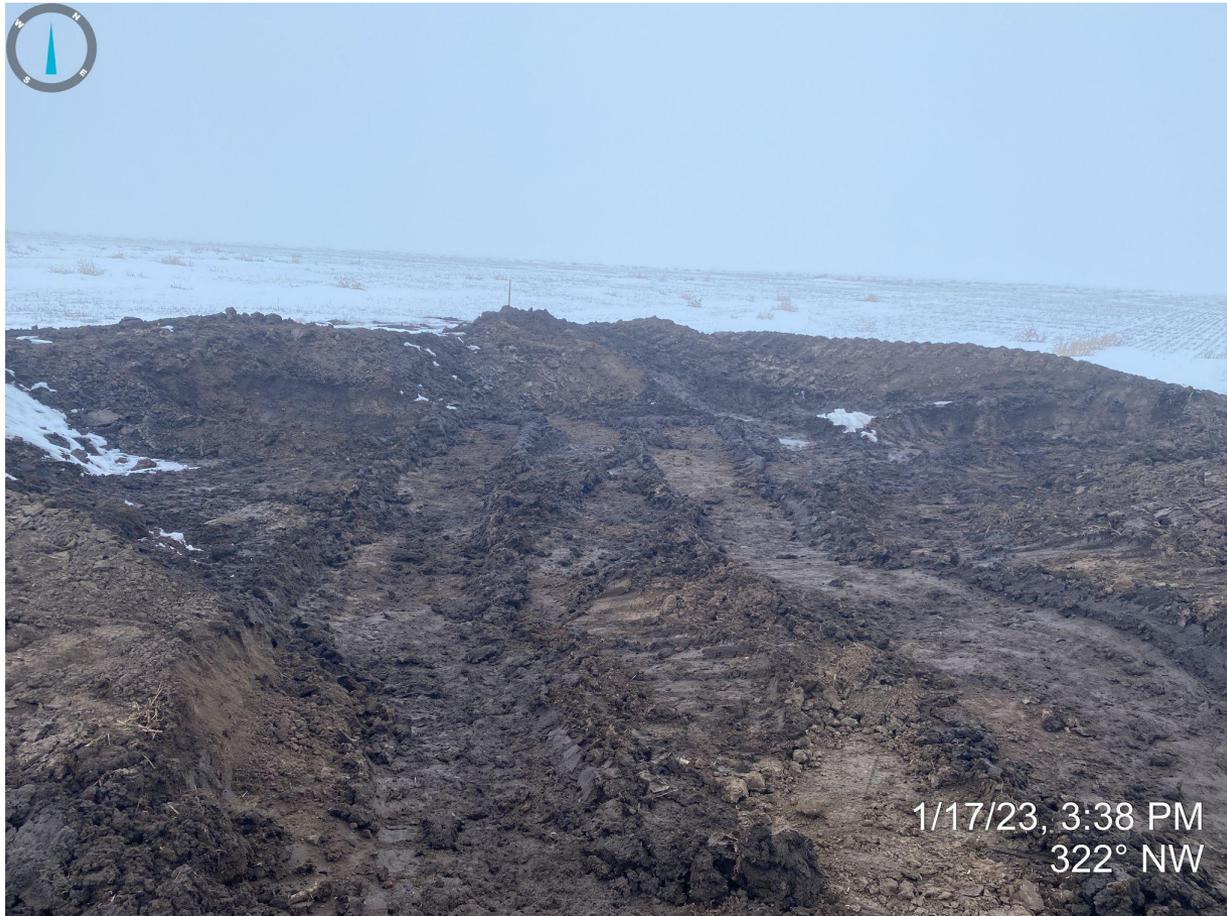
Photo 12. Facing northwest from the northwest corner of the location. Photo illustrates that the sediment trap is comprised of unconsolidated material and is not properly stabilized.

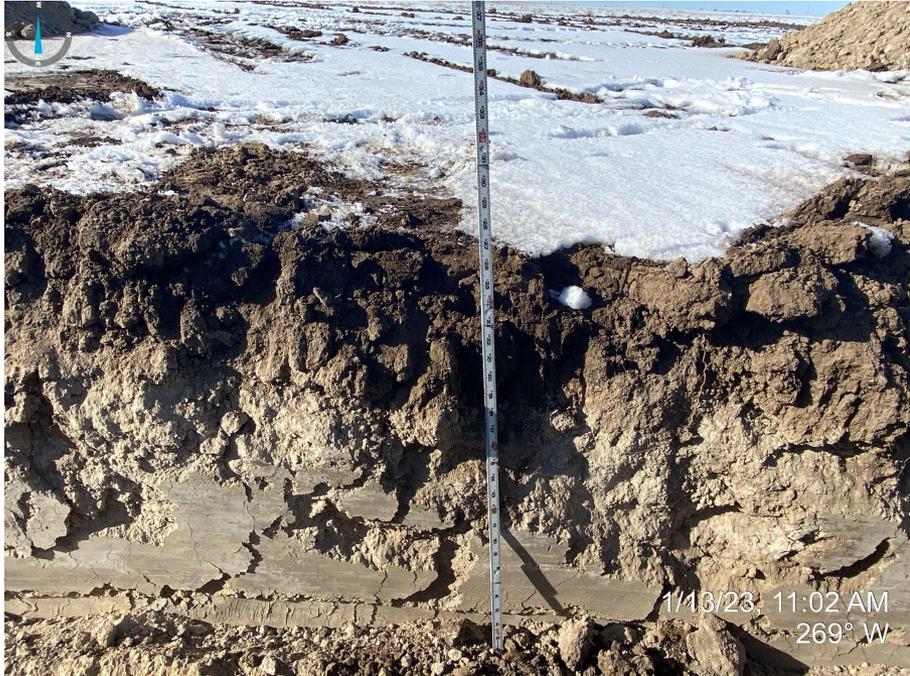
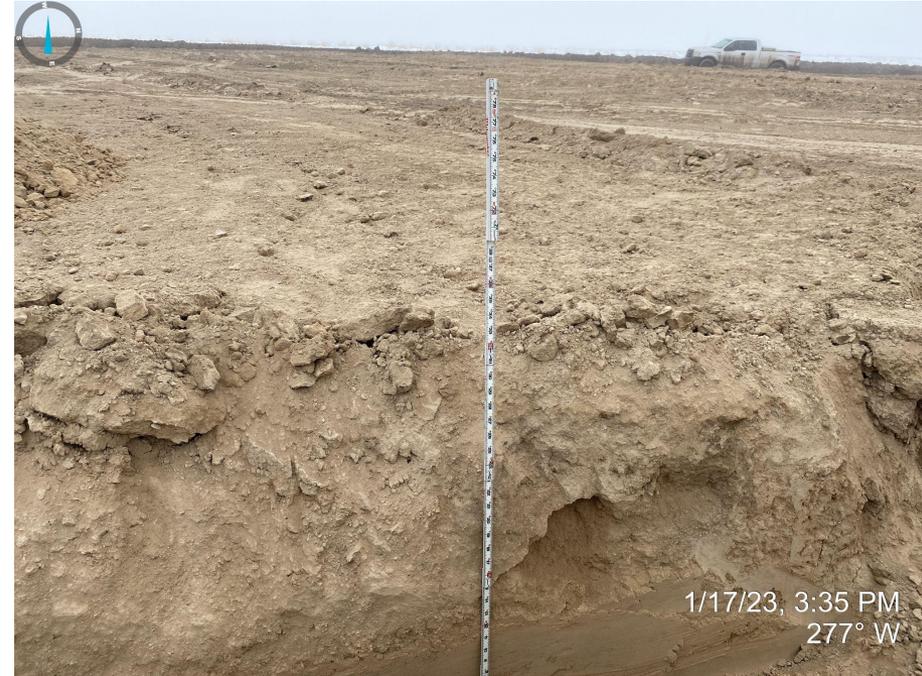
Photo 13 & 14. Photo 13 (left) taken on a 01/13/2023 inspection illustrating that several inches of topsoil remained on location; a corrective action required the operator to remove all topsoil on location. Photo 14 (right) taken 01/17/2023 illustrating that the operator has complied with the corrective action to remove the remainder of the topsoil layer/horizon.
