# Interim Reclamation and Stormwater Inspection

Operator: IMPERTO RESOURCES LLC - 10690

Location ID: 317038

Inspection Photos  
Location Name: Ray Walters  
Location ID: 317038

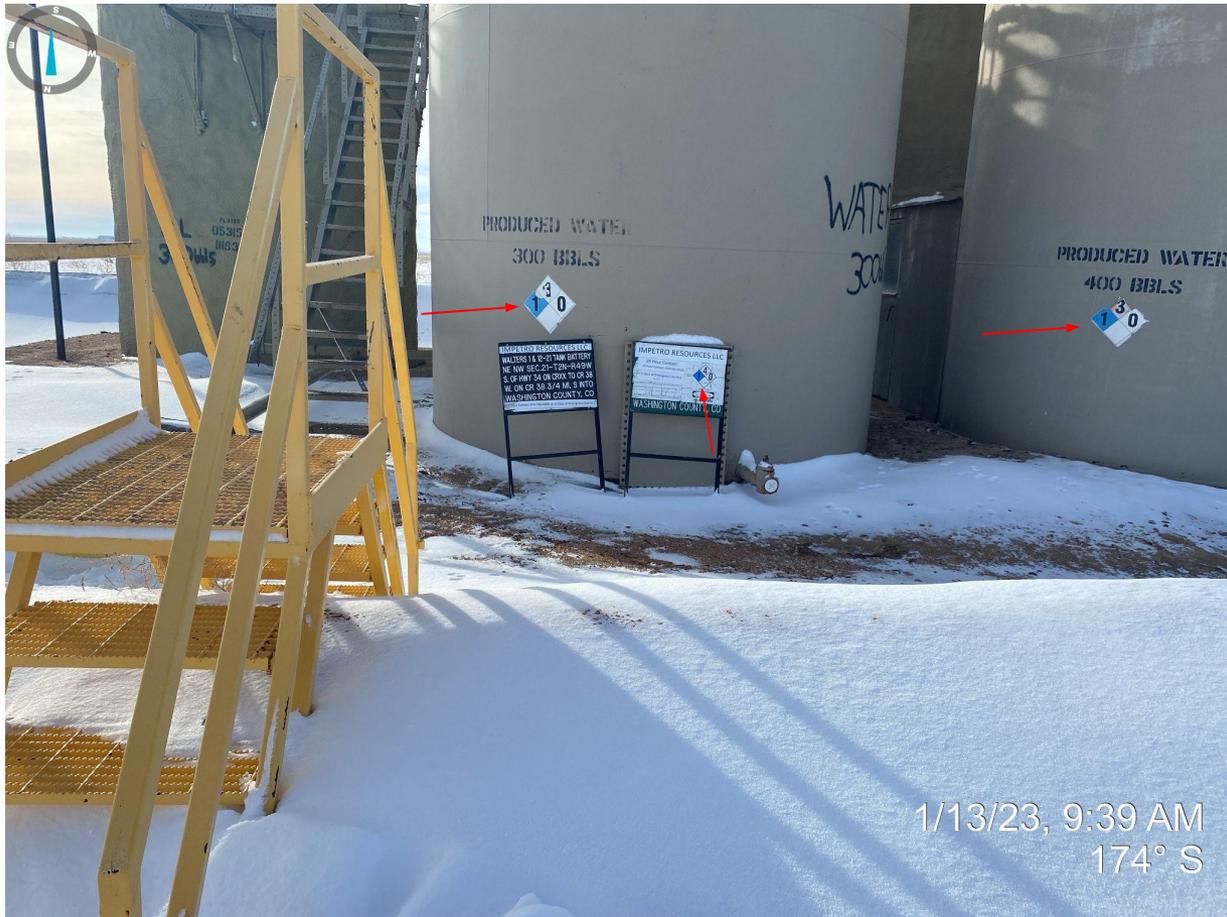
**Photo 1.** Facing south at tank battery. Tank NFPA placards are faded, cracking, and not legible.

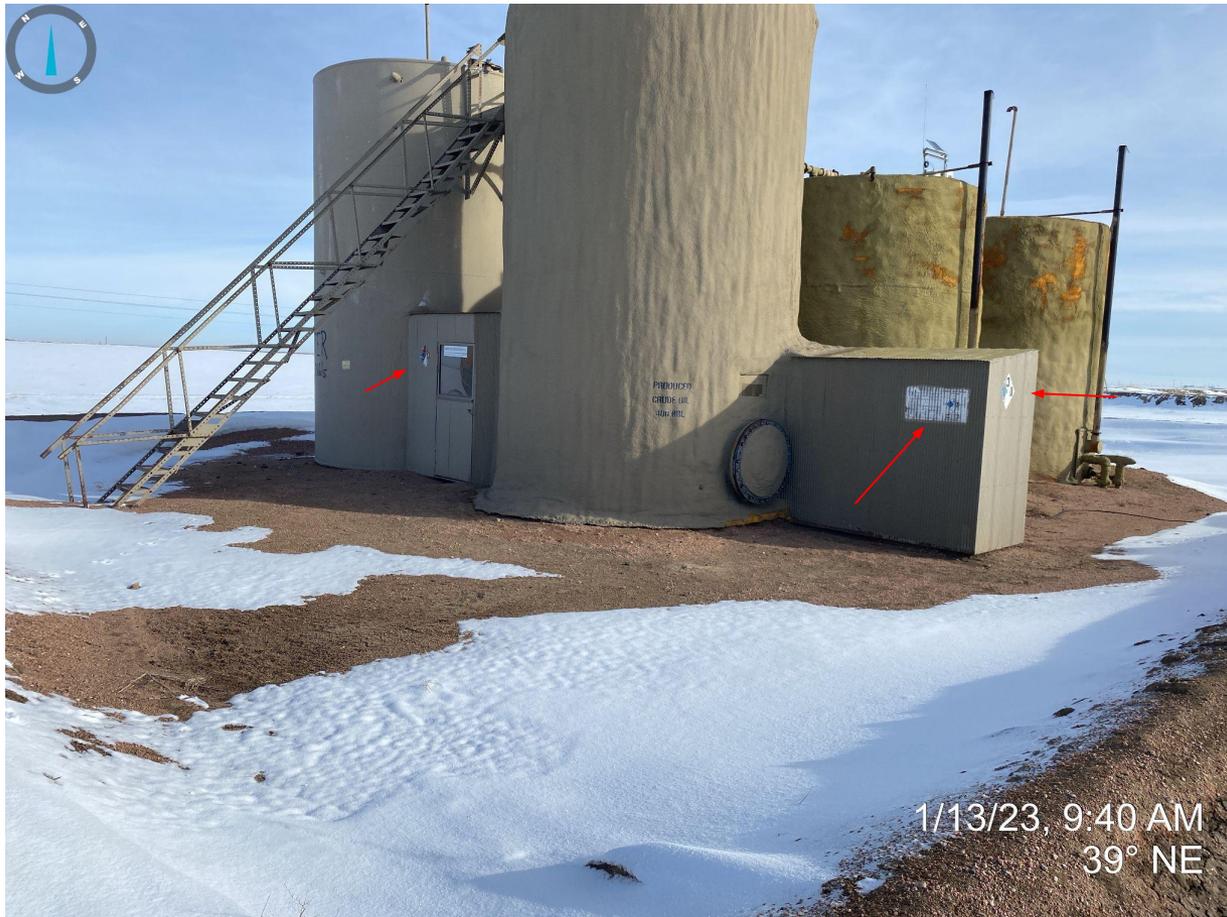
**Photo 2.** Facing northeast at tank battery. Tank NFPA placards are faded, cracking, and not legible.

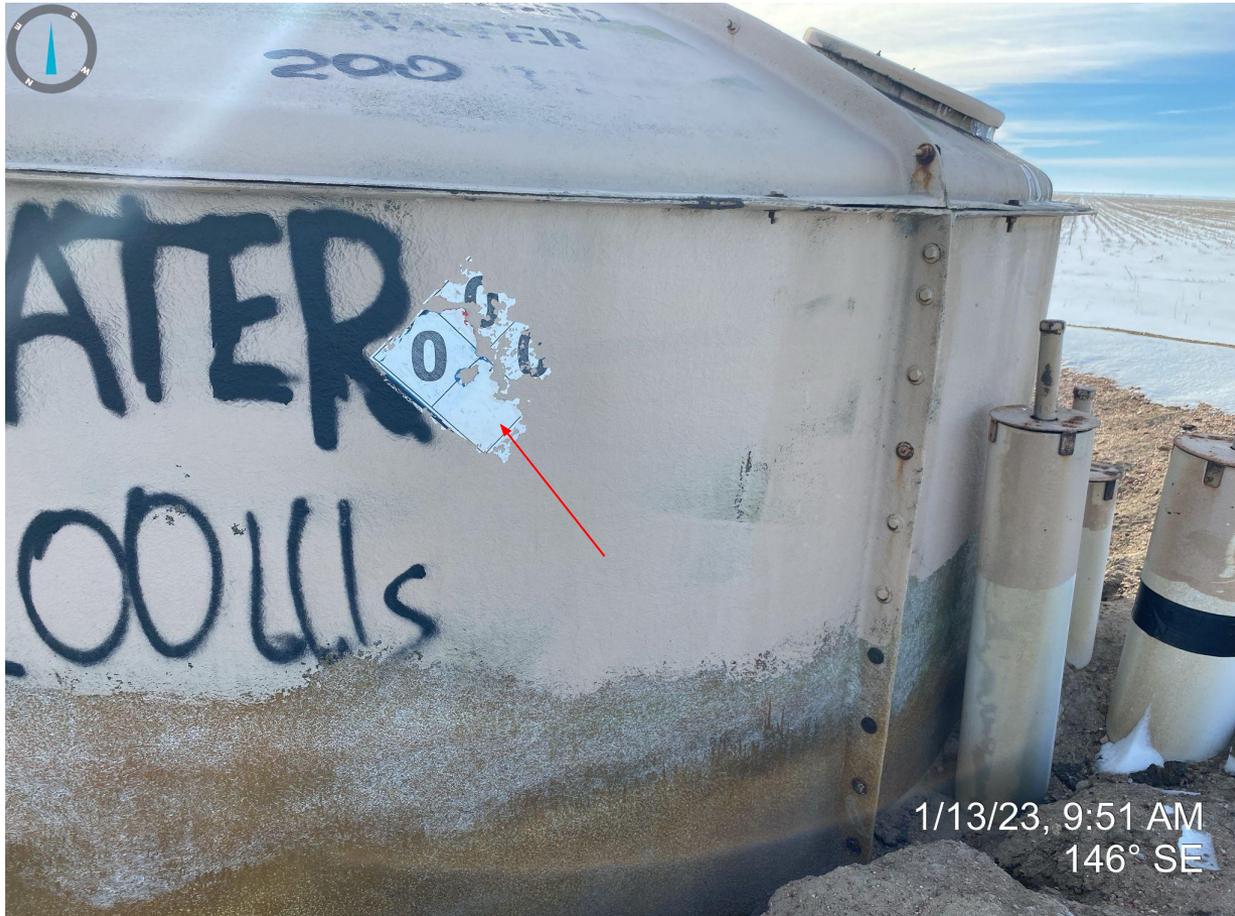
**Photo 3.** Facing southeast at produced water tank. Tank NFPA placards are faded, cracking, and not legible.

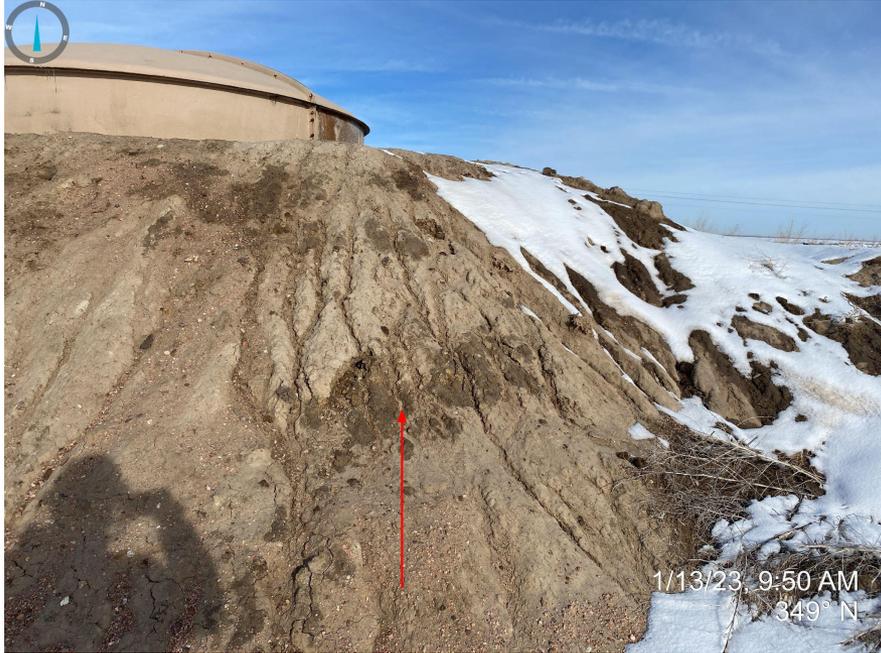
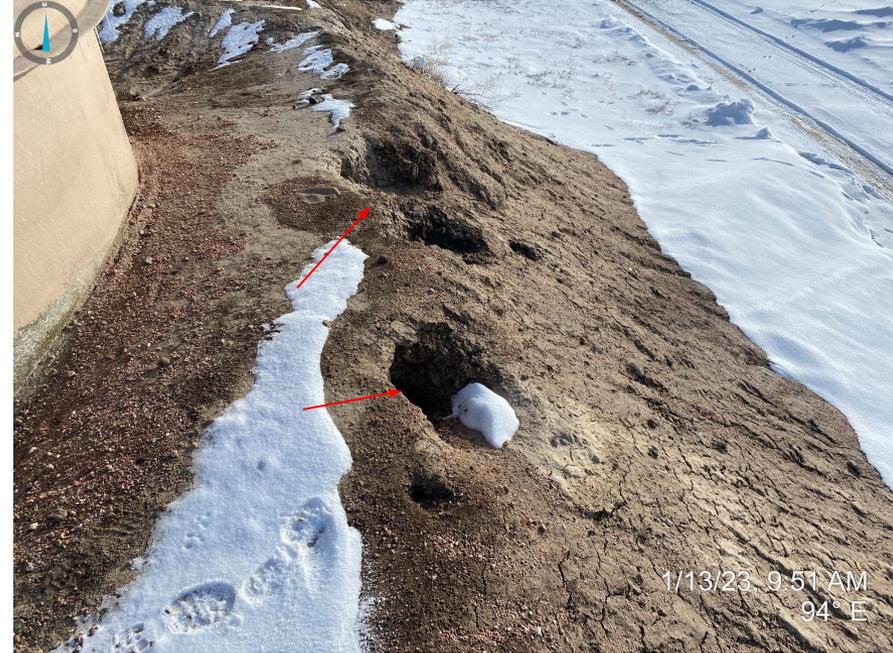
**Photos 4 & 5.** Facing north and east from the produced water tank. Evidence of rill erosion and animal burrows observed on the earthen berms.

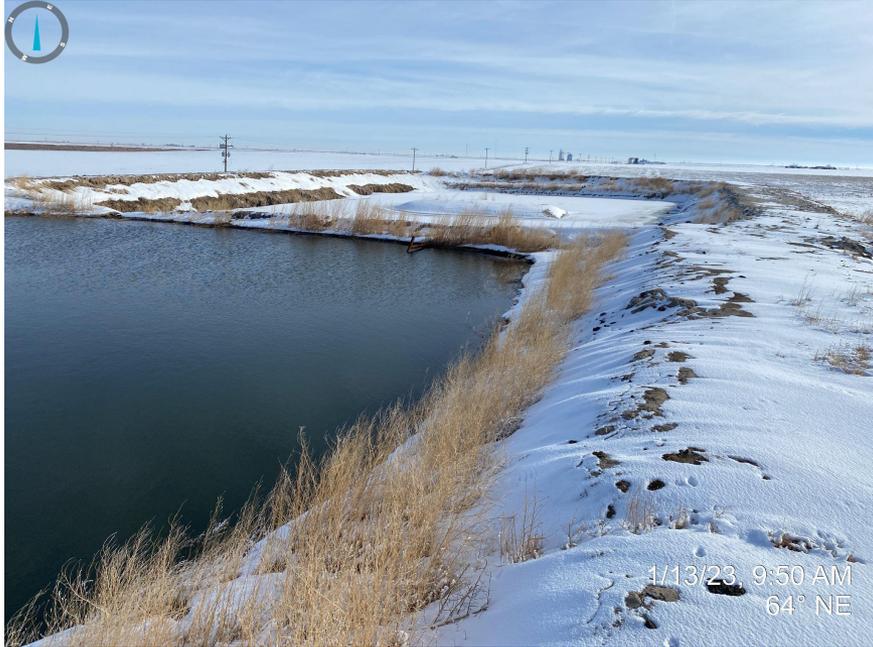
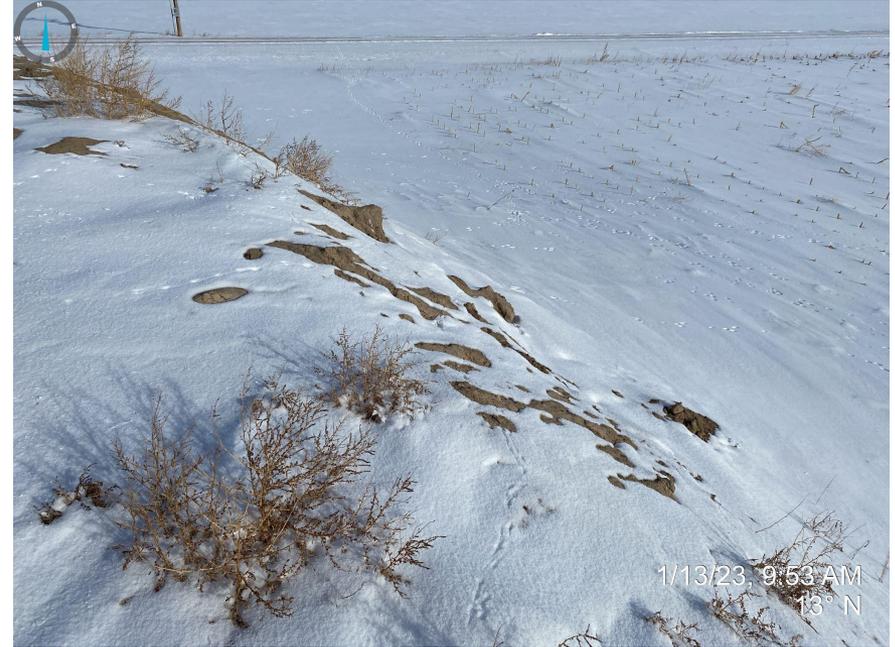
**Photos 6 & 7.** Facing northeast and north from produced water pits. Undesirable weedy vegetation observed throughout the location; weeds are now considered debris and need to be removed/managed.

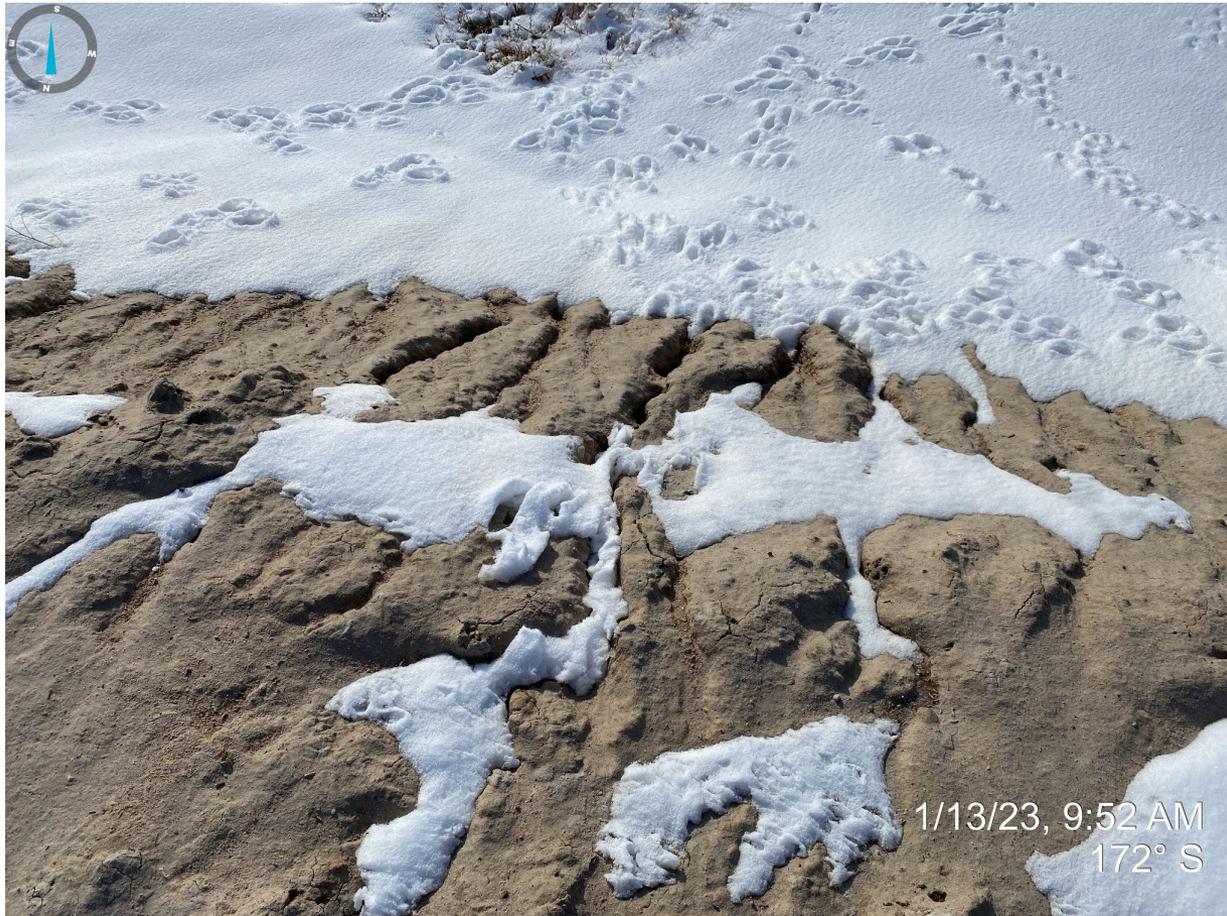
**Photo 8.** Facing south from the eastern portion of the pit walls. Photo illustrates that the pit walls have evidence of rill erosion. Due to snow cover, it is uncertain whether or not sediment laden stormwater has exited off location. This location will be inspected at a future date to reassess conditions.

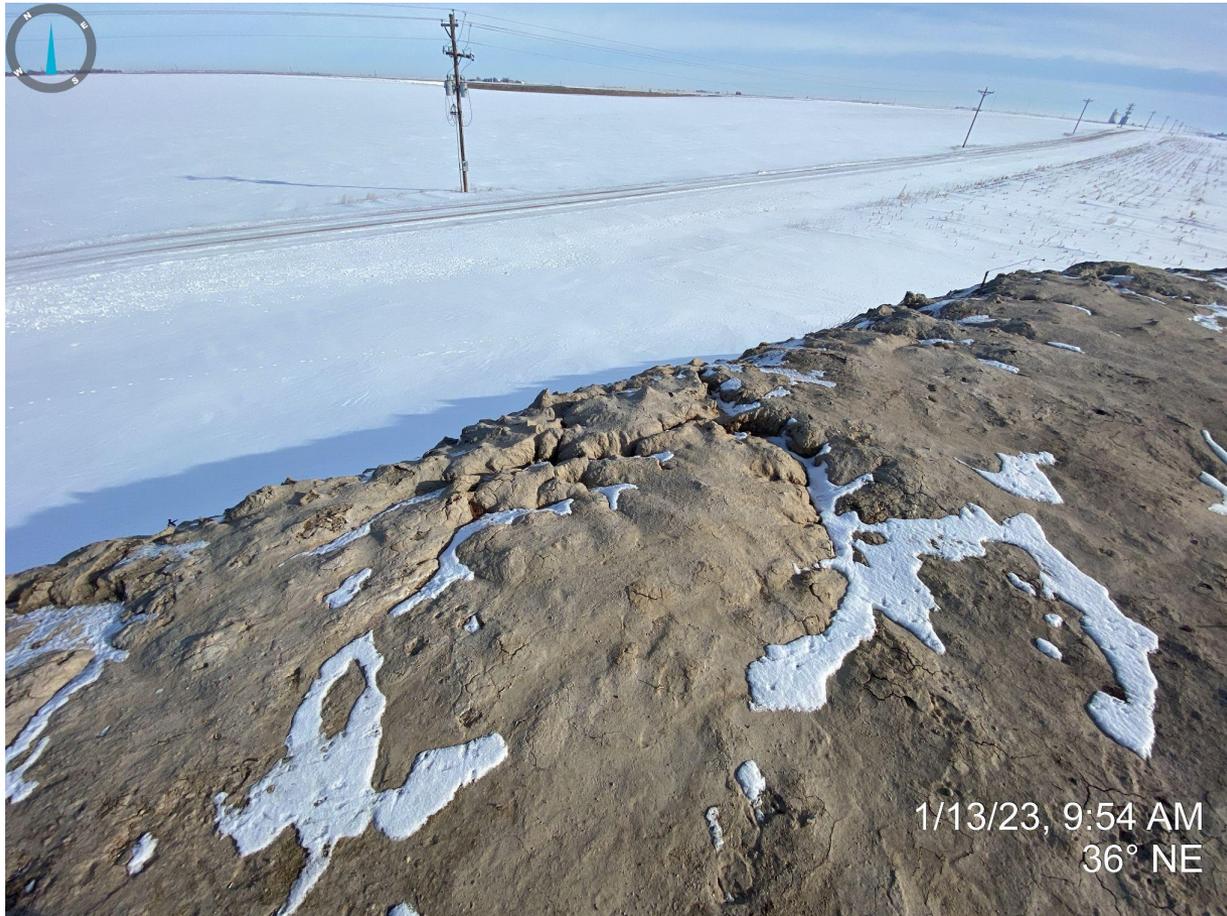
**Photo 9.** Facing northeast near the northeast corner of the pit. See comments in Photo 8.

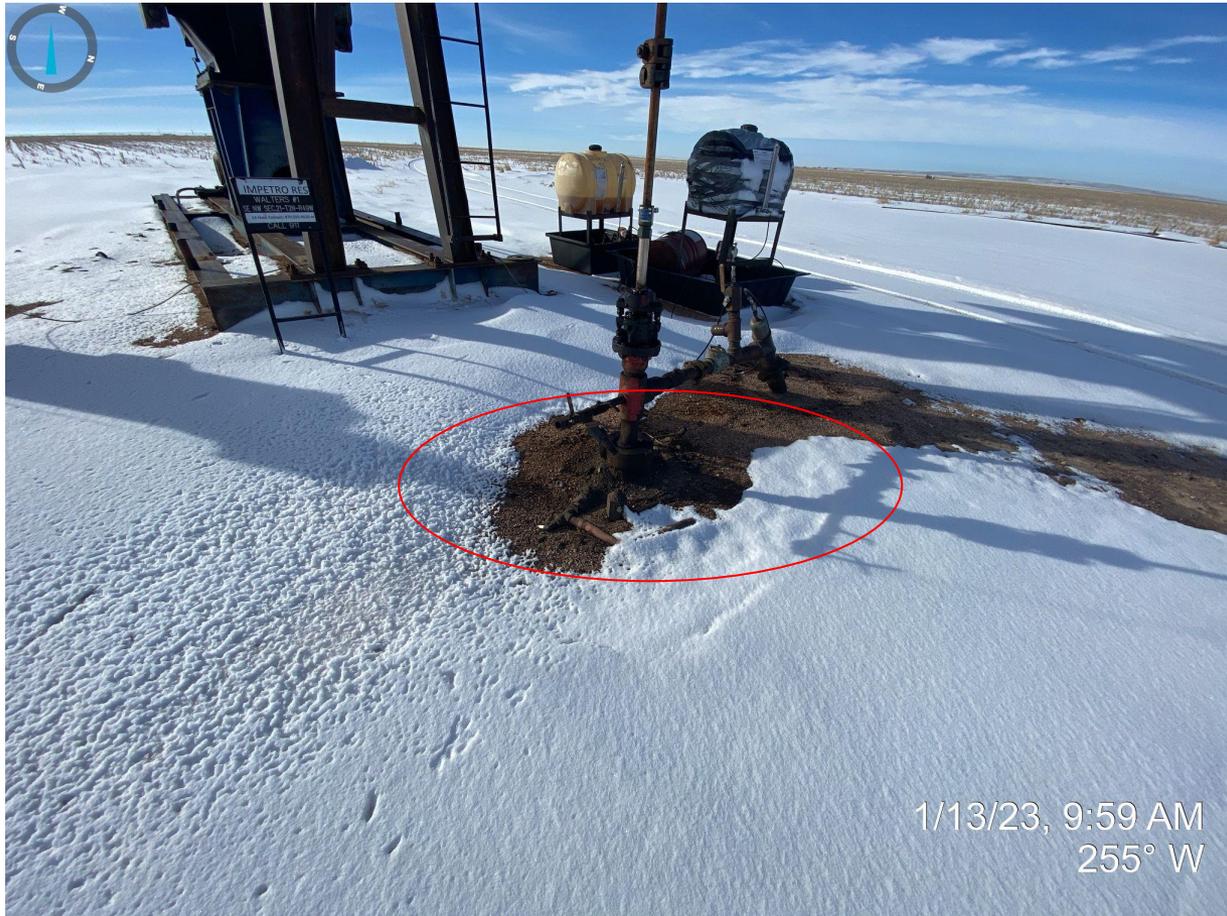
**Photo 10.** Facing west at the wellhead. Photo illustrates oily stained soil that will need to properly cleaned up.

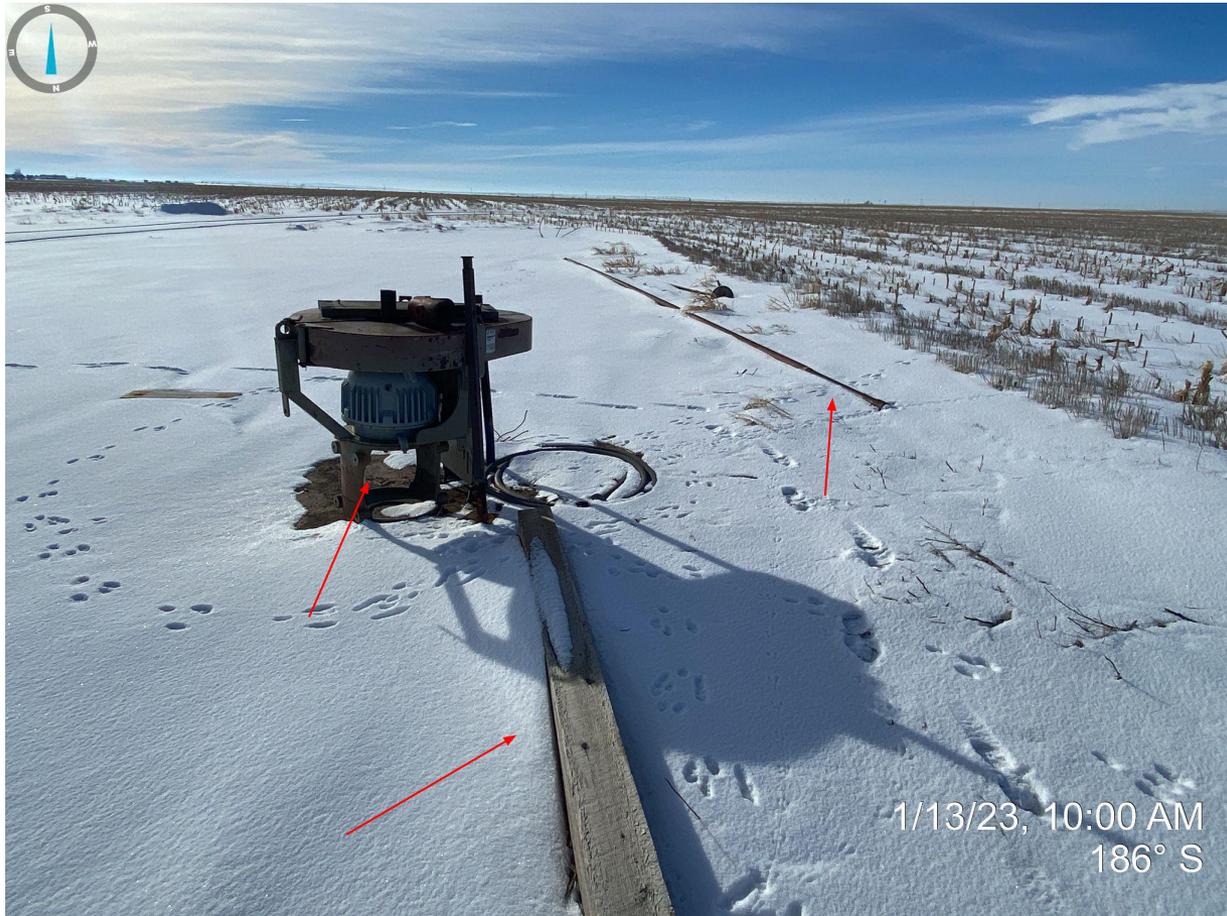
**Photo 11.** Facing south near the wellhead. Photo illustrates unused equipment being stored on location. This equipment will need to be removed.
